**Re: Summary of 2012 Site Activities
Former DuPont Barksdale Explosives Plant
BRRTS No. 02-0400156**

Attached is the field work summary report provided to DuPont CRG by URS Corporation. The report includes work activities performed during the 2012 field season at the Former DuPont Barksdale Works site.

- Figure 1 – Site Location
- Figure 2 – 2012 Field Work Locations
- Figure 3 – 2012 Delineation Field Work Locations
- Figure 4 – 2012 Surficial NNOC Mapping Sites
- Figure 5 – 2012 Surface Water Sampling Sites

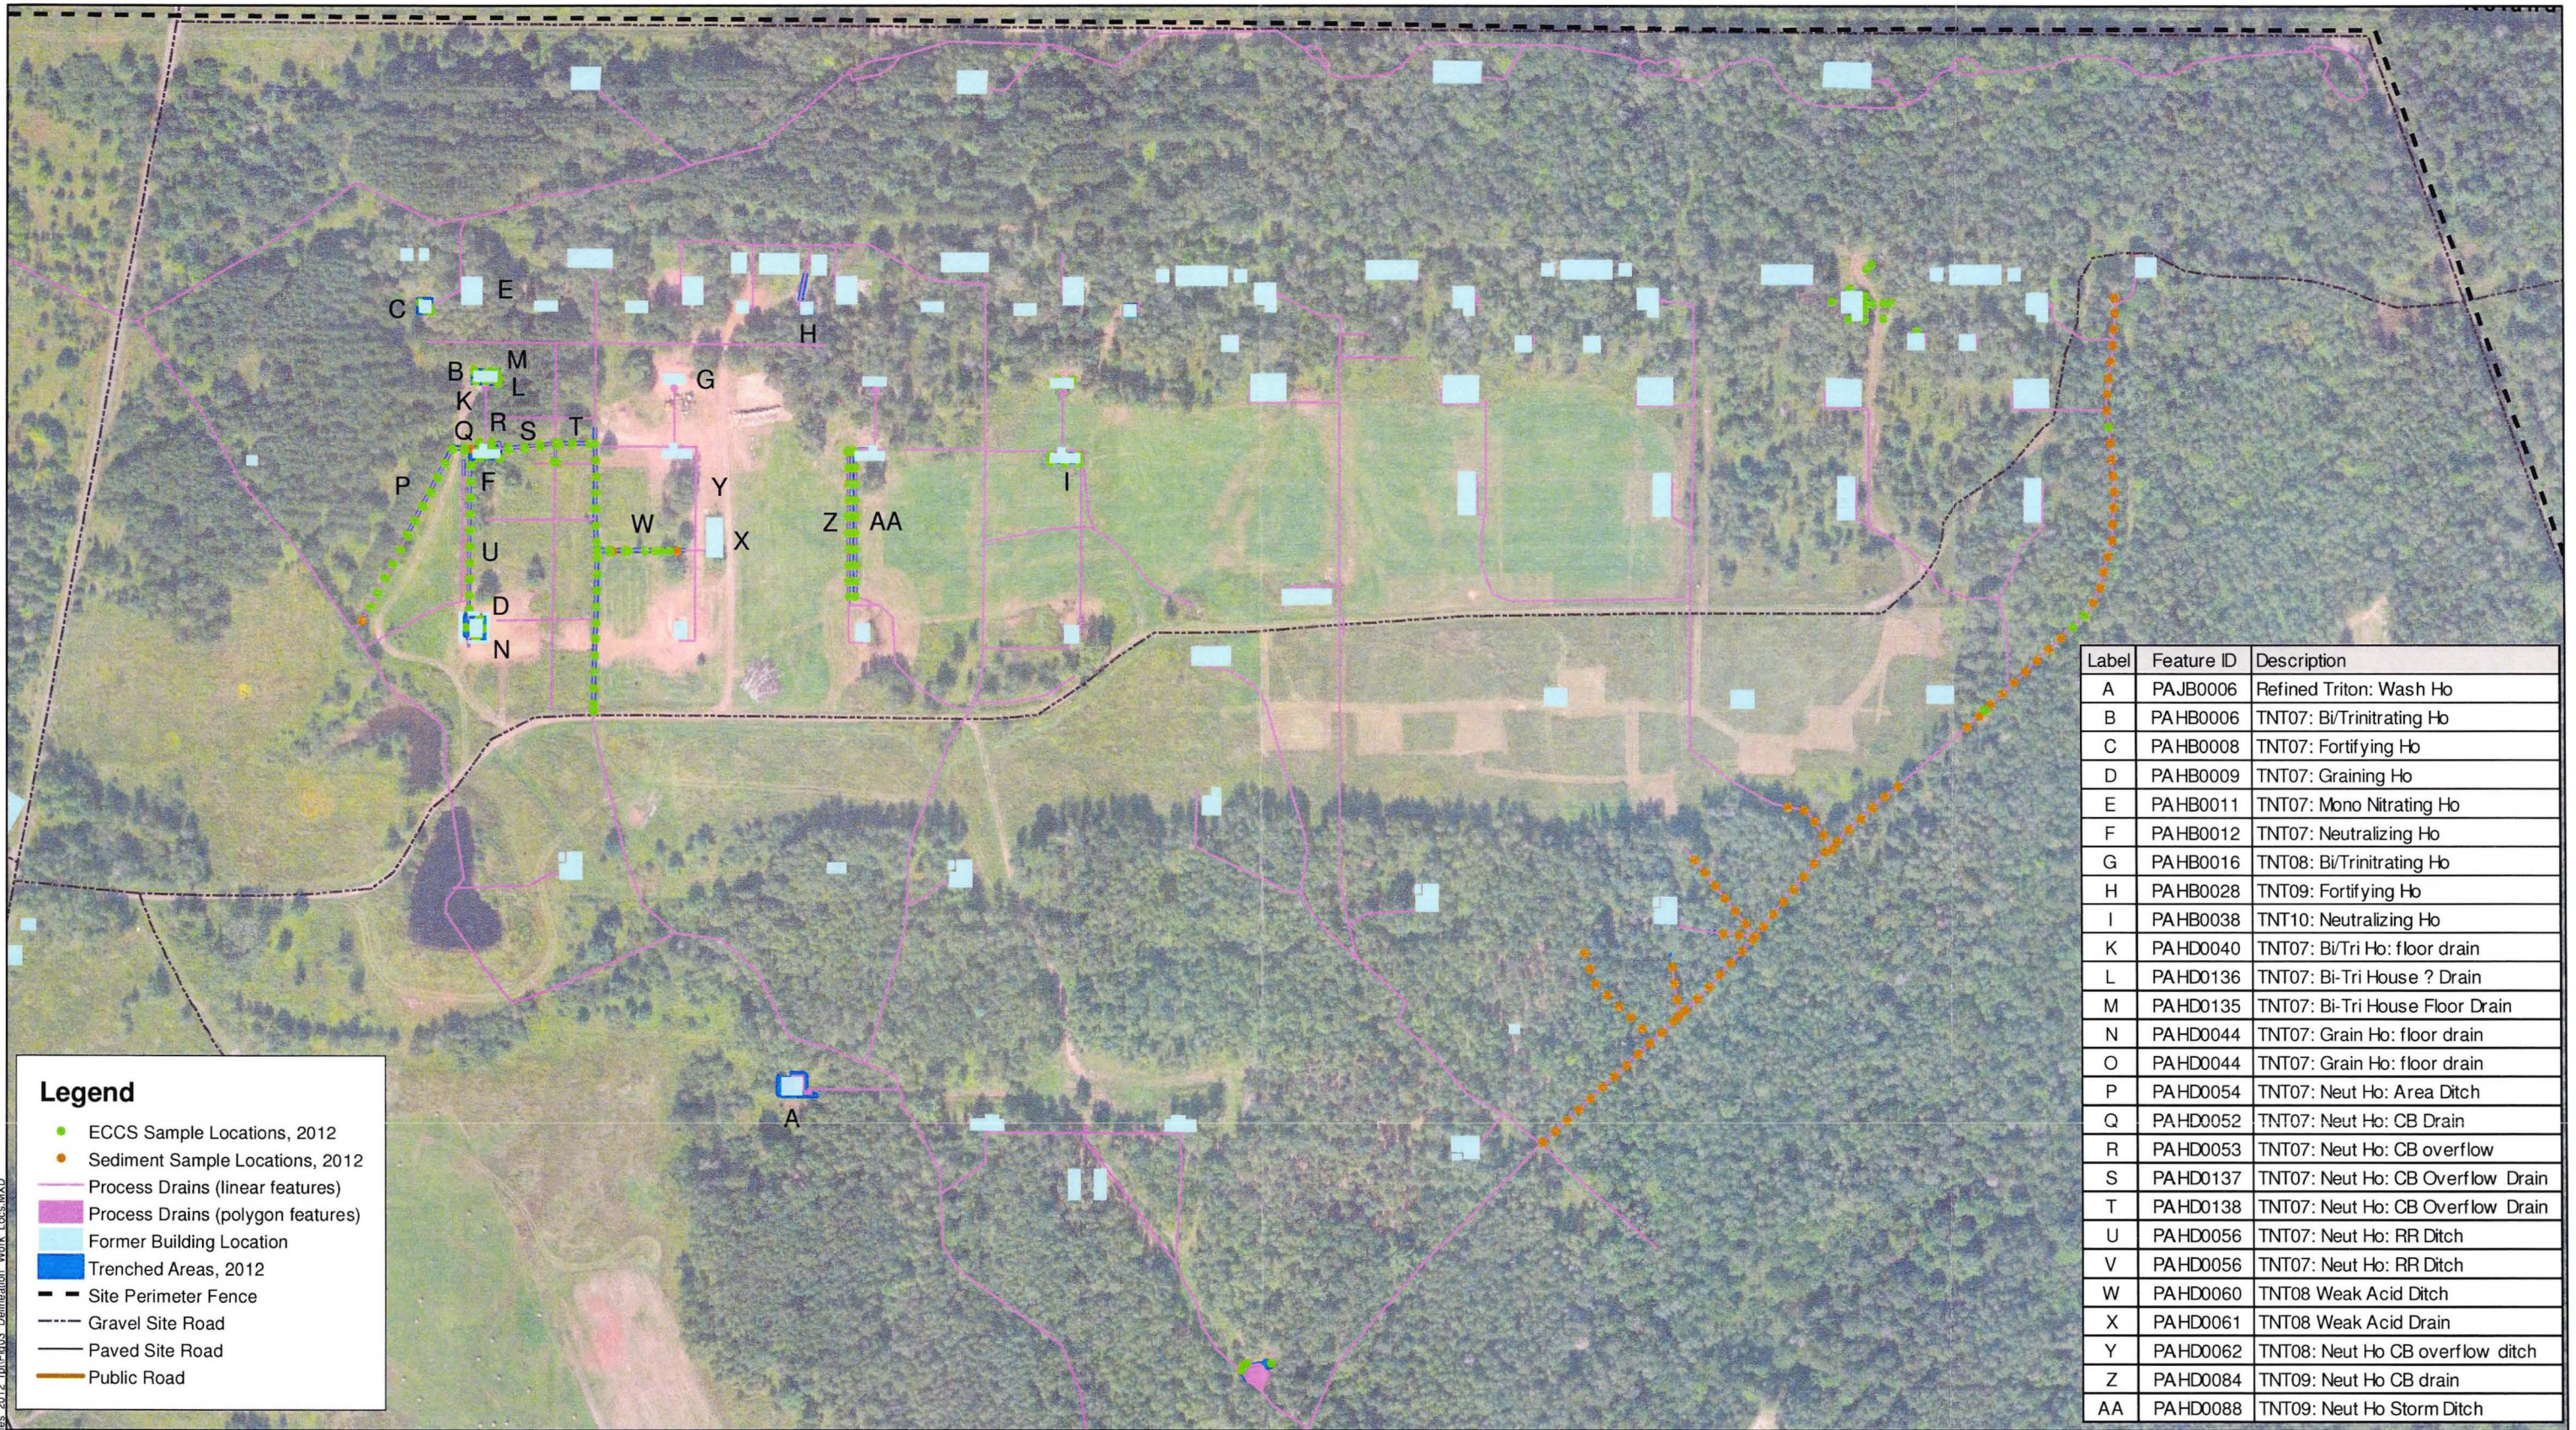
Label	Feature ID	Description
A	PAJB0006	Refined Triton: Wash Ho
B	PAHB0006	TNT07: Bi/Trinitrating Ho
C	PAHB0008	TNT07: Fortifying Ho
D	PAHB0009	TNT07: Graining Ho
E	PAHB0011	TNT07: Mono Nitrating Ho
F	PAHB0012	TNT07: Neutralizing Ho
G	PAHB0016	TNT08: Bi/Trinitrating Ho
H	PAHB0028	TNT09: Fortifying Ho
I	PAHB0038	TNT10: Neutralizing Ho
K	PAHD0040	TNT07: Bi/Tri Ho: floor drain
L	PAHD0136	TNT07: Bi-Tri House ? Drain
M	PAHD0135	TNT07: Bi-Tri House Floor Drain
N	PAHD0044	TNT07: Grain Ho: floor drain
O	PAHD0044	TNT07: Grain Ho: floor drain
P	PAHD0054	TNT07: Neut Ho: Area Ditch
Q	PAHD0052	TNT07: Neut Ho: CB Drain
R	PAHD0053	TNT07: Neut Ho: CB overflow
S	PAHD0137	TNT07: Neut Ho: CB Overflow Drain
T	PAHD0138	TNT07: Neut Ho: CB Overflow Drain
U	PAHD0056	TNT07: Neut Ho: RR Ditch
V	PAHD0056	TNT07: Neut Ho: RR Ditch
W	PAHD0060	TNT08 Weak Acid Ditch
X	PAHD0061	TNT08 Weak Acid Drain
Y	PAHD0062	TNT08: Neut Ho CB overflow ditch
Z	PAHD0084	TNT09: Neut Ho CB drain

AA	PAHD0088	TNT09: Neut Ho Storm Ditch

In 2012, shielded trenching and screening was conducted at the locations listed in Table 2 and indicated on Figure 3. Field crews screened the proposed excavation surface then utilized non-sparking hand tools to investigate detections and remove any residual product identified for off-site incineration. Once screening results were evaluated, the shielded excavator was used to remove a thin layer of soil (1–6 inches) from the work area and screening/hand investigation was repeated on the newly exposed surface. This process continued until undisturbed native soil was encountered. If the excavation depth exceeded 3.5 feet, soils were first brought to the surface by the excavator and then screening was performed in the excavator bucket.
