WIC-NO-2020-4-00852, 00857, 00858

RE: Wetland Identification Report for Three 5-Acre Project Review Areas, located in the NE1/4 of Section 23, Township 48 North, Range 05 West, Town of Barksdale, Bayfield County

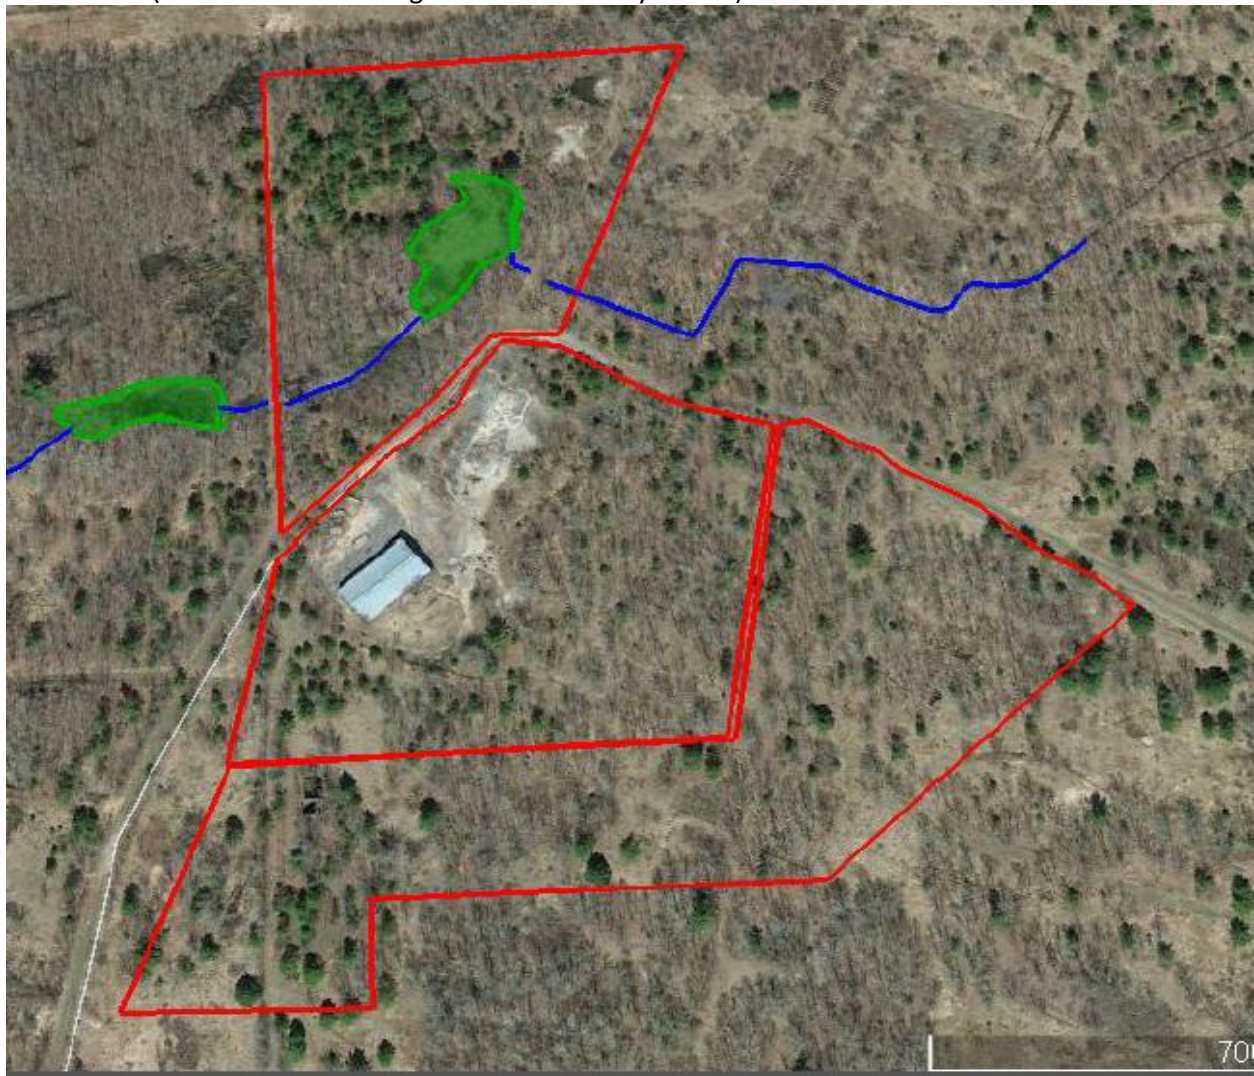
Field Sketch (Wetland indicated in green and waterway in blue)

Based on the data analyzed for the off-site review from April 27 to May 7, 2020, **one wet meadow wetland is in the northern portion of the “north” project review area (review area 00857). No wetlands were found in the “middle shed” (00852) and “southern” (00858) project review areas.** An approximate sketched wetland boundary figure is enclosed within this report. This wetland boundary corresponds to noted vegetation changes in recent and historical aerial photographs reviewed, and onsite photographs of the project review areas.

The wetland boundaries depicted on the associated field sketch are approximate only and may not be appropriate for design purposes, such as set-back or permit requirements. If wetlands are located on your property, we may recommend that a wetland delineation be conducted on your property by a qualified wetland delineator. Wetlands are regulated by various state, federal, and local units of government. Prior to conducting any activities in or around wetlands, we recommend you contact the appropriate staff from Wisconsin Department of Natural Resources, U.S. Army Corps of Engineers and Bayfield County.

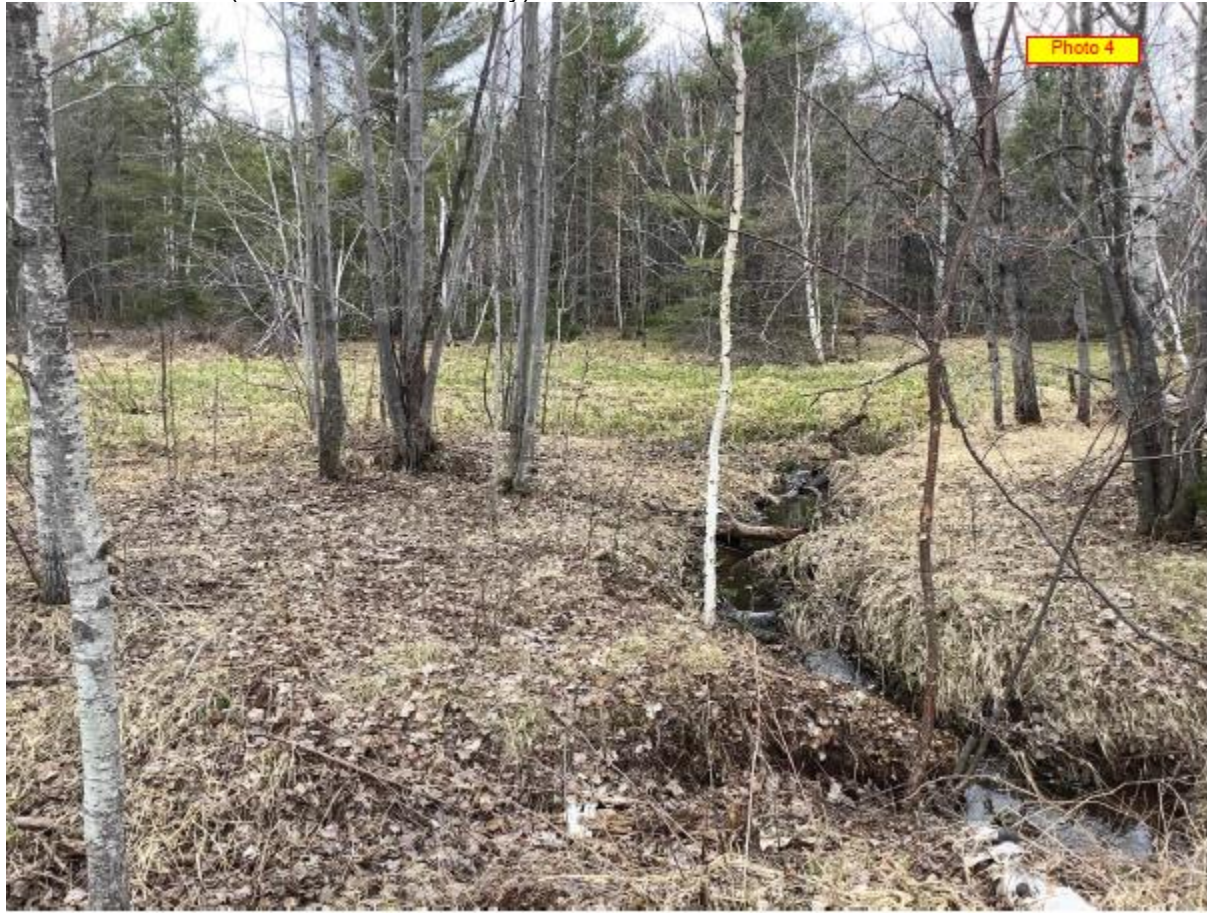
- The more recent and historic wetland signatures also corresponded to onsite photographs provided to the Department as part of the review. Onsite photographs indicated what looks like a wet meadow wetland likely dominated by *Carex* species and *Calamagrostis canadensis* (Canada bluejoint).

Onsite Photo #4 (wetland and waterway)

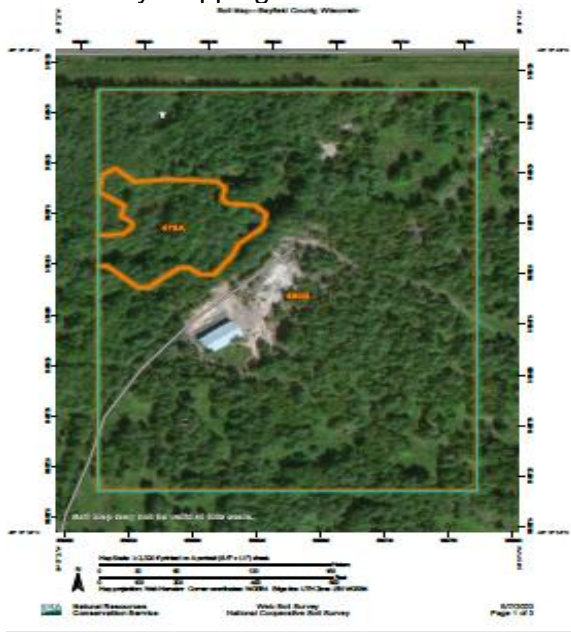
Soil Survey Mapping

- Soils mapped in the project area include the poorly drained and somewhat poorly drained Lerch-Herbster complex, 0 to 3 percent slopes (479A) and the moderately well drained and somewhat poorly drained Portwing-Herbster complex, 0 to 6 percent slopes (480B). Both mapped soils units contain different soil compositions or components that are hydric and not hydric depending on landscape position. Enclosed within this identification report is the soil survey mapping for additional information on the location of the soil type(s) within the project review areas.

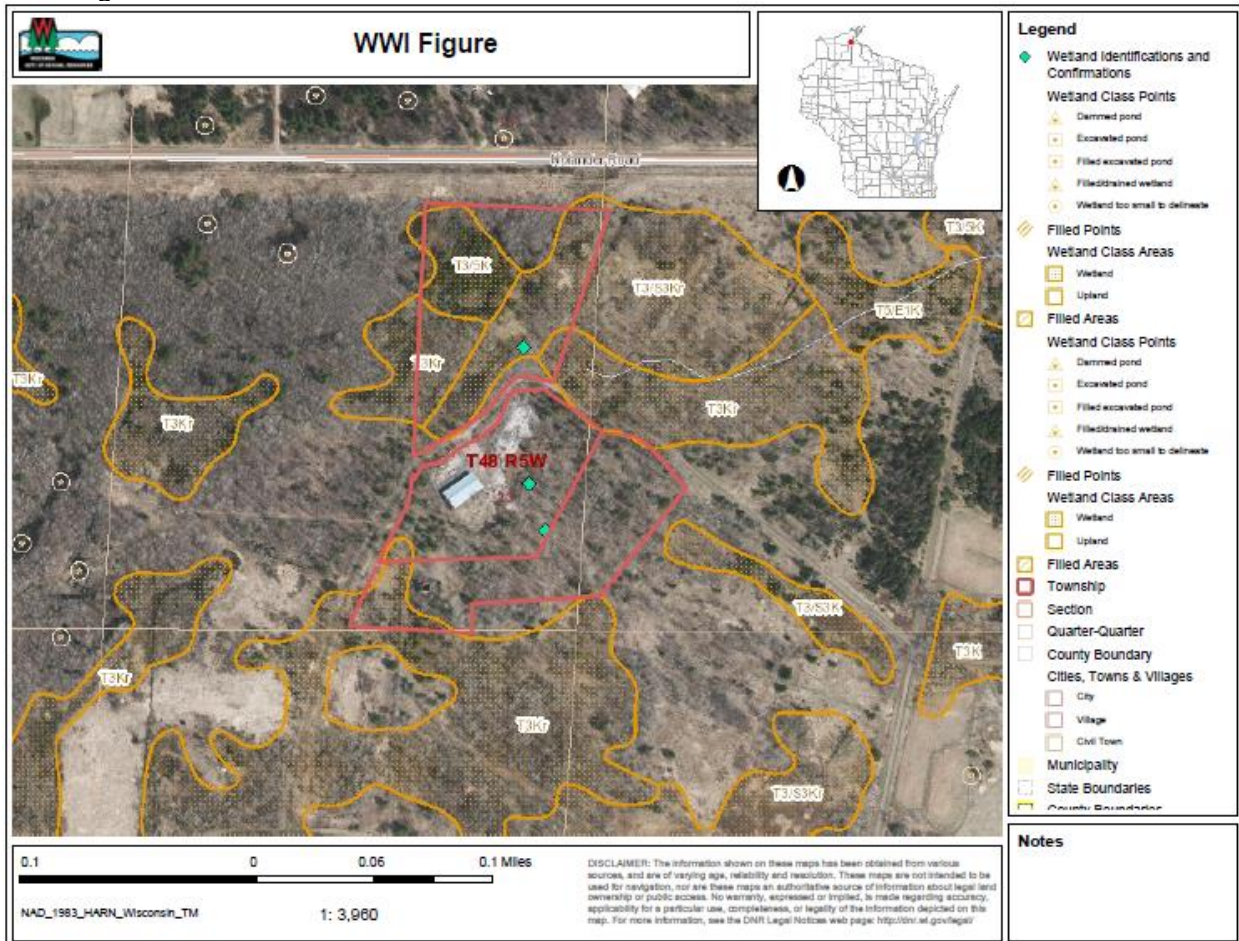
WWI Figure

- The WWI has forested, scrub/shrub wetland mapped nearly throughout the “north” project review area, and just the southwestern part of “middle shed” and “south” project review areas. Enclosed within this report is a WWI figure for reference.
