**SEVENTH FIVE-YEAR REVIEW REPORT FOR
SCHMALZ DUMP SUPERFUND SITE
Calumet County, Wisconsin**

**U.S. Environmental Protection Agency
Region 5
Chicago, Illinois**

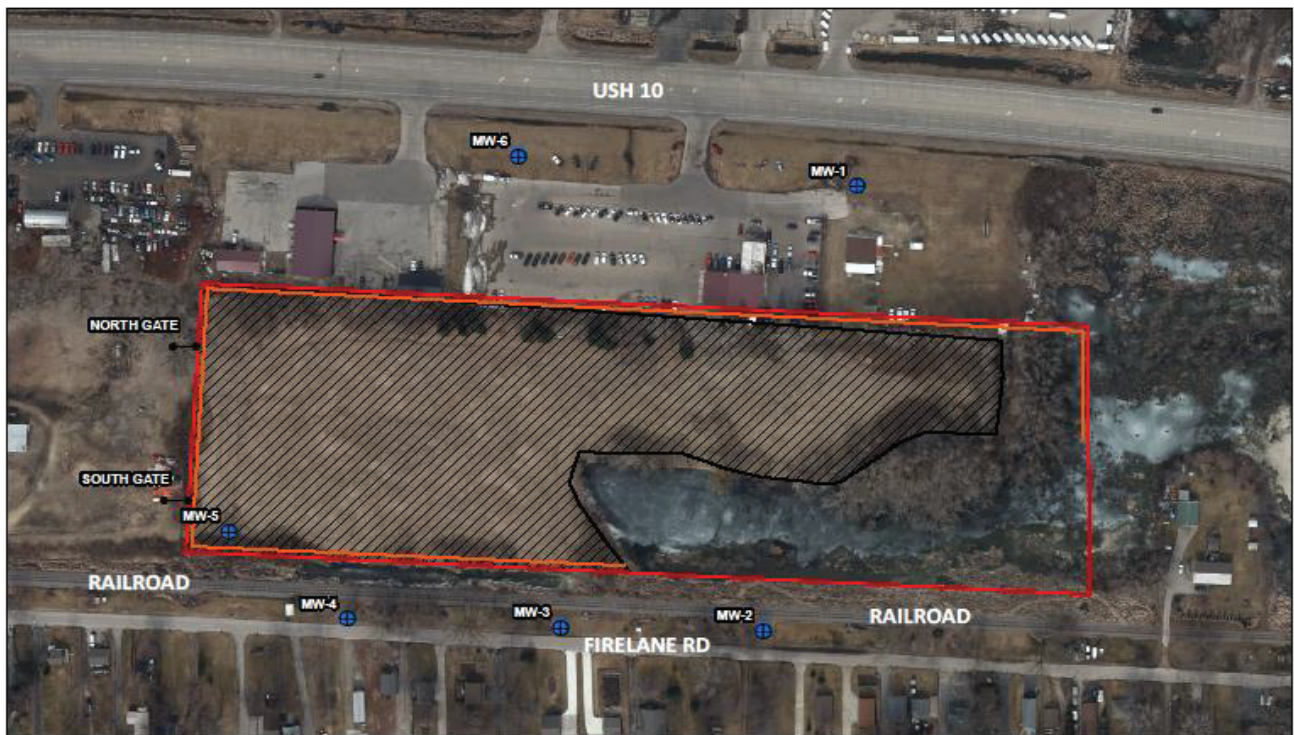
Figure 2 - Site Feature, Site boundaries, Cap Areas and Monitoring Wells.

- Gate
- ⊕ Monitoring Well
- Fence
- Property Boundary
- ▨ CAP Area
