From: Dave Cornale <dcornale@gilesengr.com>
Sent: Wednesday, April 5, 2023 9:41 AM
To: Dave Larsen
Cc: George Beatty; Saliars, Gwen N - DNR
Subject: RE: Damaged Monitoring Well at Wisconsin Chrome site
Attachments: 17824.jpeg; 17825.jpeg

From: Saliars, Gwen N - DNR <gwen.saliars@wisconsin.gov>
Sent: Thursday, March 30, 2023 3:00 PM
To: Dave Larsen <dlarsen@reiengineering.com>
Subject: Damaged Monitoring Well at Wisconsin Chrome site

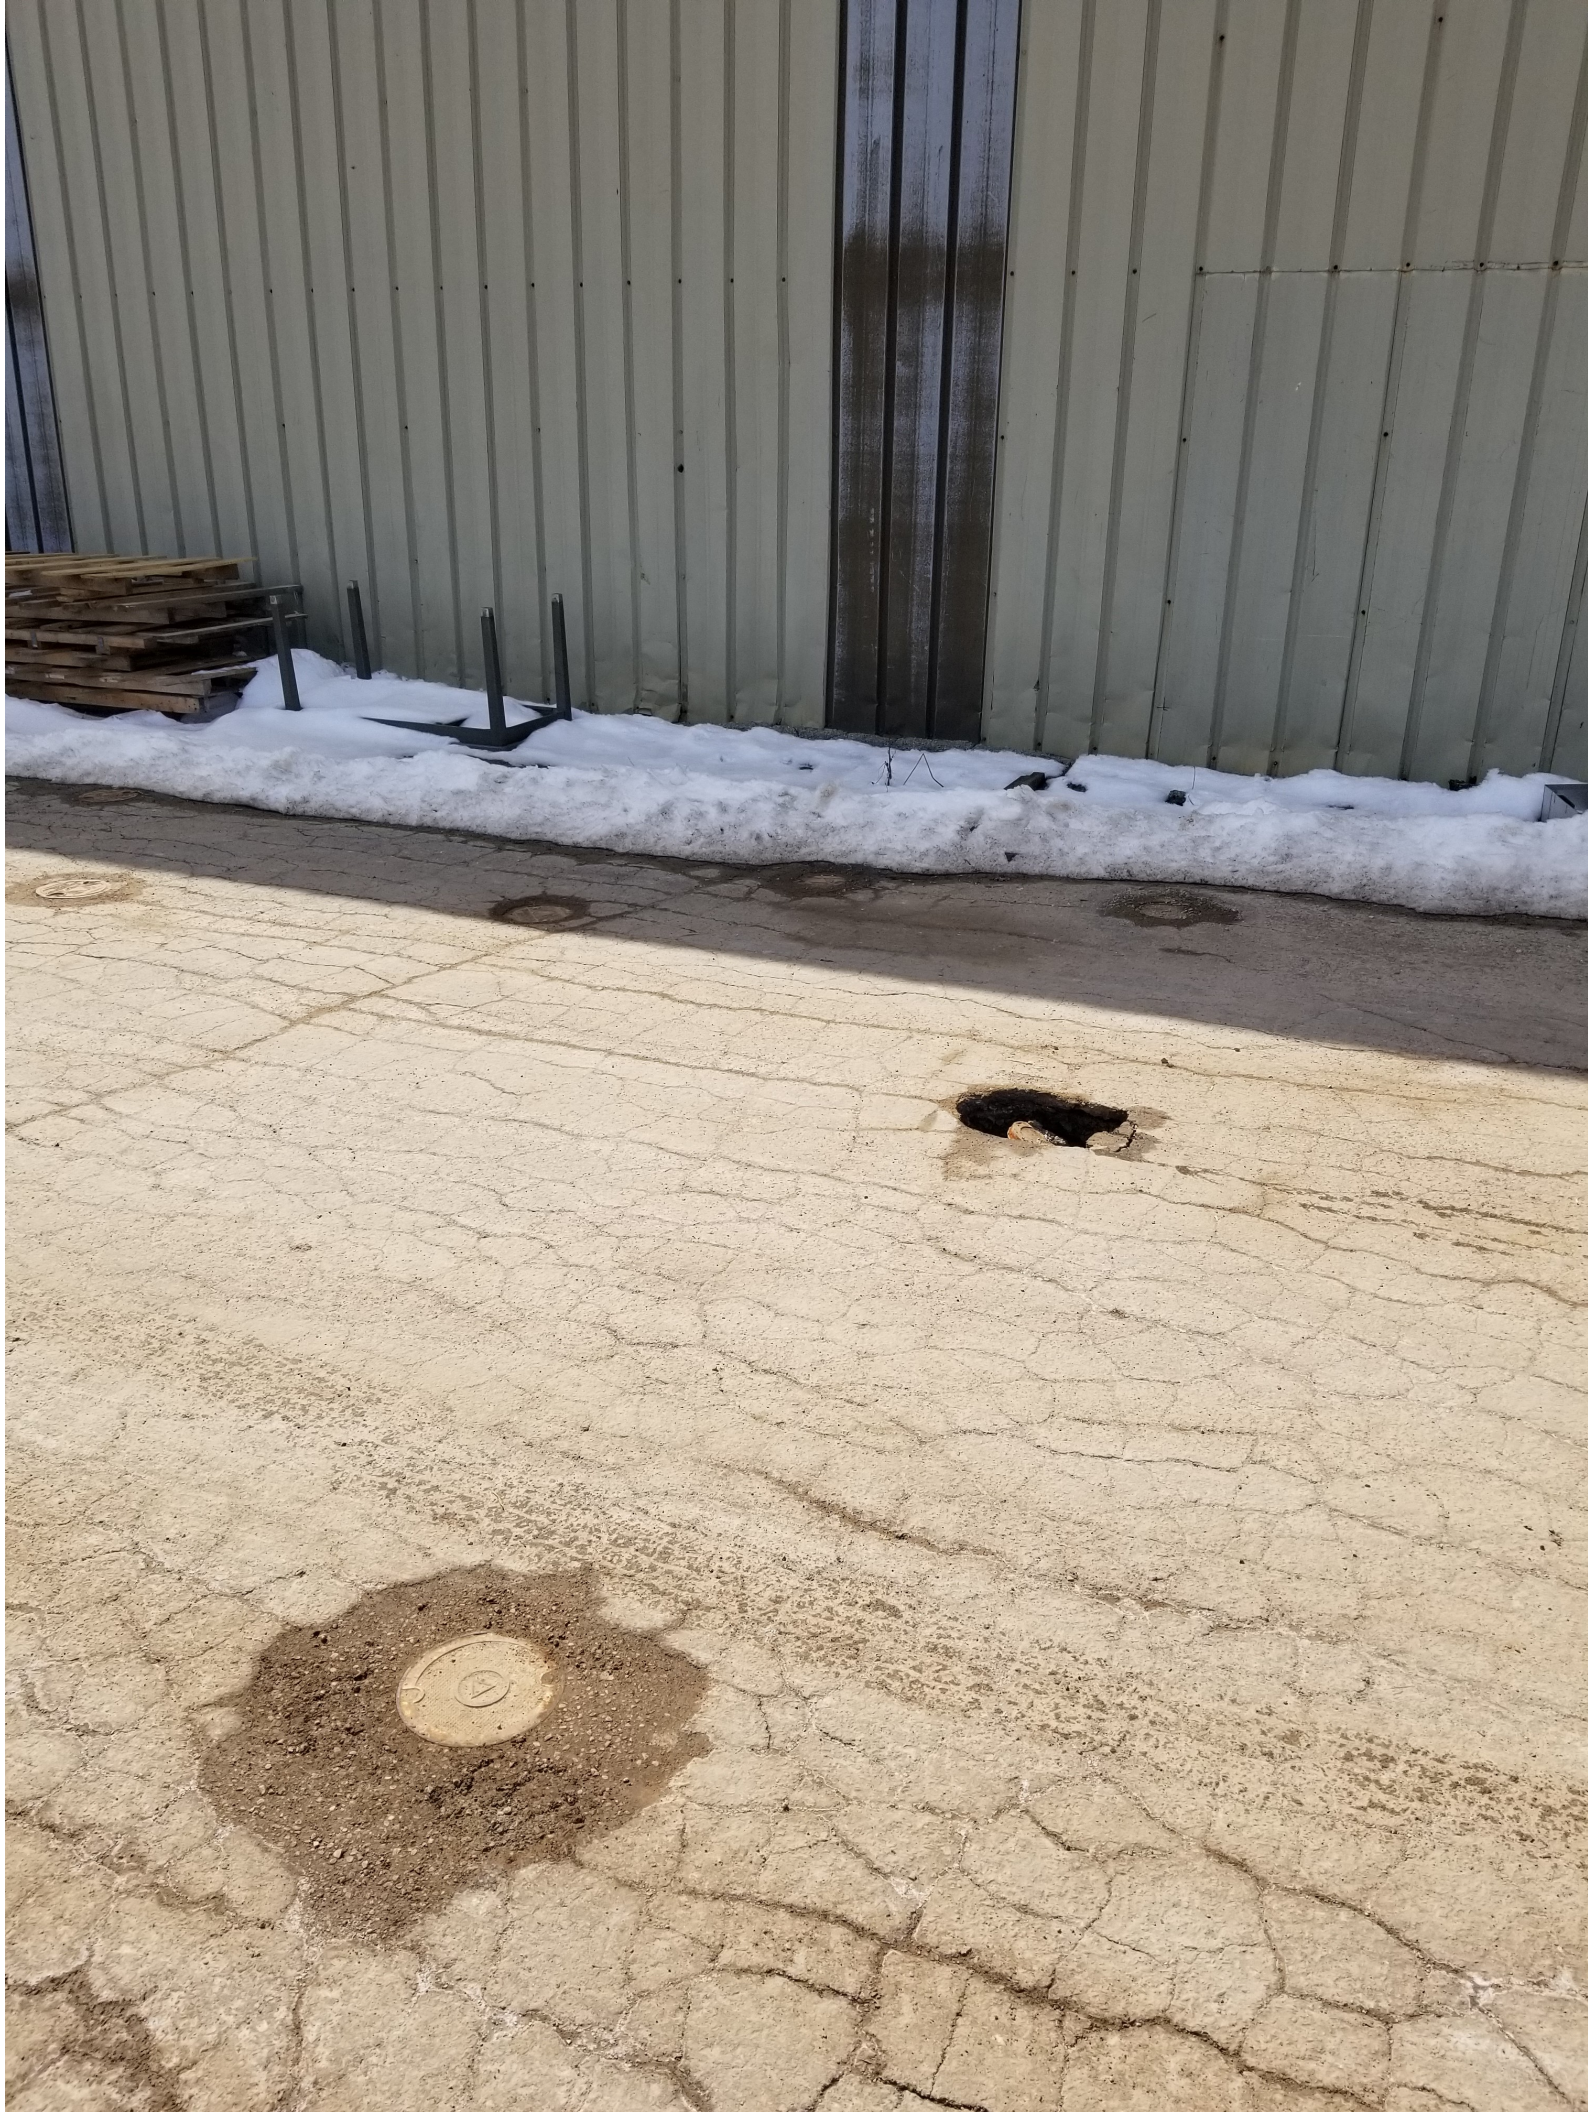
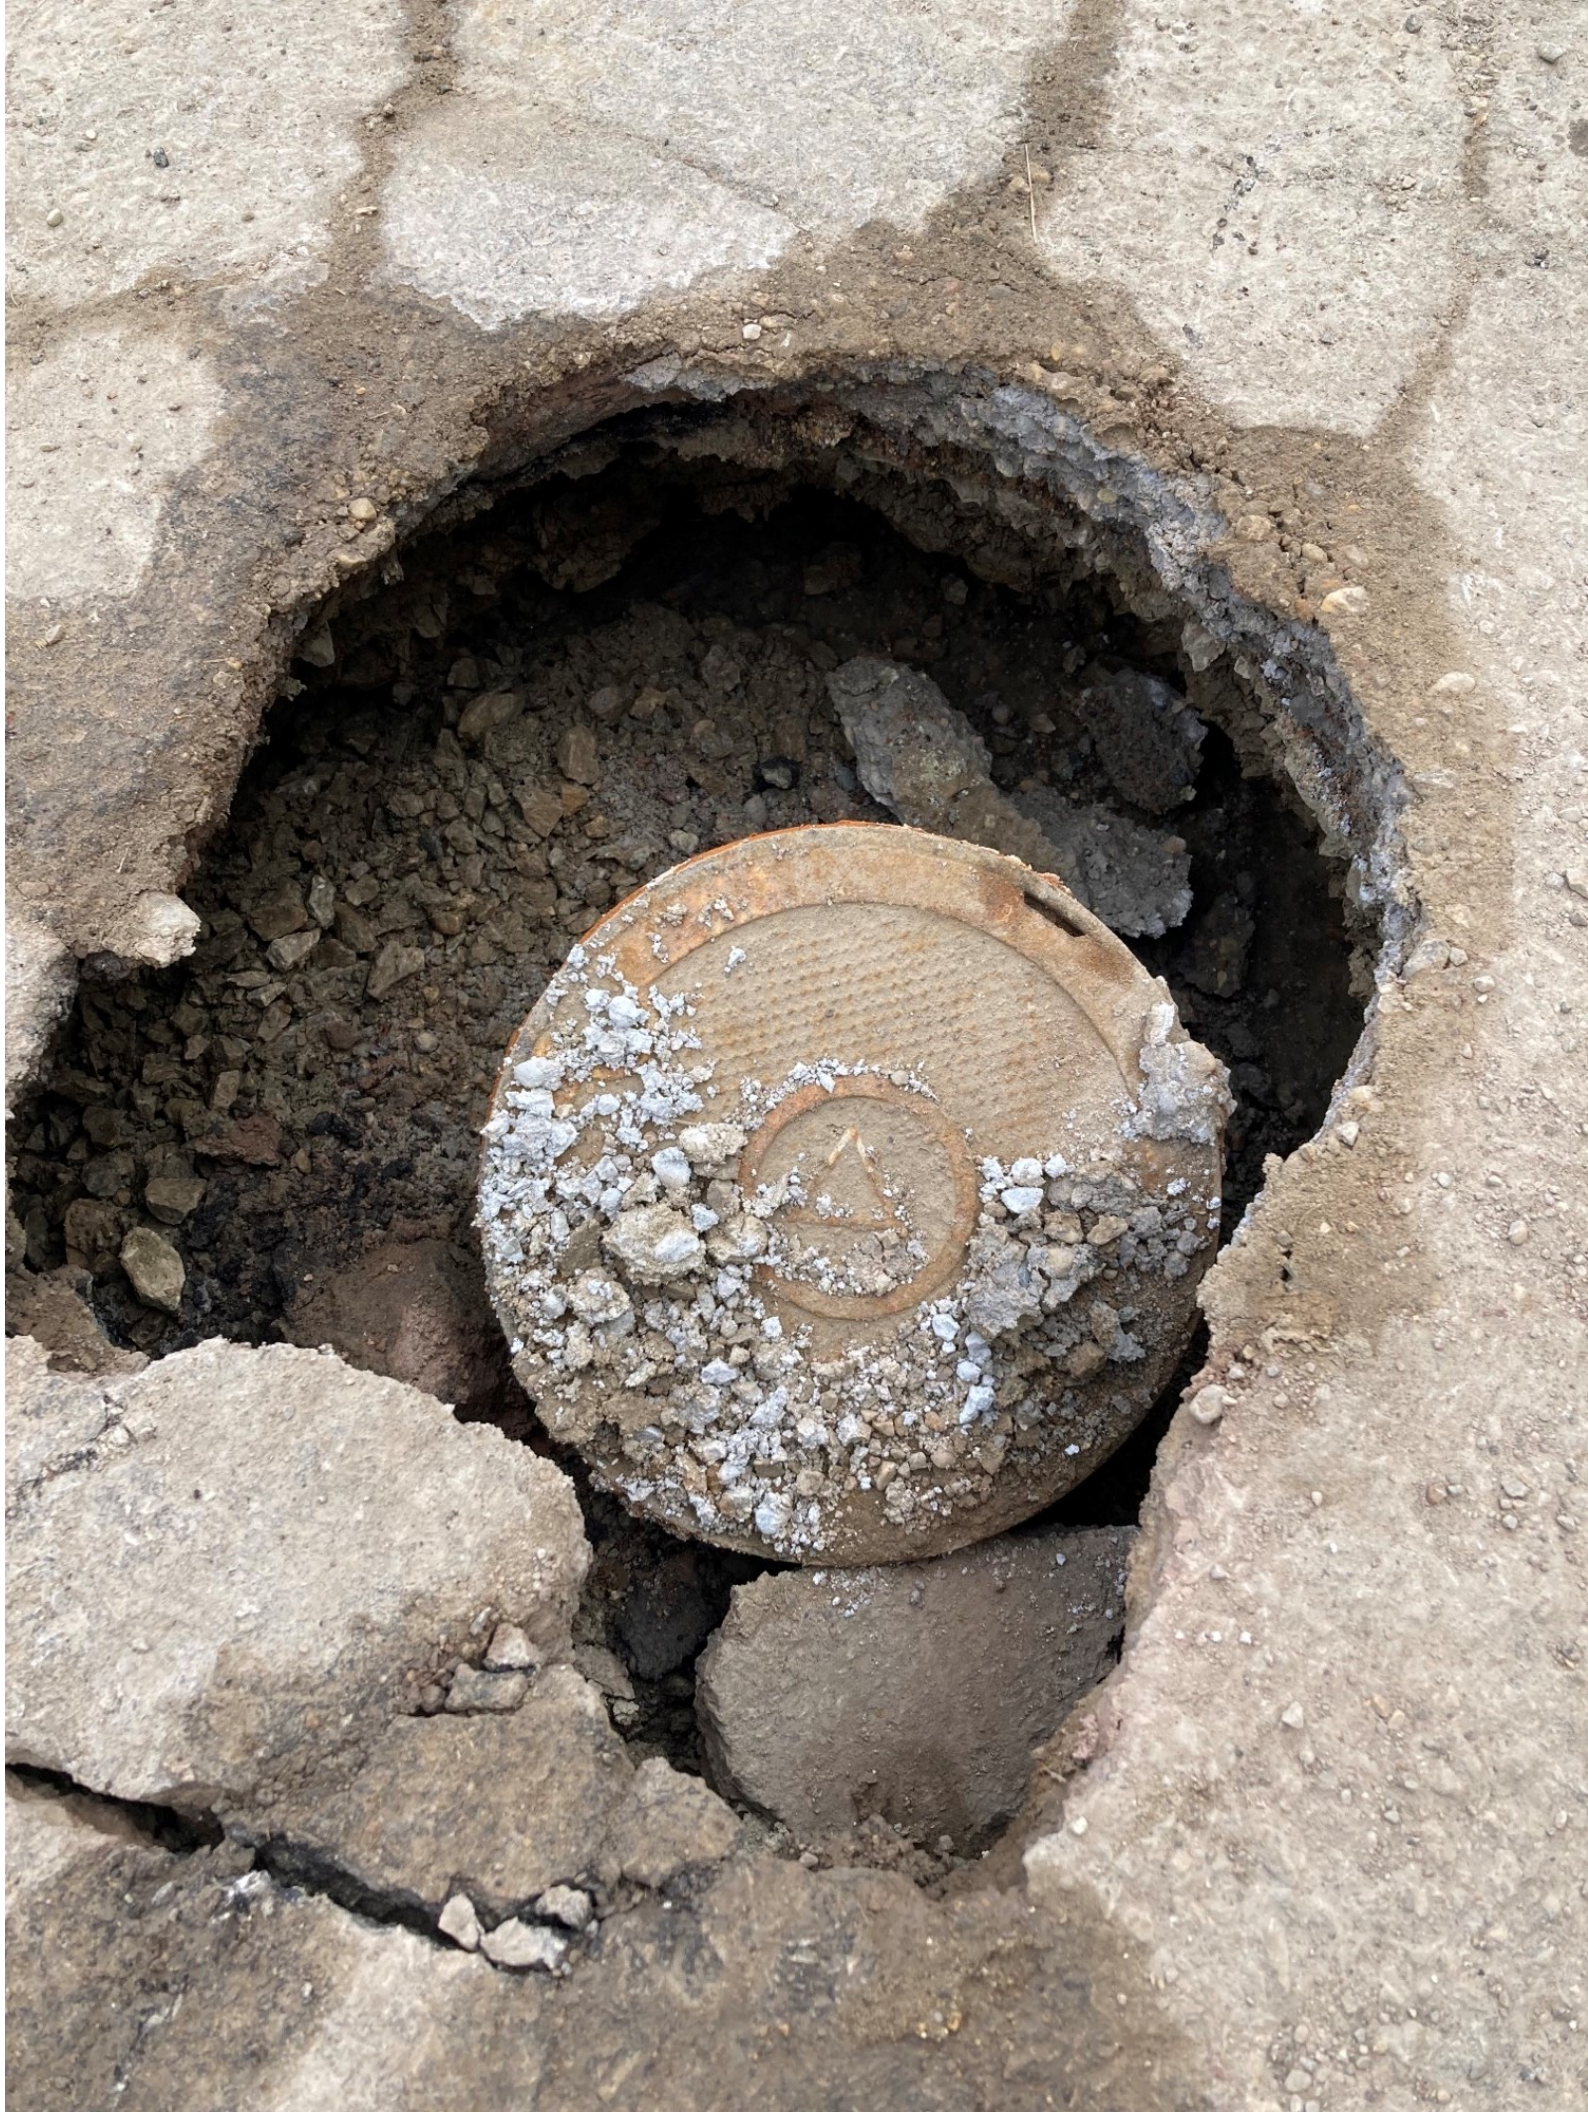
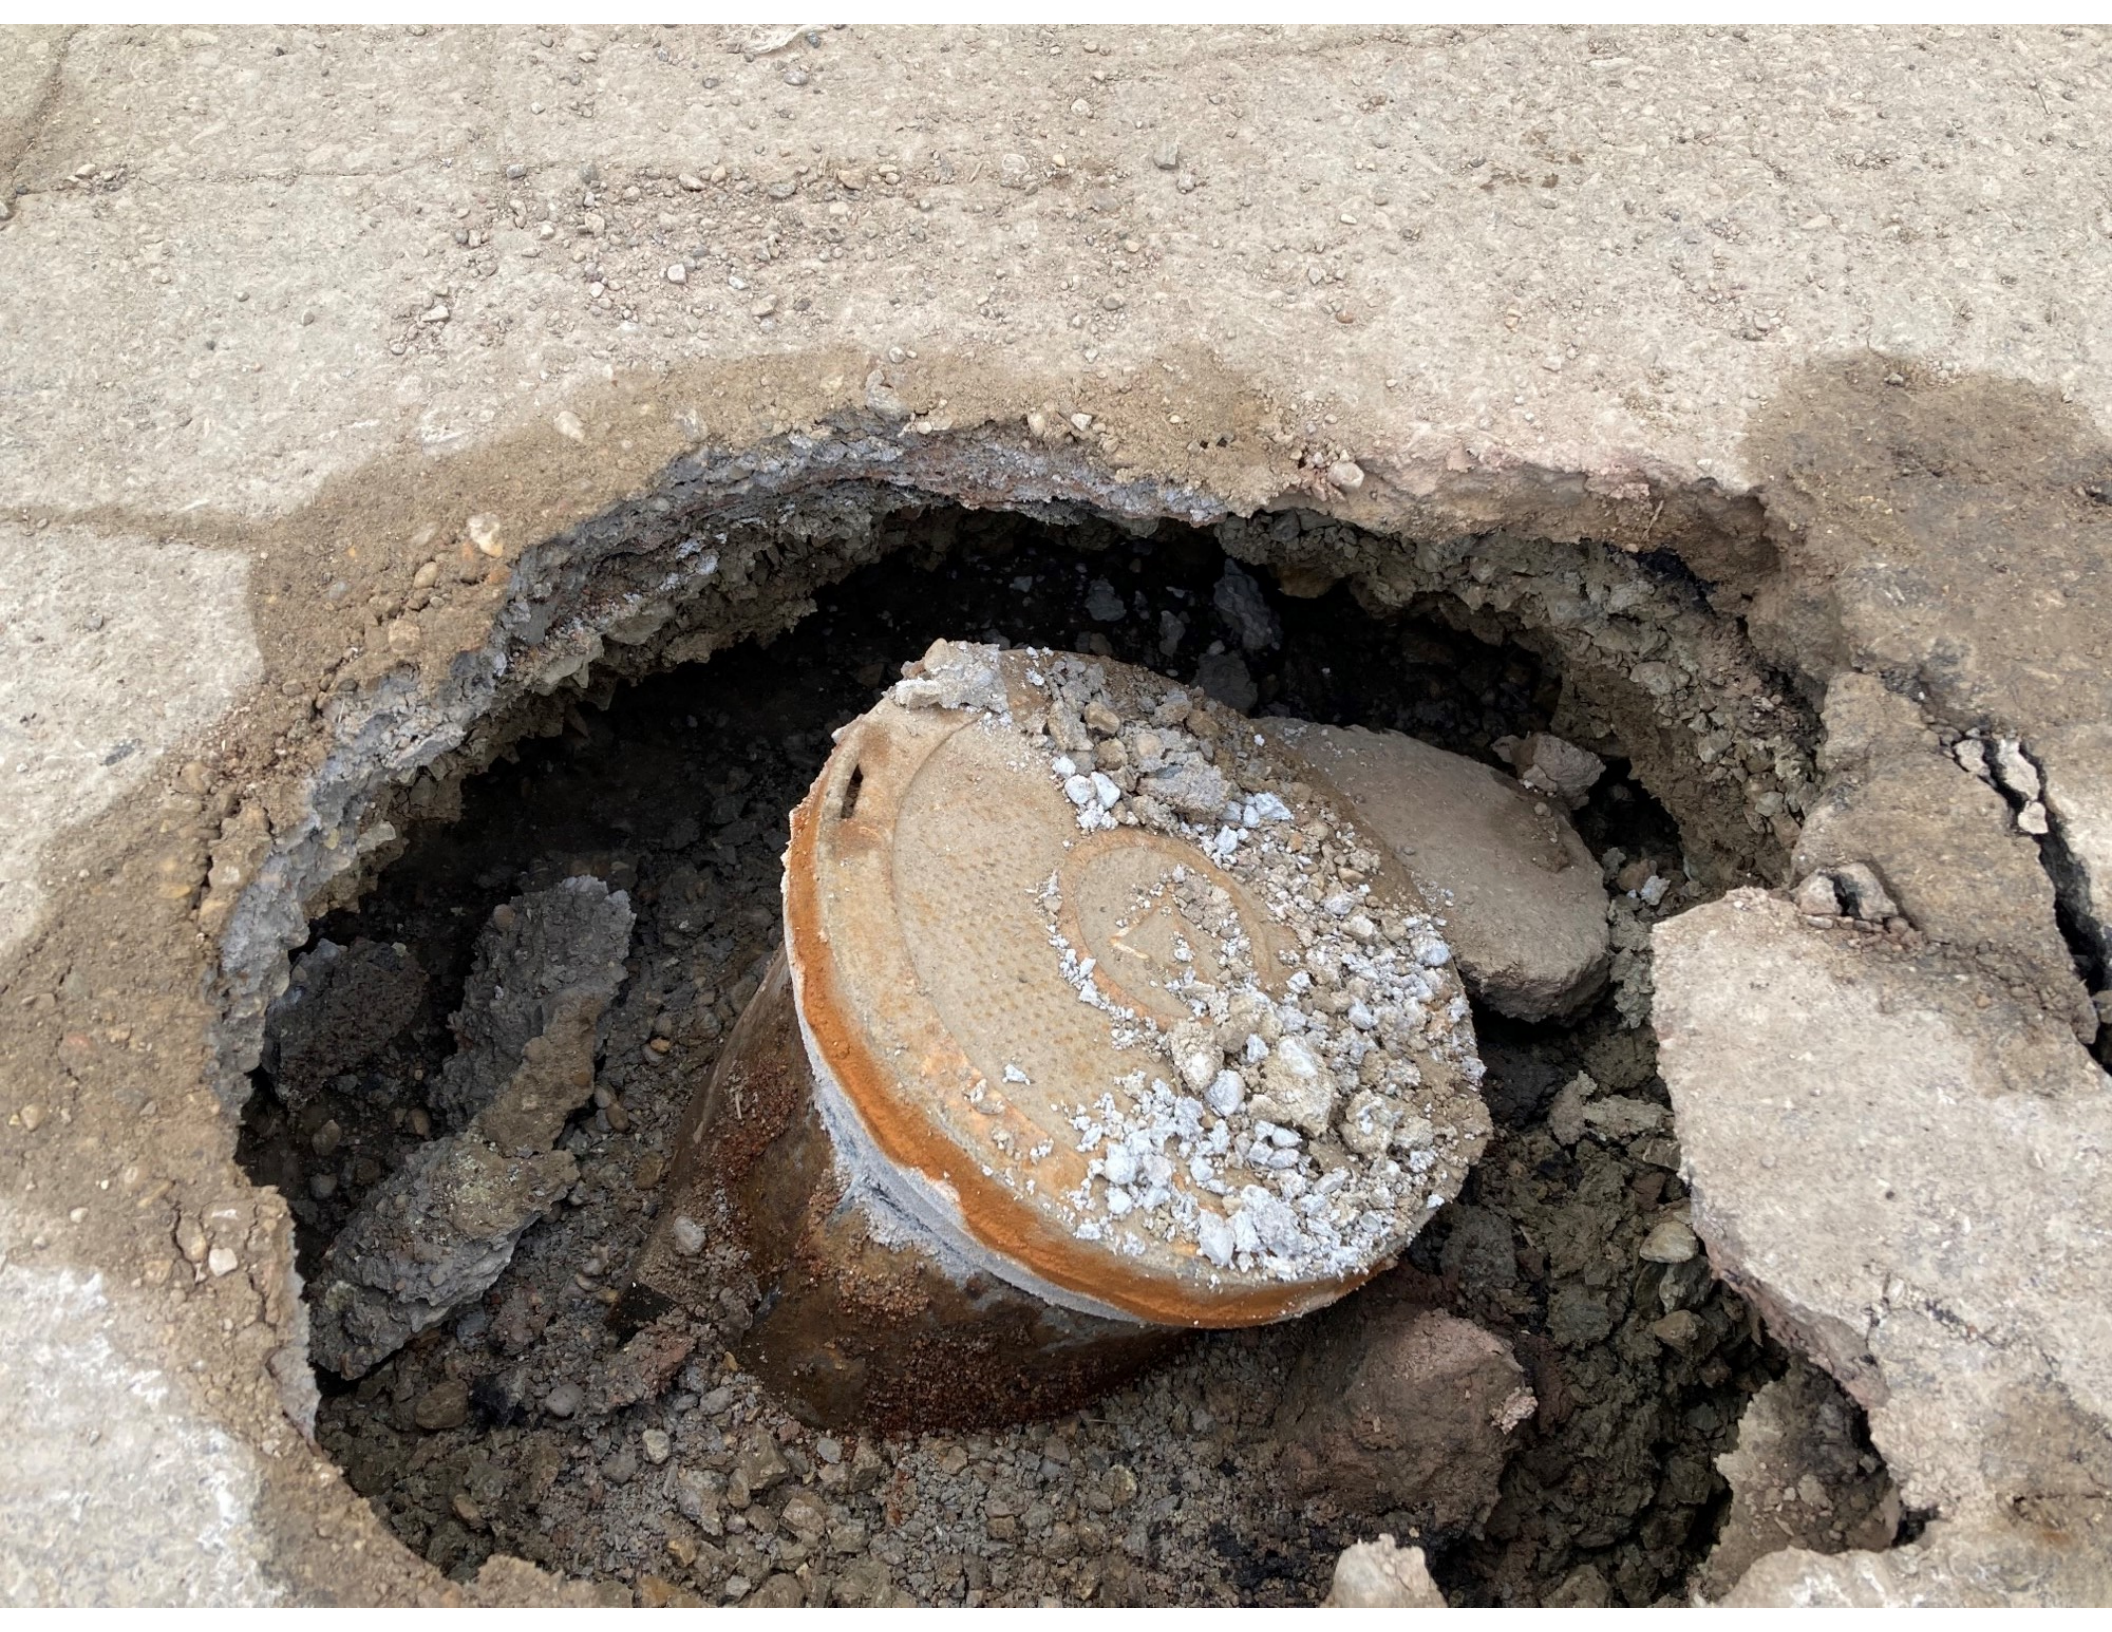
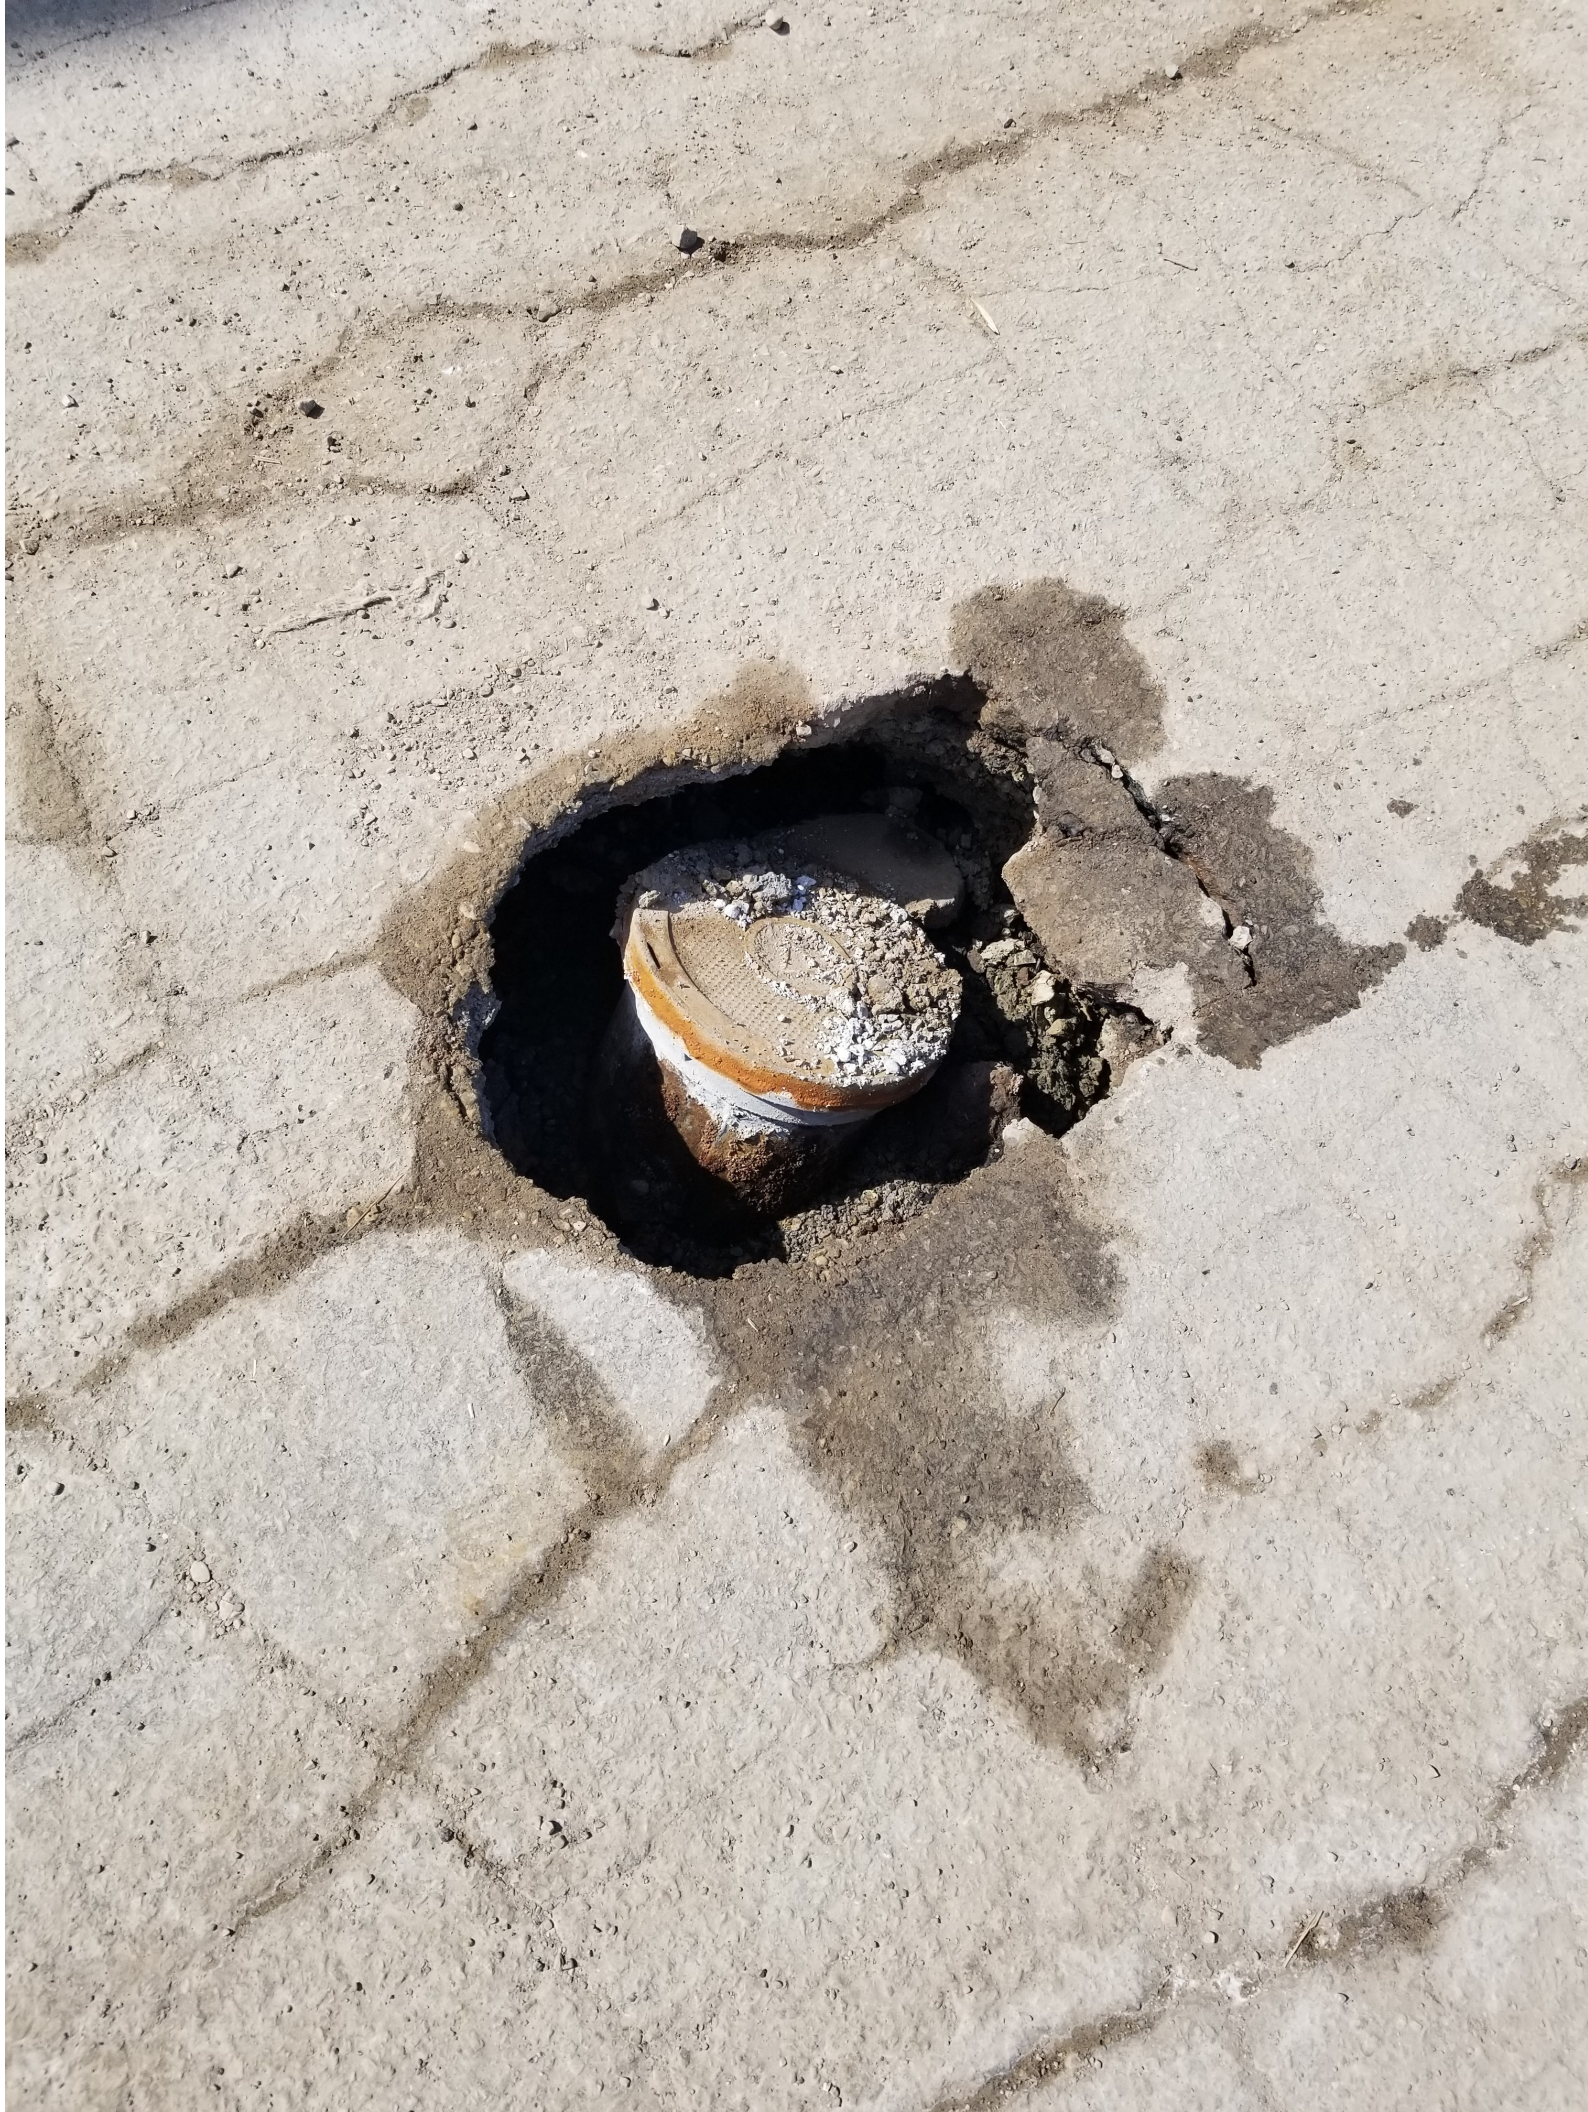
I was notified earlier today about a monitoring well that is severely damaged at Wisconsin Chrome. See the attached photos. Unfortunately, it is one of the new wells we had installed last fall. It looks like the

backfill around the well settled or a crack formed somehow and it has caused a significant sinkhole. It is about three feet wide and a foot deep. Since it is such a new well I wanted to ask if there were any warranties or similar things we could use to fix the well? Thank you,

Gwen, I just spoke with the drilling contractor (Giles Engineering) and they are planning on completing the repair in the next couple of days. I copied Dave from Giles and he will let us know when the work is scheduled so you can notify the tenants. Again, if you can get them to cordon off the hole to limit further damage, the repair should be completed in the next couple of days. Giles will be taking photographs of the repairs and I will forward them to you once the repair is complete. Thanks again for letting us know about the issue. Please let me know if there is anything else I can do to assist.

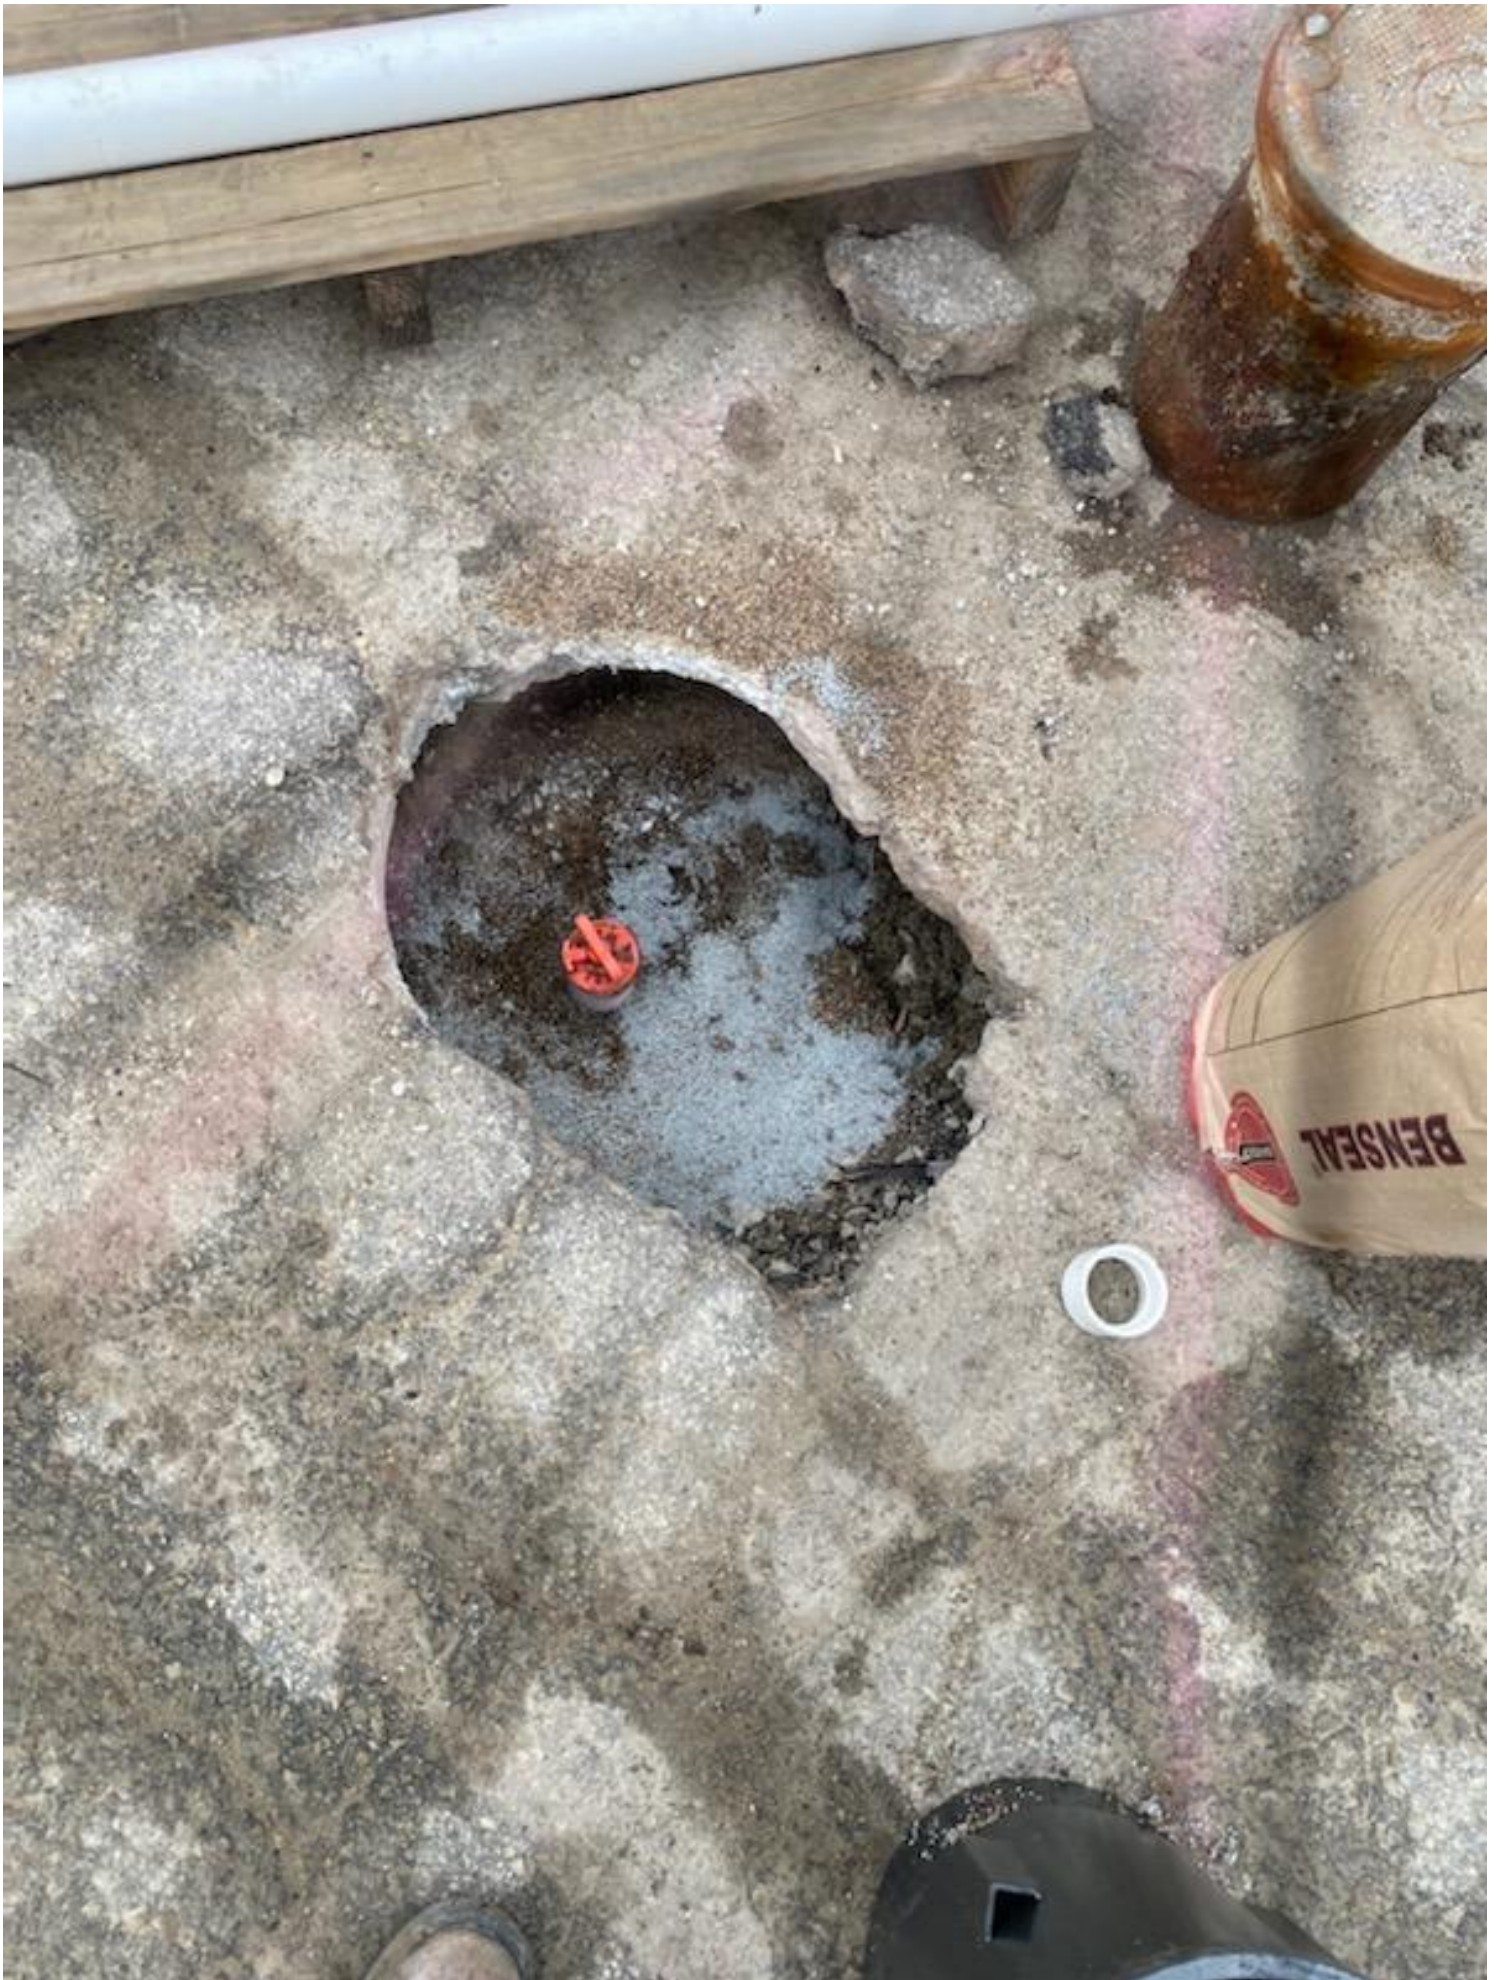
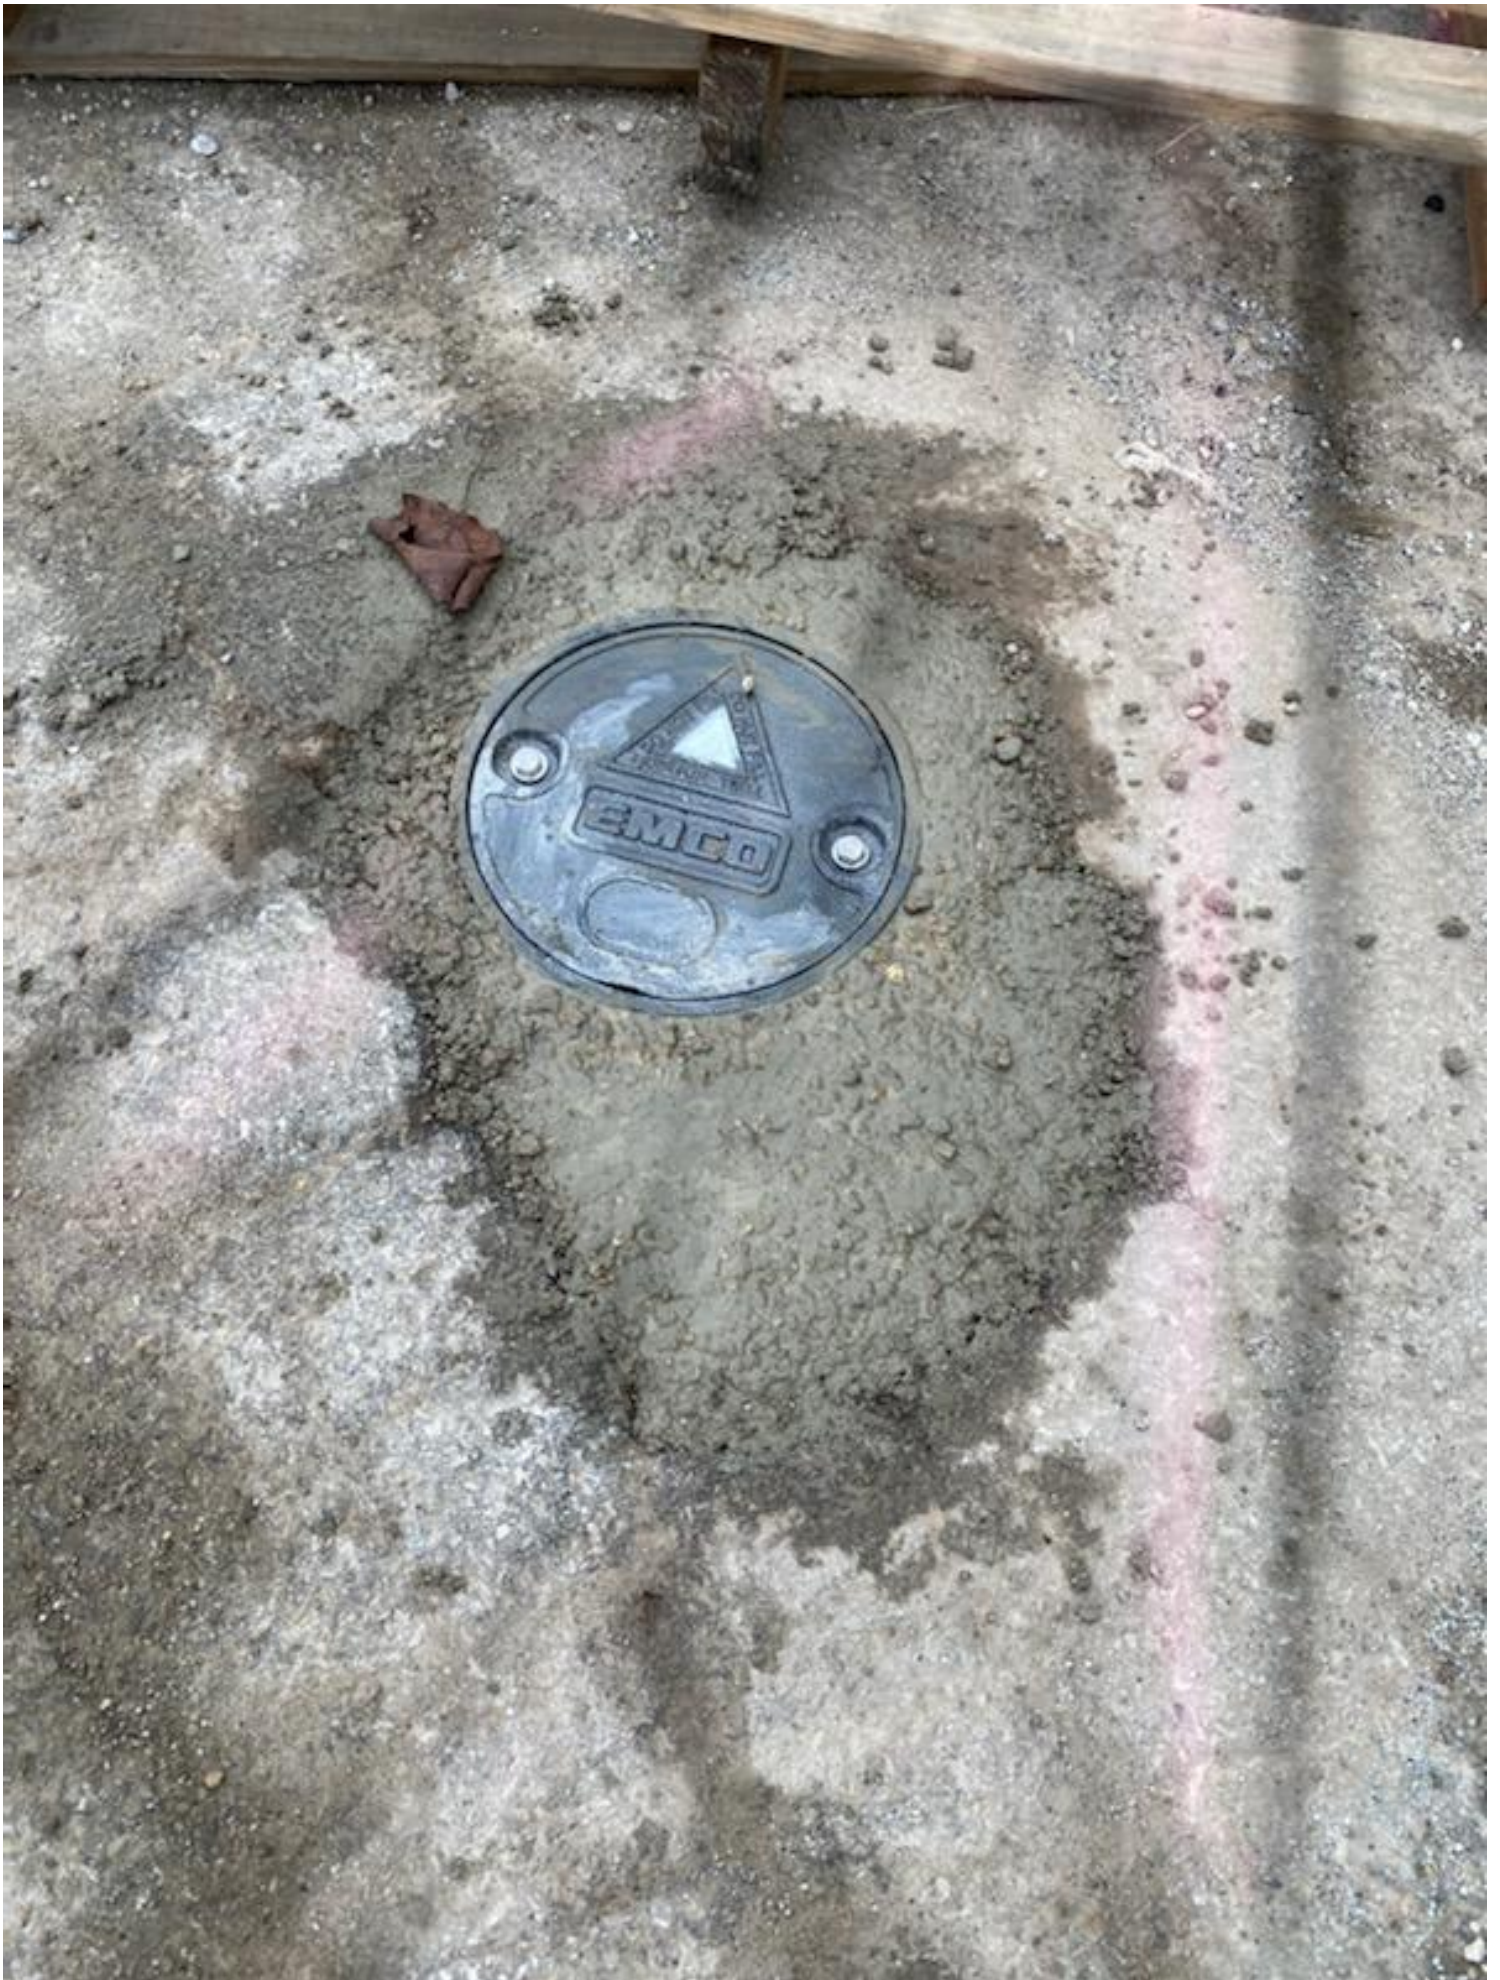
We repaired the well cover yesterday. It looks like water in the base course may have somehow eroded the materials below the asphalt concrete surface. Pictures of the well after we removed the cover and cleaned up the loose material and also after we replaced the cover and concrete, are attached.

We will plan to repair the settled well cover tomorrow morning. When the repair is completed, we will place a traffic marker on the well, so that traffic can avoid driving over the well while the concrete cures. The marker can be disposed of after a couple days.
