**RE: Removal Action Work Plan (RAWP)
Former WPSC Green Bay Manufactured Gas Plant Site, Green Bay, Wisconsin
Wisconsin Public Service Corporation
CERCLA Docket No. V-W-06-C-847, CERCLIS ID – WIN000509948, BRRTS # - 02 05
000254**

To: Frank Dombrowski and Glenn Luke - WPSC
From: Abby Small and Julie Zimdars – Ramboll
cc: Staci Goetz - Ramboll
Re: Early Removal Action Work Plan Addendum No. 1, Revision 0
 Green Bay Former Manufactured Gas Plant, Green Bay, Wisconsin
 Wisconsin Public Service Corporation
 CERCLA Docket No. V-W-06-C-847, WDNR BRRTS # 02-05-000254,
 CERCLIS ID – WIN000509948

REMOVAL ACTION WORK PLAN
FORMER GREEN BAY MANUFACTURED GAS PLANT
WISCONSIN PUBLIC SERVICE CORPORATION
GREEN BAY, WISCONSIN

Bathymetric Survey and In-River/Submerged Utility Survey Green Bay, WI

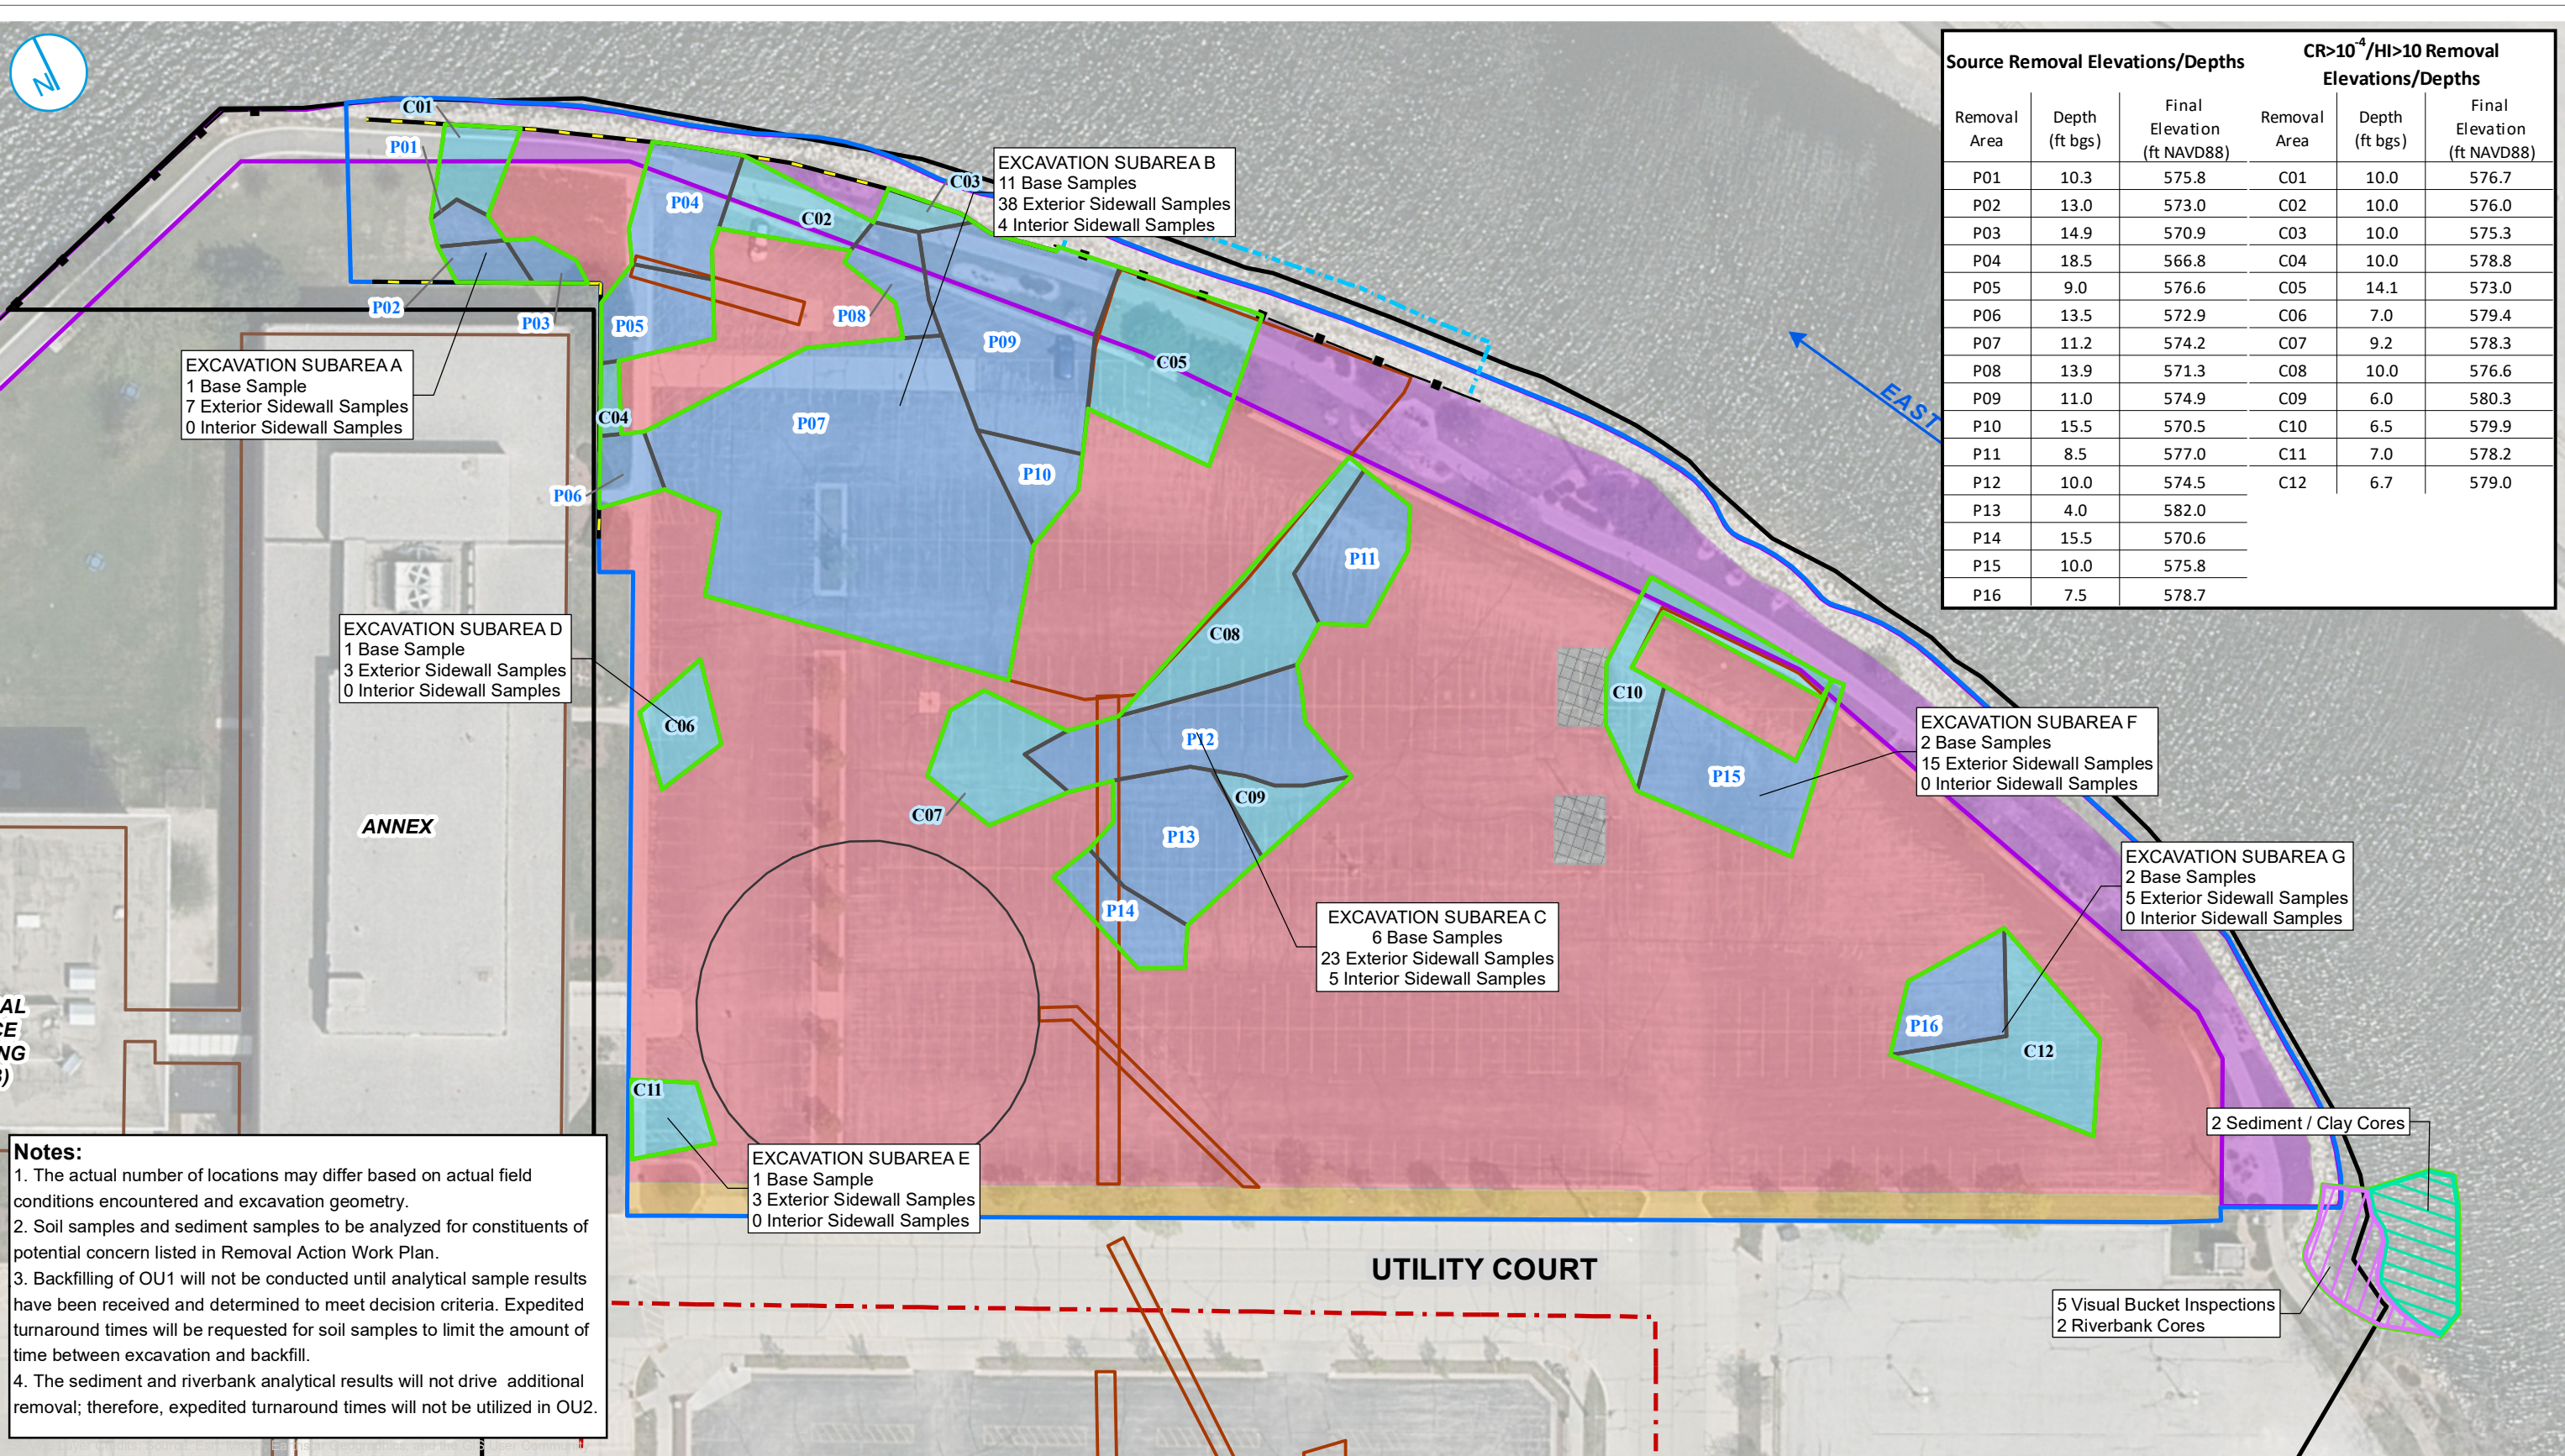
FIGURE 6

Figure 6 (Proposed Post-Excavation Sampling Plan) from the ERA Work Plan has been updated to include the proposed visual bucket inspection locations.

PROPOSED POST-EXCAVATION SAMPLING PLAN

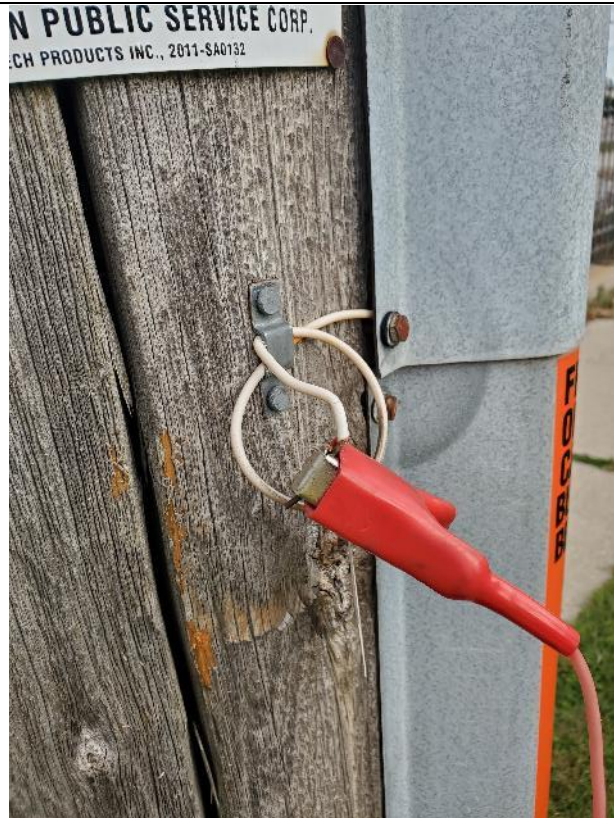
Transmitter Connection Closeup – Fiber Optic Connection

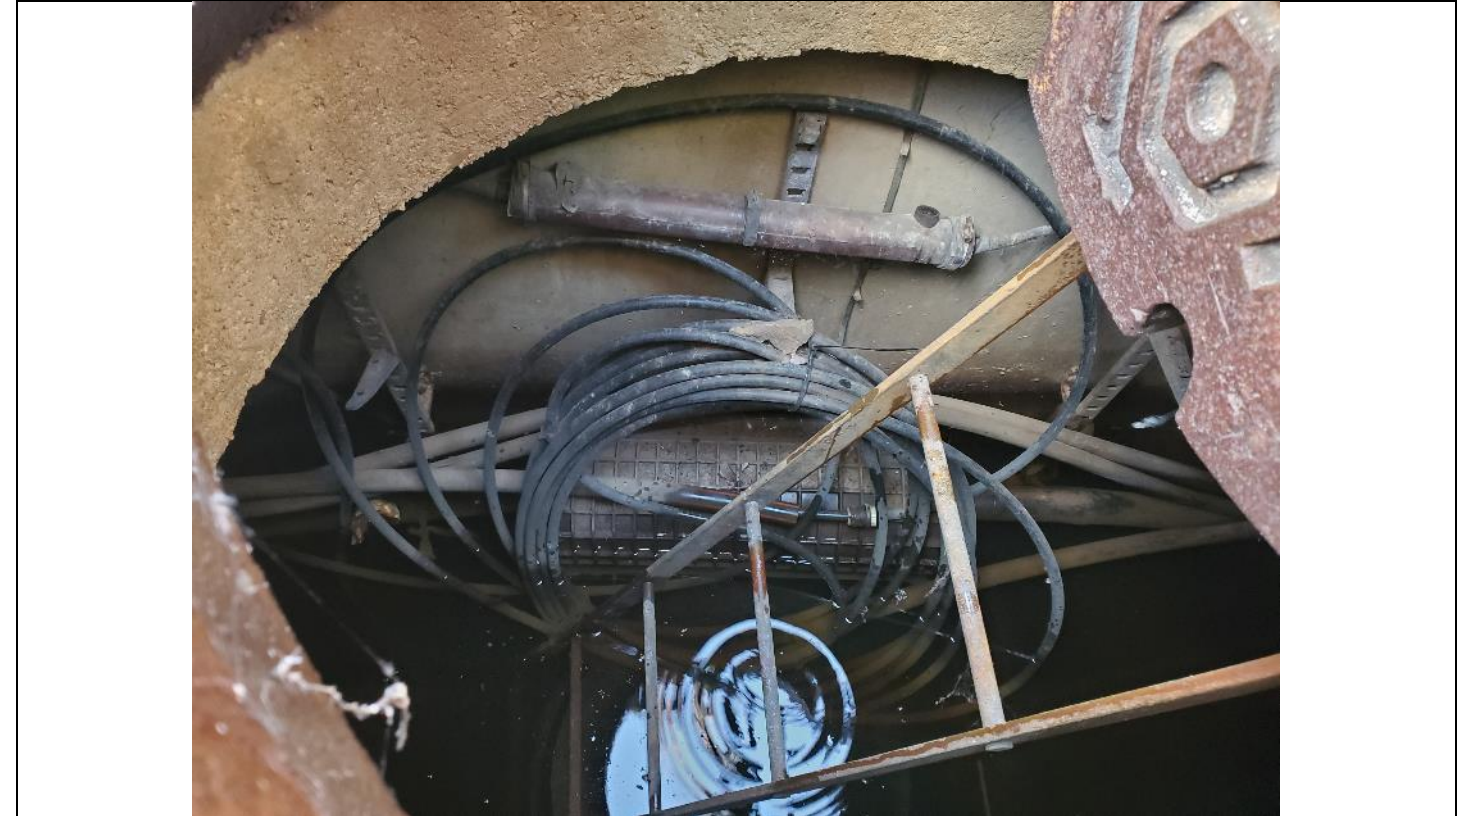
Vault on Western shore, Under CP2

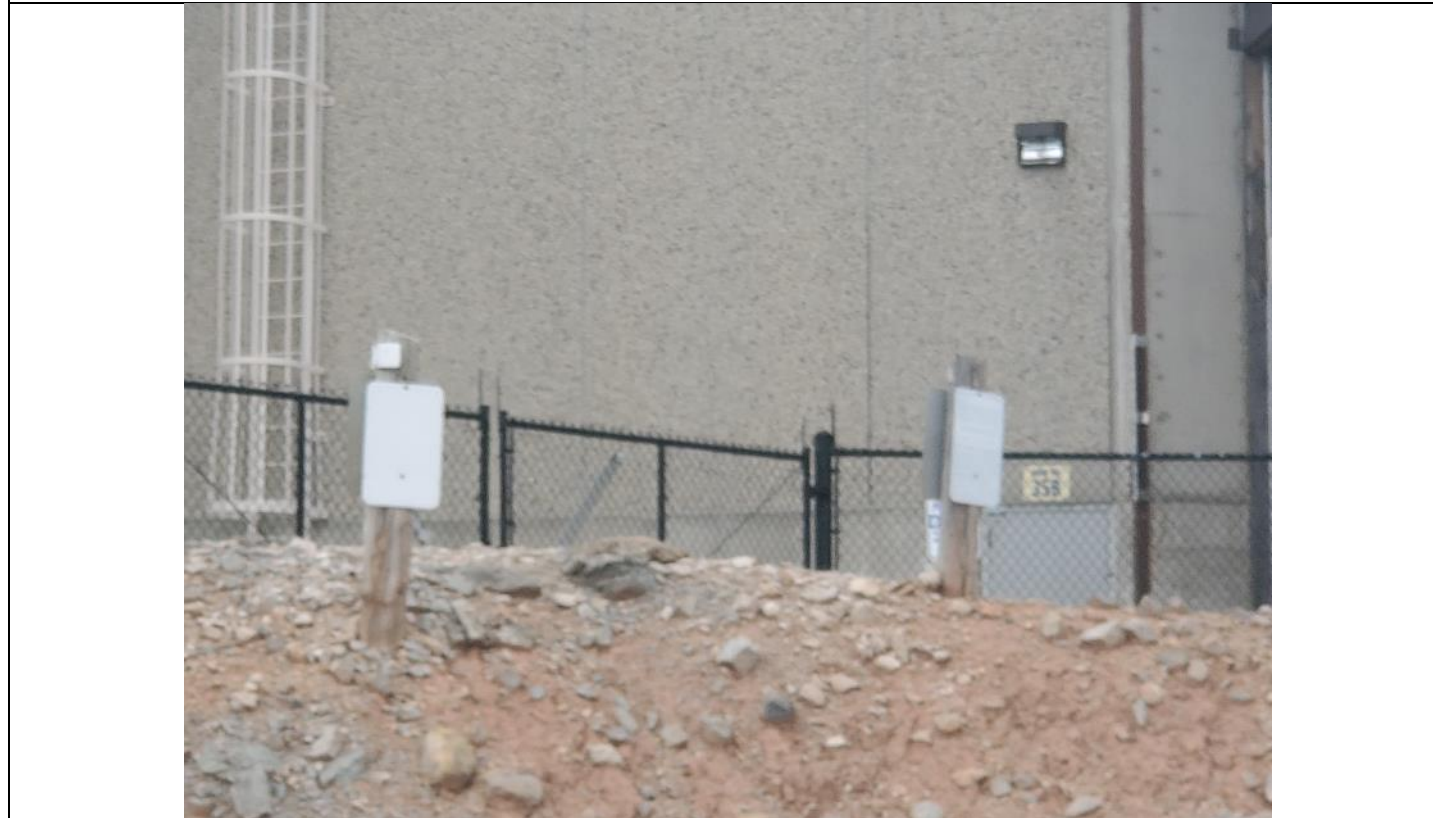
Eastern Shore signage for buried cable

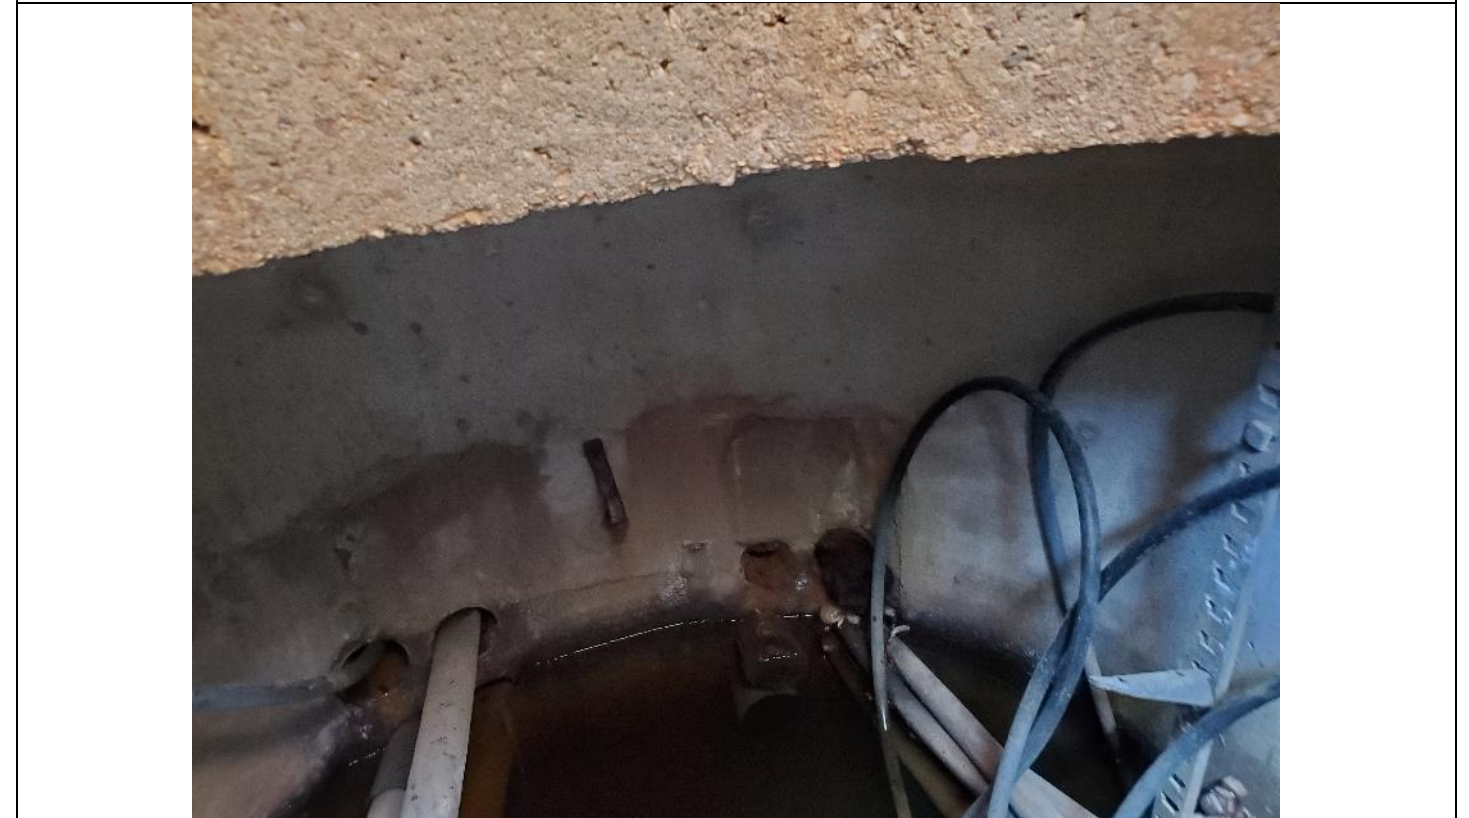
Cables in Western shore vault, possibly heading to signs on Eastern shore

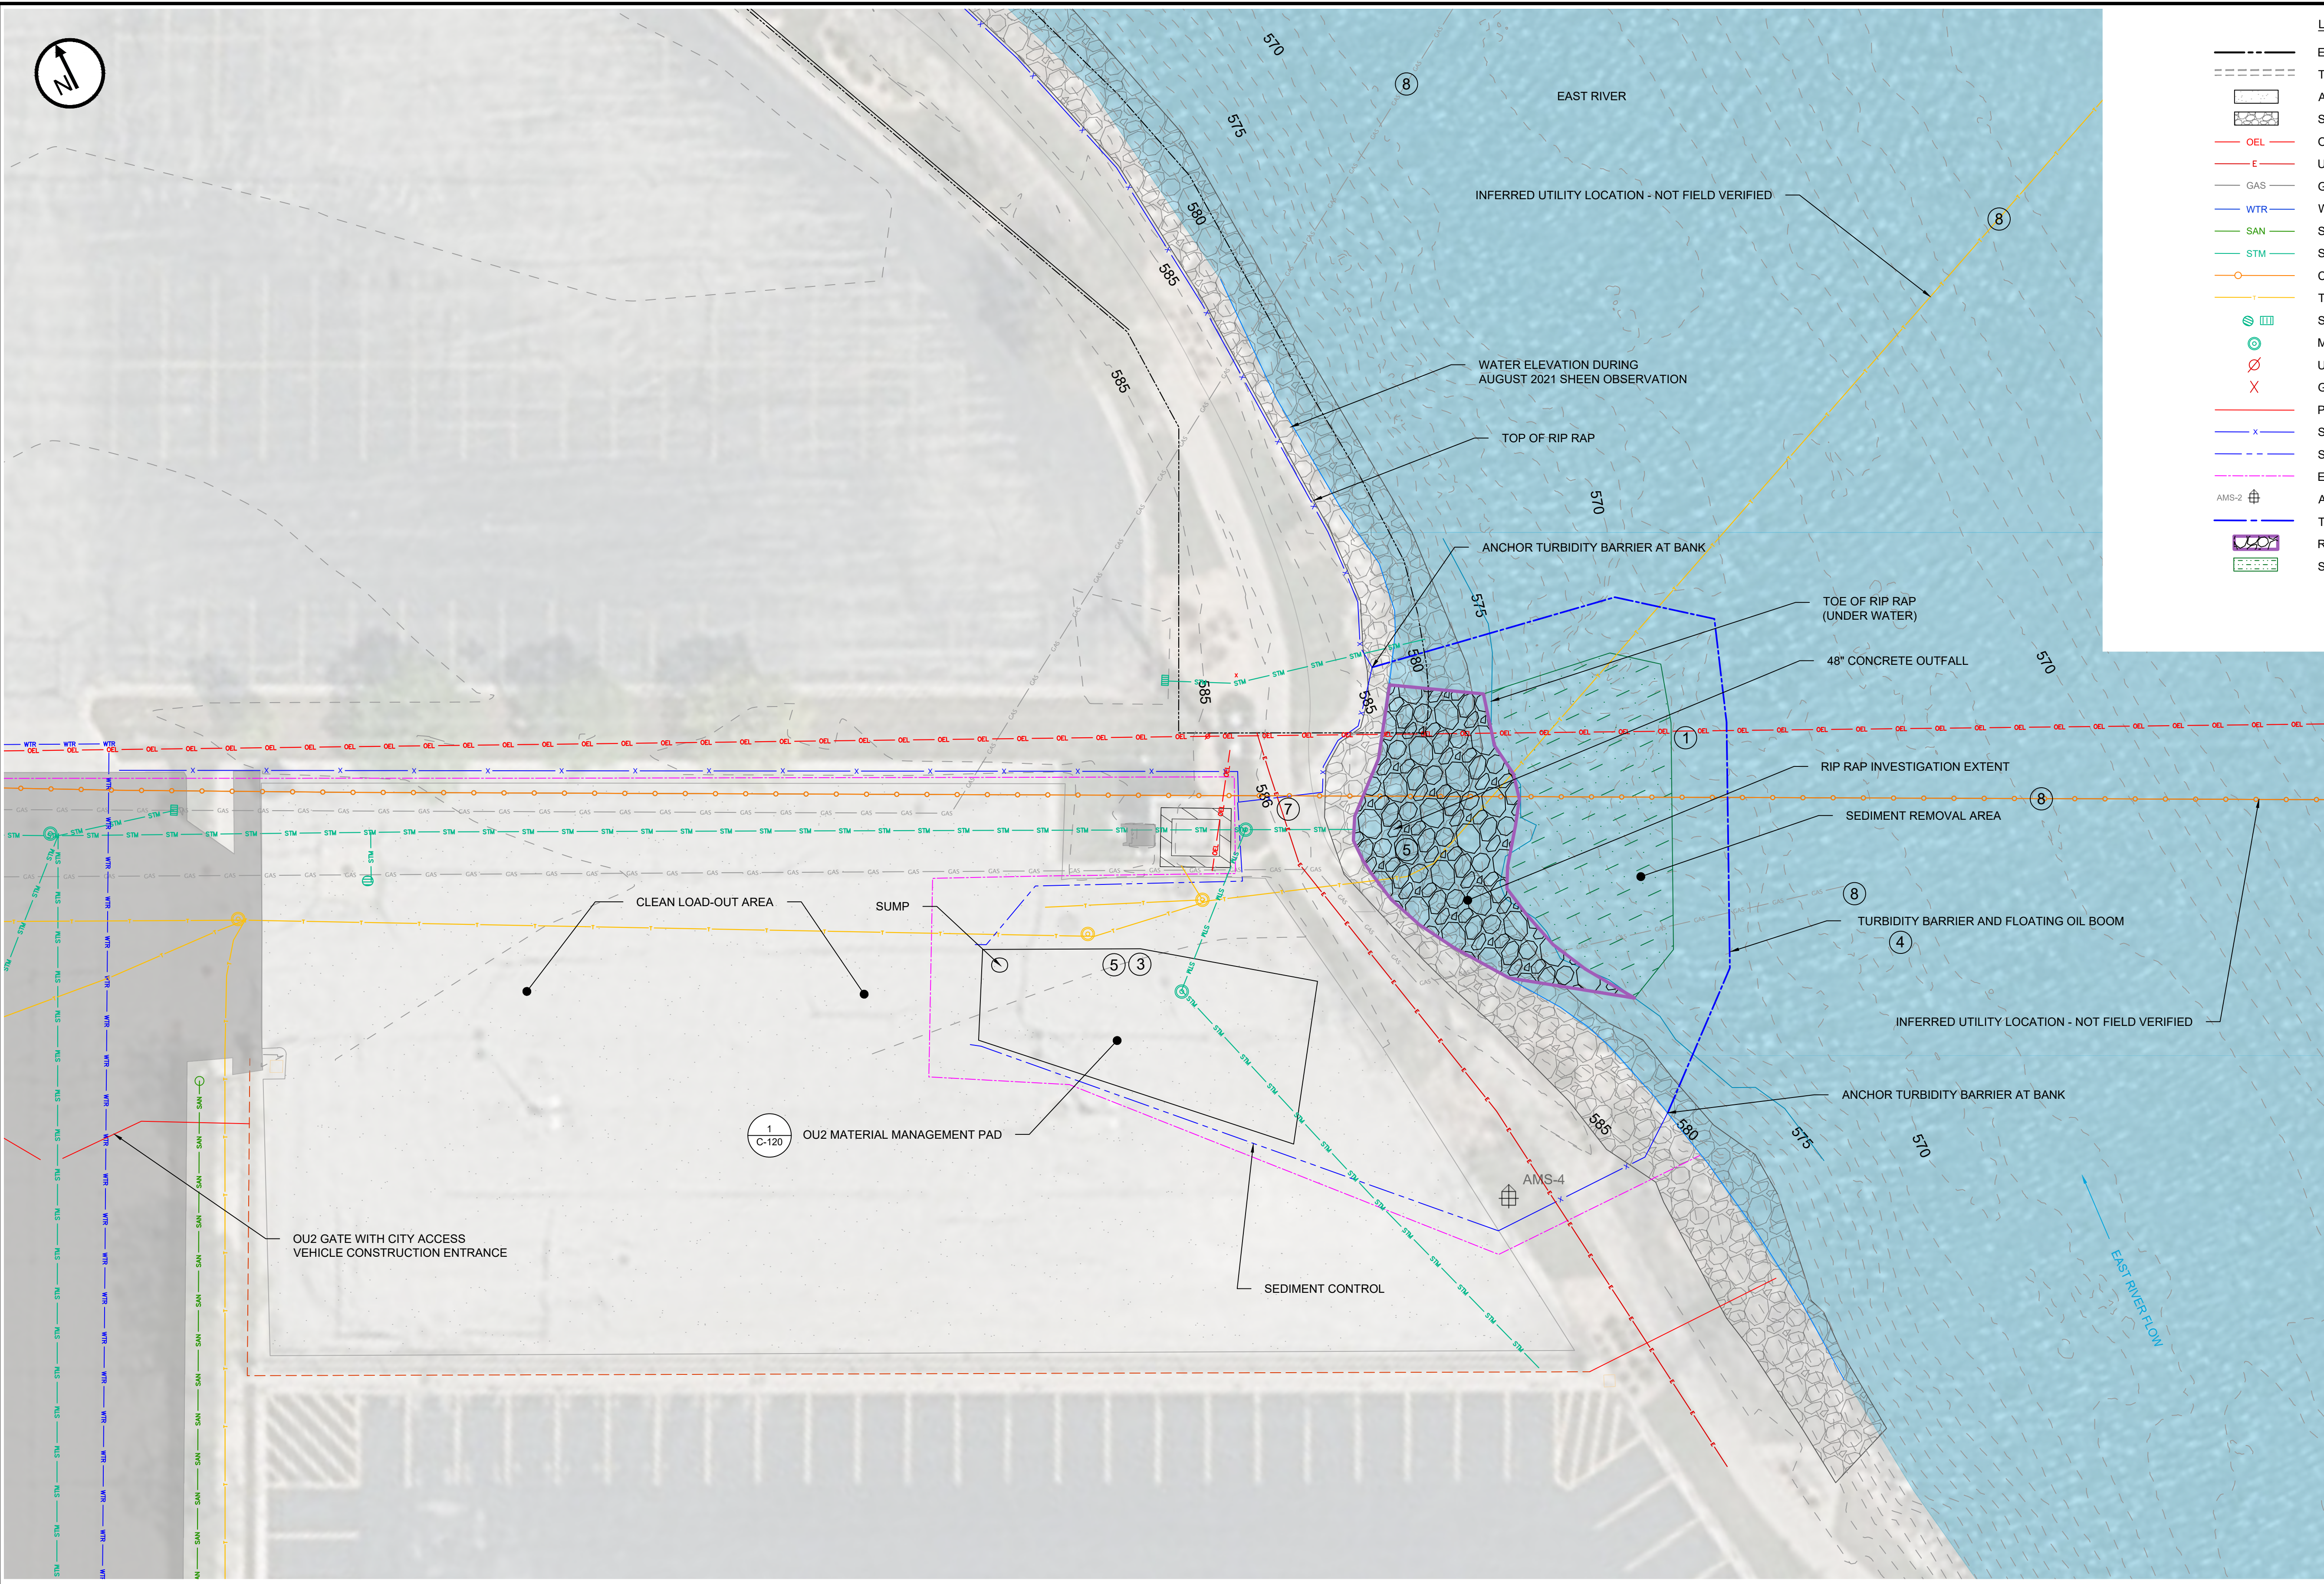
C-090

- An additional active telephone line was identified crossing the proposed removal area (Sheet C-090) along with the previously identified active communication line and abandoned gas line. As determined previously, the presence of these utilities precludes the use of sheet pile in the removal area and is not considered feasible.

As an initial step, a turbidity barrier with floating adsorbent boom will be installed to contain any turbidity during construction activities as shown on Sheet C-090. The barrier system will be 200 feet long and extend to bottom of riverbed (likely maximum 13 feet deep) with low permeability fabric, equipped with foam floatation logs, ballast chains, and associated hardware. The barrier will be connected to concrete jersey barriers located on the riverbank at both ends of the containment. In the river, the barrier will be held in place with a series of anchor systems connected every 50 feet and at critical corners. Anchor systems will include 50 lb. Danforth anchors, ballast chains, shock lines and buoys. Inside the barrier, the remedial contractor will also deploy and maintain sorbent boom to contain any potential sheen and/or collect any potential floating non-aqueous phase liquid (NAPL). The remedial contractor will have additional barrier and sorbent boom available on-site in the event the primary barrier is damaged, or that a secondary barrier is needed based on the Water Quality Monitoring Plan provided in Section 5.7 of the ERA Work Plan. The barrier will not be keyed into the riverbank as it is unnecessarily intrusive and would require removal of rip-rap and sediment in areas beyond the remedial limits, creating turbidity during installation and removal with no significant improvement of the barrier performance. Steel posts will also not be used due to the presence of utilities.

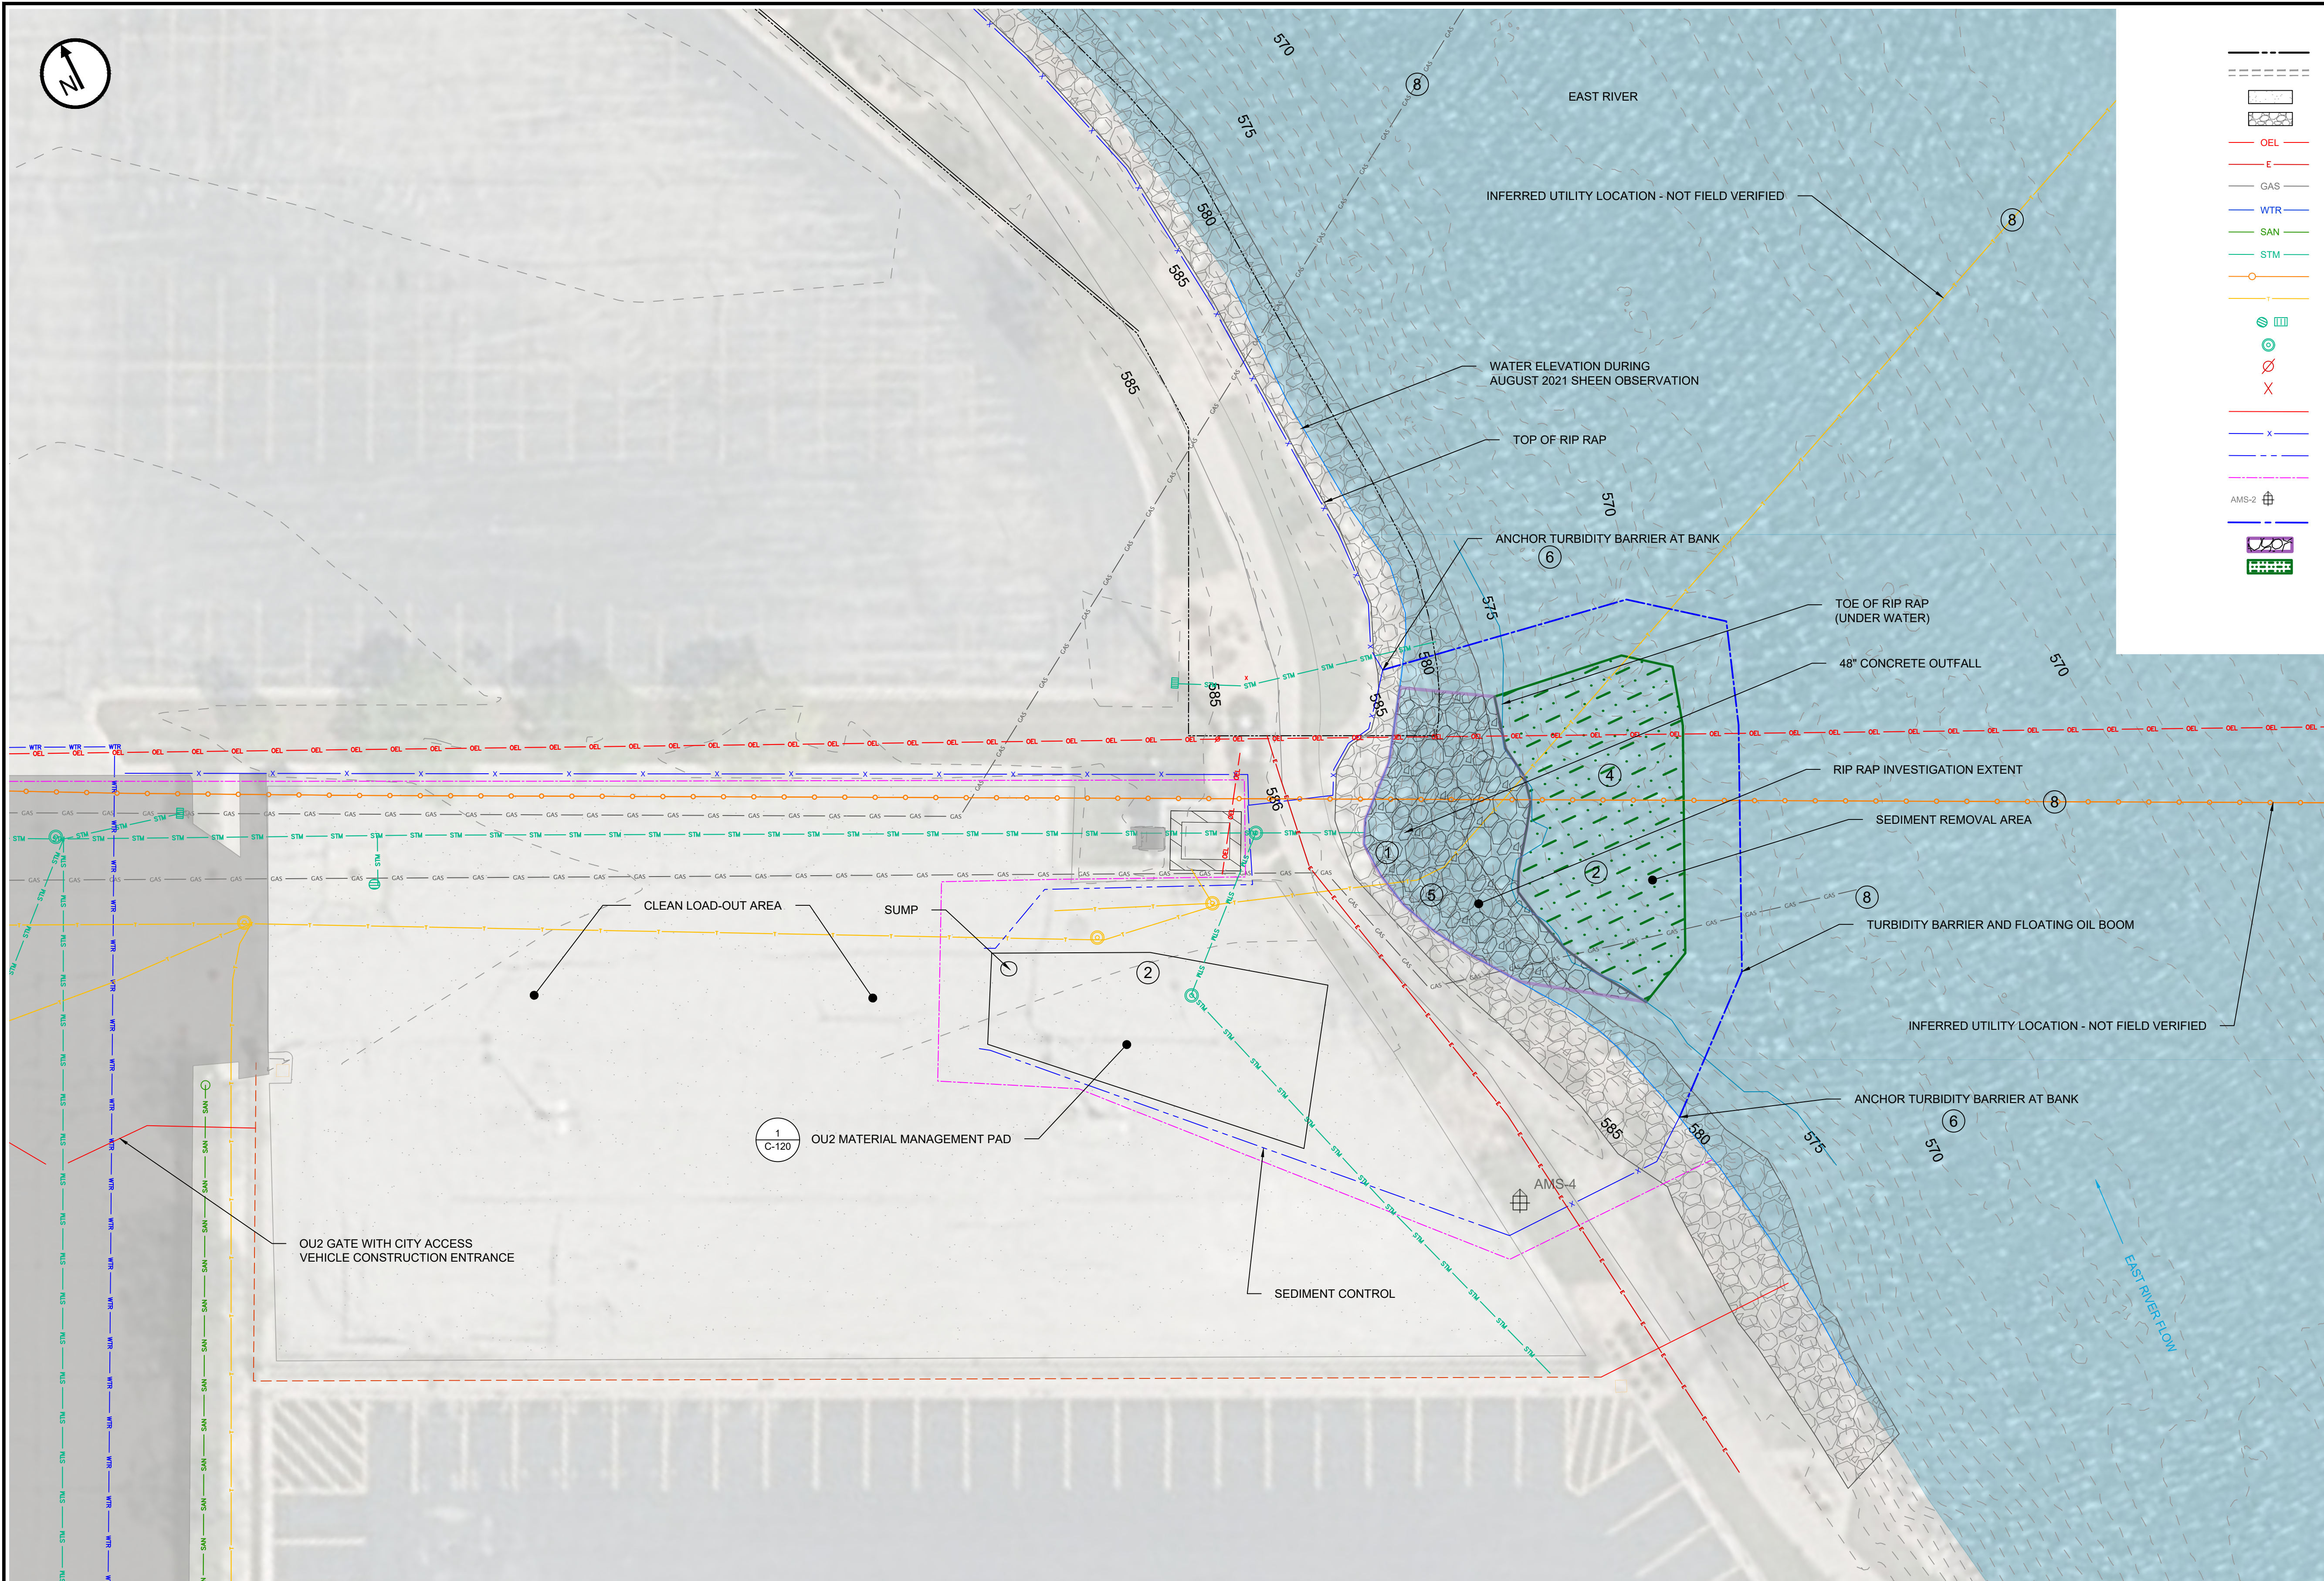
Saturated, soft in-channel sediments will be removed from within the Sediment Removal Area as shown on Sheet C-100. The removal extent is based on observations of sheen generated during sediment probing activities, soft sediment thickness observations measured by poling activities, and sediment sampling analytical results as presented on Figure 4 of the ERA Work Plan. All soft sediment within the lateral extent will be removed down to the underlying native clay bottom. Saturated sediments will be staged on MMP and gravity-dewatered and amended with a drying agent (e.g., Portland cement or calciment) as needed to meet landfill disposal requirements.

- CONTRACTOR NOTES:**
1. Remove 6 inches of bank soil material and all soft sediment below riprap removal area.
 2. Remove all soft sediment to hard bottom (approximately 6" to 18" thick), as directed by Engineer, in designated sediment removal area. Transport to material management pad for dewatering, drying and mixing to acceptable dried conditions for transport to the landfill.

5. Place and anchor geotextile fabric on bottom and backfill riprap area with gravel from commercial quarry. Carefully replace riprap to similar sizing and configuration, elevation and location as previous.

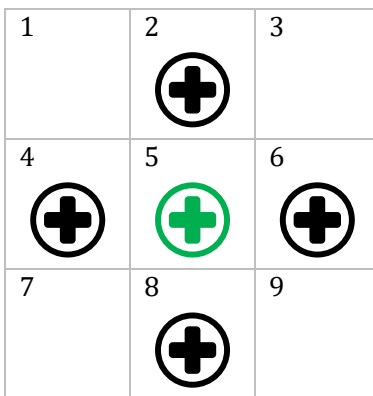
Figure 2a Sample step-out scheme for "significant visual DNAPL observation" scenario

1. One bucket deeper will be collected from the same location to observe DNAPL at depth below the original bucket sample;
2. One bucket will be collected in each remaining cardinal direction stepping out one bucket-width from the original bucket sample; and
3. If a bucket sample collected from one of the cardinal primary step-out locations contains significant visual DNAPL, then repeat steps 1 and 2.
4. If after repeating steps 1 and 2 significant visual DNAPL is still observed, then a collaborative discussion will be held with the A/OT representative on the barge to determine how to proceed.

A schematic illustration is shown below in Figure 2 to demonstrate the sample step-out process in plan-view.
