From: Mafizul Islam, P.E. <mislam@thesigmagroup.com>
Sent: Monday, April 3, 2023 3:24 PM
To: Martinez, Joseph J - DNR
Cc: Edlebeck, John (J.Edlebeck@wfbvillage.org)
Subject: RE: Whitefish Bay Landfill - Green Tree Prep. Academy Vapor Sampling
Attachments: Green Tree School IAQ & SSV Lab Report - March 30, 2023.pdf; Figure 2 - IA & SSV Sample Locations - March 2023.pdf

**SUB-SLAB VAPOR (SSV) AND INDOOR AIR (IA)
PASSIVE SAMPLE LOCATIONS**
MPS: GREEN TREE PREPARATORY ACADEMY
MARCH 2 THRU 9, 2023
PERFORMED BY THE SIGMA GROUP, INC.

FIGURE 2
GROUND FLOOR PLAN

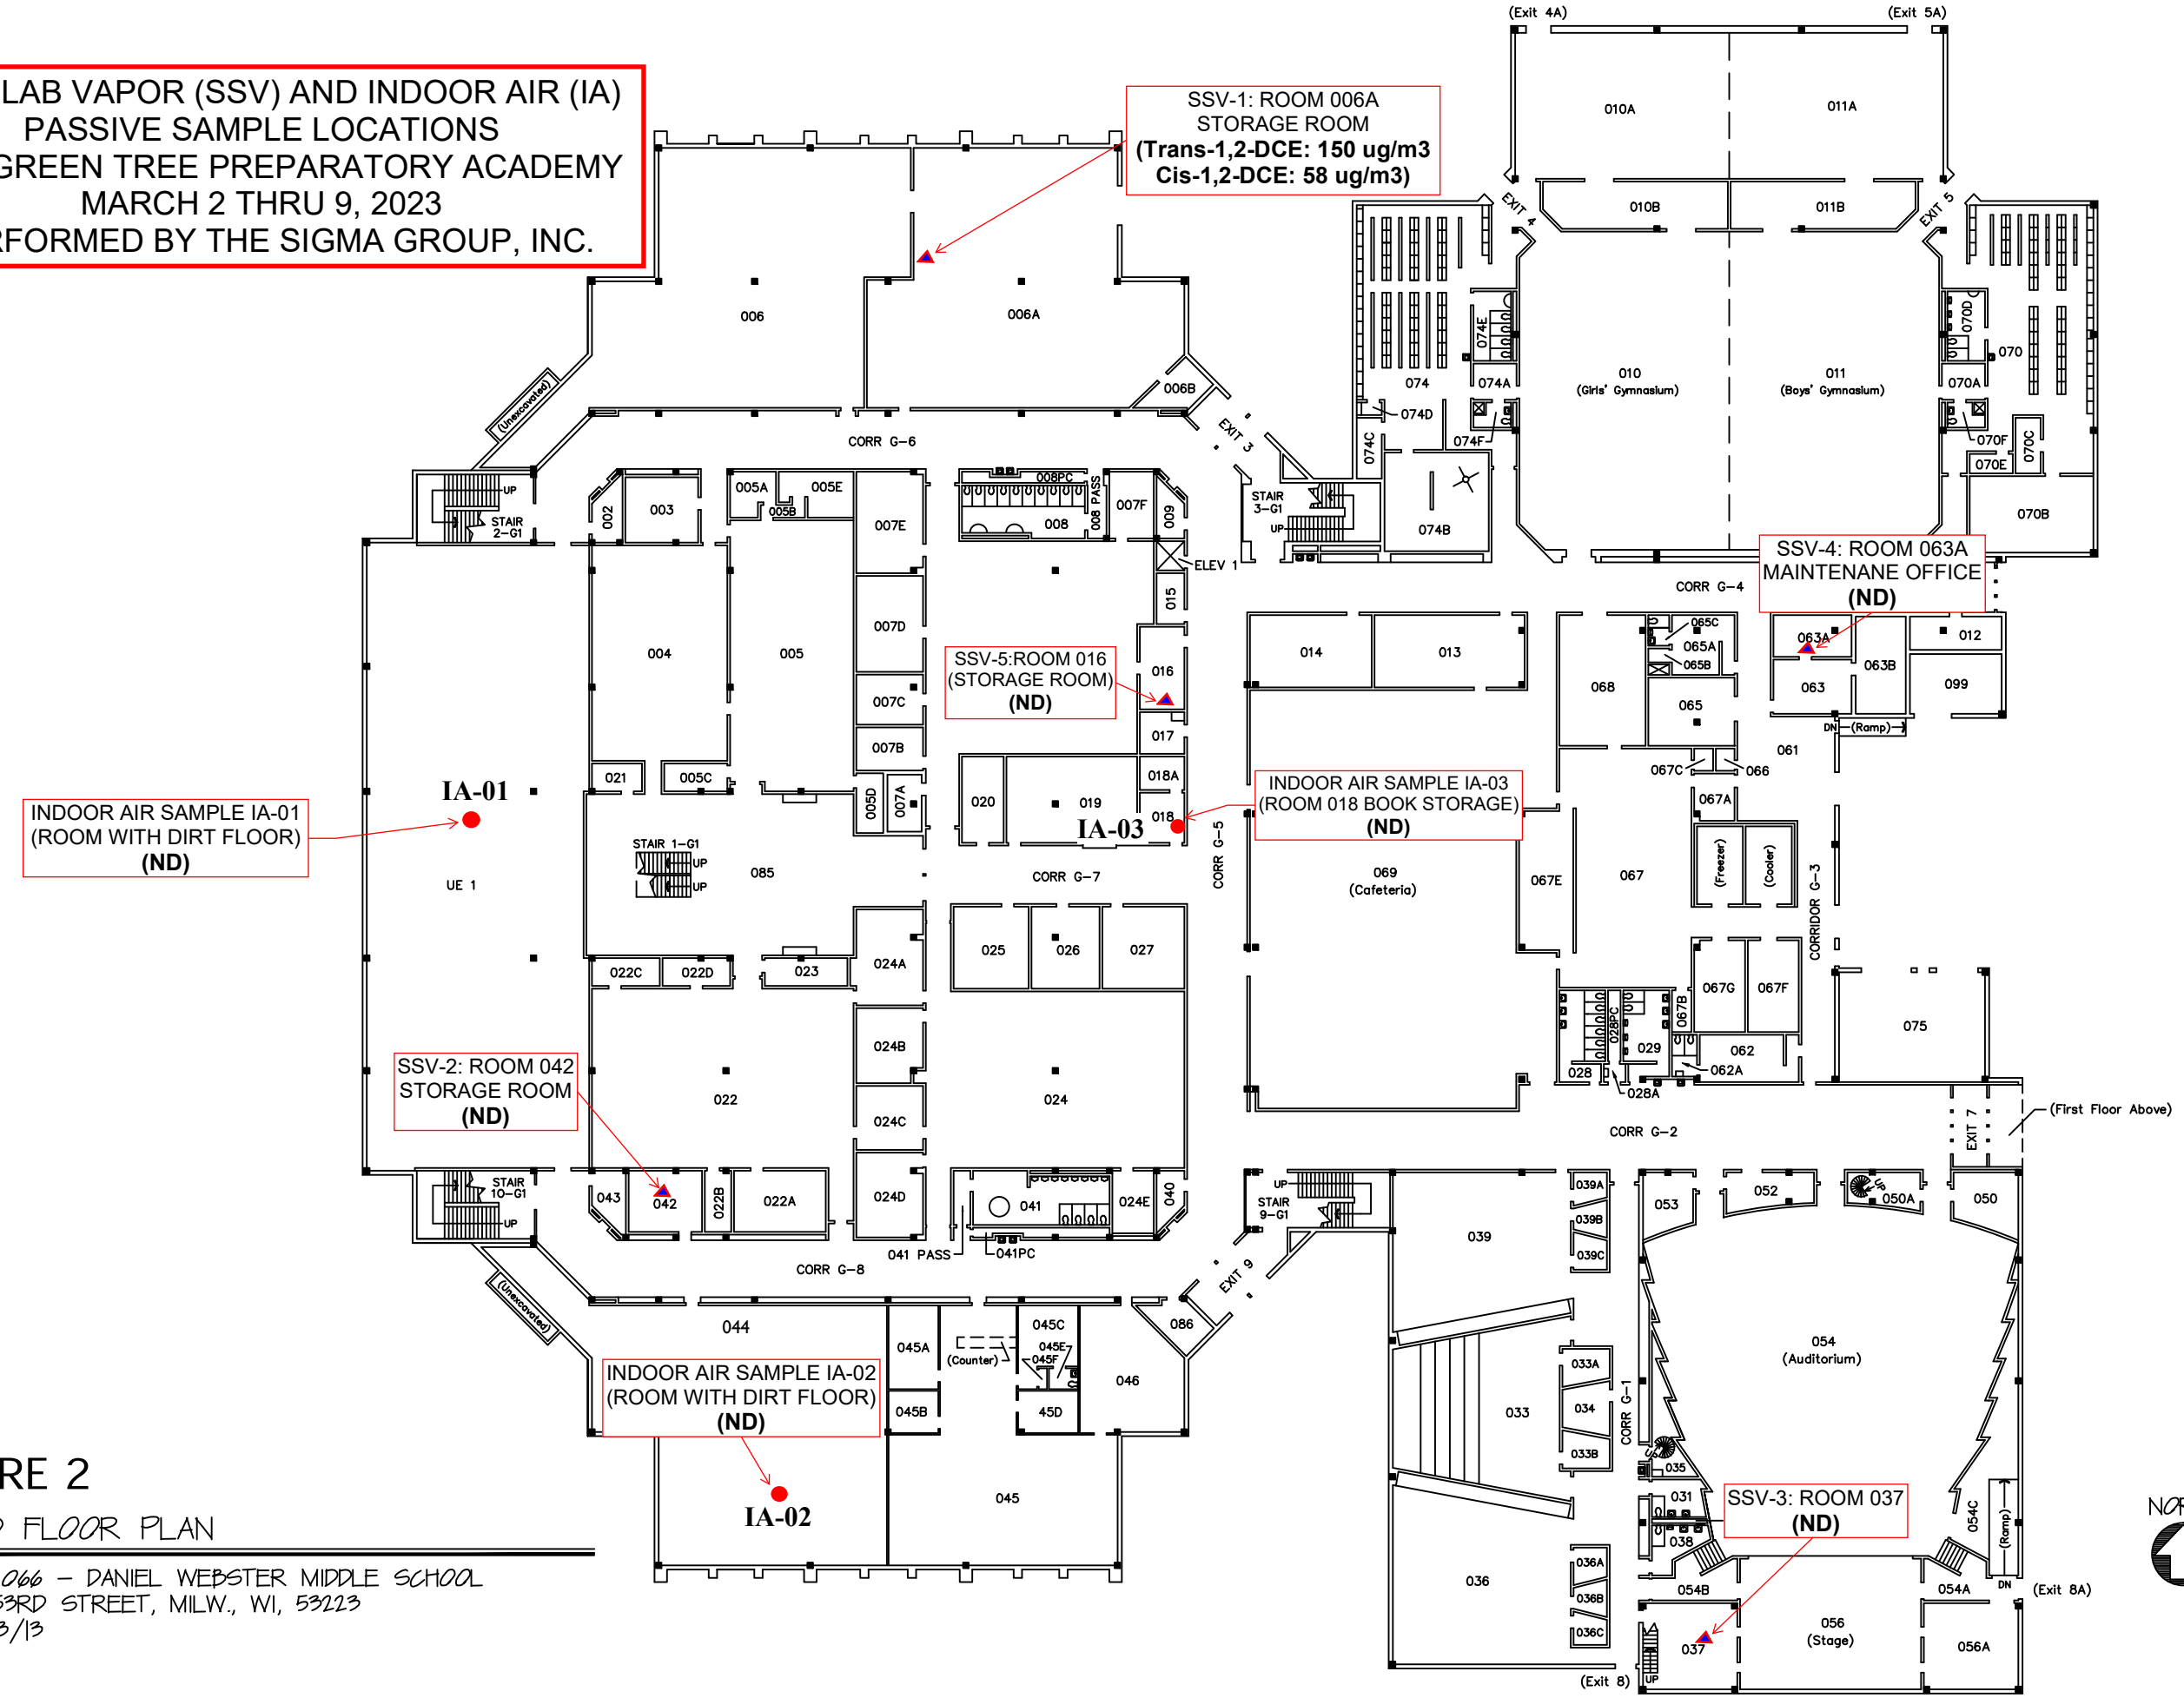
For your reference attached please find **Figure 2** which depicts the locations of the indoor air samples and sub-slab vapor samples.

We were able to collect three indoor air samples – two samples from two rooms with bare ground (no concrete) and one from a book storage room near the middle of the building. All three samples were reported non-detect for chlorinated VOCs (see attached lab report).

Also, four of the five sub-slab vapor samples collected from below the building slab were reported non-detect for chlorinated VOCs. The only sub-slab vapor sample detected with two chlorinated compounds (Cis-1,2-Dichloroethene, and Trans-1,2-Dichloroethene) were detected at concentrations significantly below their VRSL value of 1,400 ug/m³.
