Semi-Annual Operation and Monitoring Report, January - June 2019

Former Kenosha Engine Plant, Kenosha, Wisconsin

WDNR FID 230004500, BRRTS# 02-30-000327

October 9, 2019

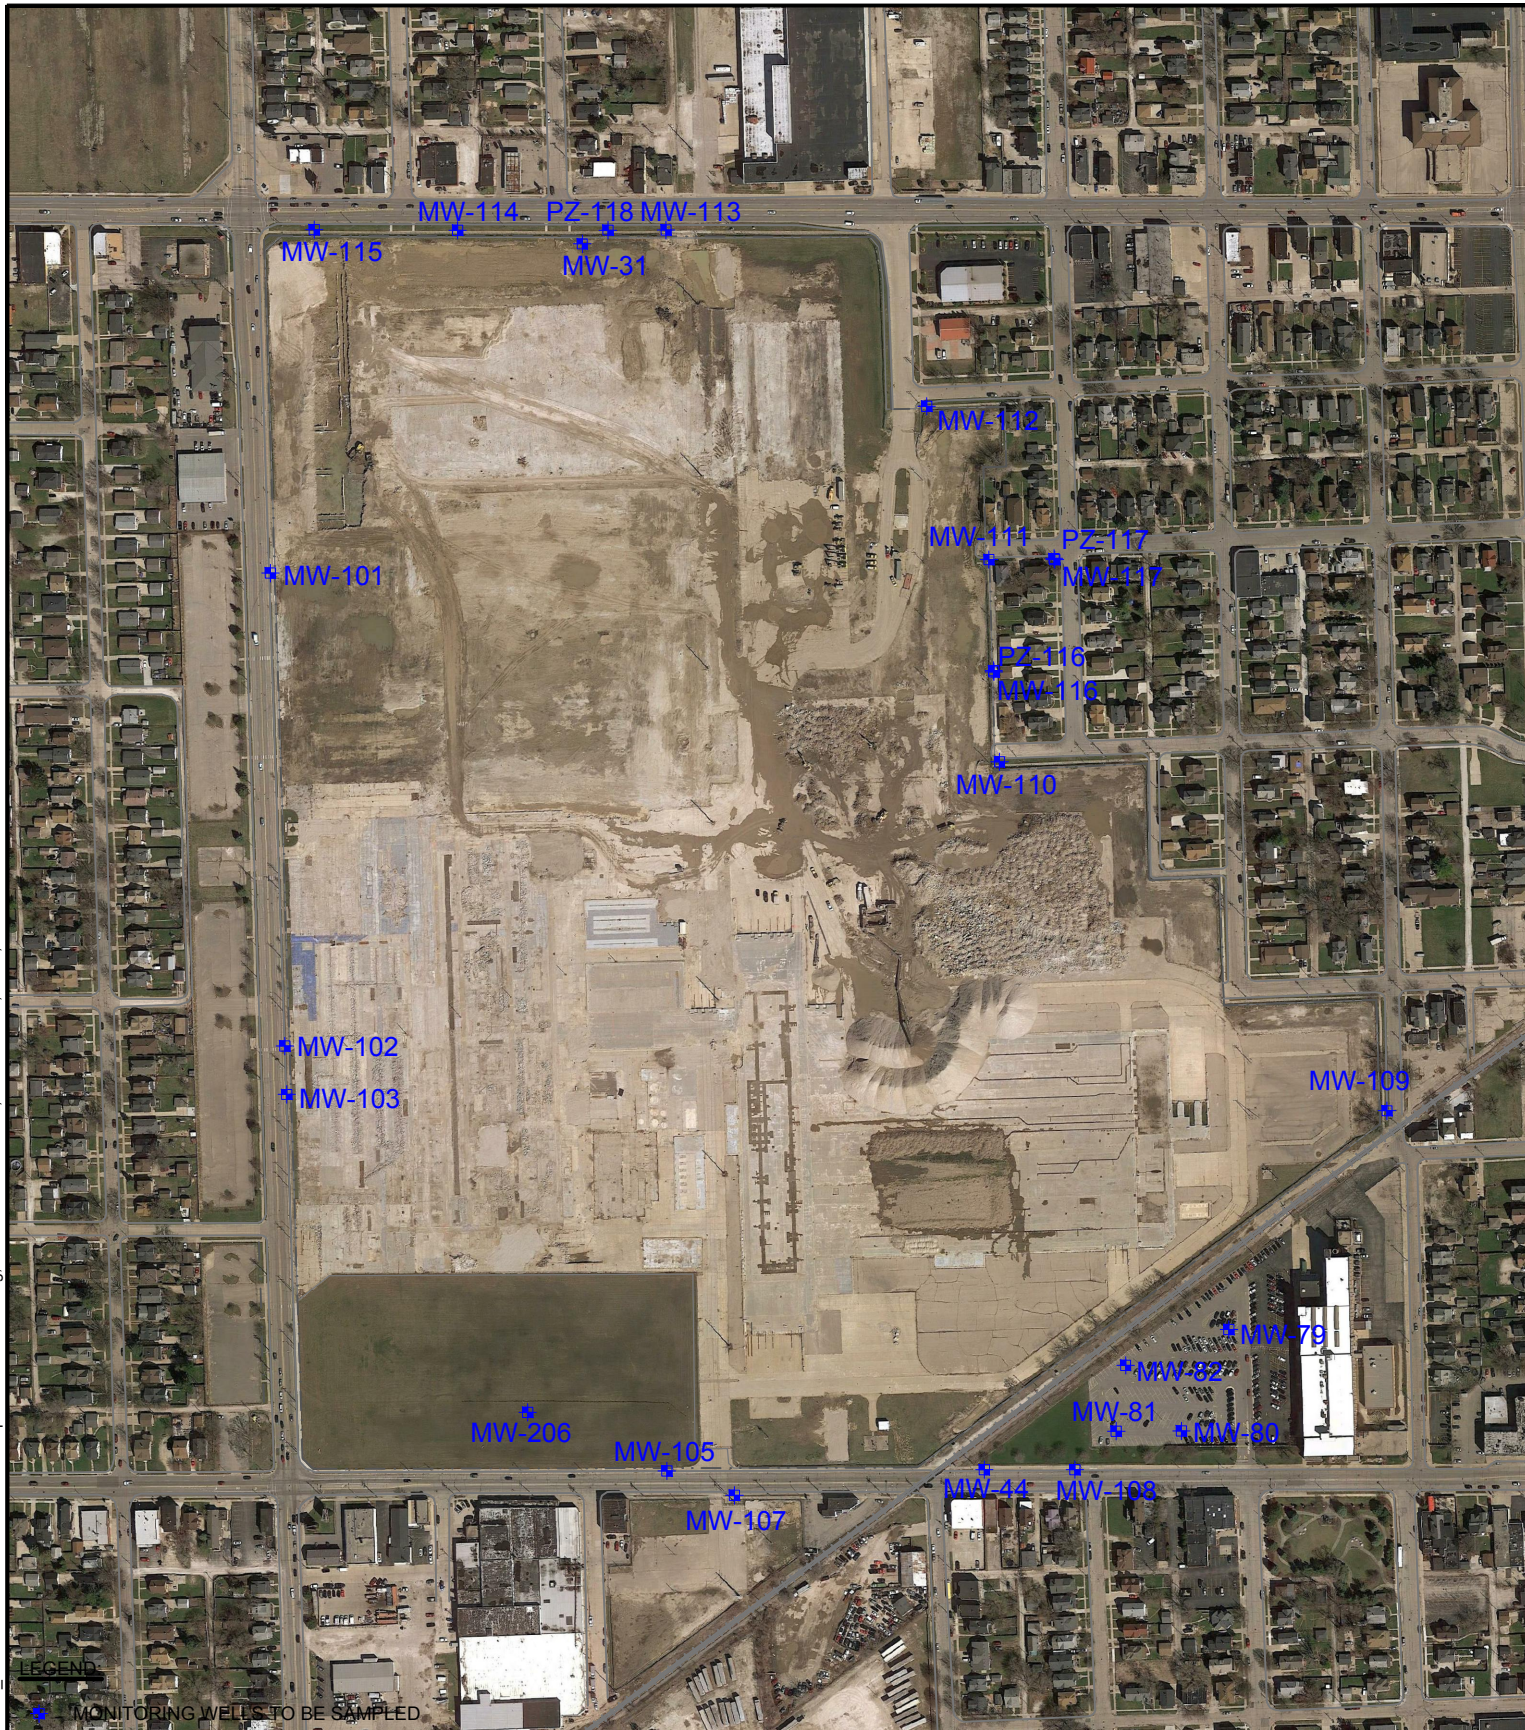
FIGURE NUMBER 1

AECOM continues operation, maintenance, and monitoring (OM&M) of three groundwater remediation systems at the KEP (location shown on Figure 1).

MONITORING WELL LOCATION MAP
 KENOSHA ENGINE PLANT
 CITY OF KENOSHA
 KENOSHA, WISCONSIN
