OUTBOARD MARINE CORPORATION

20 September 1994

RE: *Previous Locations of Trailers and Site Cleanup Activities
Former Ecolab Facility Remediation Project
Mequon, WI*

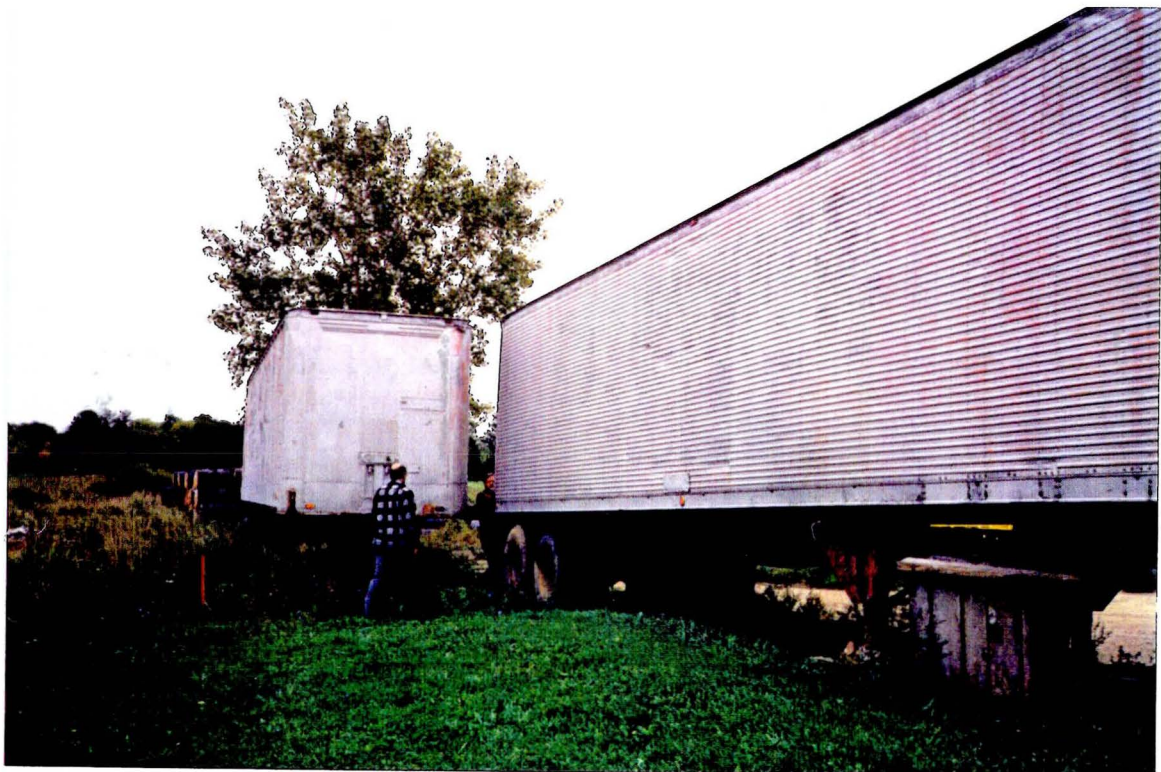
Attachment 3 - Photos of Trailers from 1988

Other OMC employees were on-site in 1988 and again in 1989 after the trailers had been moved and photos show their locations to the west of the tree box, including during removal/cleanup (June 1989). Refer to Attachments 3 and 4 for copies of trailer photos from 1988 and 1989. (Note that at that time, the drums attributed to Northern Precision were stacked along the gravel drive across from the current hazardous waste storage unit.)

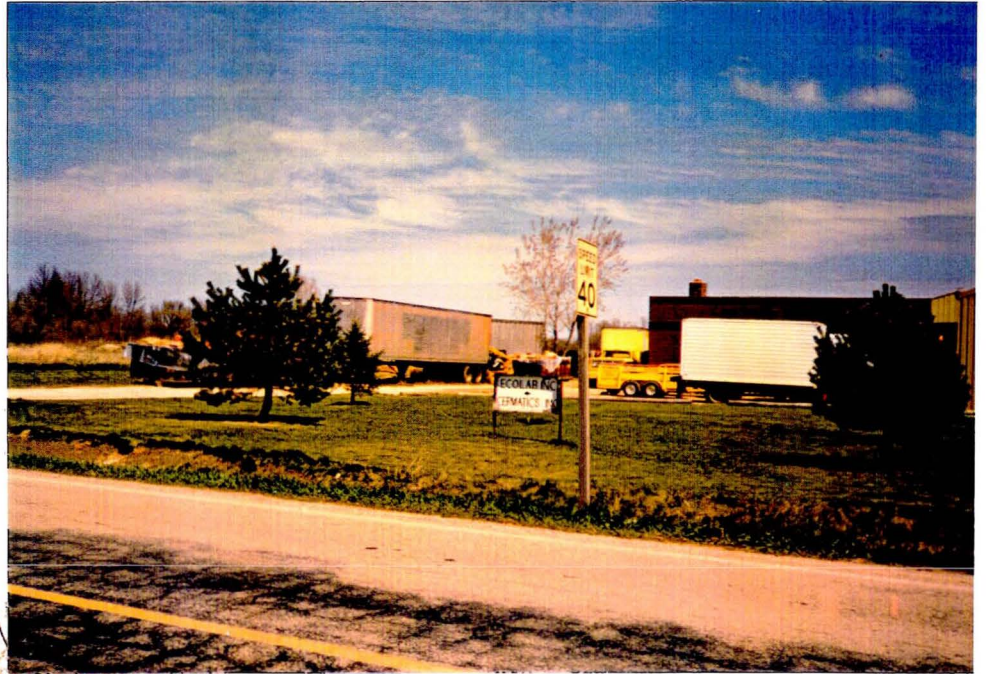
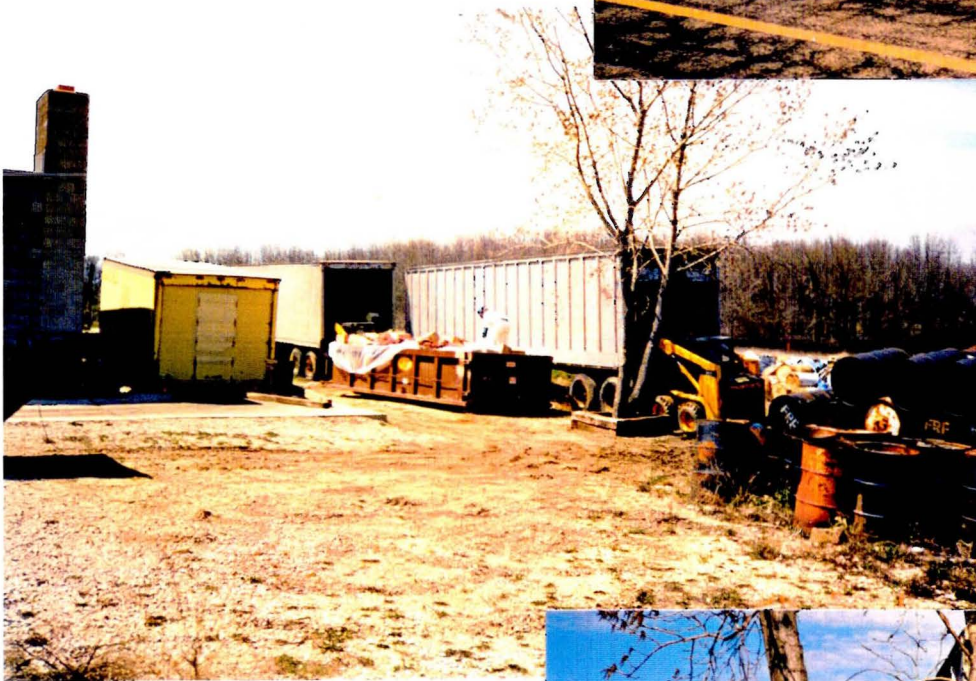
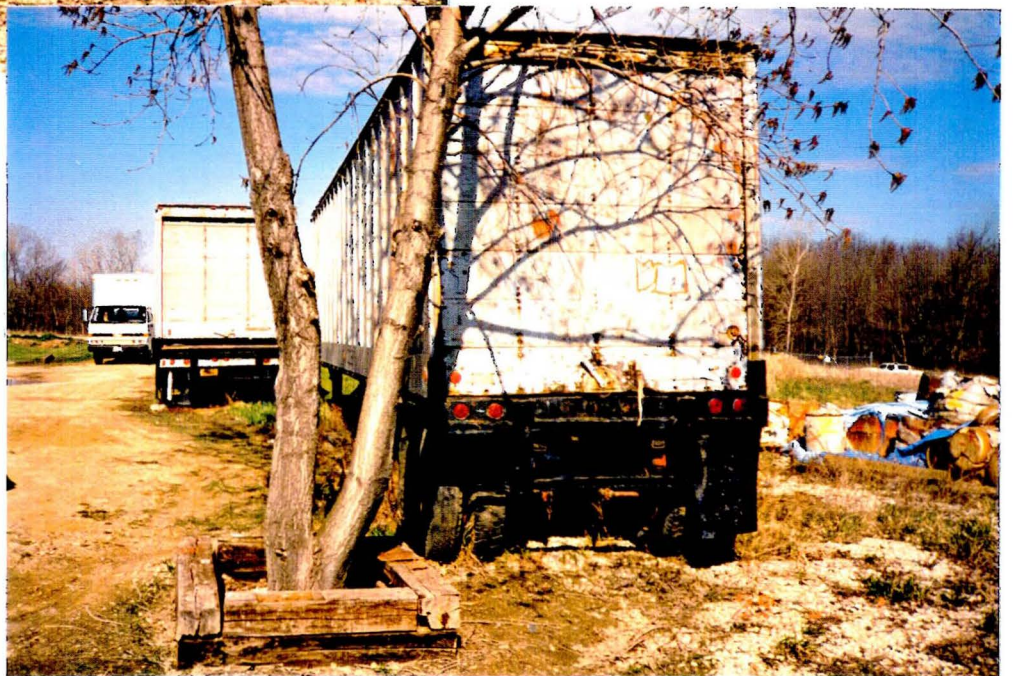
Attachment 4 - Photos of Trailers from 1989

In 1989 at the time of removal/disposal, a group of drums and block wax were located in the area near the tree, basically in the same area as in 1988 and 1987. Attachment 7 shows photos of block wax and drums to the north and west of the tree in 1989. This group of material is also somewhat visible relative to the trailers and the tree in Attachments 3 and 4.

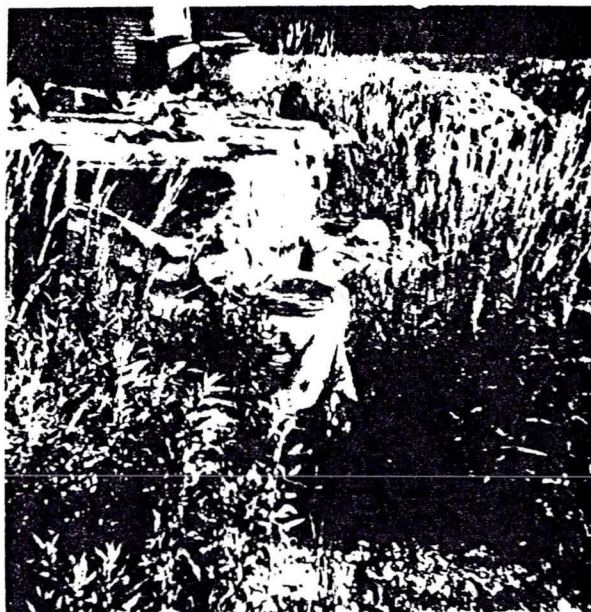
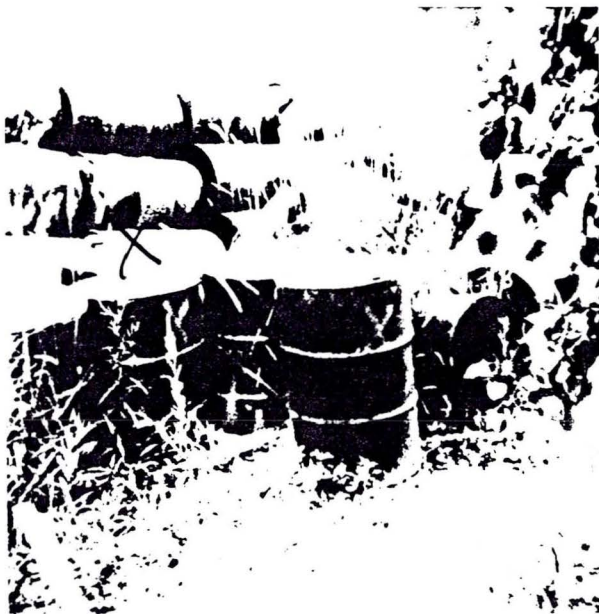
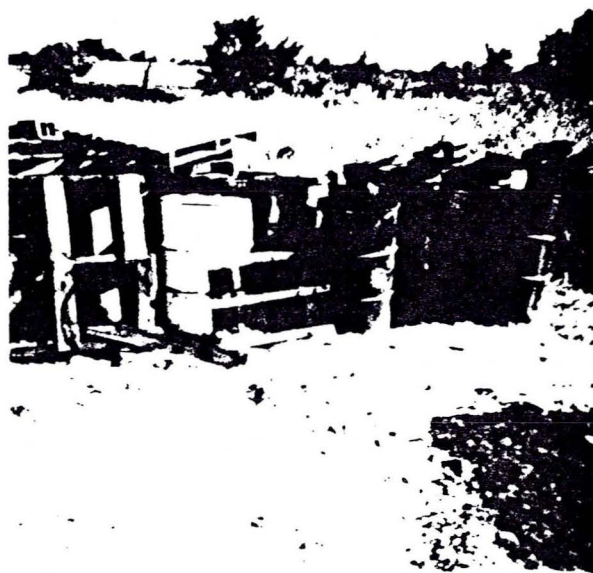
Attachment 5 - DNR File Photos of Drum Locations from 1987

DNR wanted to verify where wax materials and drums of wax had been located outside of trailers (uncontained). Photos in DNR files from June 1987 show some drums at the west end of the trailers and a group of drums to the north of what appears to be a portion of the tree (in the upper right corner of the photo at the bottom left of the page; Attachment 5). OMC file notes from 1987 indicate approximately 72 drums were present between the trailers at that time. Steve Otto recalled that most of the material outside was within 20 feet of the trailers.

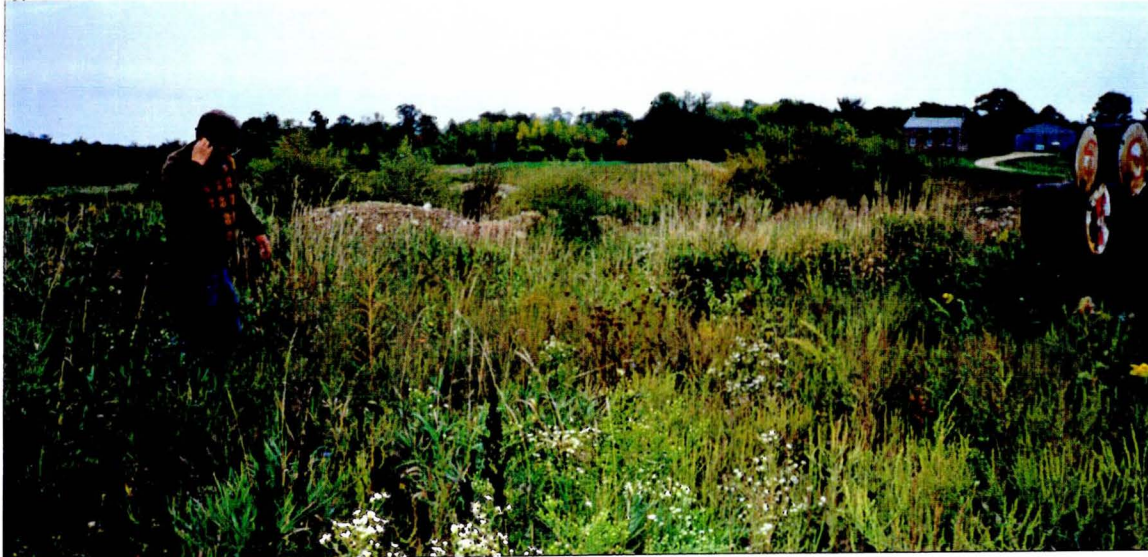
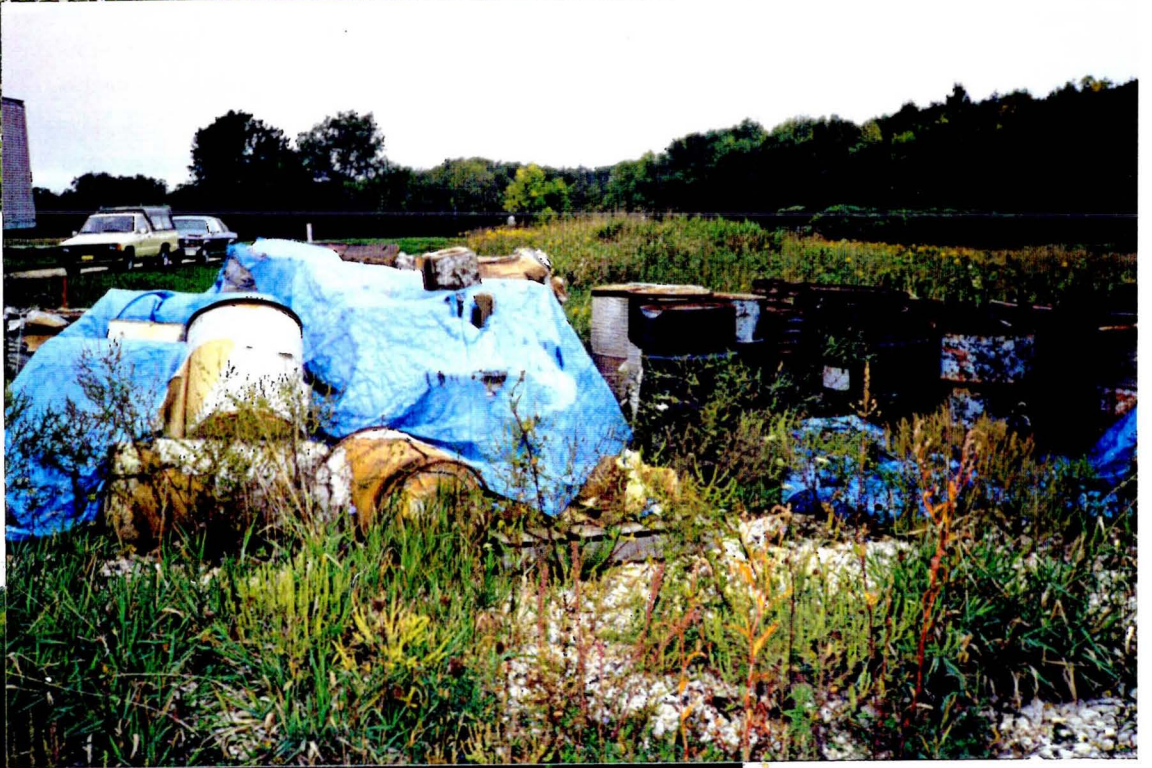
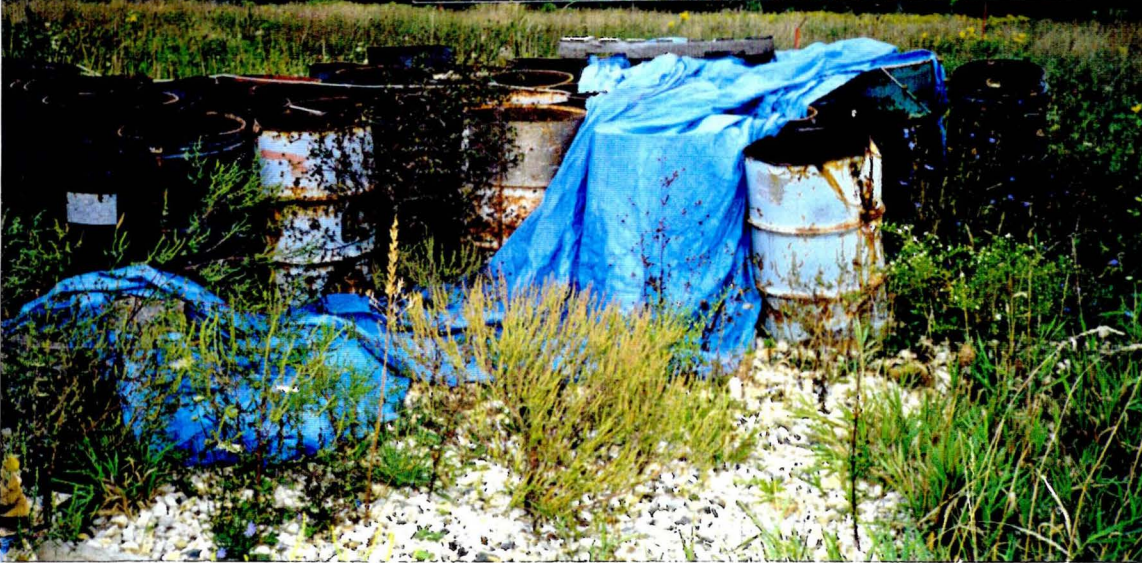
Attachment 6 - Photos of Drums and Wax from 1988

Attachment 6 includes photos showing the location of loose drums and bulk wax outside during the 1988 site visit, including the area where uncontained wax had previously been located (top photo). This location appears to be north and a bit west of the tree, in the same general area as shown in the DNR photos and within the 30 foot by 35 foot area where soil removal work has been conducted. According to OMC notes from the 1988 site visit, the uncontained wax had

been placed in drums and put into the trailer to the north.

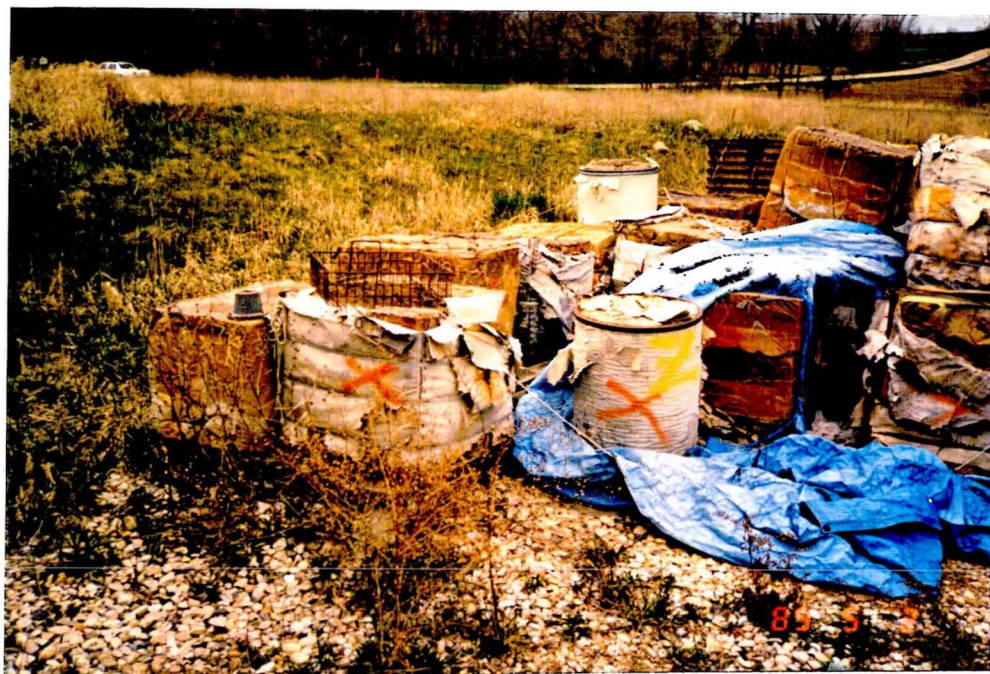
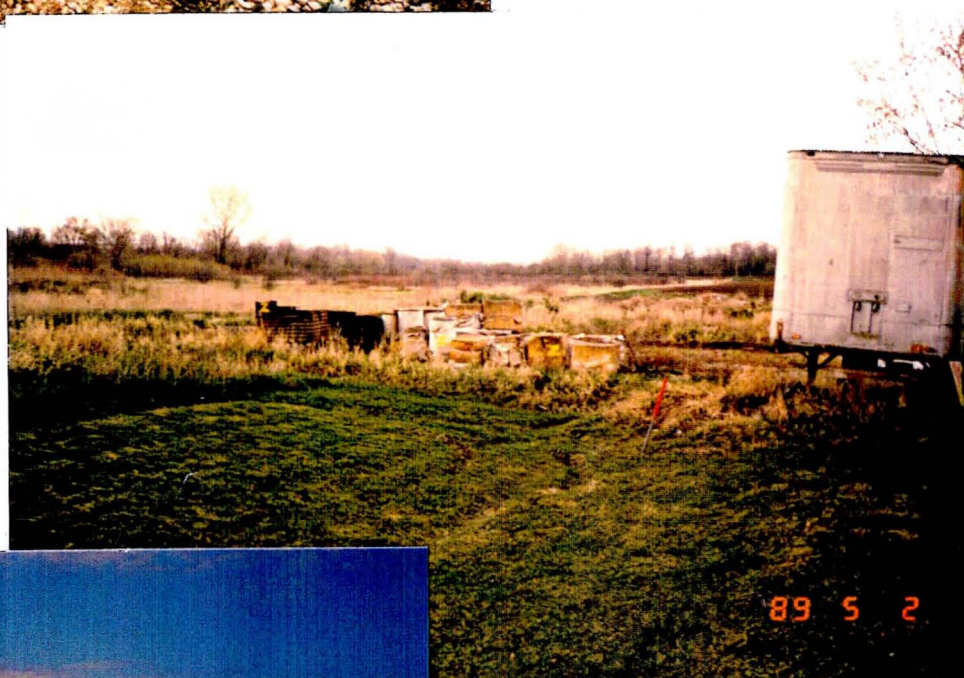
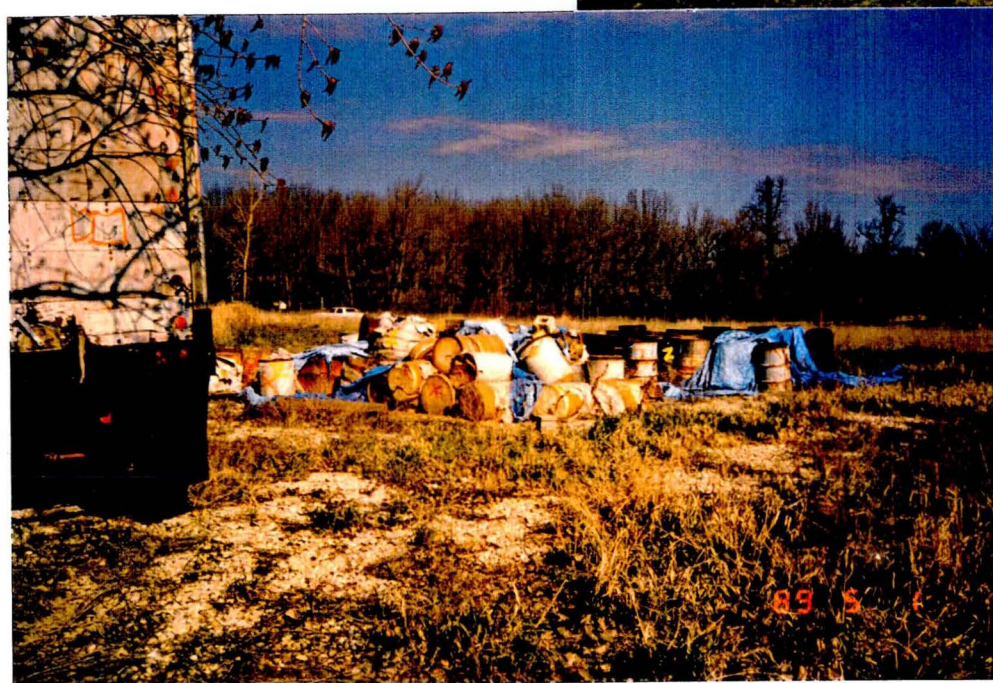
Attachment 7 - Photos of Wax and Drums in 1989

Overall, it appears that the drums and bulk wax materials which were not contained in the trailers were located just northwest of the tree (in the area which was excavated later due to spilled wax on the ground). Wax was spilled or evident on the ground during removal only adjacent to the bulk wax/drums shown on Attachments 6 and 7. Some miscellaneous drums were initially between and adjacent to the trailers but were later consolidated and put inside one of the trailers.

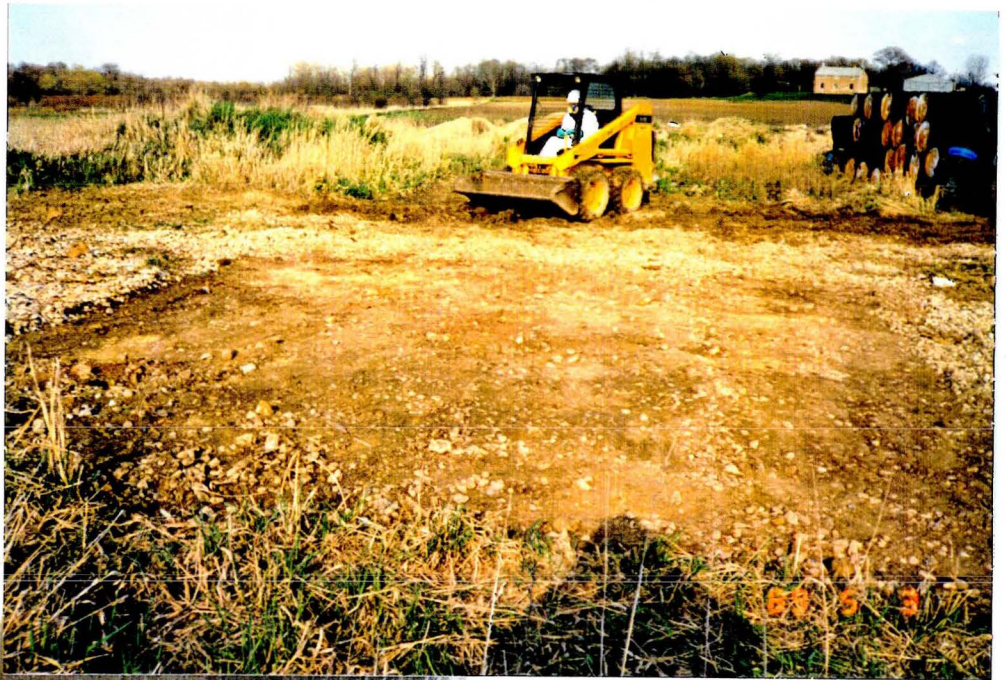
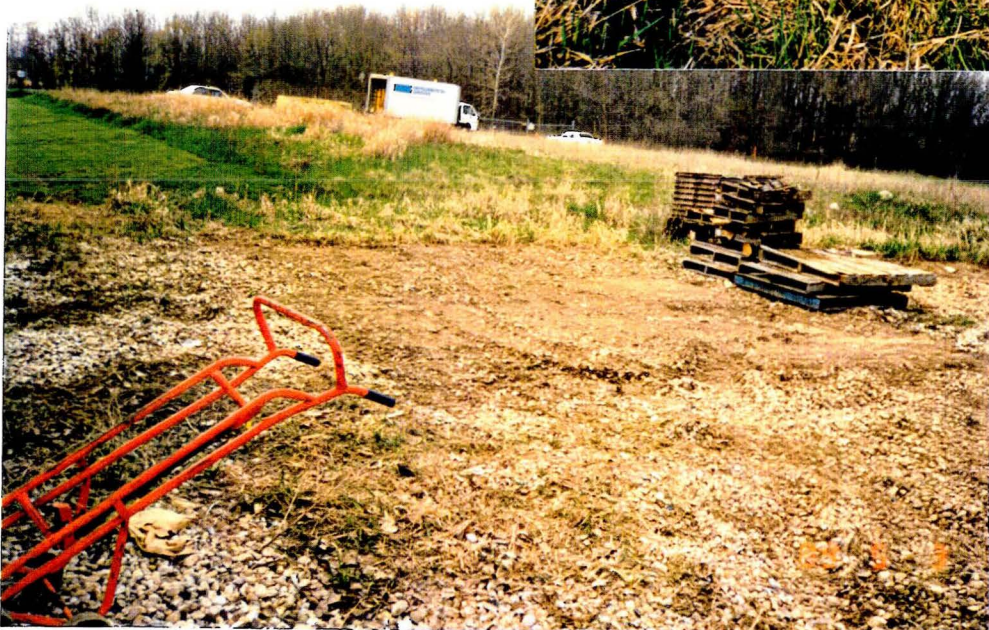
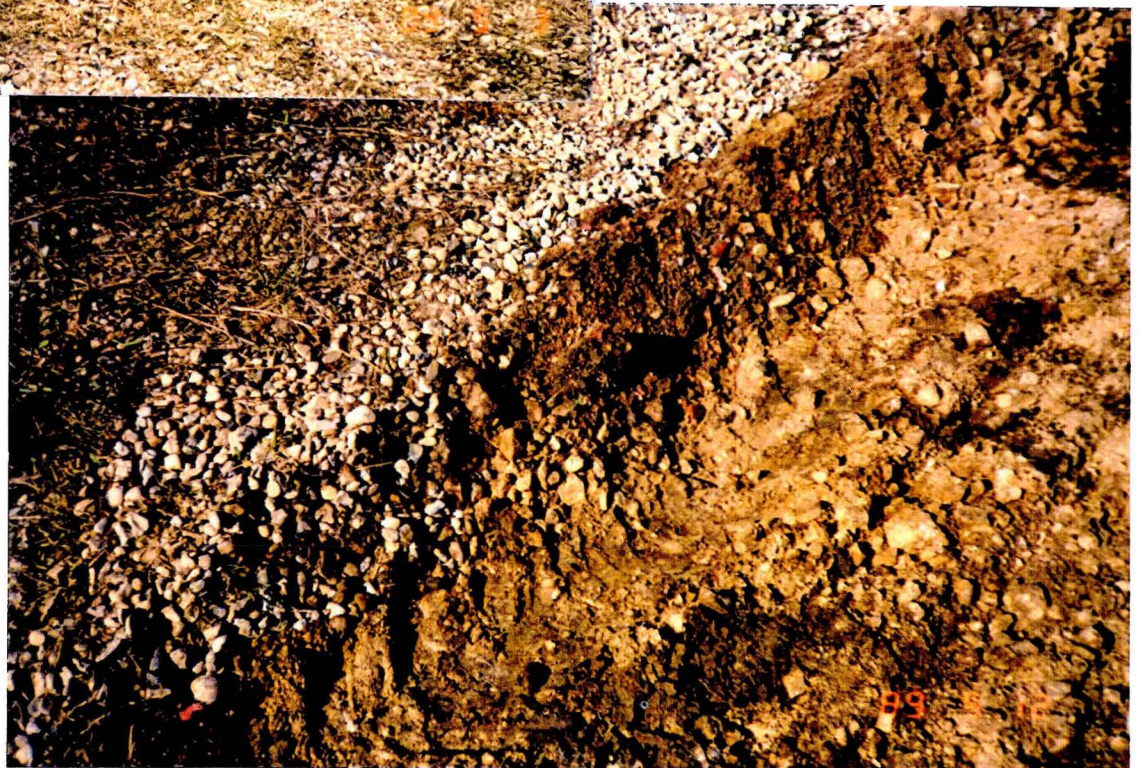
Attachment 9 - Photos of Soil Excavation Area (1989)

Based on the December 1988 letter from DNR approving the PRP Committee's removal/cleanup work plan, sampling was to be done where there was evidence of spilled wax. As stated above, this was the area where loose drums and bulk wax were stored to north of the tree at the Mequon site. Soil was excavated from this area in 1989 after the wax material was removed. Attachment 9 includes photos showing the area of soil excavation to north of the tree. This area is approximately 30 feet wide by 35 feet long, as shown on Attachments 10 and 11. Samples were collected in a 3 by 3 grid pattern across the excavation area and included locations near the doors of the trailers at that time in 1989 (Attachment 10). The sampling was felt to cover all areas of concern to DNR in its December 1988 letter. The area was resampled in November 1989 and no PCB was detected, however, review of the chromatograms revealed that the tests were not run for a sufficient time to assure that DCB would have eluted. The area was resampled again for PCB/DCB in September 1990 and Attachment 11 shows the sample locations. This last sampling confirmed that residual levels of PCB/DCB were present in the soil.

As you are aware, the PRP Committee submitted a work plan to remove additional soil from the 30 foot by 35 foot area and resample. The committee has selected Residuals Management Technology, Inc. (RMT) to conduct the work. Contract work on-site will be done by RTE, Inc. of Lombard, IL. I expect work may begin in early October. I will contact you with a more exact date when I have the contractor's schedule.
