Re: Koppers Inc. (formerly known as Koppers Industries, Inc., or KII) Wood-Treating Facility,
Superior, Wisconsin – Crawford Creek Floodplain Investigation Results
BBL Project #: 388.42.003 #2

Crawford Creek Floodplain Test Pit Observations

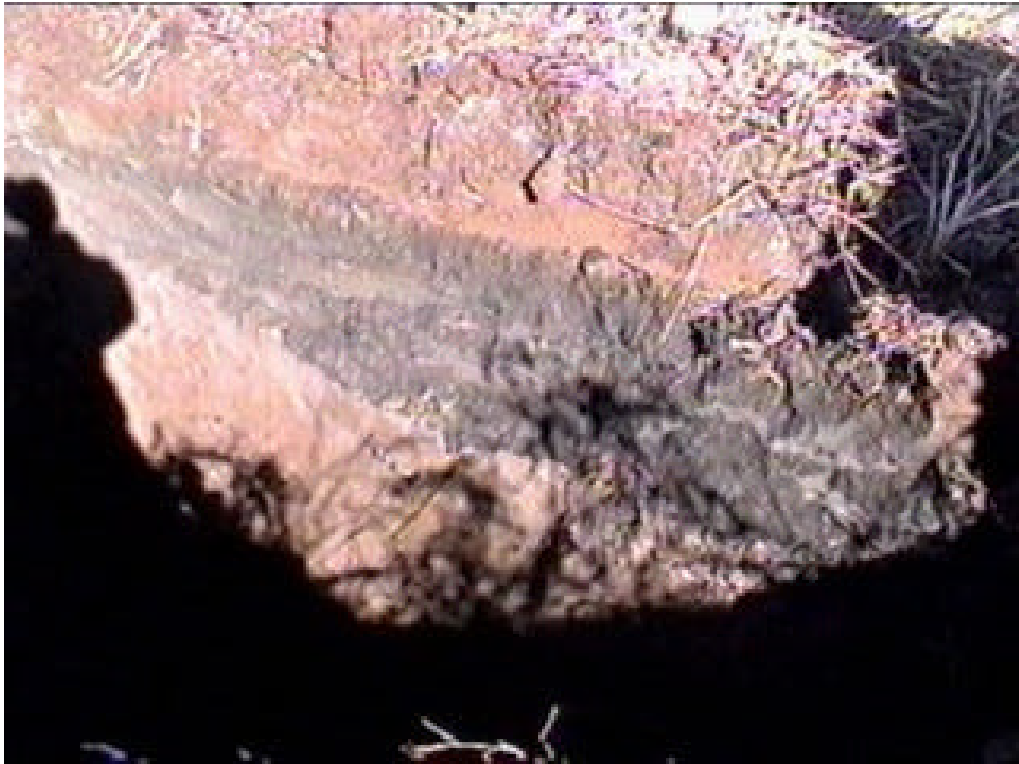
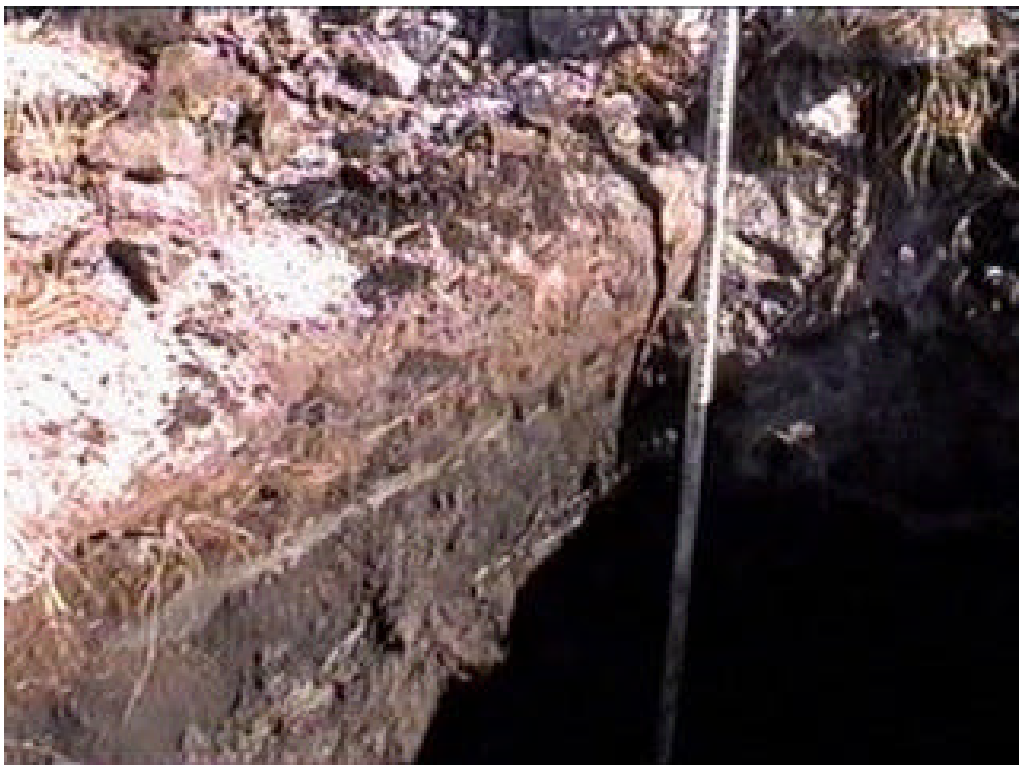
When encountered, the black stained layer was located at depths of 0.5 to 8 feet below grade and represented a continuous stratigraphic layer ranging from approximately 0.4 to 5 feet thick (average thickness of 2.0 feet). The black stained layer appeared to be a silty sand material that was visibly distinguishable from the overlying and underlying deposits (predominantly red/brown clays and silty clays) and typically exhibited a creosote-like odor. With the exception of a single instance where an isolated seam of creosote-like product occurred within the black stained layer, there was no visual evidence of residual "free product" occupying the soil matrix within this stained soil layer.

Black stained silty sand: Within a specified interval, a continuous layer of black stained silty sand material was observed.

Photographs of black “stained” layer in test pits

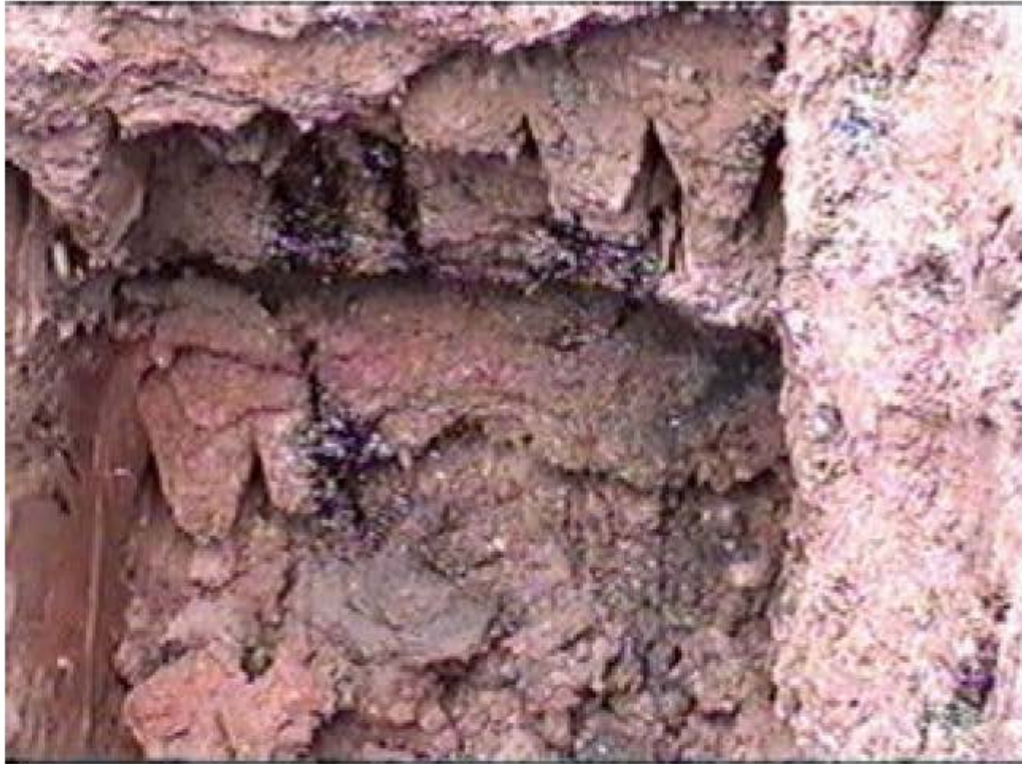
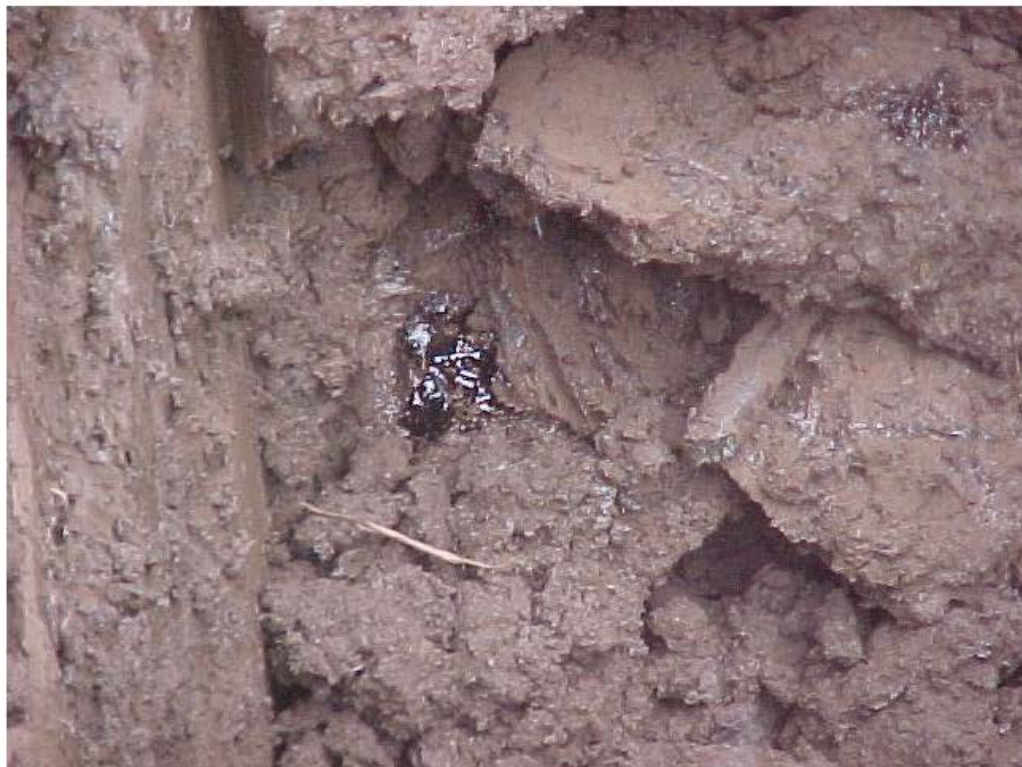
The isolated seams of creosote-like product were observed at discrete locations along the walls of certain test pits at depths ranging from near-surface to 17 feet below grade. The seams were not continuous throughout this depth range; rather, seams occurred in discrete, isolated locations at one or more points along the test pit sidewalls within this depth range. The seams were attributed to locations where creosote-like product had come to be present in isolated fractures within the clay matrix. At such

locations, a small quantity of material would flow from the excavation sidewall due to the pressure release associated with removal of adjacent soils from the test pit. When encountered, seams typically represented a very small fraction (i.e., less than 1%) of the surface area of the test pit sidewalls.

Isolated seams of creosote-like product: Within a specified interval, isolated seams of creosote-like product were observed in discrete fractures in the clay matrix.

Photographs of isolated seams of creosote-like product in test pits

Photographs of isolated seams of creosote-like product in test pits (continued)
