FORMER KOPPERS INC. FACILITY – SUPERIOR, WI OFF-PROPERTY CORRECTIVE ACTION EVALUATIONS

Project Meeting with WDNR and USEPA in Madison, WI

November 19-20, 2015

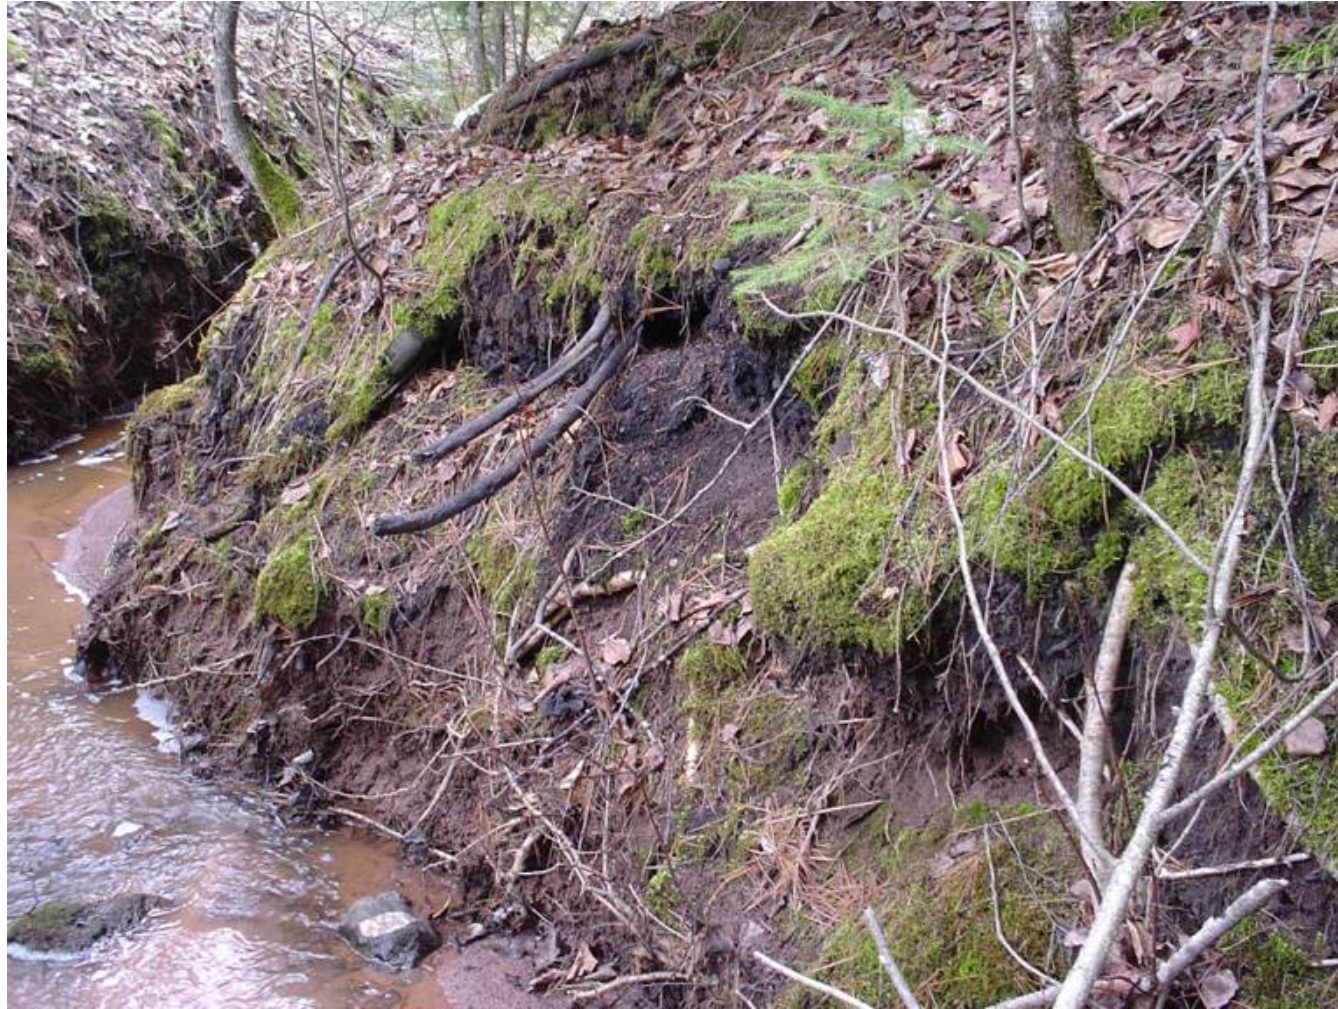
Photograph showing steep Tributary banks

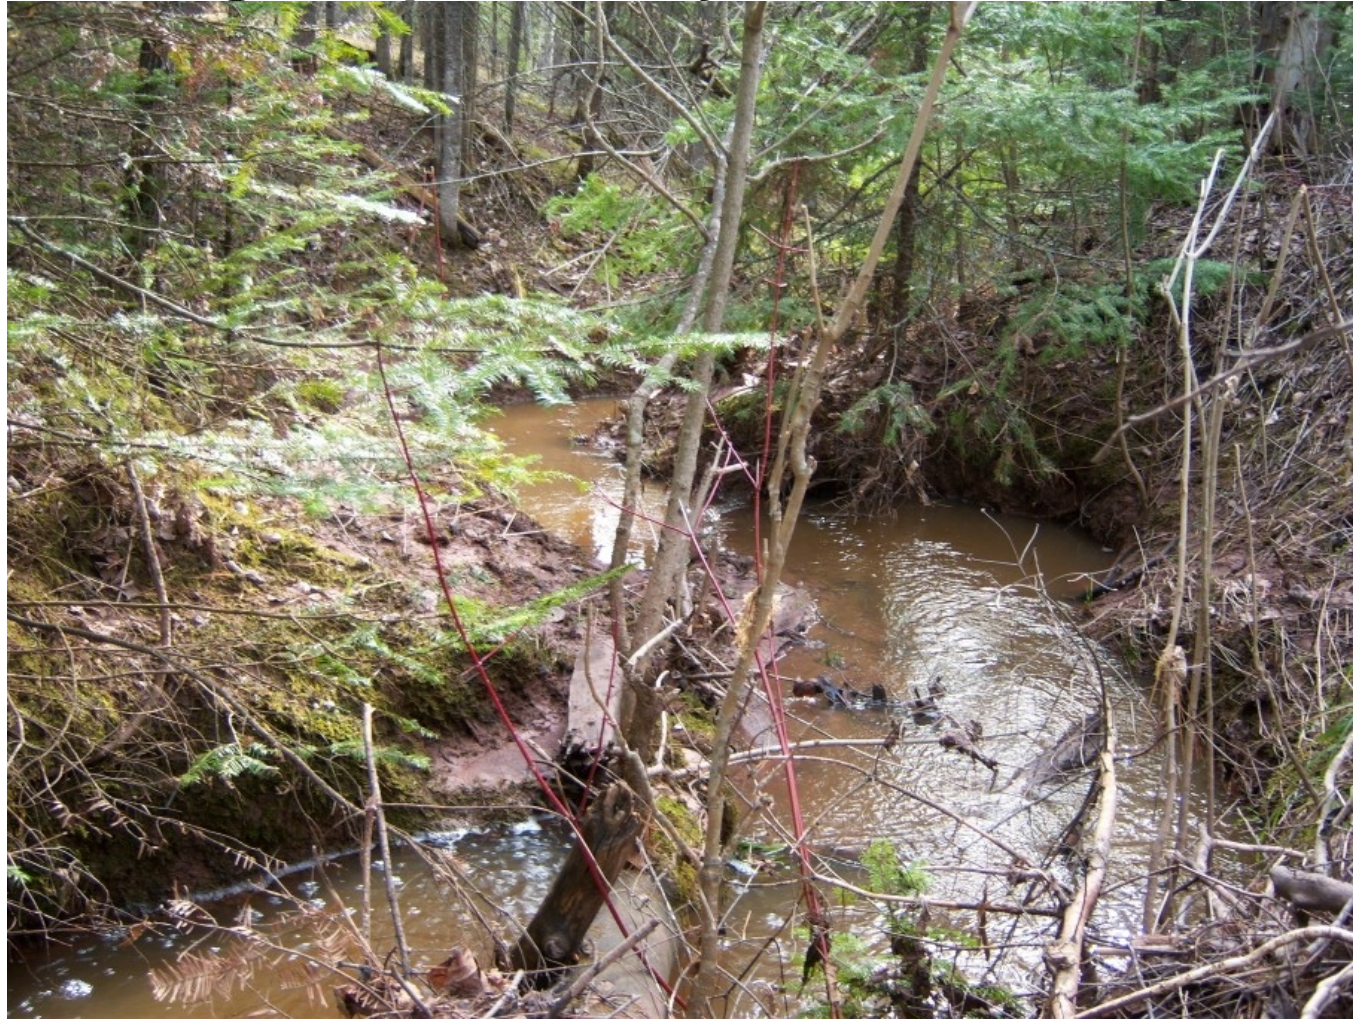
Photograph showing steep Tributary banks and vegetation

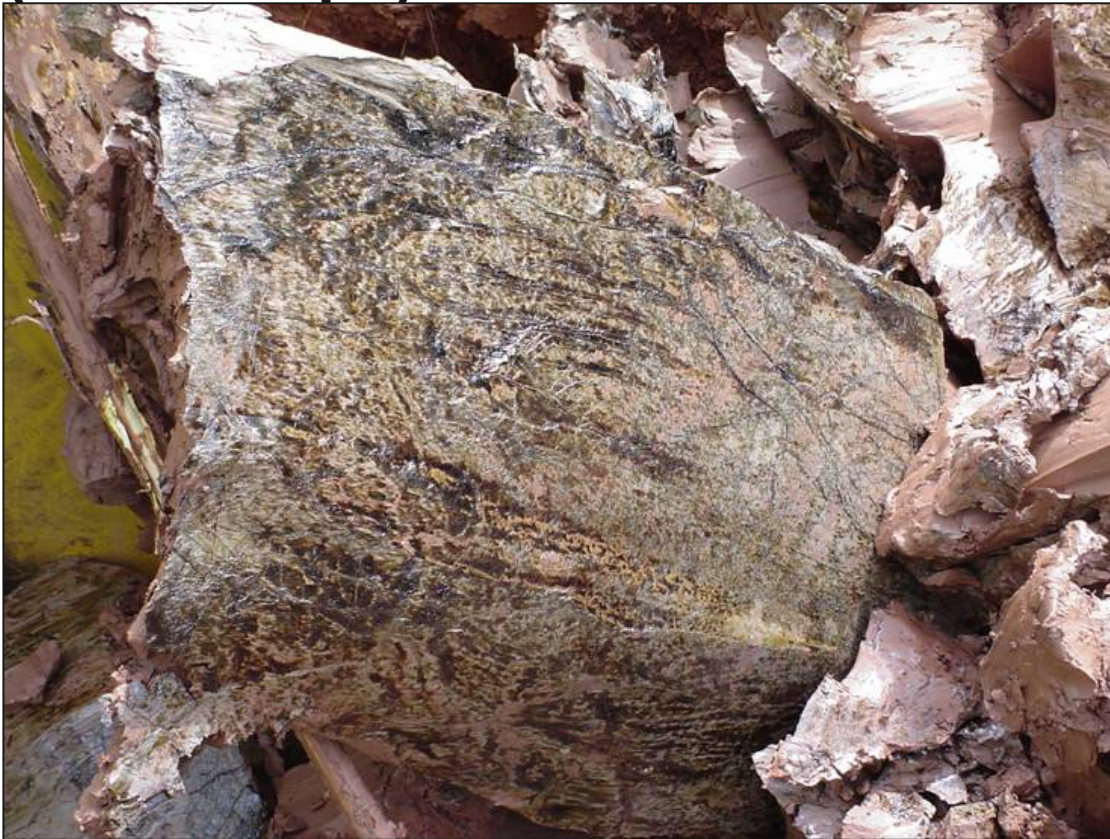
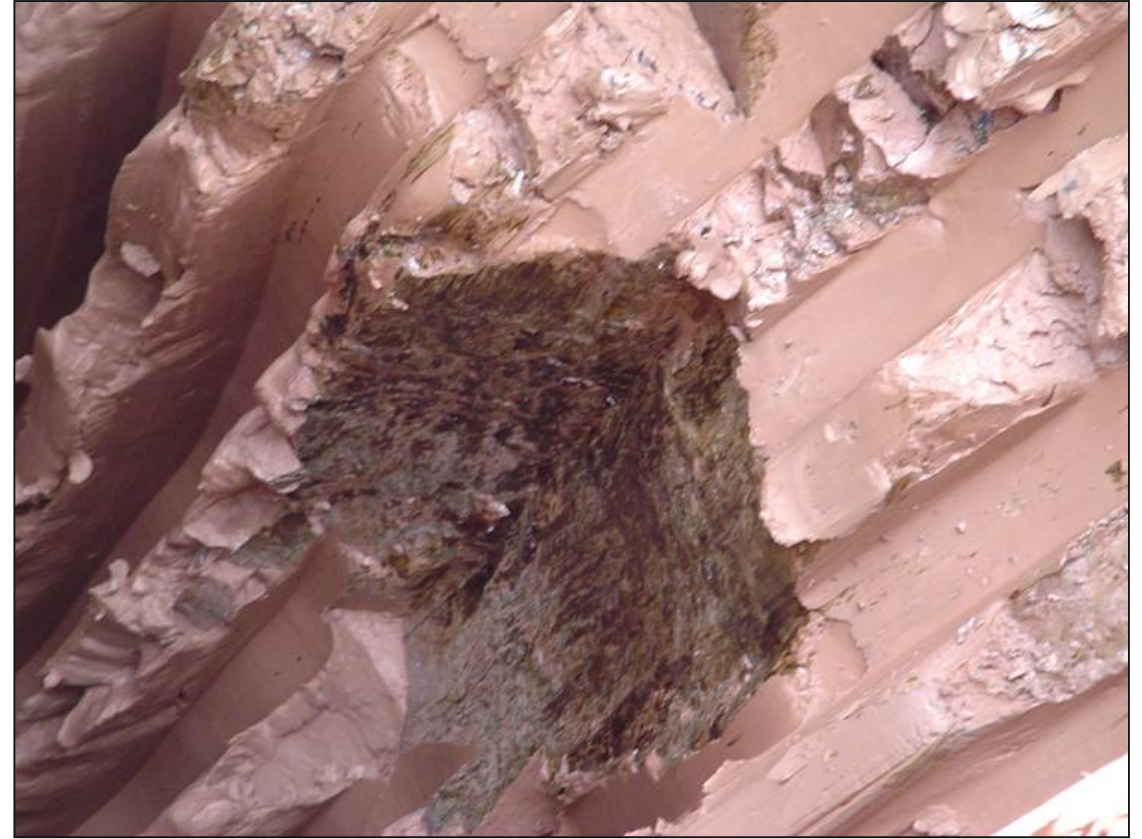
Photographs of creosote-like product in clay cracks/fractures
(2005 test pit)

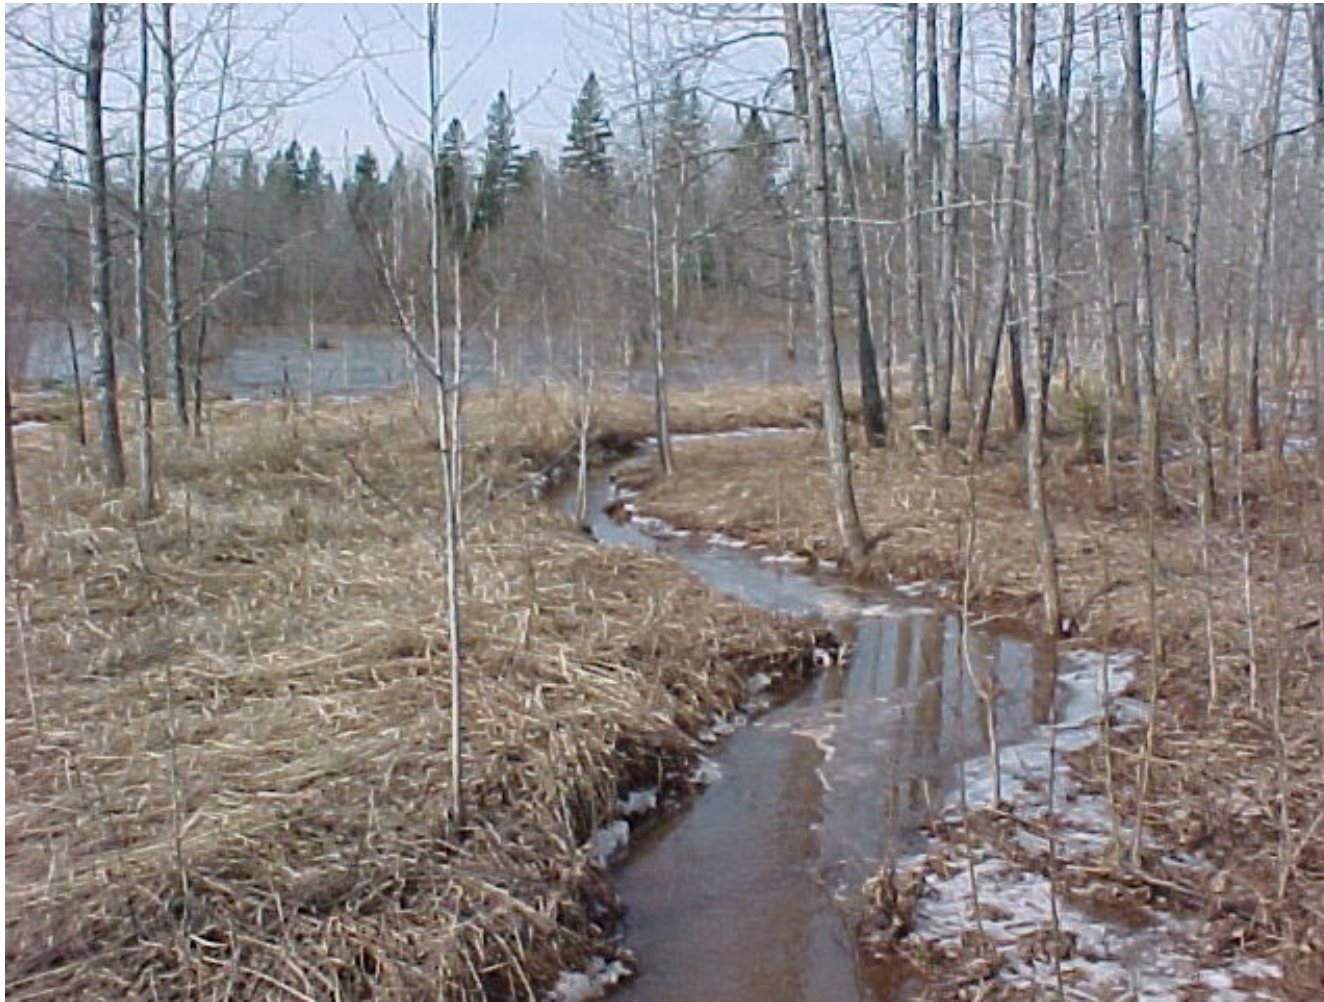
Photograph showing steep Tributary in floodplain

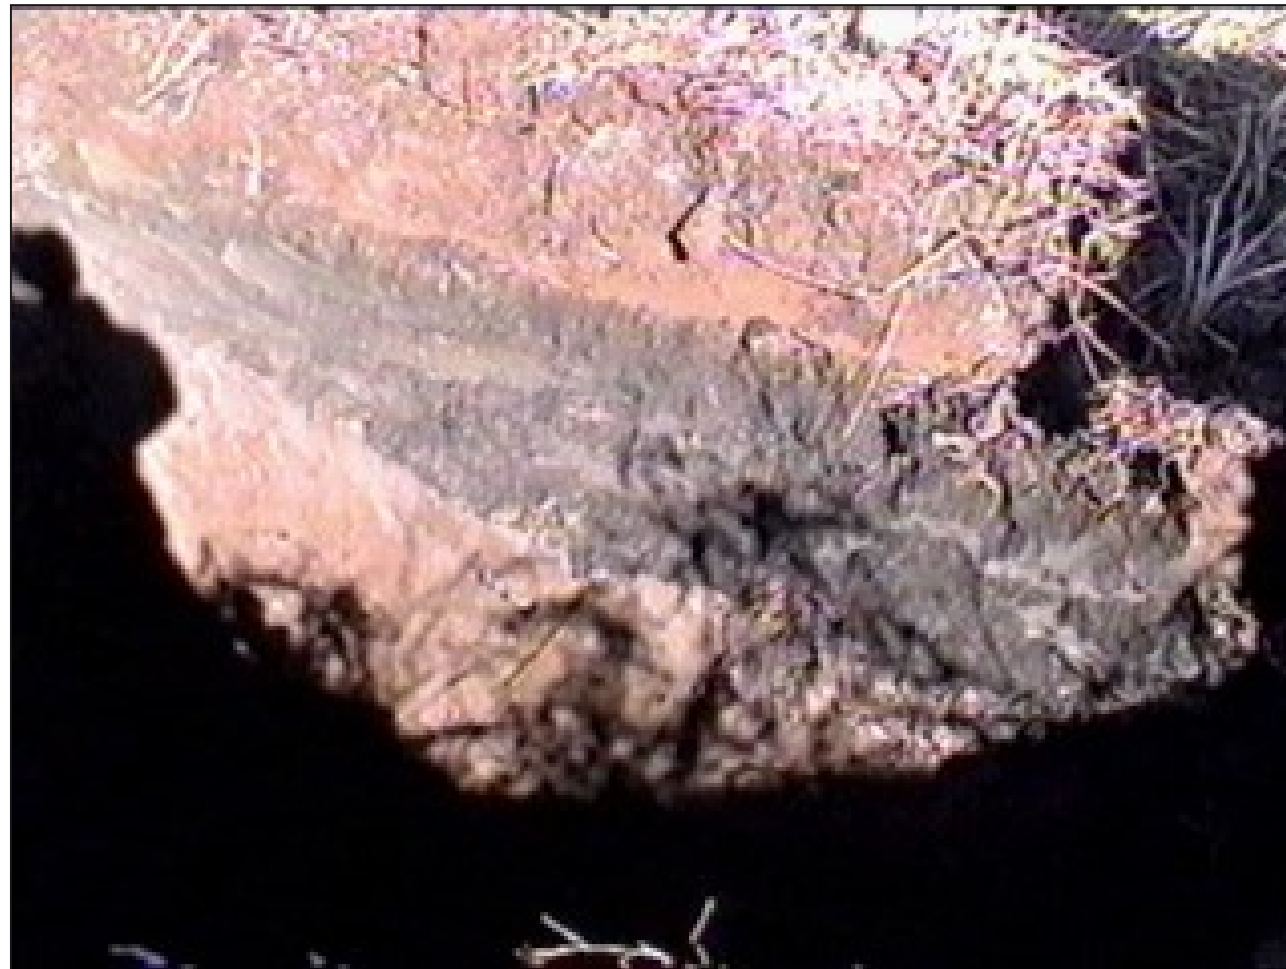
Photograph of “black stained layer” (2003 test pit)

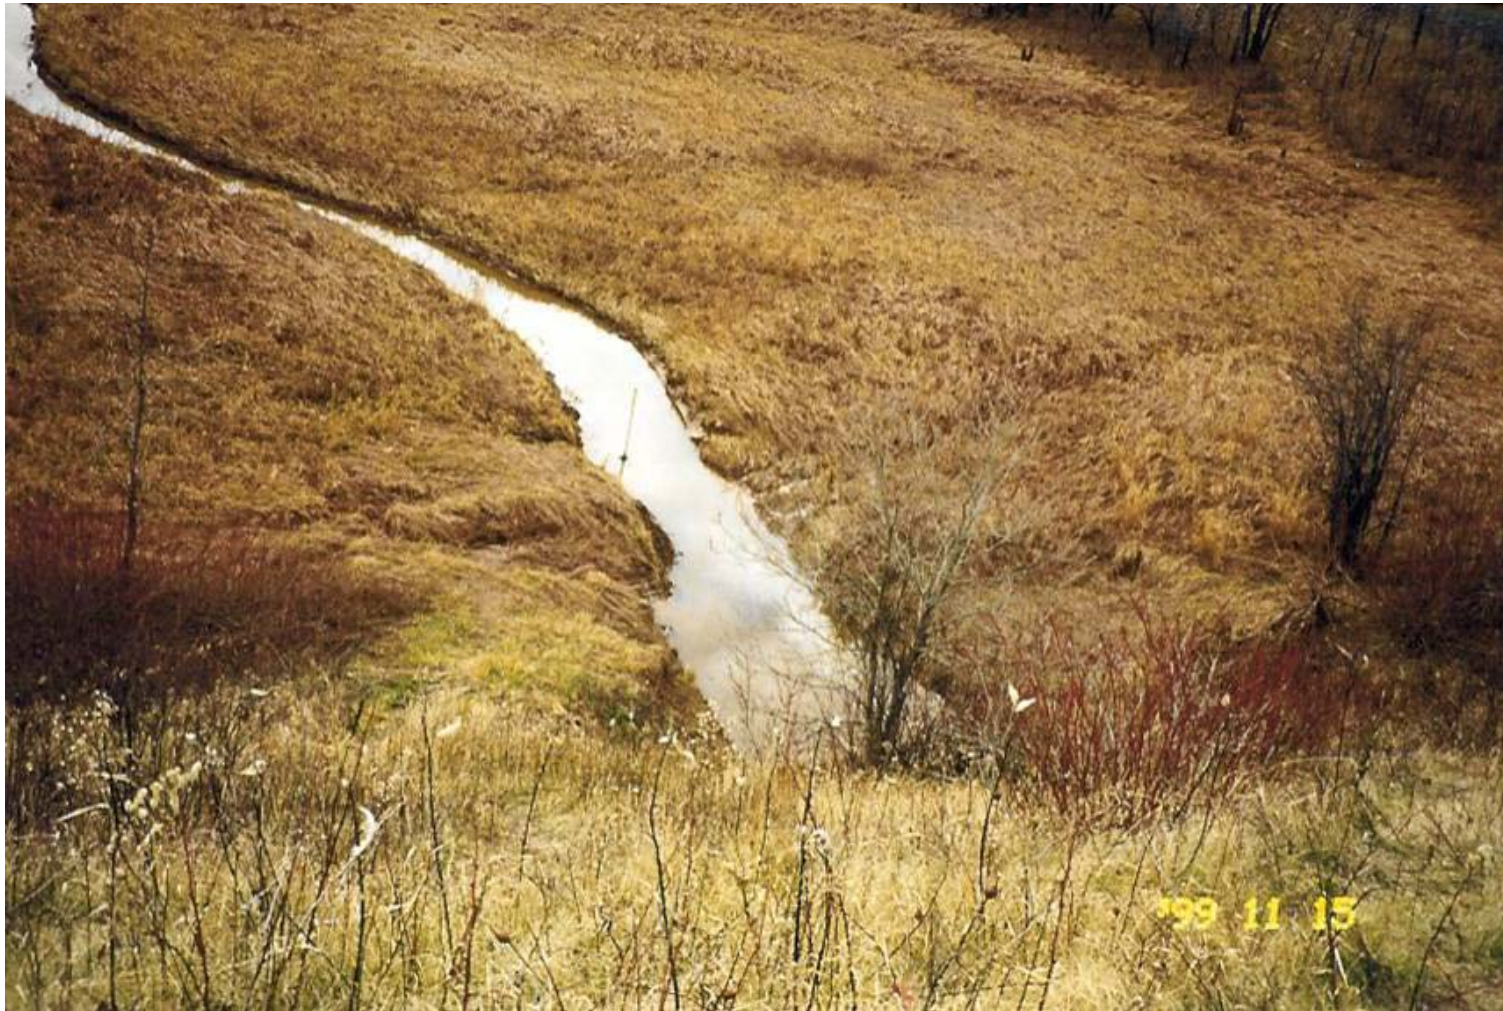
Photograph showing “typical” Crawford Creek flow conditions

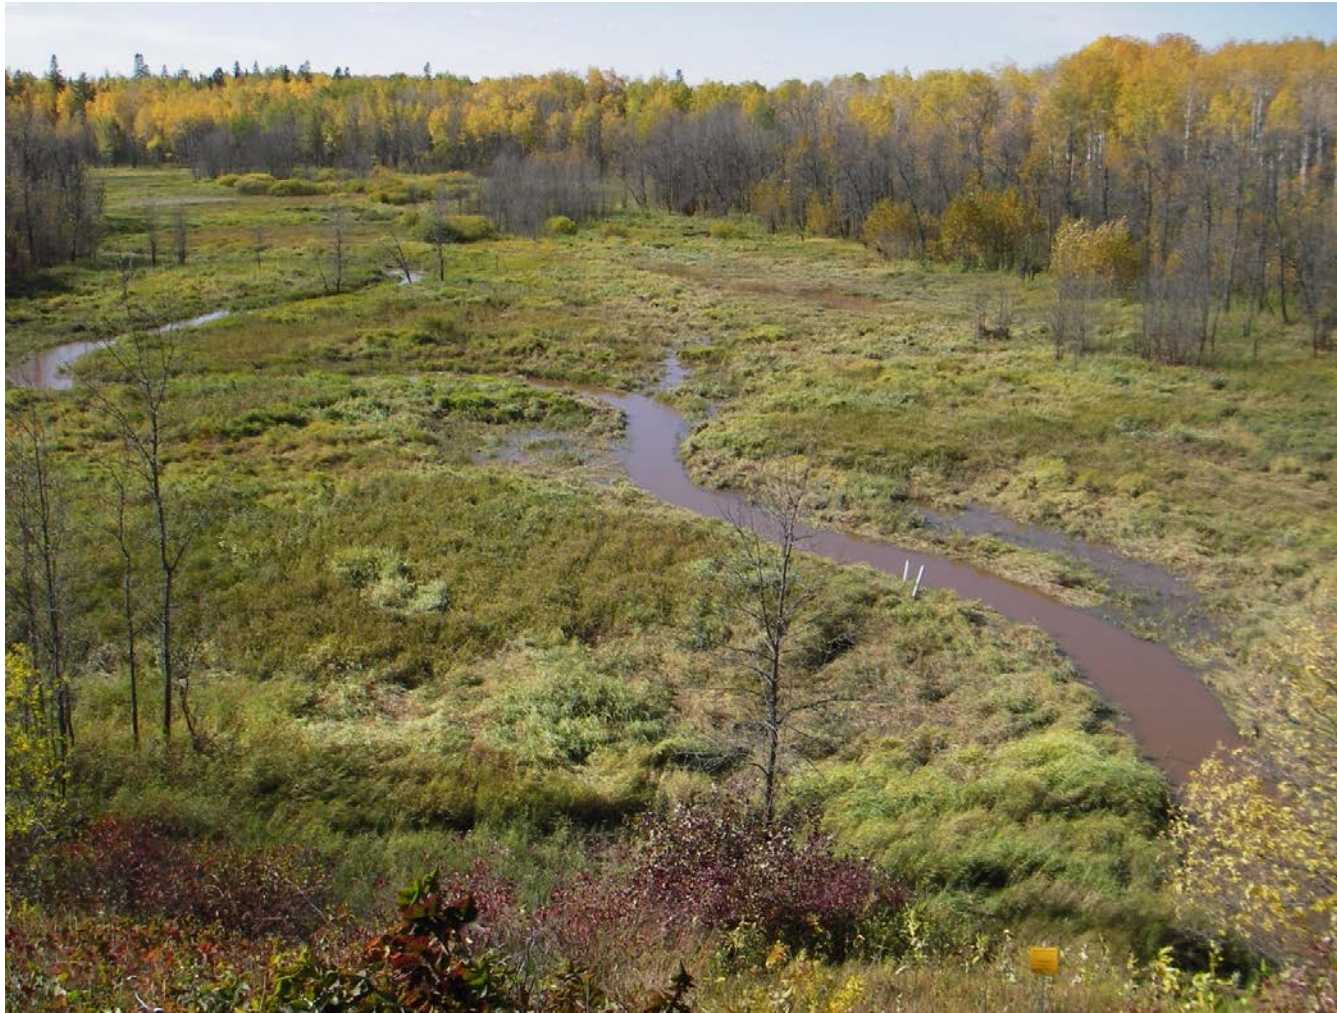
Photograph showing “bank full” Crawford Creek flow conditions

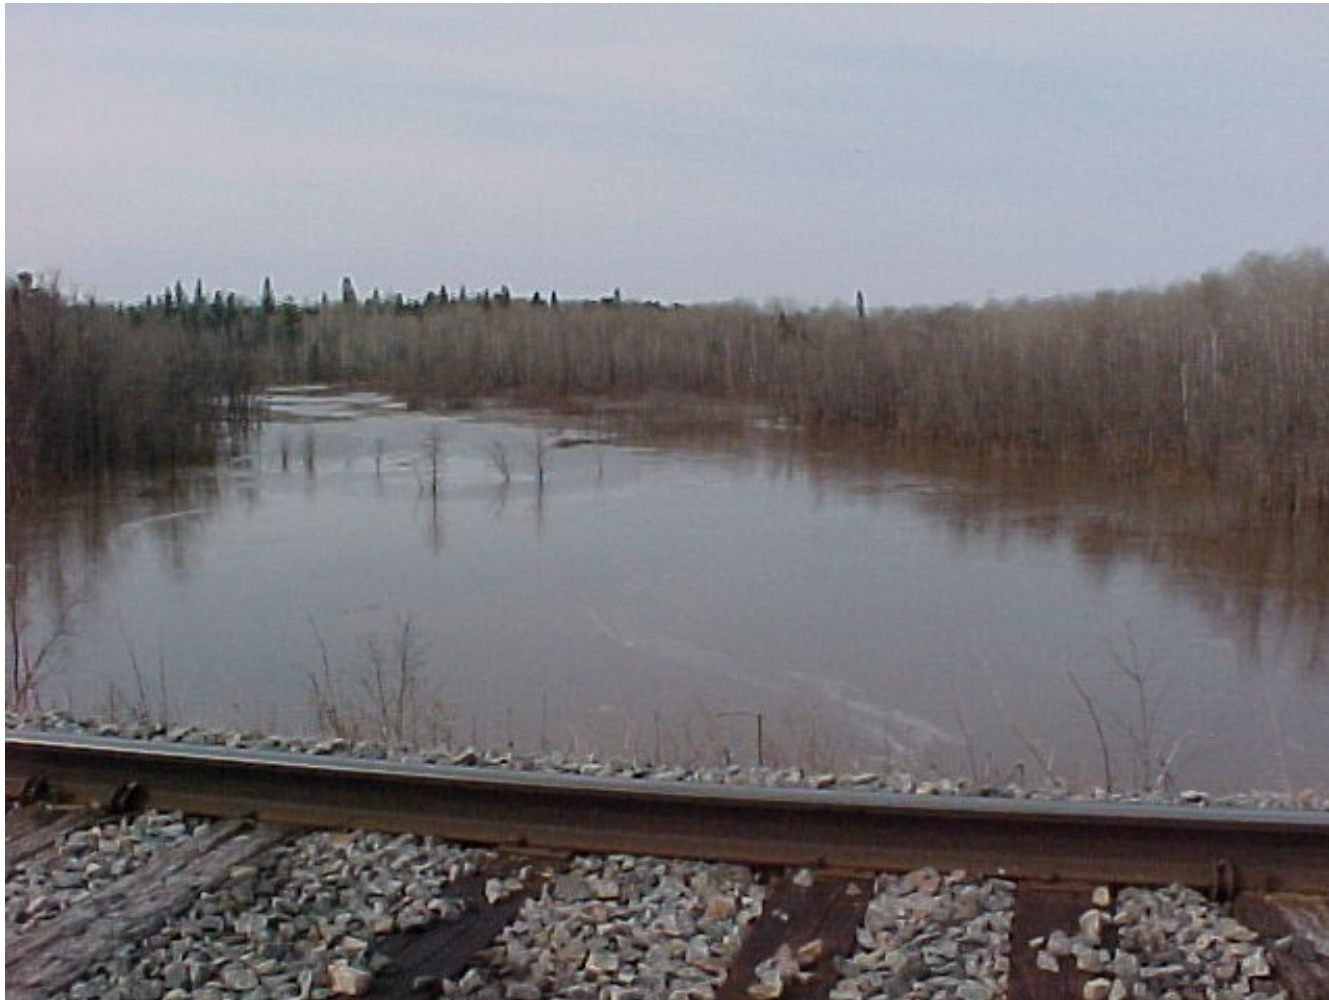
Photograph showing flooded Crawford Creek flow conditions

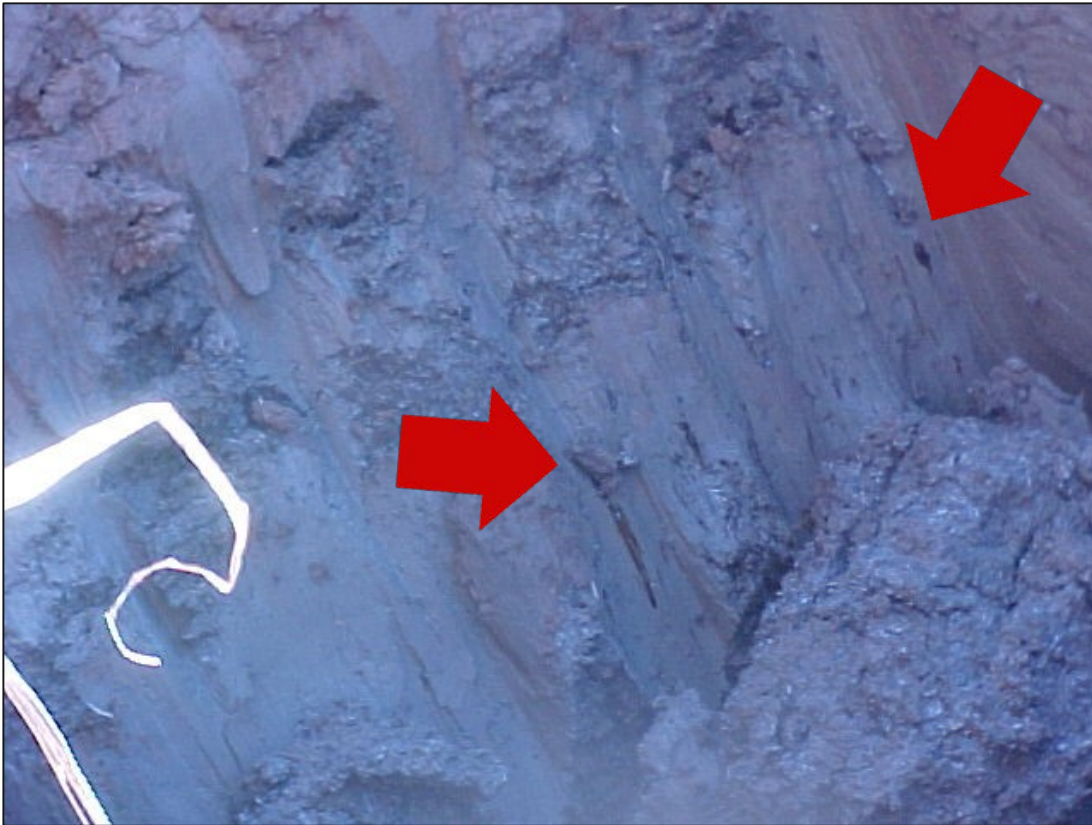
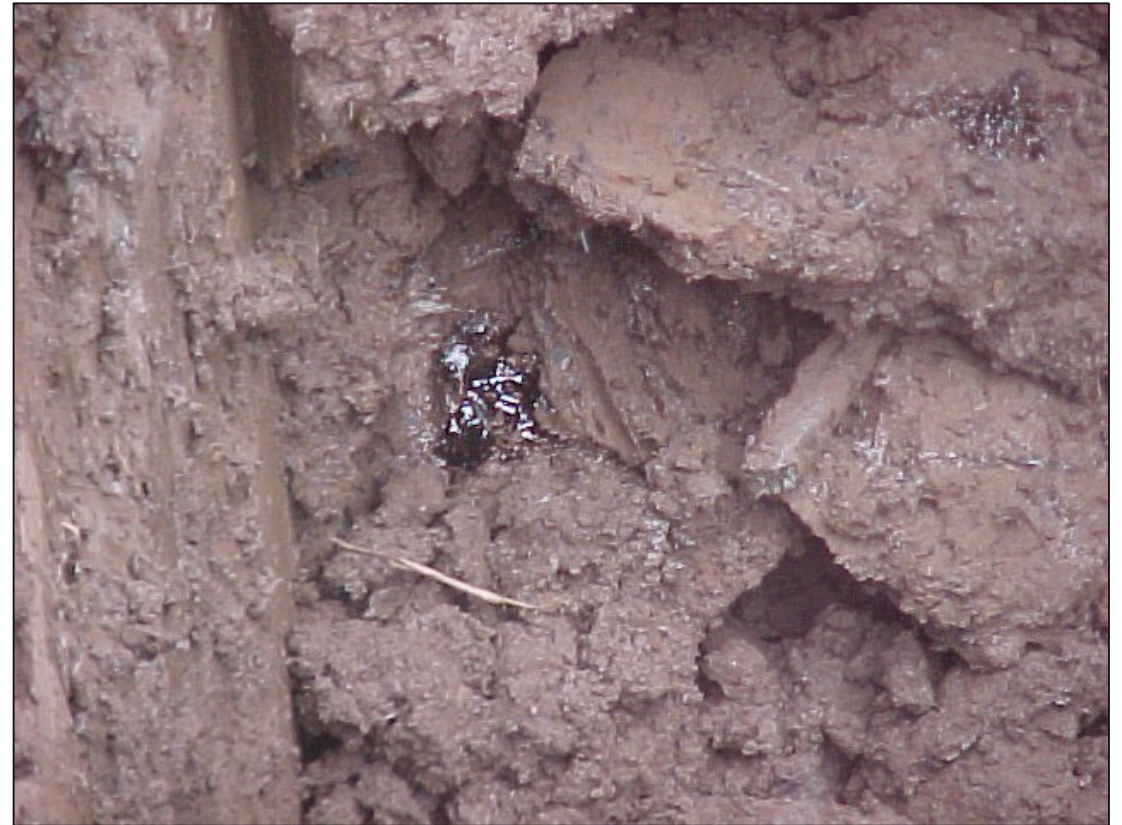
Photographs of creosote-like product in clay cracks/fractures
(2003 test pits)
