MEMO

To: File
From: Elizabeth Victor *EVN*
Date: August 29, 2016
Site Name/BRRTS: Kewaunee Marsh Arsenic Spill (02-31-000508)
Re: Field Activities Report for July 15, 2016

Scope of Work for Field Visit

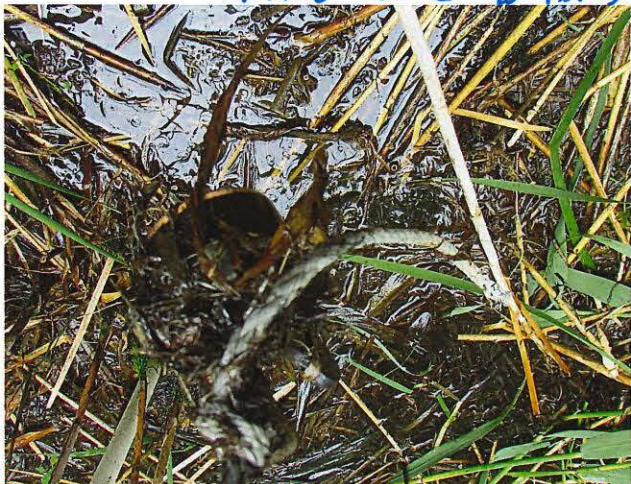
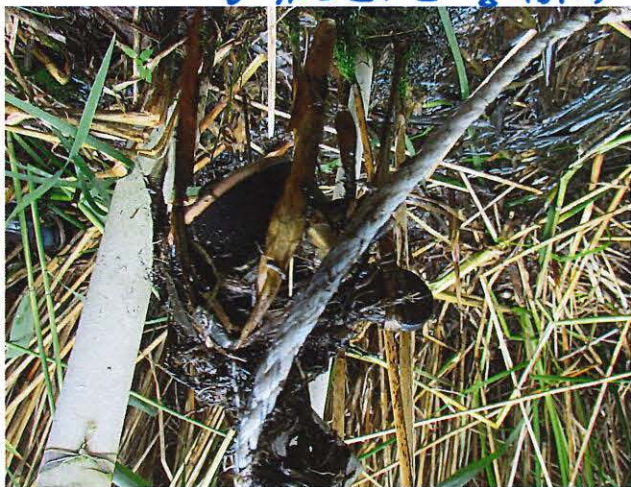
6w01-8 7 15 2016 b

| Well ID | DTW | TD | Color/turbidity | Bailing | Comments |
|---|---|---|---|---|---|
| GW01-8 | 1.75 | 4.95 | NA | Well not bailed | Cap in mud, no lock, PVC well marker broken |

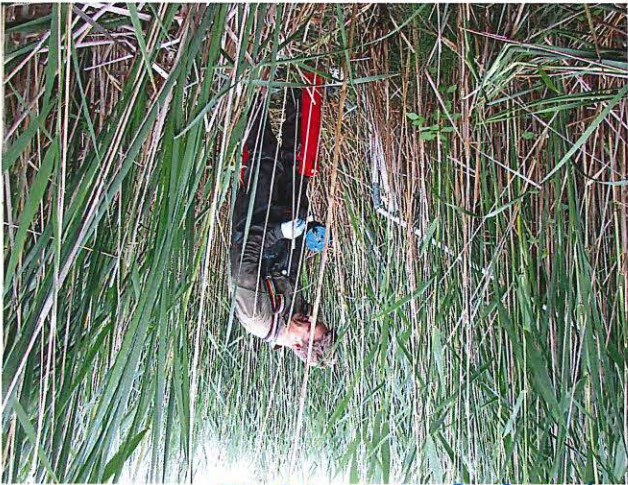
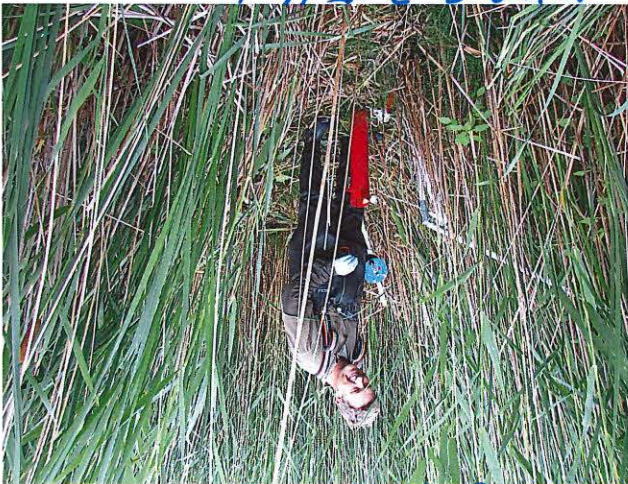
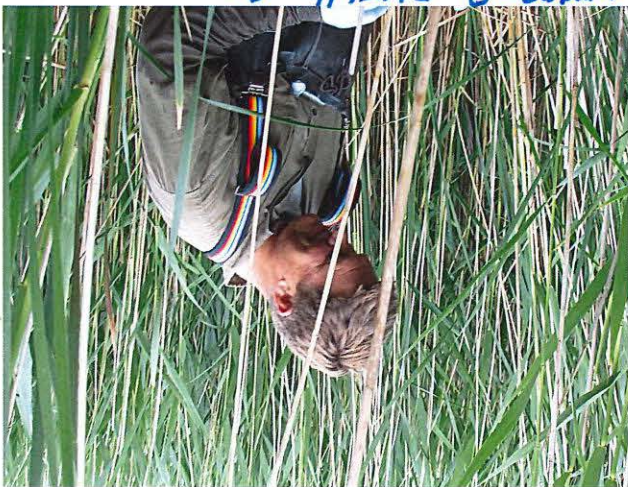
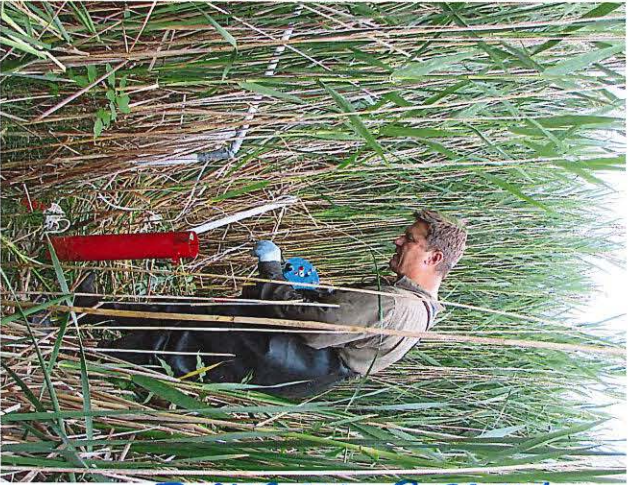
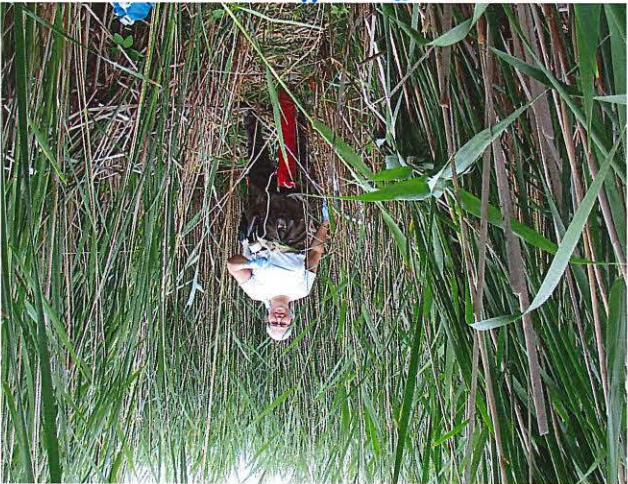
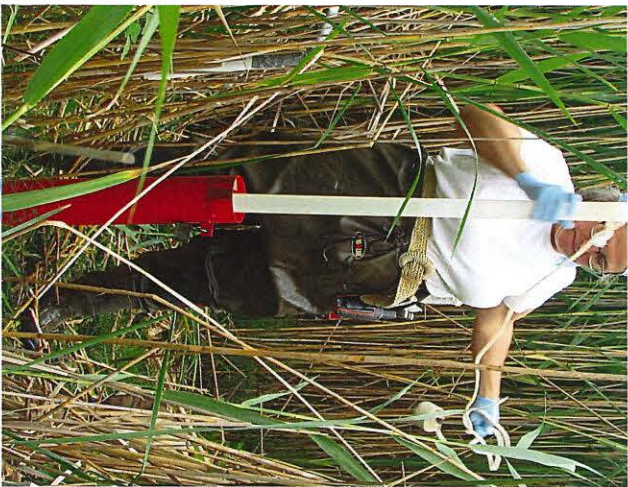
Mw02-8 7 15 2016 a

| Well ID | DTW | TD | Color/turbidity | Bailing | Comments |
|---|---|---|---|---|---|
| MW02-8 | 3.57 | 11.95 | clear | Bailed to ~18" from bottom, then good recharge | PVC well marker is broken, tall phragmites |

- Obtain a list of well, pond, and gate coordinates in both WTM & Lat./Long. To any gps unit can be used in the field.
- MW02-8/MW02-8i: Comparing total well depth to well name in the above table, it looks like either the depth to water was recorded incorrectly or the well casings were mislabeled. Verify well IDs in the field by double checking the total well depth.

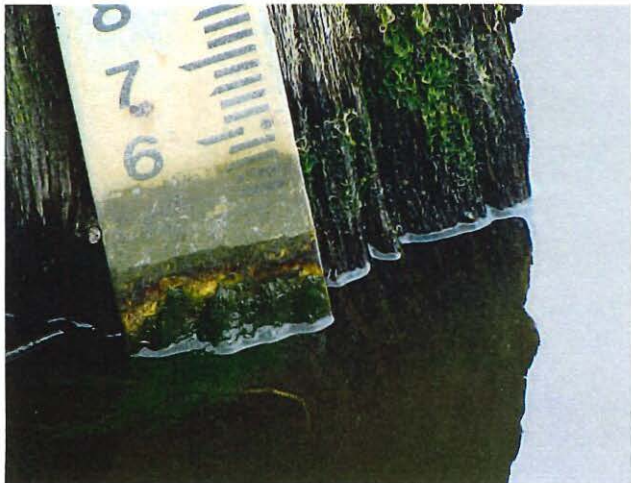
River Staff base
7 15 2016 a

| Well ID | DTW | TD | Color/turbidity | Bailing | Comments |
|---|---|---|---|---|---|
| River | Gage: 3.40ft | | Measured from staff gage mounted to wood pilings on north east side of rail trail bridge. | | |

- In the future, take photo of river staff gage for later reference in determining river level. Staff gage can be hard to read from bridge.

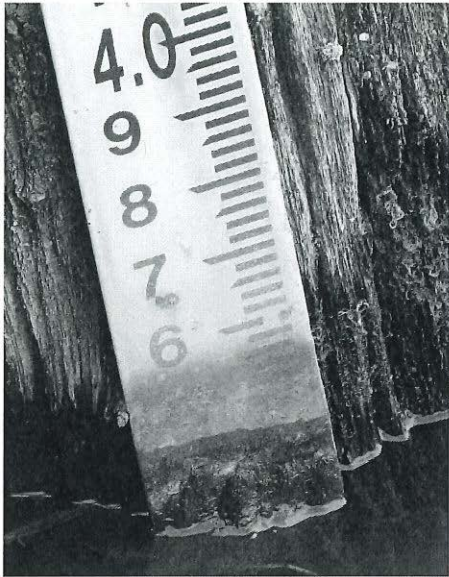
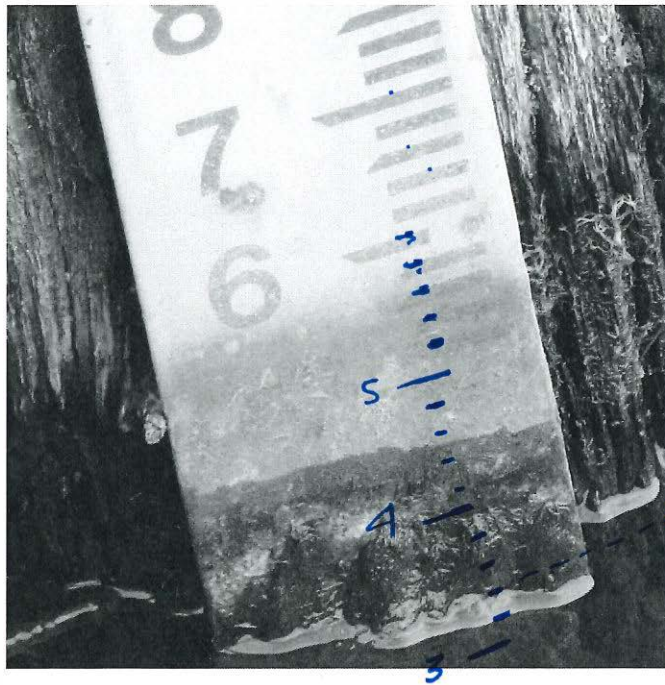
Photo of river staff gage, Kewaunee Marsh, July 15, 2016.

--- 3.40' verified by GAV

Depth to water observed from bridge and reported in field notes: ~3.4'.

Depth to water based on closer examination of above photo: ~~3.40~~
3.40

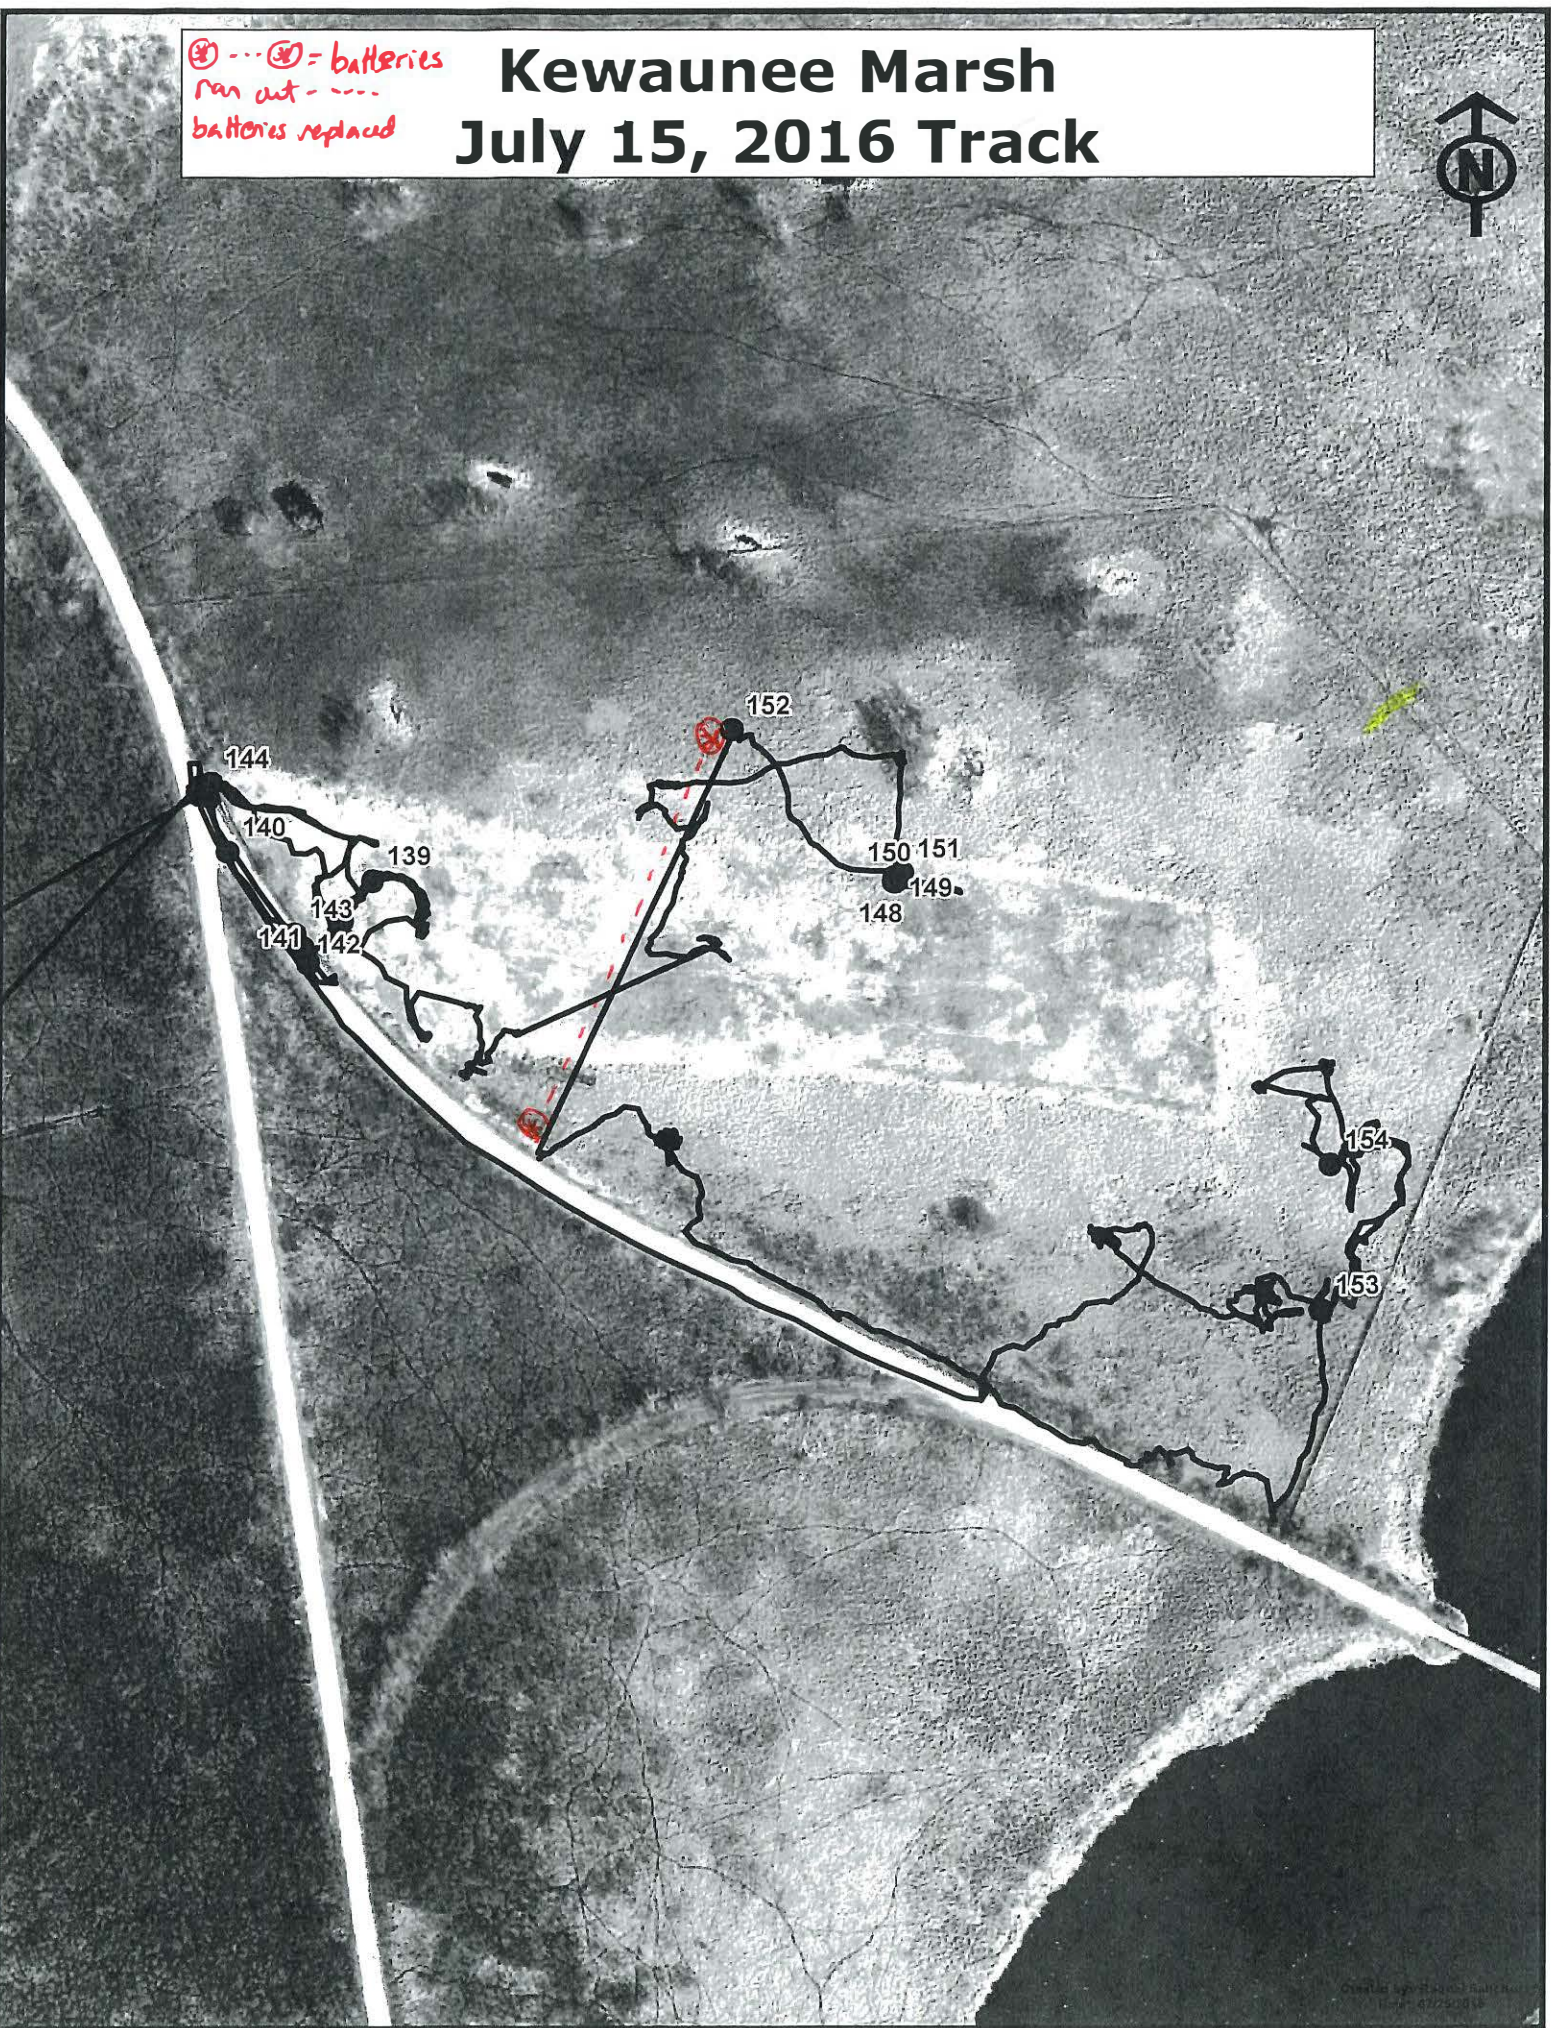
Kewaunee Marsh July 15, 2016 Track

GPS unit used: garmin eTrex 20 Sof (operated by EAV)
comments by EAV

⊙ --- ⊙ = batteries
ran out - - -
batteries replaced

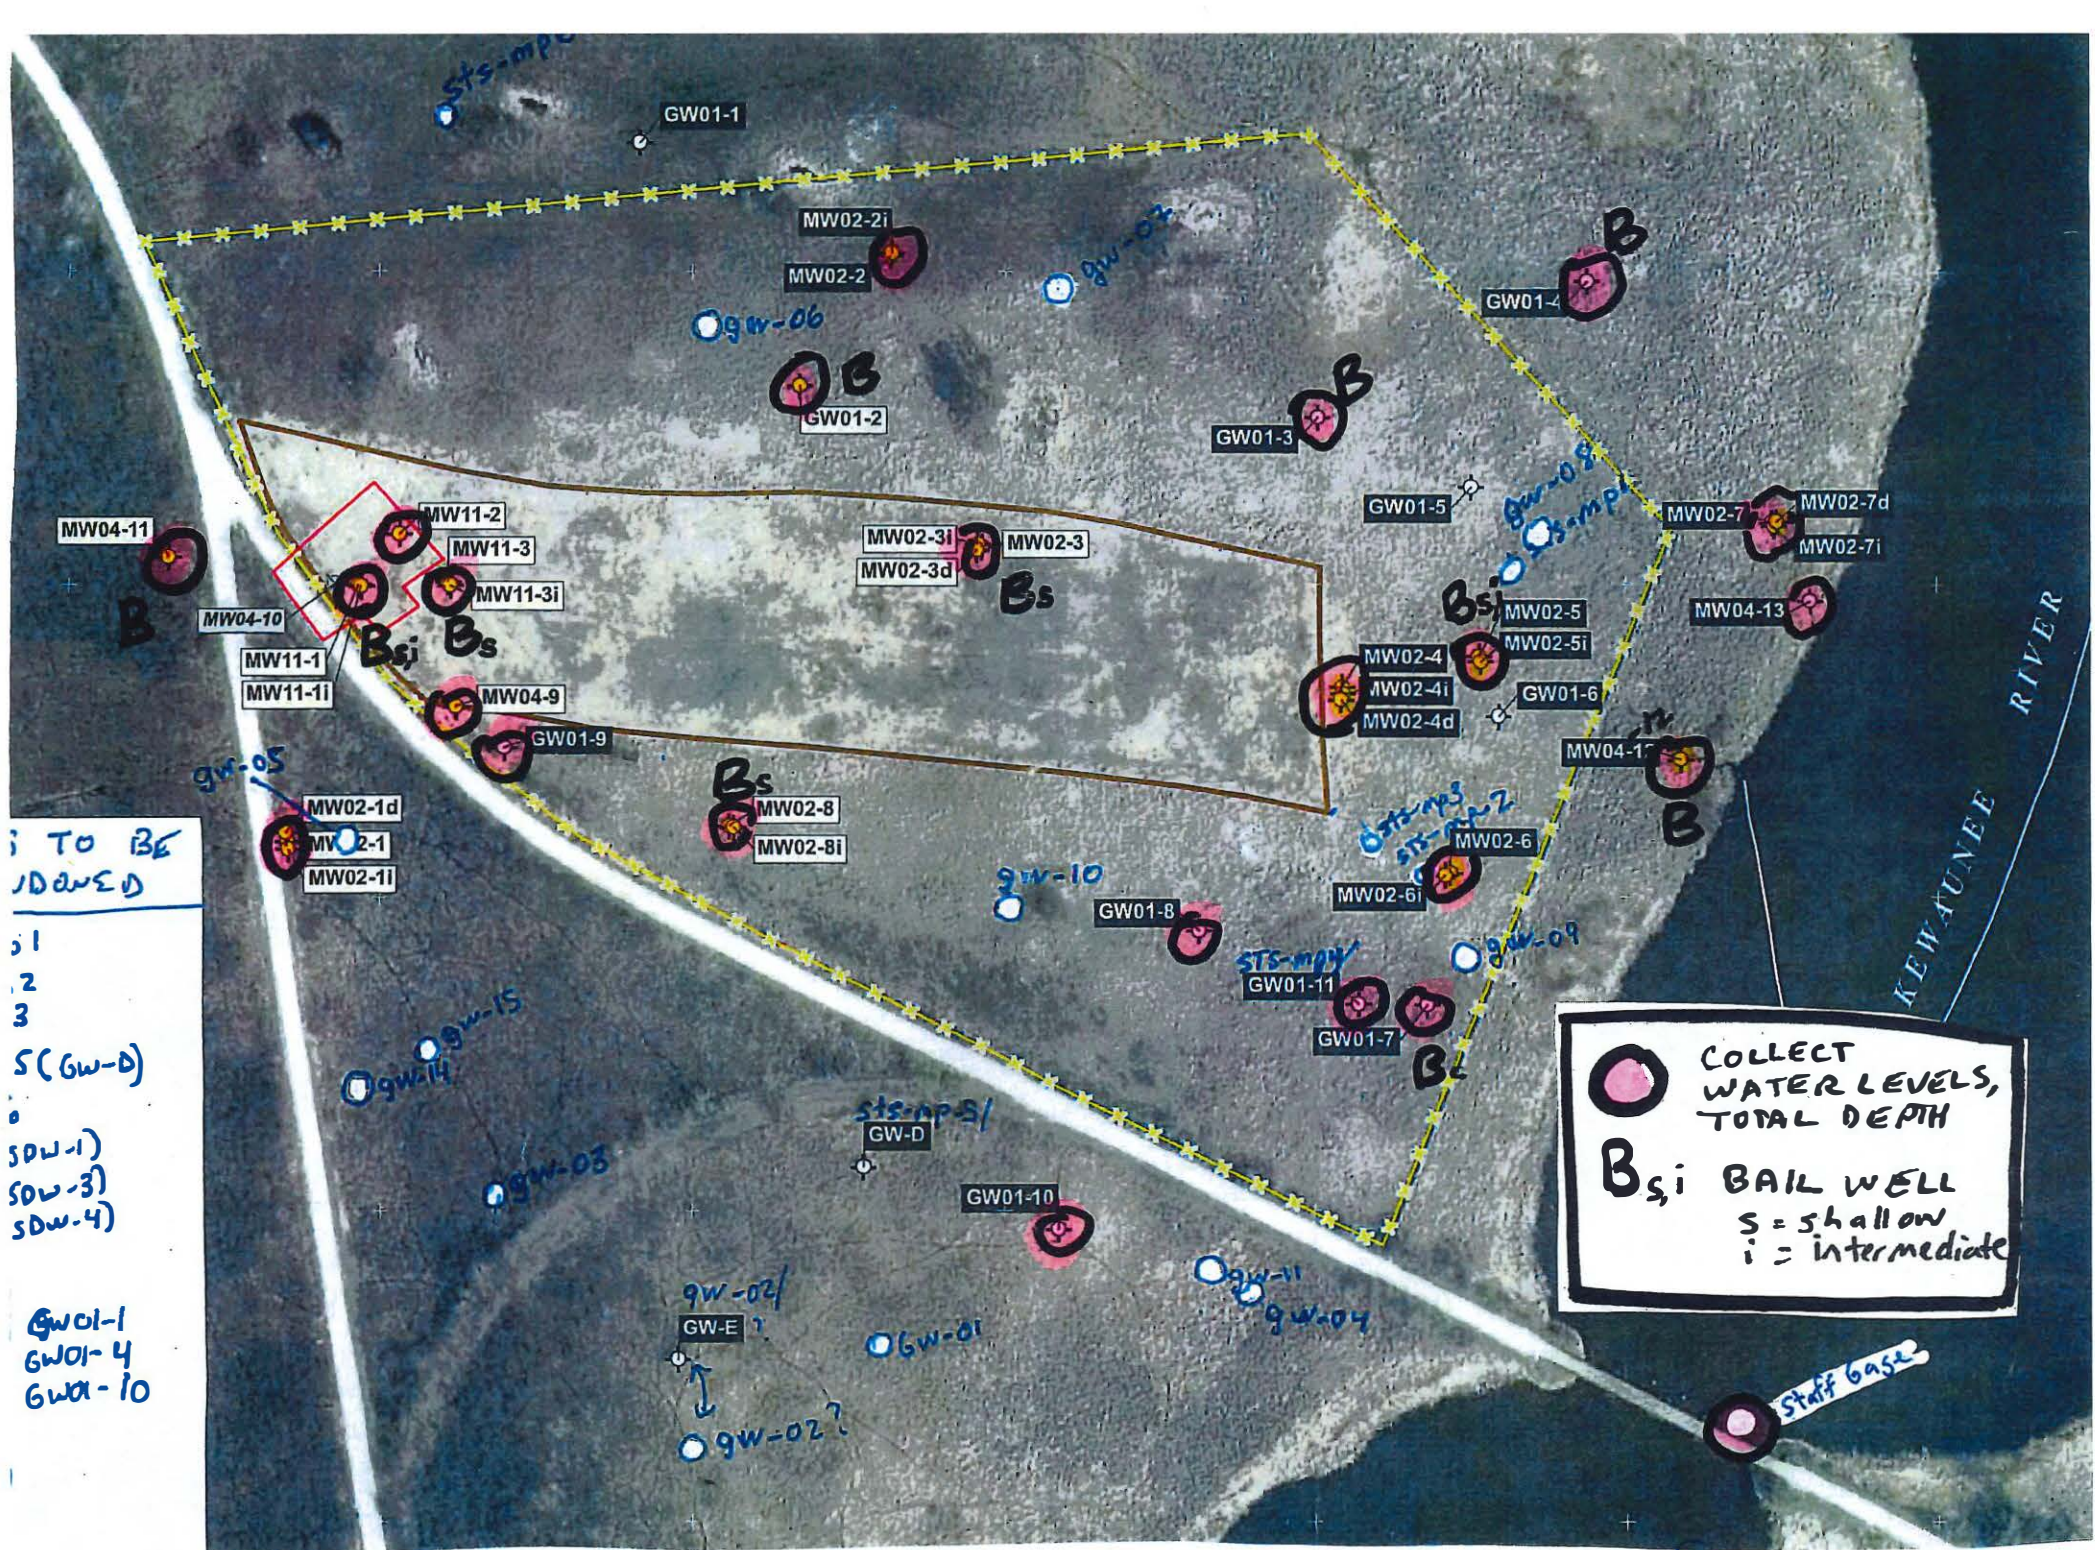
DRAWING by STS Consultants Ltd, 10/18/14 with proposed scope of work for water levels and bailings.

COLLECT WATER LEVELS, TOTAL DEPTH

B_{si} BAIL WELL
 S = shallow
 i = intermediate
