**MEMO**

Date: May 18, 2017  
Site Name/BRRTS: Kewaunee Marsh Arsenic Spill (02-31-000508)  
Re: **Field Activities Report for March 22, 2017**

**Purpose of Field Visit:** Verify presence of 2 benchmarks using metal detector & GPS. These will be used for upcoming topographic survey. In preparation of spring groundwater sampling, collect one round of groundwater elevation data and remove bailers from all wells. Locate and GPS GW-08.

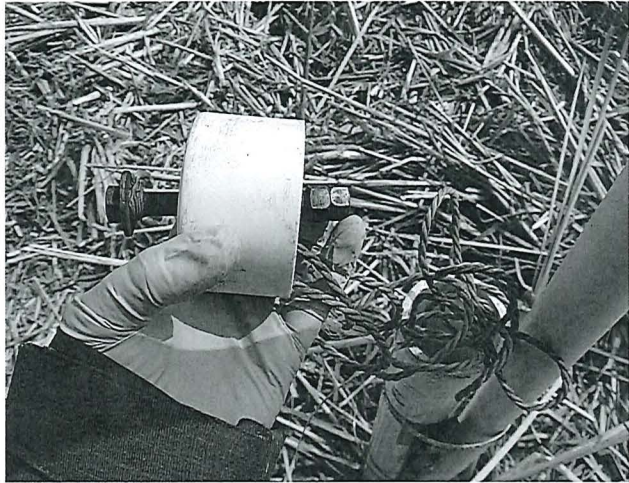
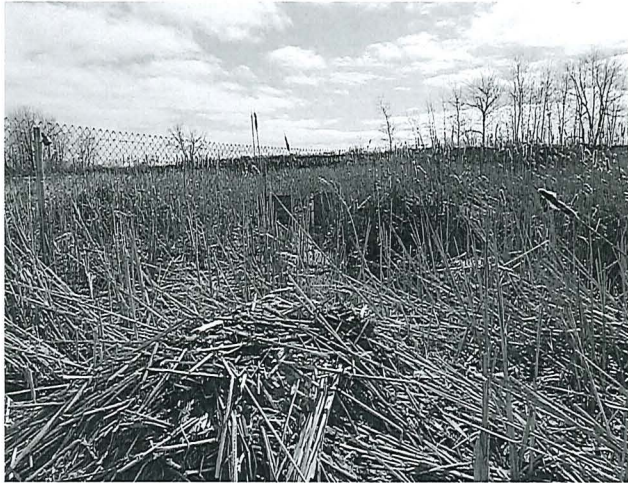
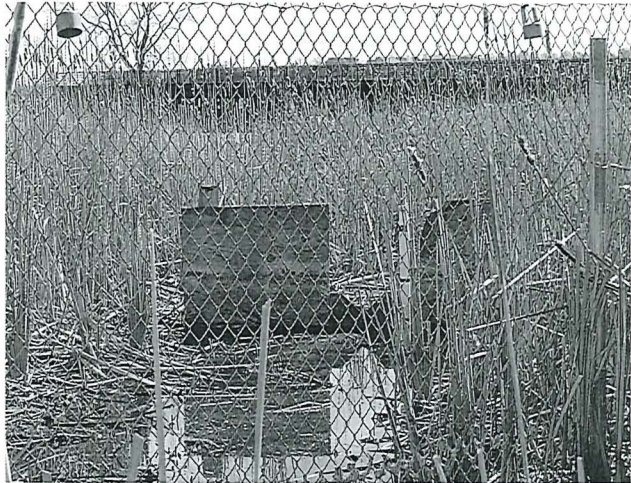
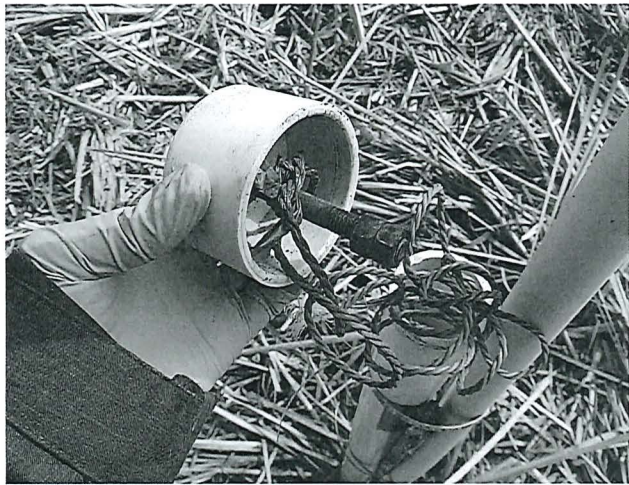
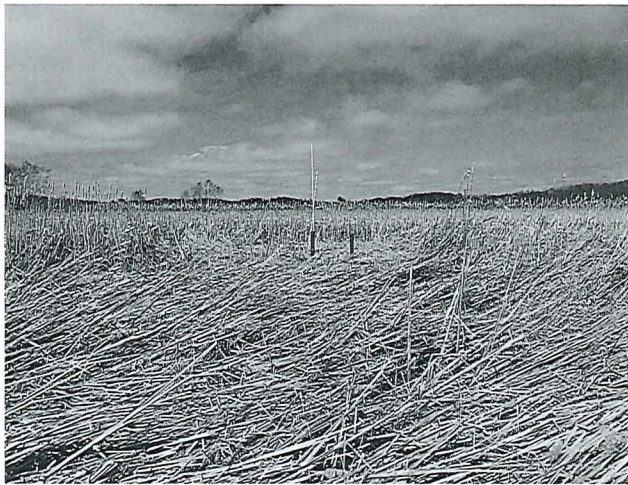
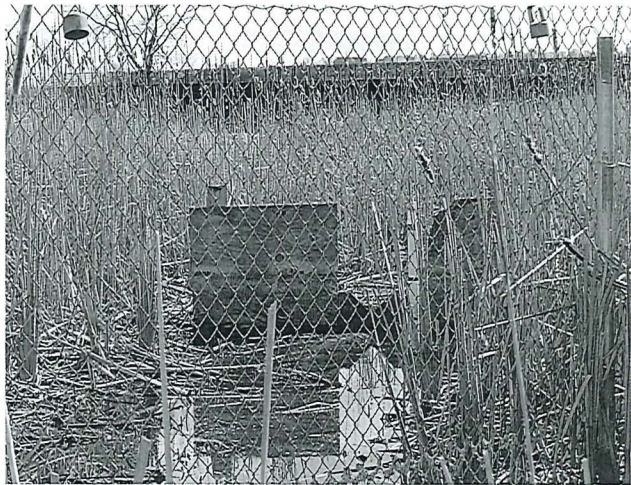
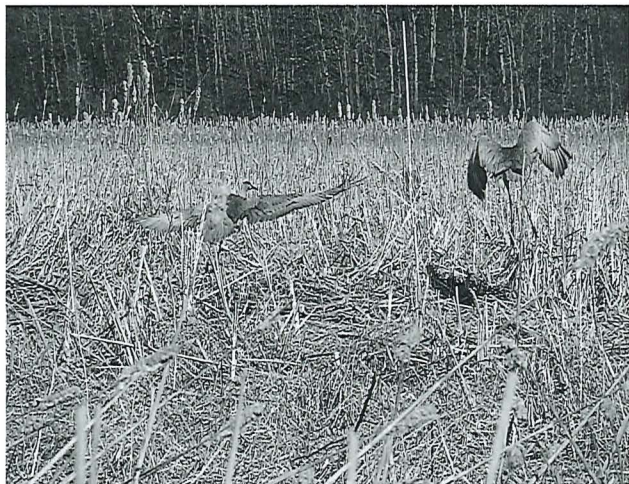
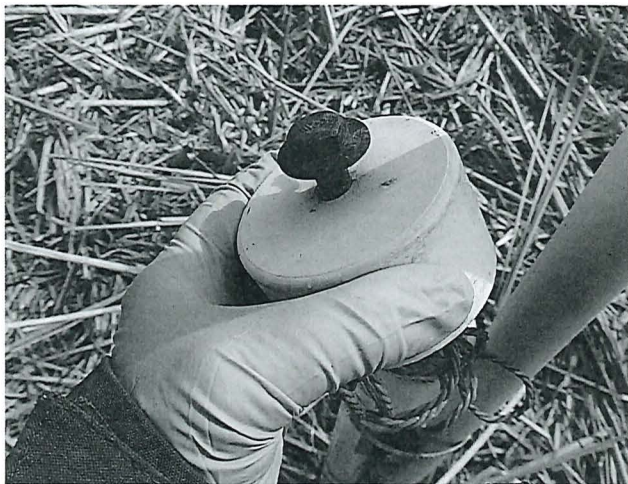
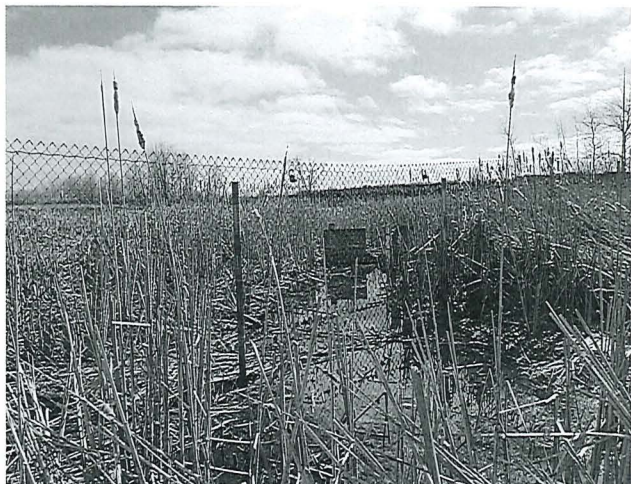
- Most of the wells were still frozen, even though we had a period of warming in early spring.
- I did not find the benchmarks – they appeared to be buried under rail trail gravel.

- Bailers: Most of the bailers are submerged in the water columns making collecting water elevation data problematic because the bailers need to be removed before data collection. Because of the large number of wells and the time required for equilibration, I decided to do away with the dedicated bailers and go to either using disposable bailers or decontaminating existing bailers. Many of the bailers were stained and had a film of sediment and the braided polyethylene cords are very dirty.

- I found GW-08: N44.47551 W 87.51353
- The trail access gate (on Kuehl's property) has been lifted from its hinge and is tied to the post by rope. This will need to be fixed.

- The weir in the south slough can be seen through the fence. It appears to be in good shape. At the fence near the south slough is a muskrat den.

**Recommendations/Follow-up:** Get assistance from Jim Killian in locating the benchmarks. Fix gate.

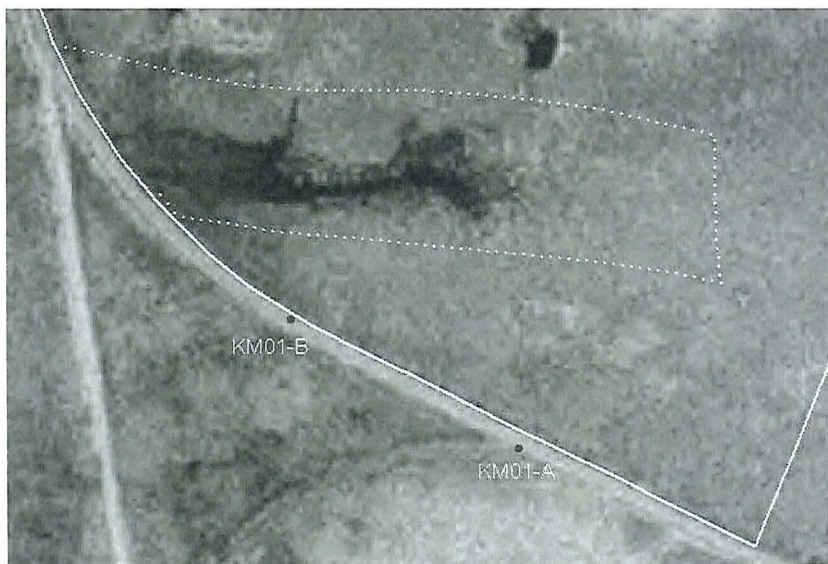
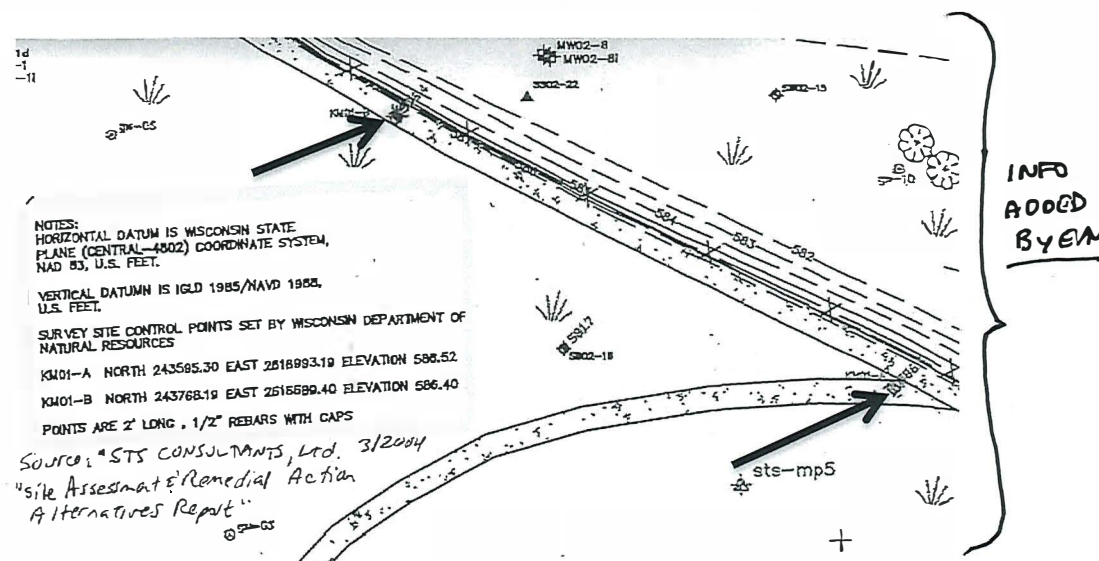
## DNR TOPOGRAPHIC SURVEY CONTROL POINTS

Both monuments are 2' long, 1/2" rebar pounded flush with surface and have yellow plastic caps. Controls were set using a Trimble 4800 RTK GPS, referencing COE first-order monument 76-4 and NGS Tidal Bench Mark 908 7068 G. (see enclosed .pdf pages)

KM01-A is located between the main RR line and the older spur, 22.8' from the opposite fencepost (painted orange)

KM01-B is located just north of the main RR line, and is 6.2' from the painted/flagged section of fence.

Both monuments were located and marked with paint and lathe on 12/27/01. They were also checked for vertical stability at this time and found to be true.
