To: File  
From: Liz Victor *LV*  
Date: January 5, 2018  
Site Name/BRRTS: Kewaunee Marsh Arsenic Spill (02-31-000508)  
Re: Field Activities Report for October 3, 2017

**Purpose of Field Visit:** Cap Inspection and Site Visit

**Kewaunee Marsh**  
**Waypoint/Tracks Map 10/03/2017**  
**Map Date: 11/28/2017**

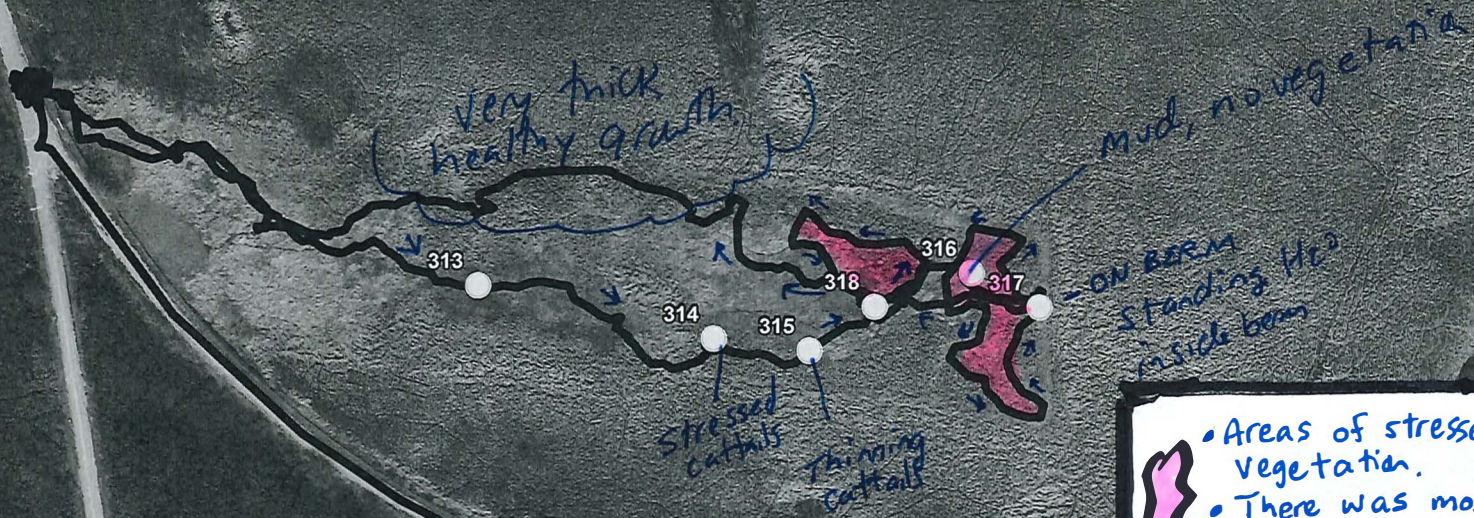
• Areas of stressed/thin/lacking vegetation.  
• There was more than what is shown on this map.  
• Decided to quit and instead use Aerial photo as guide

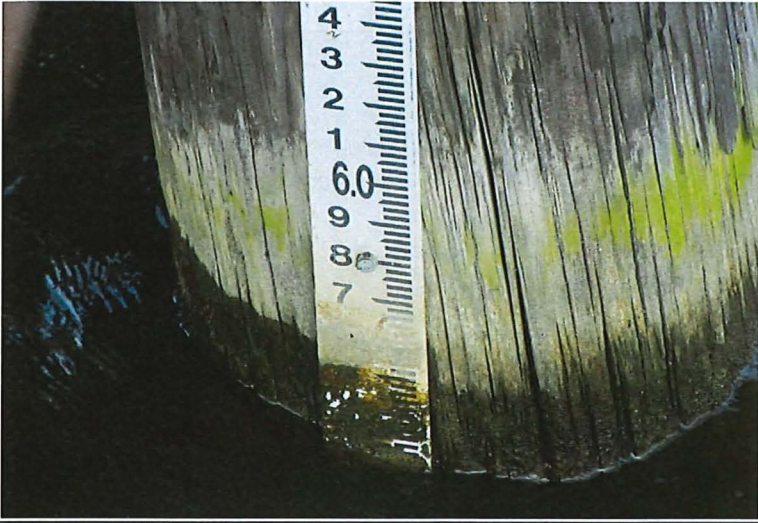
<table border="1"> <tr> <td>Photo #:</td> <td>001</td> </tr> <tr> <td>Date/Time of Photo:</td> <td>10/03/2017</td> </tr> <tr> <td>Photo Location:</td> <td>Kewaunee Marsh</td> </tr> <tr> <td>Photo By:</td> <td>Cheryl Bougie</td> </tr> <tr> <td>Photo Description:</td> <td>New (West) Staff Gauge looking North. Water level estimated to be ~5.25 ft (see field notes for details) WPT 312</td> </tr> </table>	Photo #:	001	Date/Time of Photo:	10/03/2017	Photo Location:	Kewaunee Marsh	Photo By:	Cheryl Bougie	Photo Description:	New (West) Staff Gauge looking North. Water level estimated to be ~5.25 ft (see field notes for details) WPT 312
Photo #:	001										
Date/Time of Photo:	10/03/2017										
Photo Location:	Kewaunee Marsh										
Photo By:	Cheryl Bougie										
Photo Description:	New (West) Staff Gauge looking North. Water level estimated to be ~5.25 ft (see field notes for details) WPT 312

- New Staff Gauge: algae on the staff gauge (installed May 2017) was noted as high as 5.56ft – indicating the river elevation has been as high as 5.56 ft (581.39 ft msl).

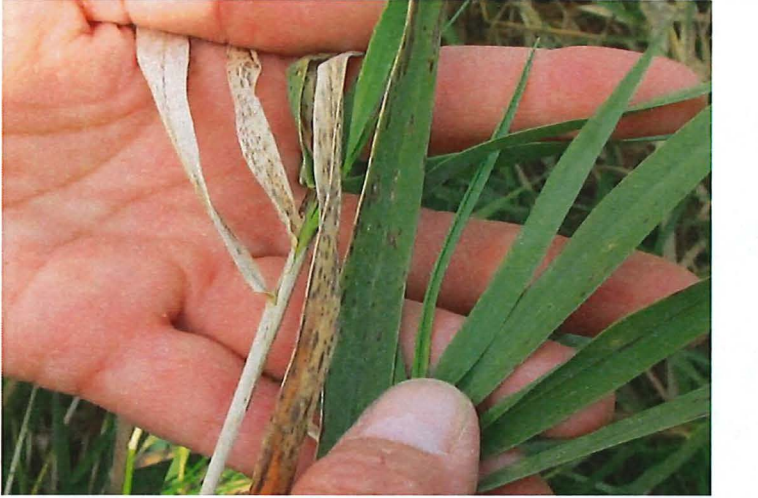
<table border="1"> <tr> <td>Photo #:</td> <td>002</td> </tr> <tr> <td>Date/Time of Photo:</td> <td>10/03/2017</td> </tr> <tr> <td>Photo Location:</td> <td>Kewaunee Marsh</td> </tr> <tr> <td>Photo By:</td> <td>Cheryl Bougie</td> </tr> <tr> <td>Photo Description:</td> <td>Reed Canary Grass - comparison between "stressed" and healthy. WPT 318</td> </tr> </table>	Photo #:	002	Date/Time of Photo:	10/03/2017	Photo Location:	Kewaunee Marsh	Photo By:	Cheryl Bougie	Photo Description:	Reed Canary Grass - comparison between "stressed" and healthy. WPT 318
Photo #:	002										
Date/Time of Photo:	10/03/2017										
Photo Location:	Kewaunee Marsh										
Photo By:	Cheryl Bougie										
Photo Description:	Reed Canary Grass - comparison between "stressed" and healthy. WPT 318

- There was a marked difference in quality of vegetation between the western and eastern portions of the cap. In the west, the vegetation was green, thick and tall for all species: phragmites, cattails, reed canary grass, and nettles. In the east, the vegetation was brown, shorter and thinner for all species (no nettles noted). We discussed the possibility that the cattails in the east were a different variety or a hybrid.

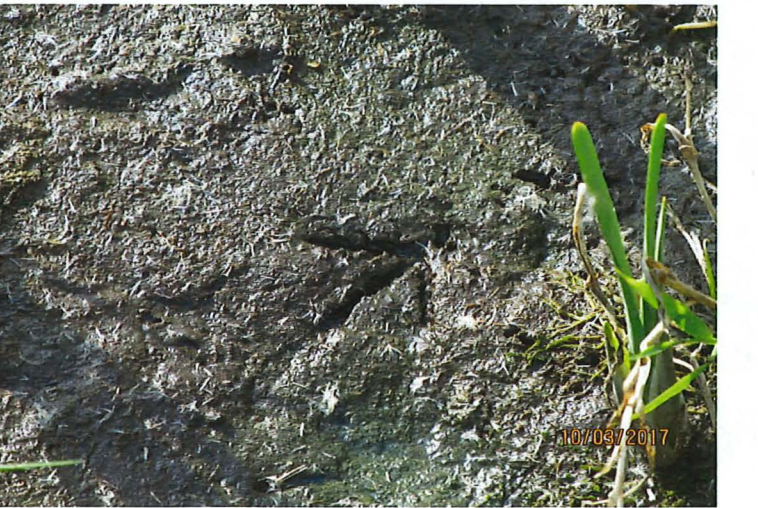
<table border="1"> <tr> <td>Photo #:</td> <td>003</td> </tr> <tr> <td>Date/Time of Photo:</td> <td>10/03/2017</td> </tr> <tr> <td>Photo Location:</td> <td>Kewaunee Marsh</td> </tr> <tr> <td>Photo By:</td> <td>Cheryl Bougie</td> </tr> <tr> <td>Photo Description:</td> <td>Crane track in stressed vegetation area WPT 316</td> </tr> </table>	Photo #:	003	Date/Time of Photo:	10/03/2017	Photo Location:	Kewaunee Marsh	Photo By:	Cheryl Bougie	Photo Description:	Crane track in stressed vegetation area WPT 316

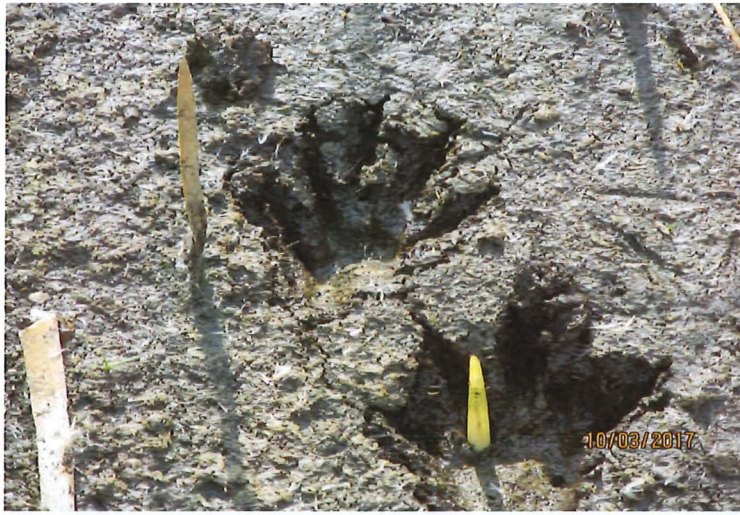
Photo #:	004
Date/Time of Photo:	10/03/2017
Photo Location:	Kewaunee Marsh
Photo By:	Cheryl Bougie
Photo Description:	Raccoon tracks in stressed vegetation area WPT 316

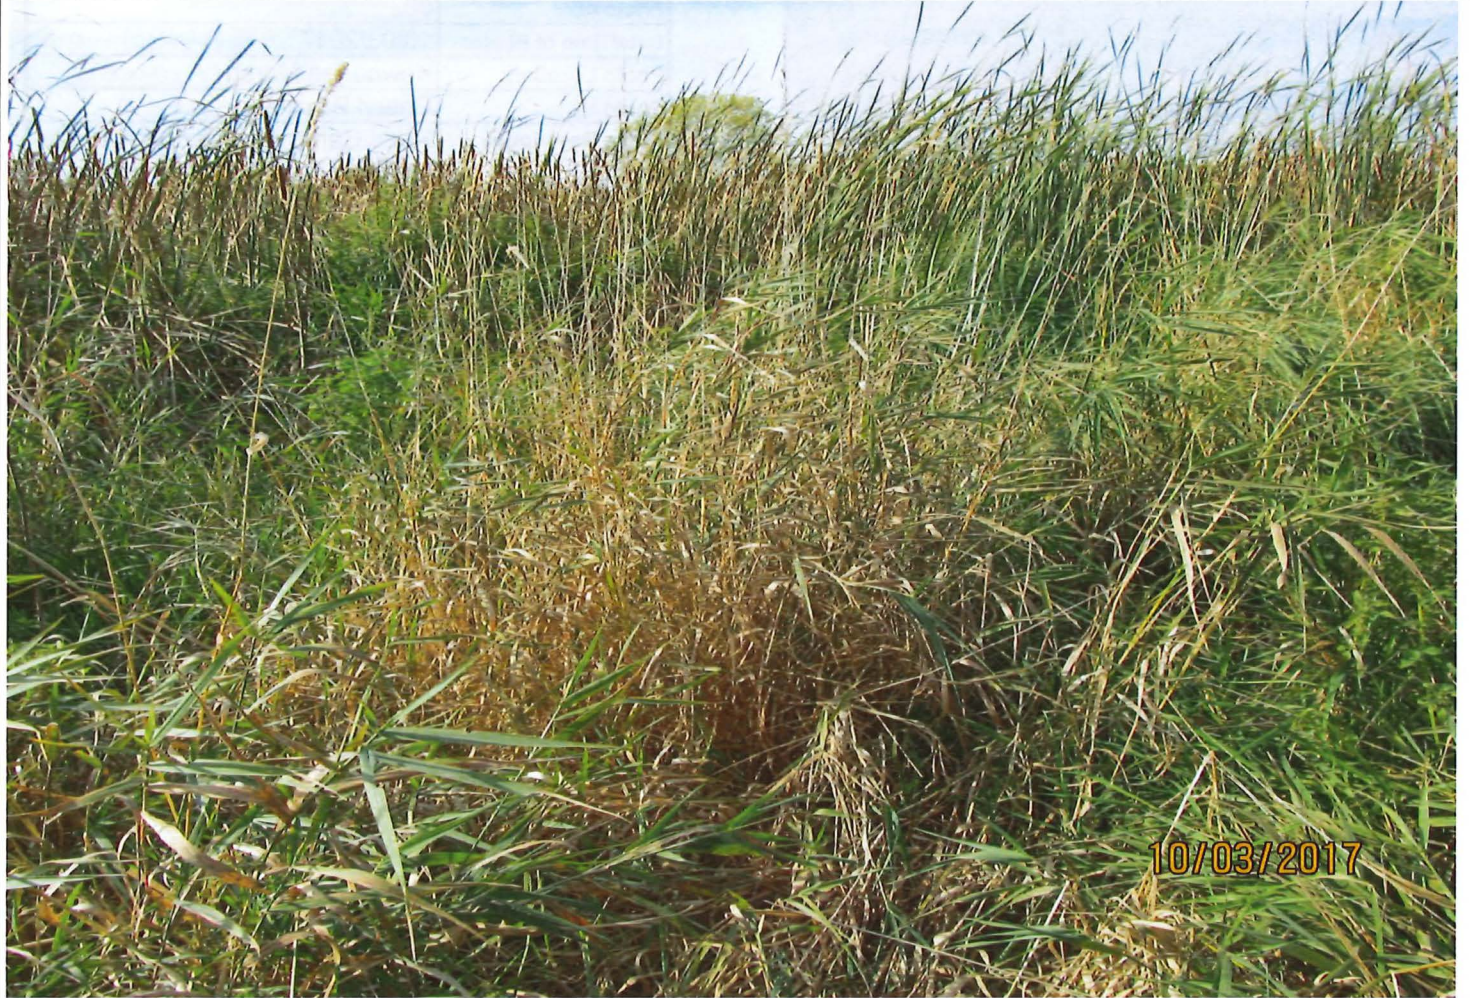
Photo #:	005
Date/Time of Photo:	10/03/2017

Above Photo: Thick reed canary grass. Facing S WPT 313  
 Photo by: Cheryl Bougie

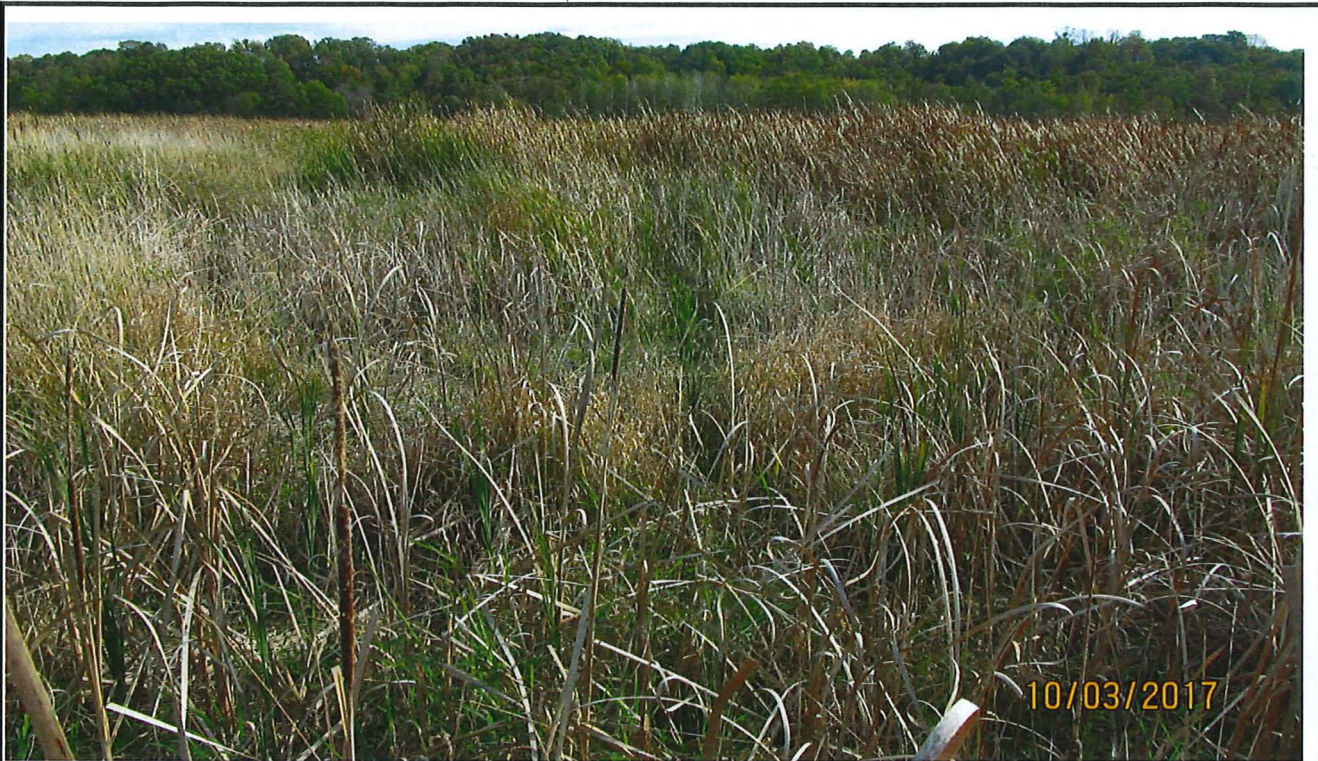
Photo #: 006

Above Photo: Pond 8 View to ~north.  
by: Cheryl Bougie

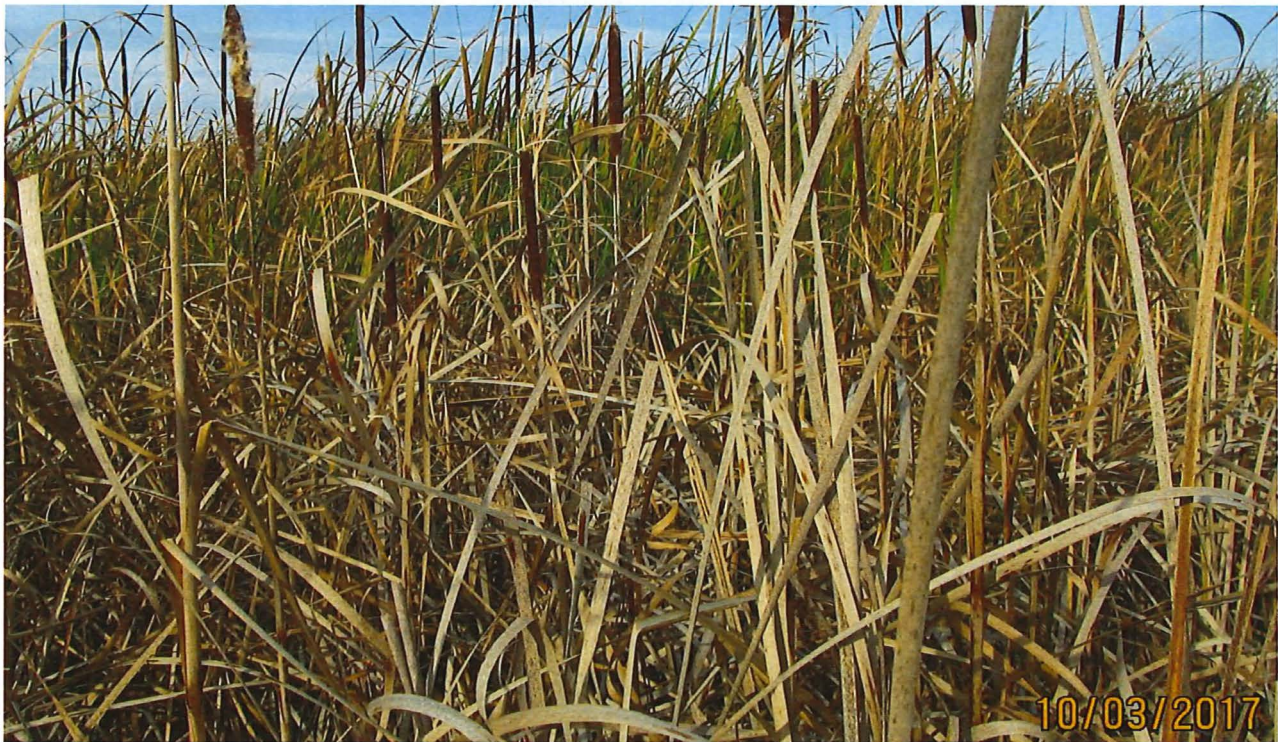
Photo #: 007

Above Photo: Pond 8 View to ~north.  
by: Cheryl Bougie

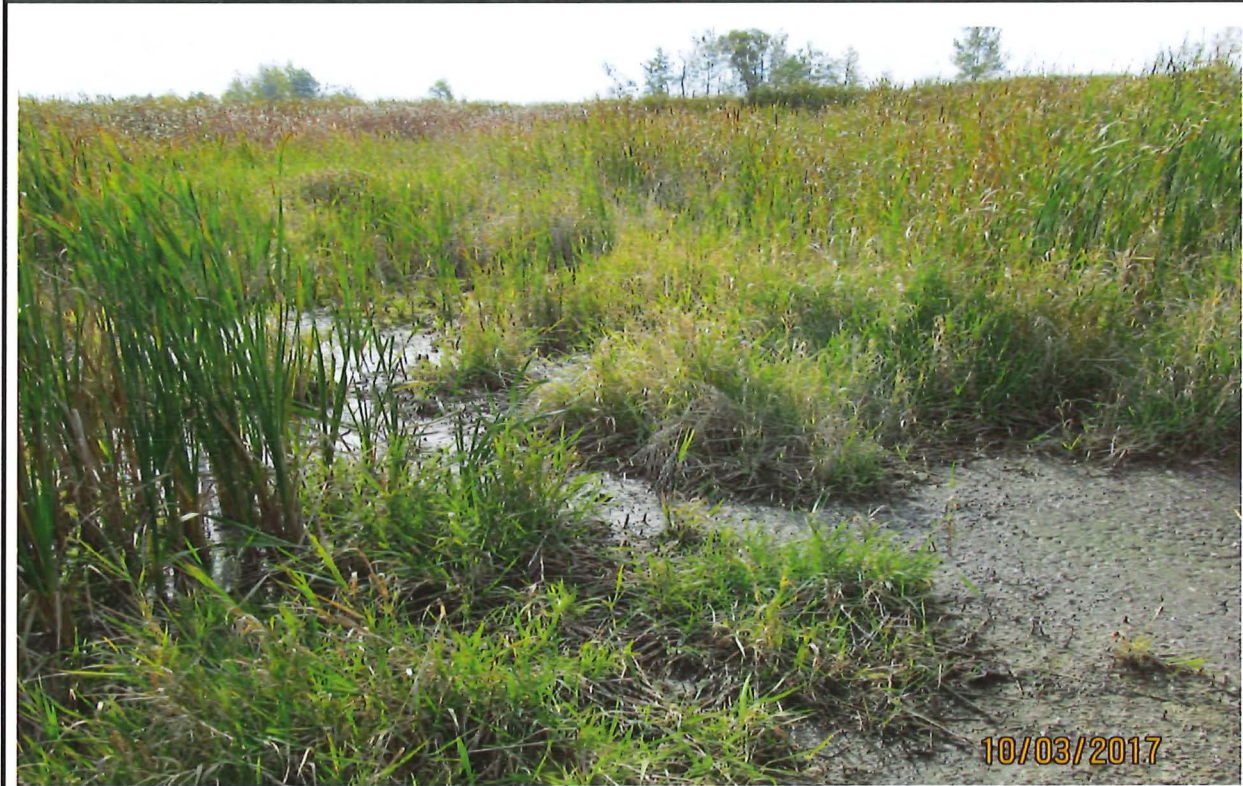
Above Photo: stressed/stunted Vegetation Zone	Photo #:	008
Facing SE WPT 316 Photo by: Cheryl Bougie	Date/Time of Photo:	10/03/2017

- There were large areas in the east on the cap where nothing was growing. It looked like sediment/soil/mud; the woodchips have decomposed.
- We observed abundant deer, bird and raccoon tracks and saw a leopard frog. The areas of standing water had duck weed.

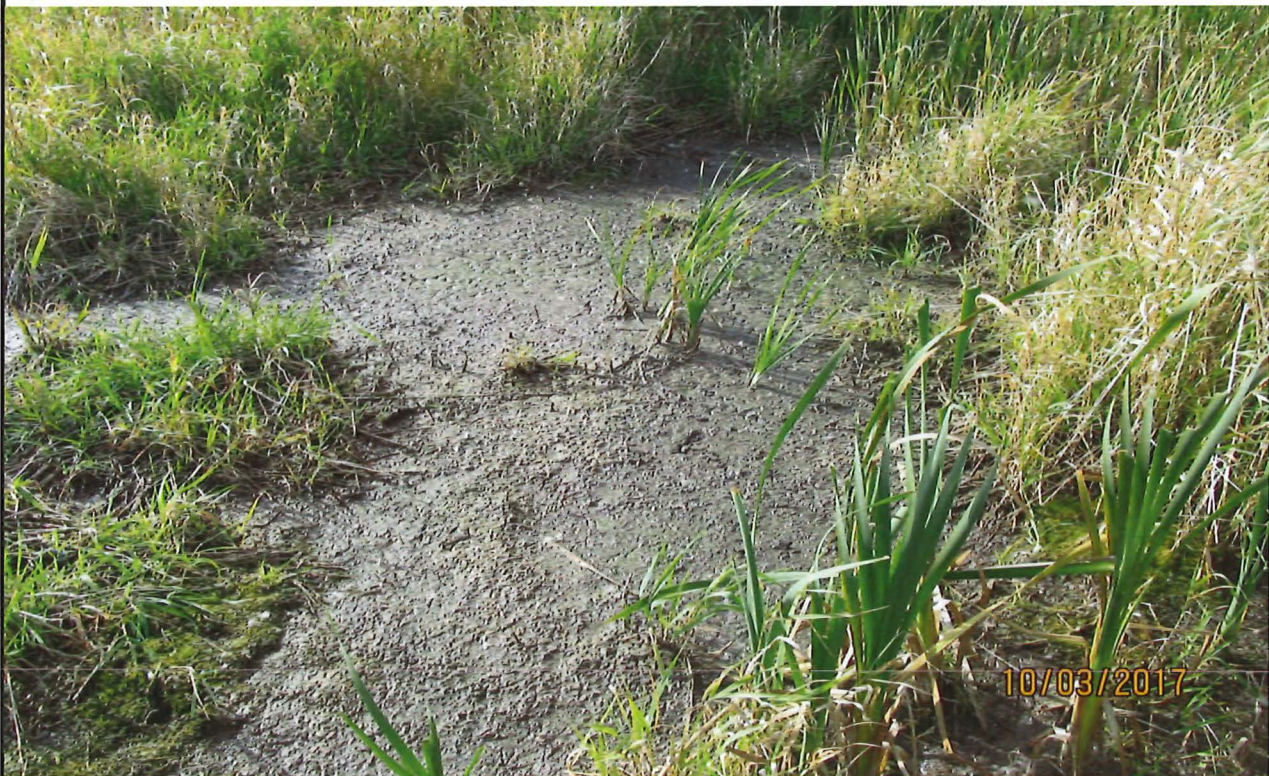
Above Photo: stressed/stunted Vegetation Zone Facing	Photo #:	009
SE WPT 316 Photo by: Cheryl Bougie	Date/Time of Photo:	10/03/2017

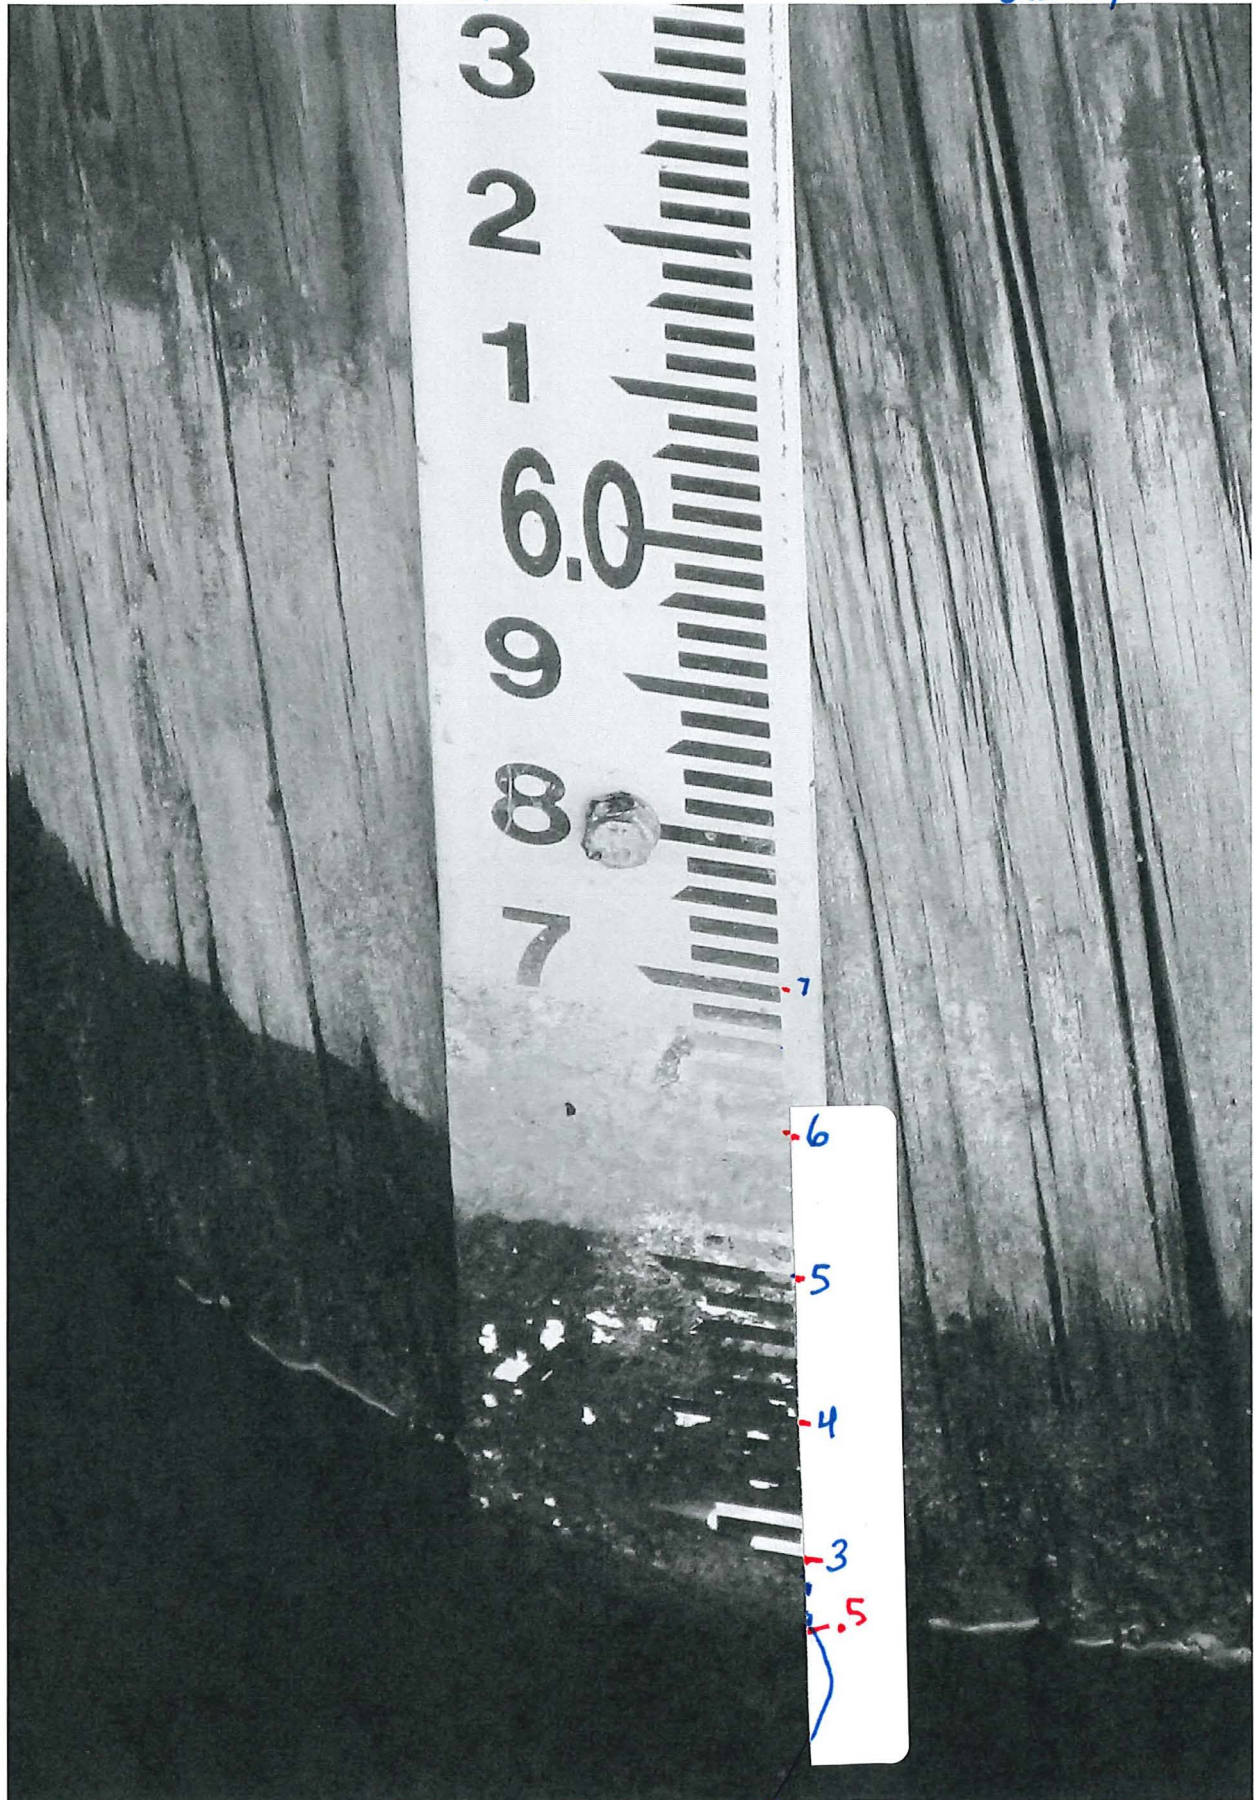
"WEST" STAFF GAUGE WPT 312 - 87.51304 44.47352

ESTIMATION OF STAFF GAUGE READING  
BY EAV PHOTO TAKEN 10/3/17

5.25'
