Susies Restaurant (Former) LGU WI DOT  
02-36-000516  
Telemetry System Install – Josie Schultz Notes  
Photo Log from January 20, 2023

VaporSafe installed the Vapor Sentinel telemetry system at the Golden Flame Restaurant on January 19, 2023. On January 20, 2023, an electrician connected power to the telemetry system, and connected the system to the blower fan to measure the amps being used by the blower fan. VaporSafe also connected tubing from the telemetry system to inside the piping to measure vacuum. The VaporSafe technician mentioned that they generally like to install the tubing on the top of piping in case water comes into the pipe, but the plug that the tubing inserts into protrudes into the pipe more than 0.5", so it is unlikely that moisture will be an issue.

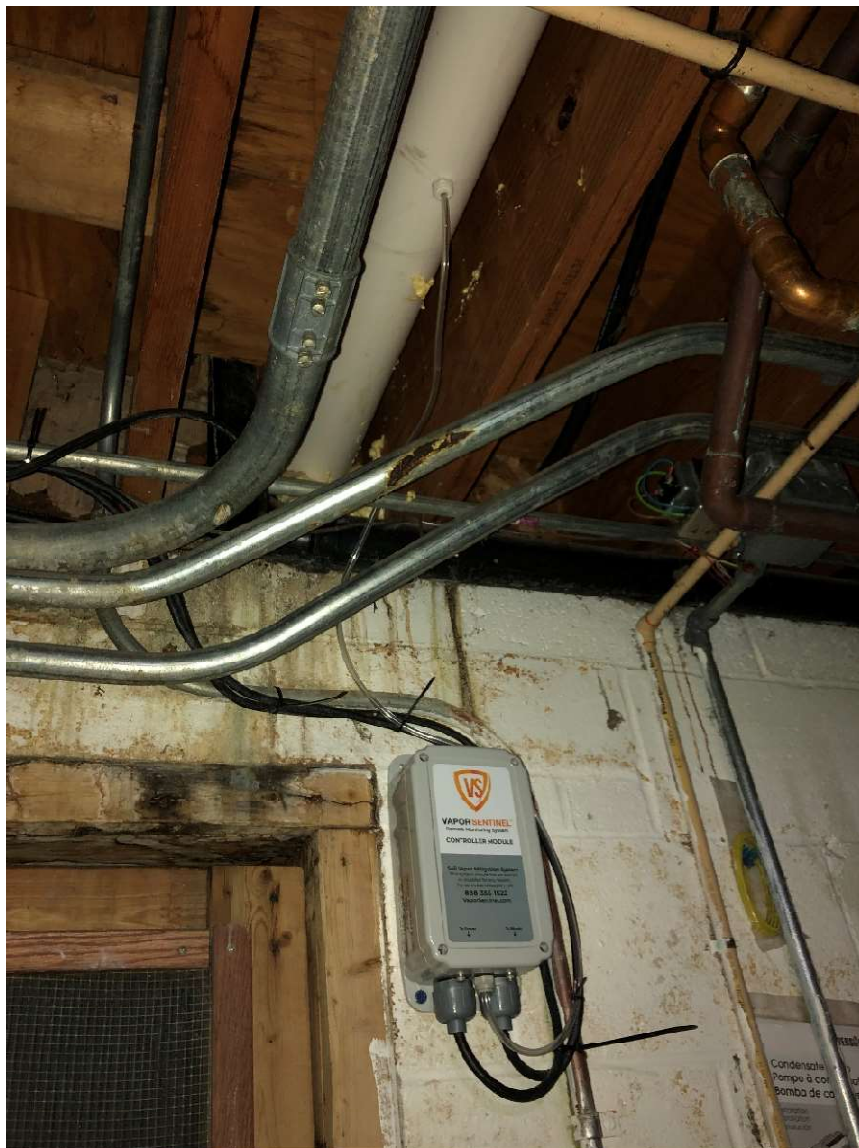
The telemetry system is located right next to the basement entrance on the west side of the restaurant. Tubing to measure vacuum is tapped into the bottom of the piping that is exiting the building to the blower fan located outside

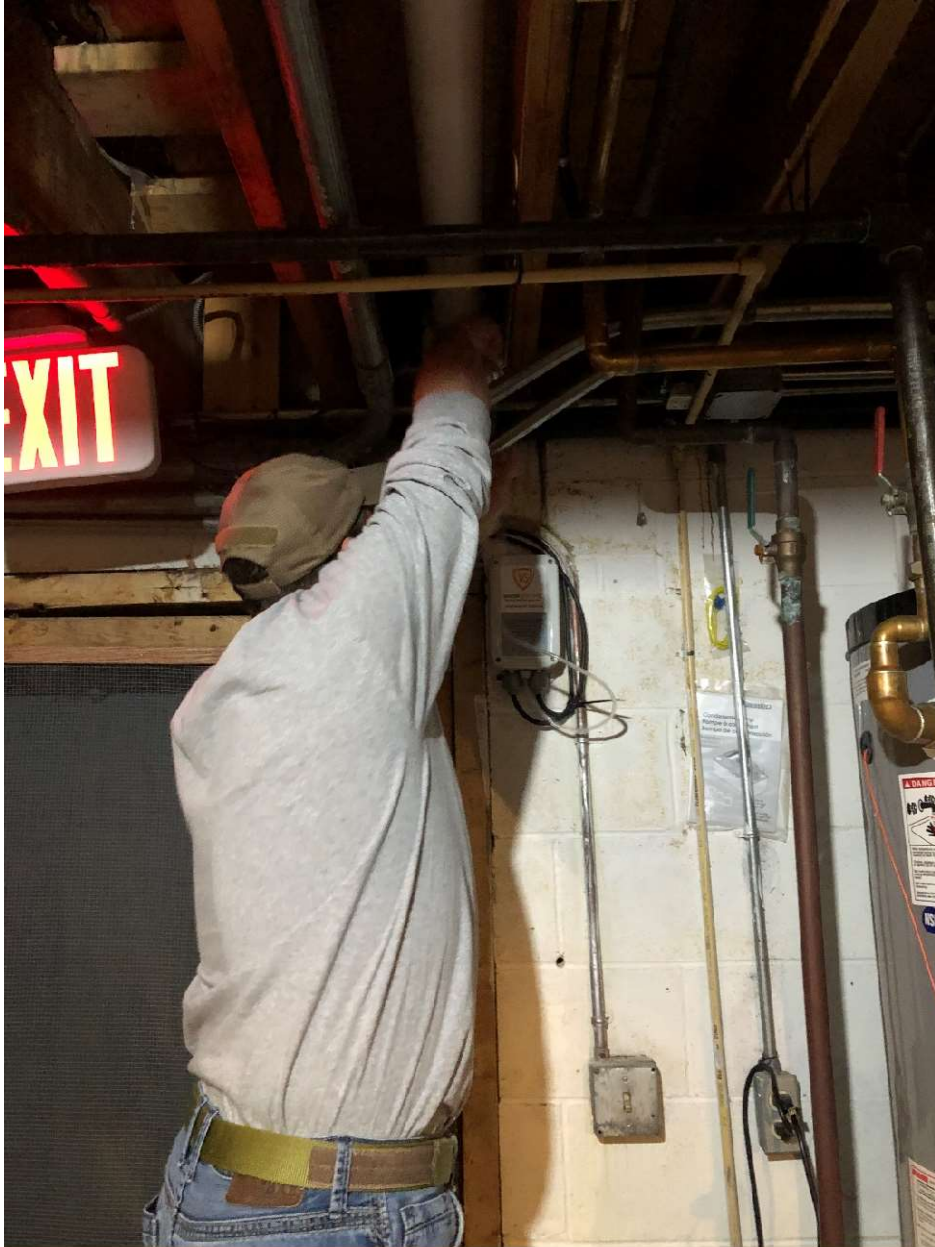
VaporSafe installing tubing into piping to measure vacuum.

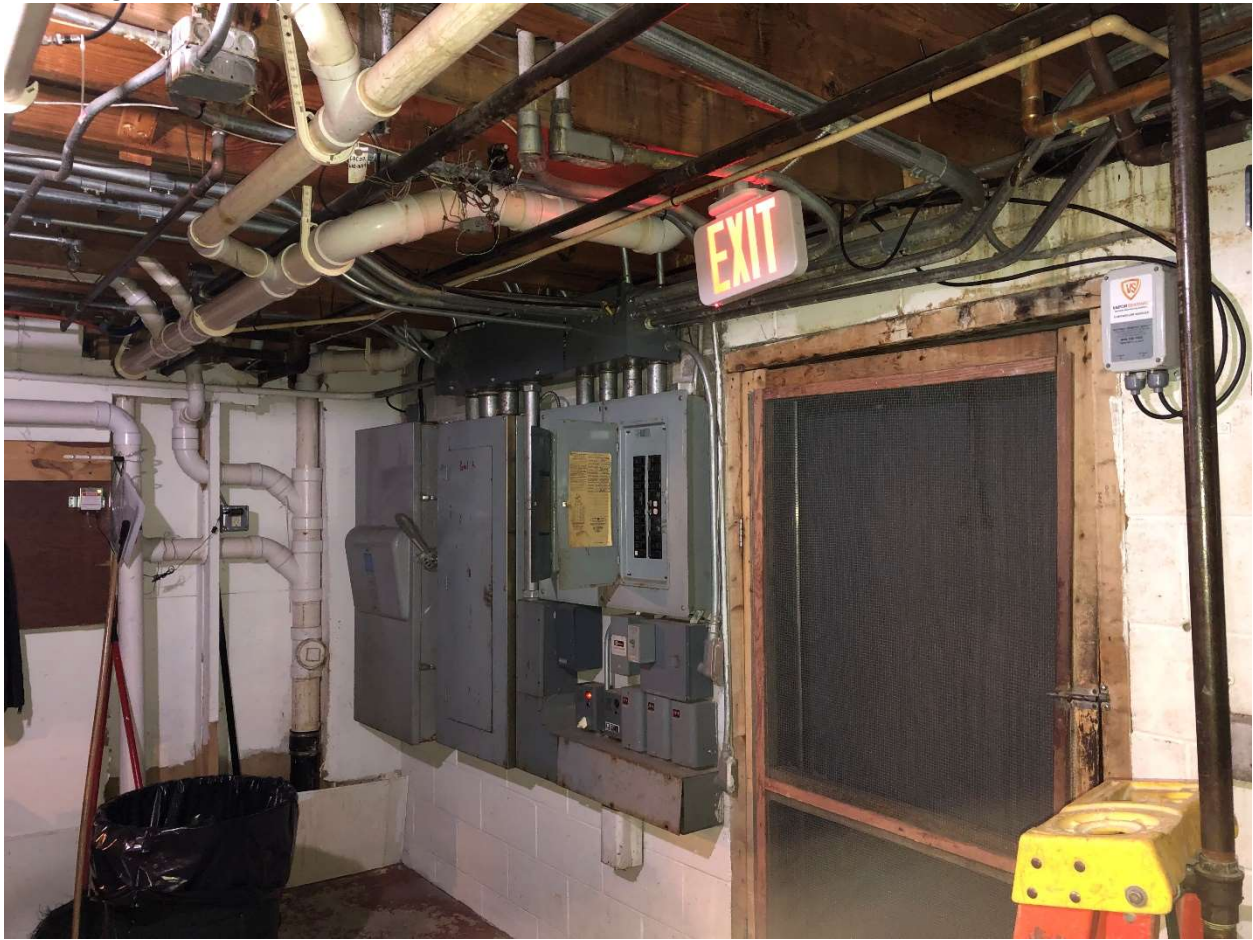
Telemetry system located to the right of the west entrance to the basement of the restaurant. Drop point and alarm for the vapor mitigation system is located on the left side of the photo.
