Subject: Vapor Intrusion Investigation Results – Sampling Event 1  
Former Northwoods Laundry Site, Minocqua, Wisconsin  
WisDOT Project ID #0656-50-31; WDNR BRRTS #02-44-000517

This letter presents a summary of the first round of vapor intrusion (VI) monitoring completed for the Former Northwoods Laundry Site (BRRTS #02-44-000517) in Minocqua, Wisconsin (Figure 1). The purpose of this document is to provide a summary of the monitoring completed to evaluate vapor intrusion in select properties near the Former Northwoods Laundry Site and to provide recommendations for further monitoring.

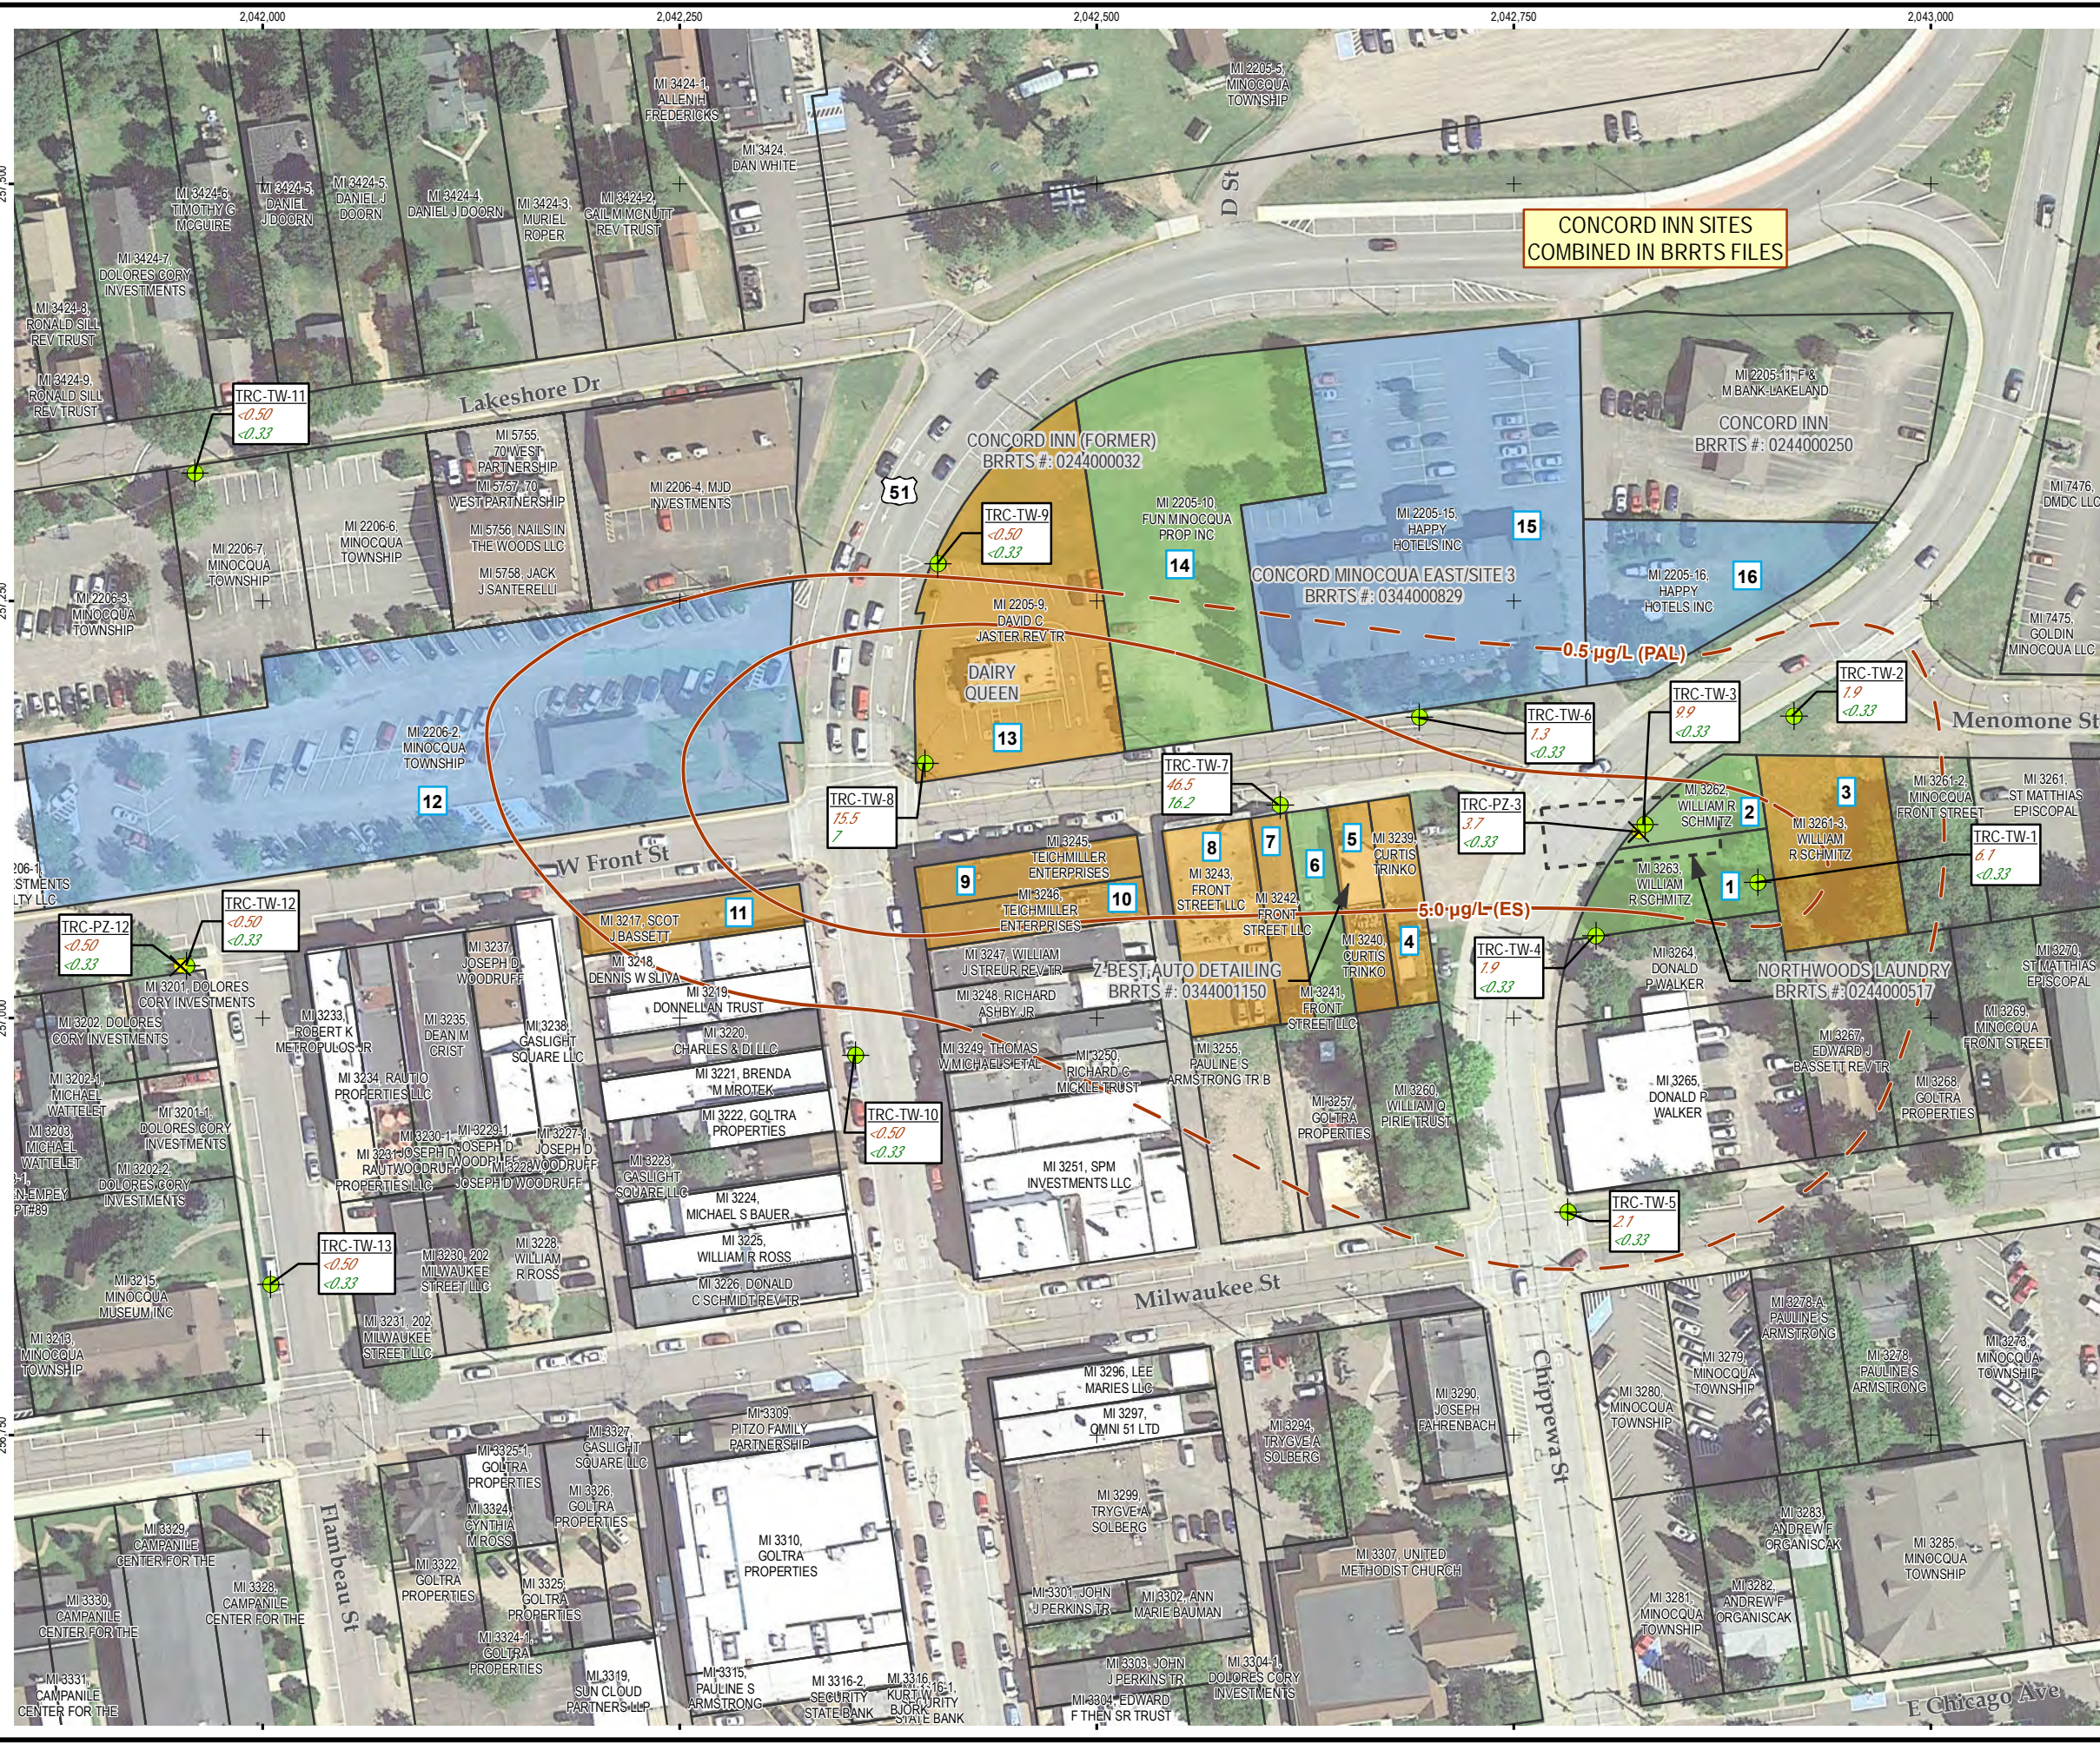
The number and type of samples recommended were based on the type and condition of each property. Table 1 includes a list of the properties with sample details and Figure 2 identifies the location of each property with respect to the Site.

In accordance with the Work Plan, TRC completed background air, indoor air, and sub-slab vapor sampling at nine parcels identified in Table 1 and on Figure 2. TRC was onsite between March 21 and 23, 2018 to complete the monitoring event. This initial VI monitoring event was conducted to assess the VI pathway at the site under conservative sampling conditions. The locations of the sample collection points for each parcel are shown on Figures 3 – 7.

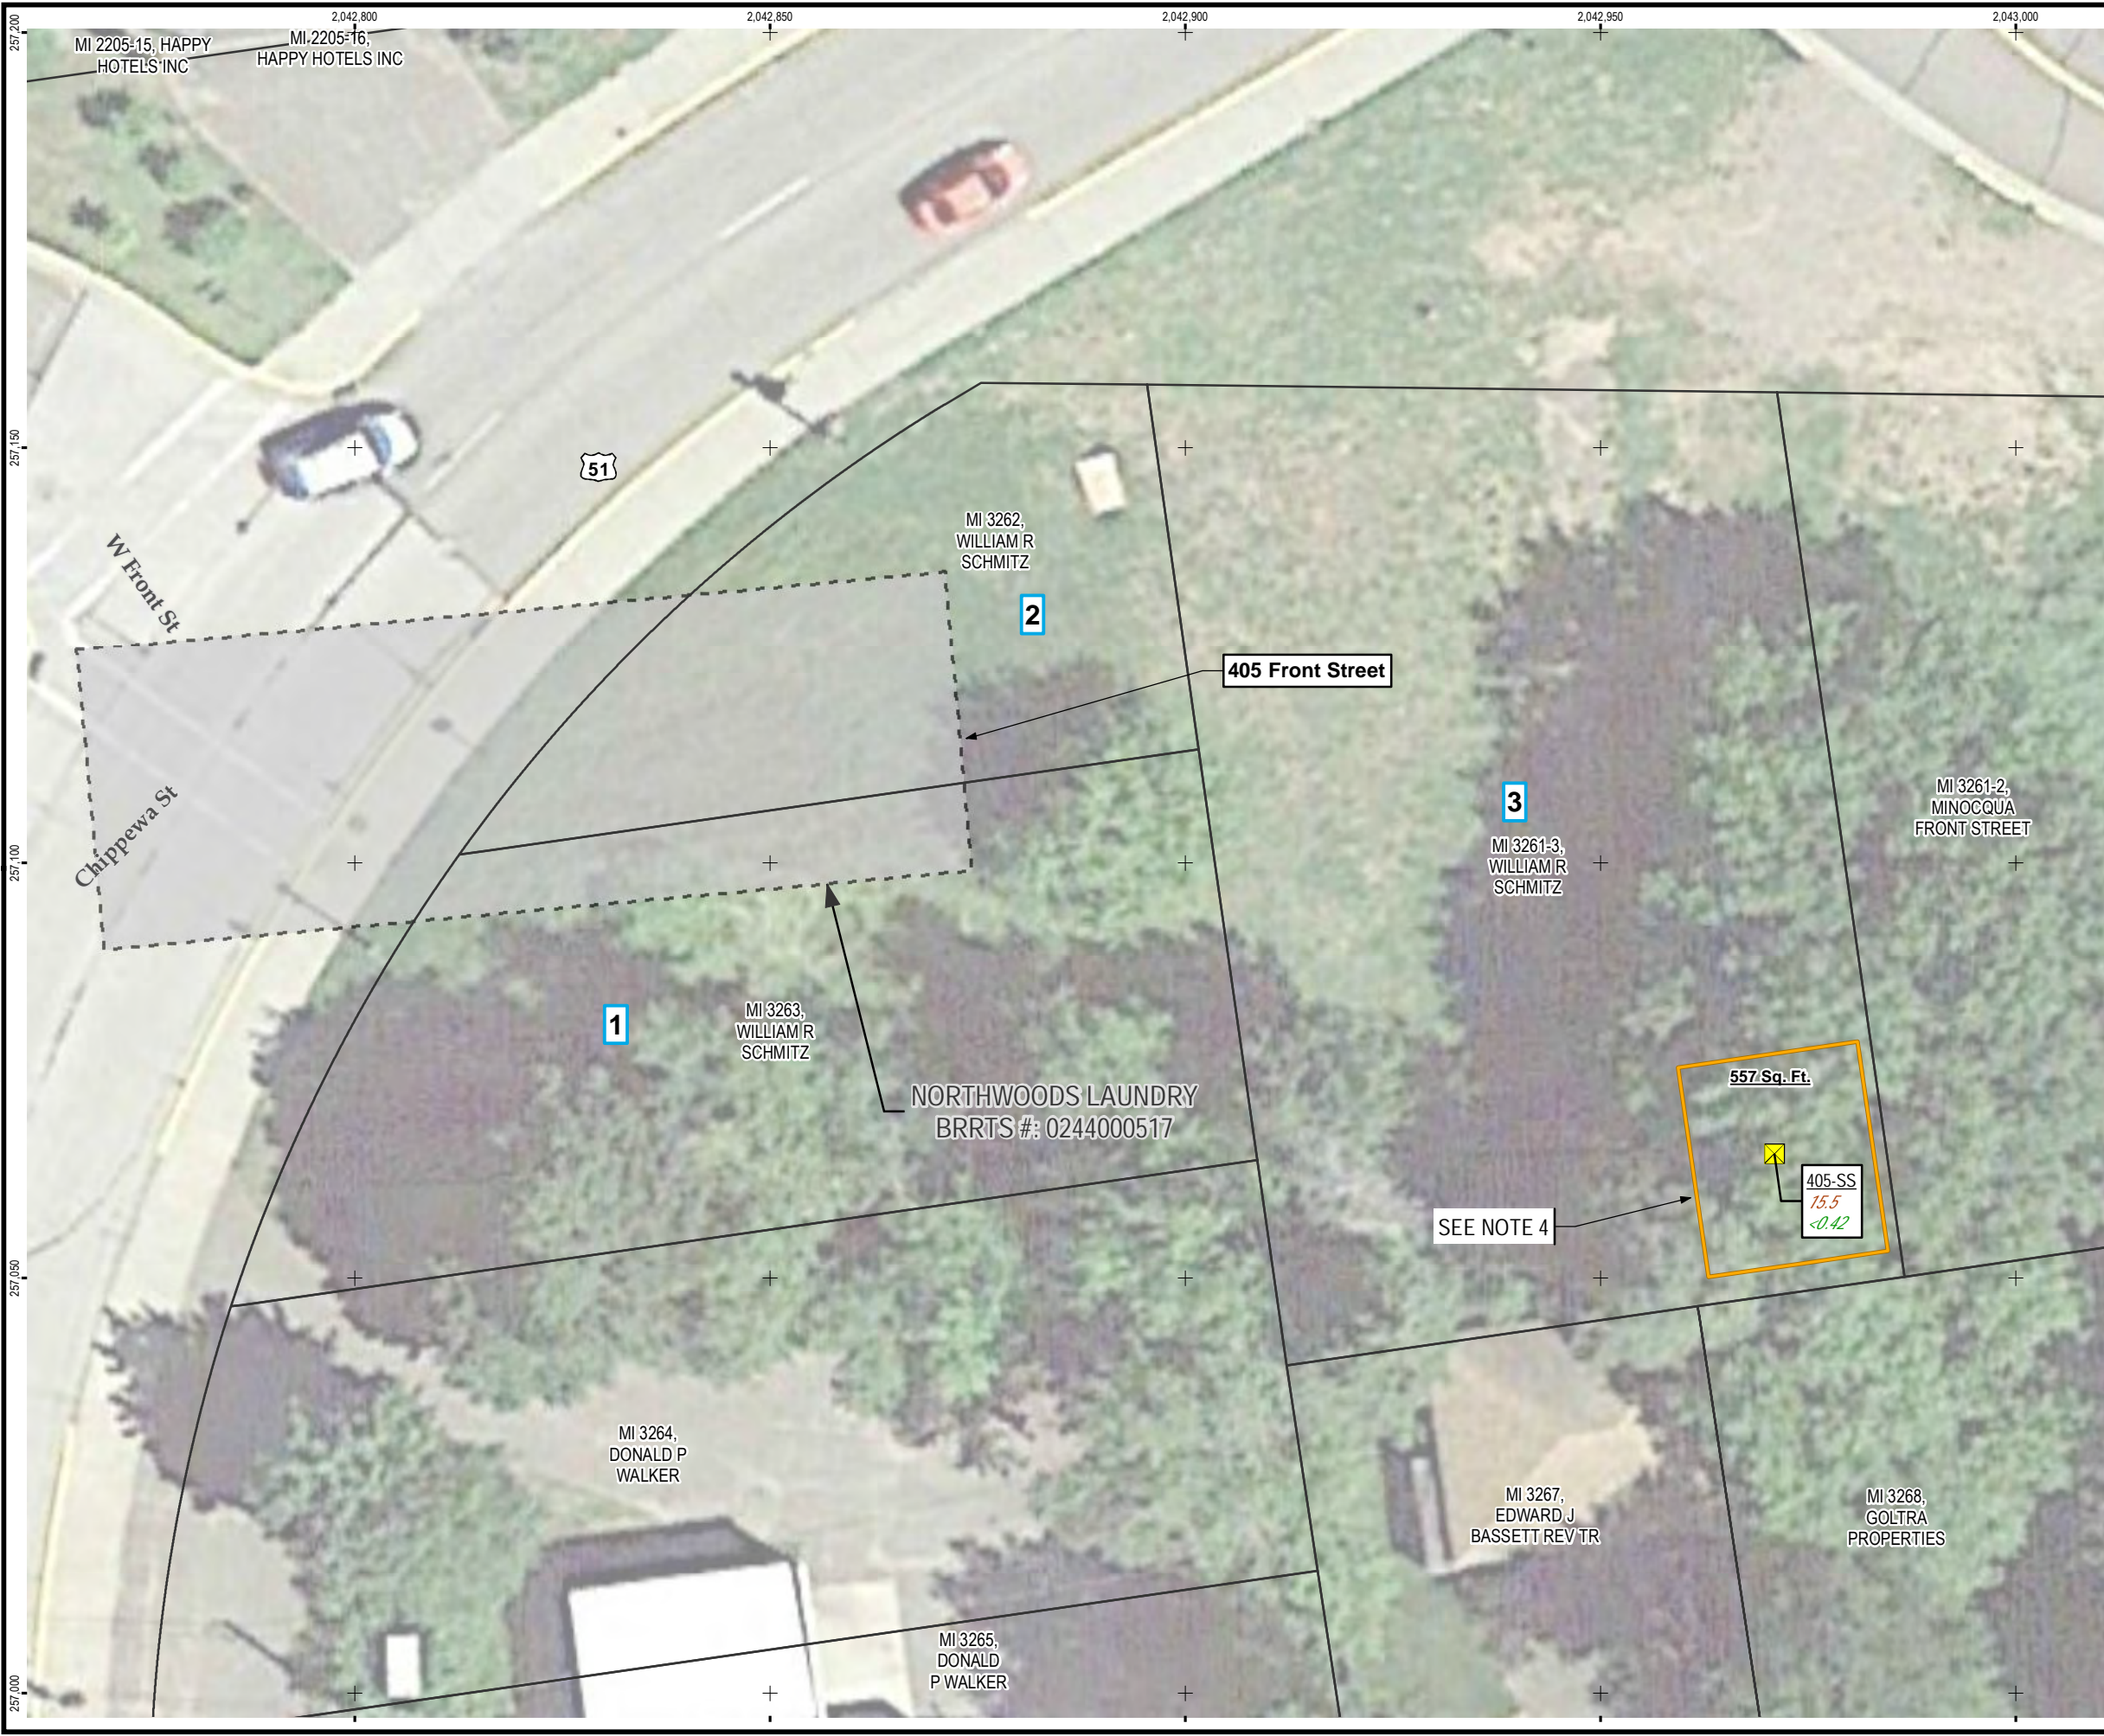
<b>PROJECT:</b>	
WISDOT ID# 0656-50-31 FORMER NORTHWOODS LAUNDRY MINOCQUA, ONEIDA COUNTY, WISCONSIN	
<b>TITLE:</b>	
PROPERTY LAYOUT/RESULTS - PROPERTY IDs 1 THROUGH 3	
DRAWN BY: R. SUEMNICHT	PROJ NO.: 298526
CHECKED BY: T. O'CONNELL	<b>FIGURE 3</b>
APPROVED BY: D. HAAK	
DATE: MAY 2018	
<span style="float: right; font-size: small;">708 Heartland Trail, Suite 3000 Madison, WI 53717 Phone: 608.826.3600 www.trcsolutions.com</span>	
FILE NO.: 298526-016mb.mxd

Sub-slab vapor sample(s) were collected from the lower level of the residential building and from the lower level or main level for the small commercial buildings (depending on construction). Based on the layout and size of select properties, multiple sub-slab samples were collected. Overall, 12 sub-slab vapor samples and one duplicate sample were collected during the monitoring event. The duplicate sample was collected in conjunction with the sub-sample collected from 300 Front Street as a quality assurance measure. In addition, three leak tests (Water Dam Test, Helium Shroud Test, and Shut-in Test) were completed as outlined in the Work Plan to check the integrity of the sampling equipment. Each sub-slab vapor sample was collected using a 6-liter SUMMA<sup>®</sup> canister with a 30-minute regulator. The sample duration was extended past 30-minutes for select samples where sufficient vacuum had not depreciated to below at least 8 in Hg. Each SUMMA<sup>®</sup> canister was submitted to PACE Analytical Laboratory for EPA Method TO -15 analyses for a select list of CVOCs (PCE, TCE, cis-1,2 dichloroethene, trans-1,2 dichloroethene, and vinyl chloride). The locations of the sub-slab vapor samples are shown on Figures 3 - 7.

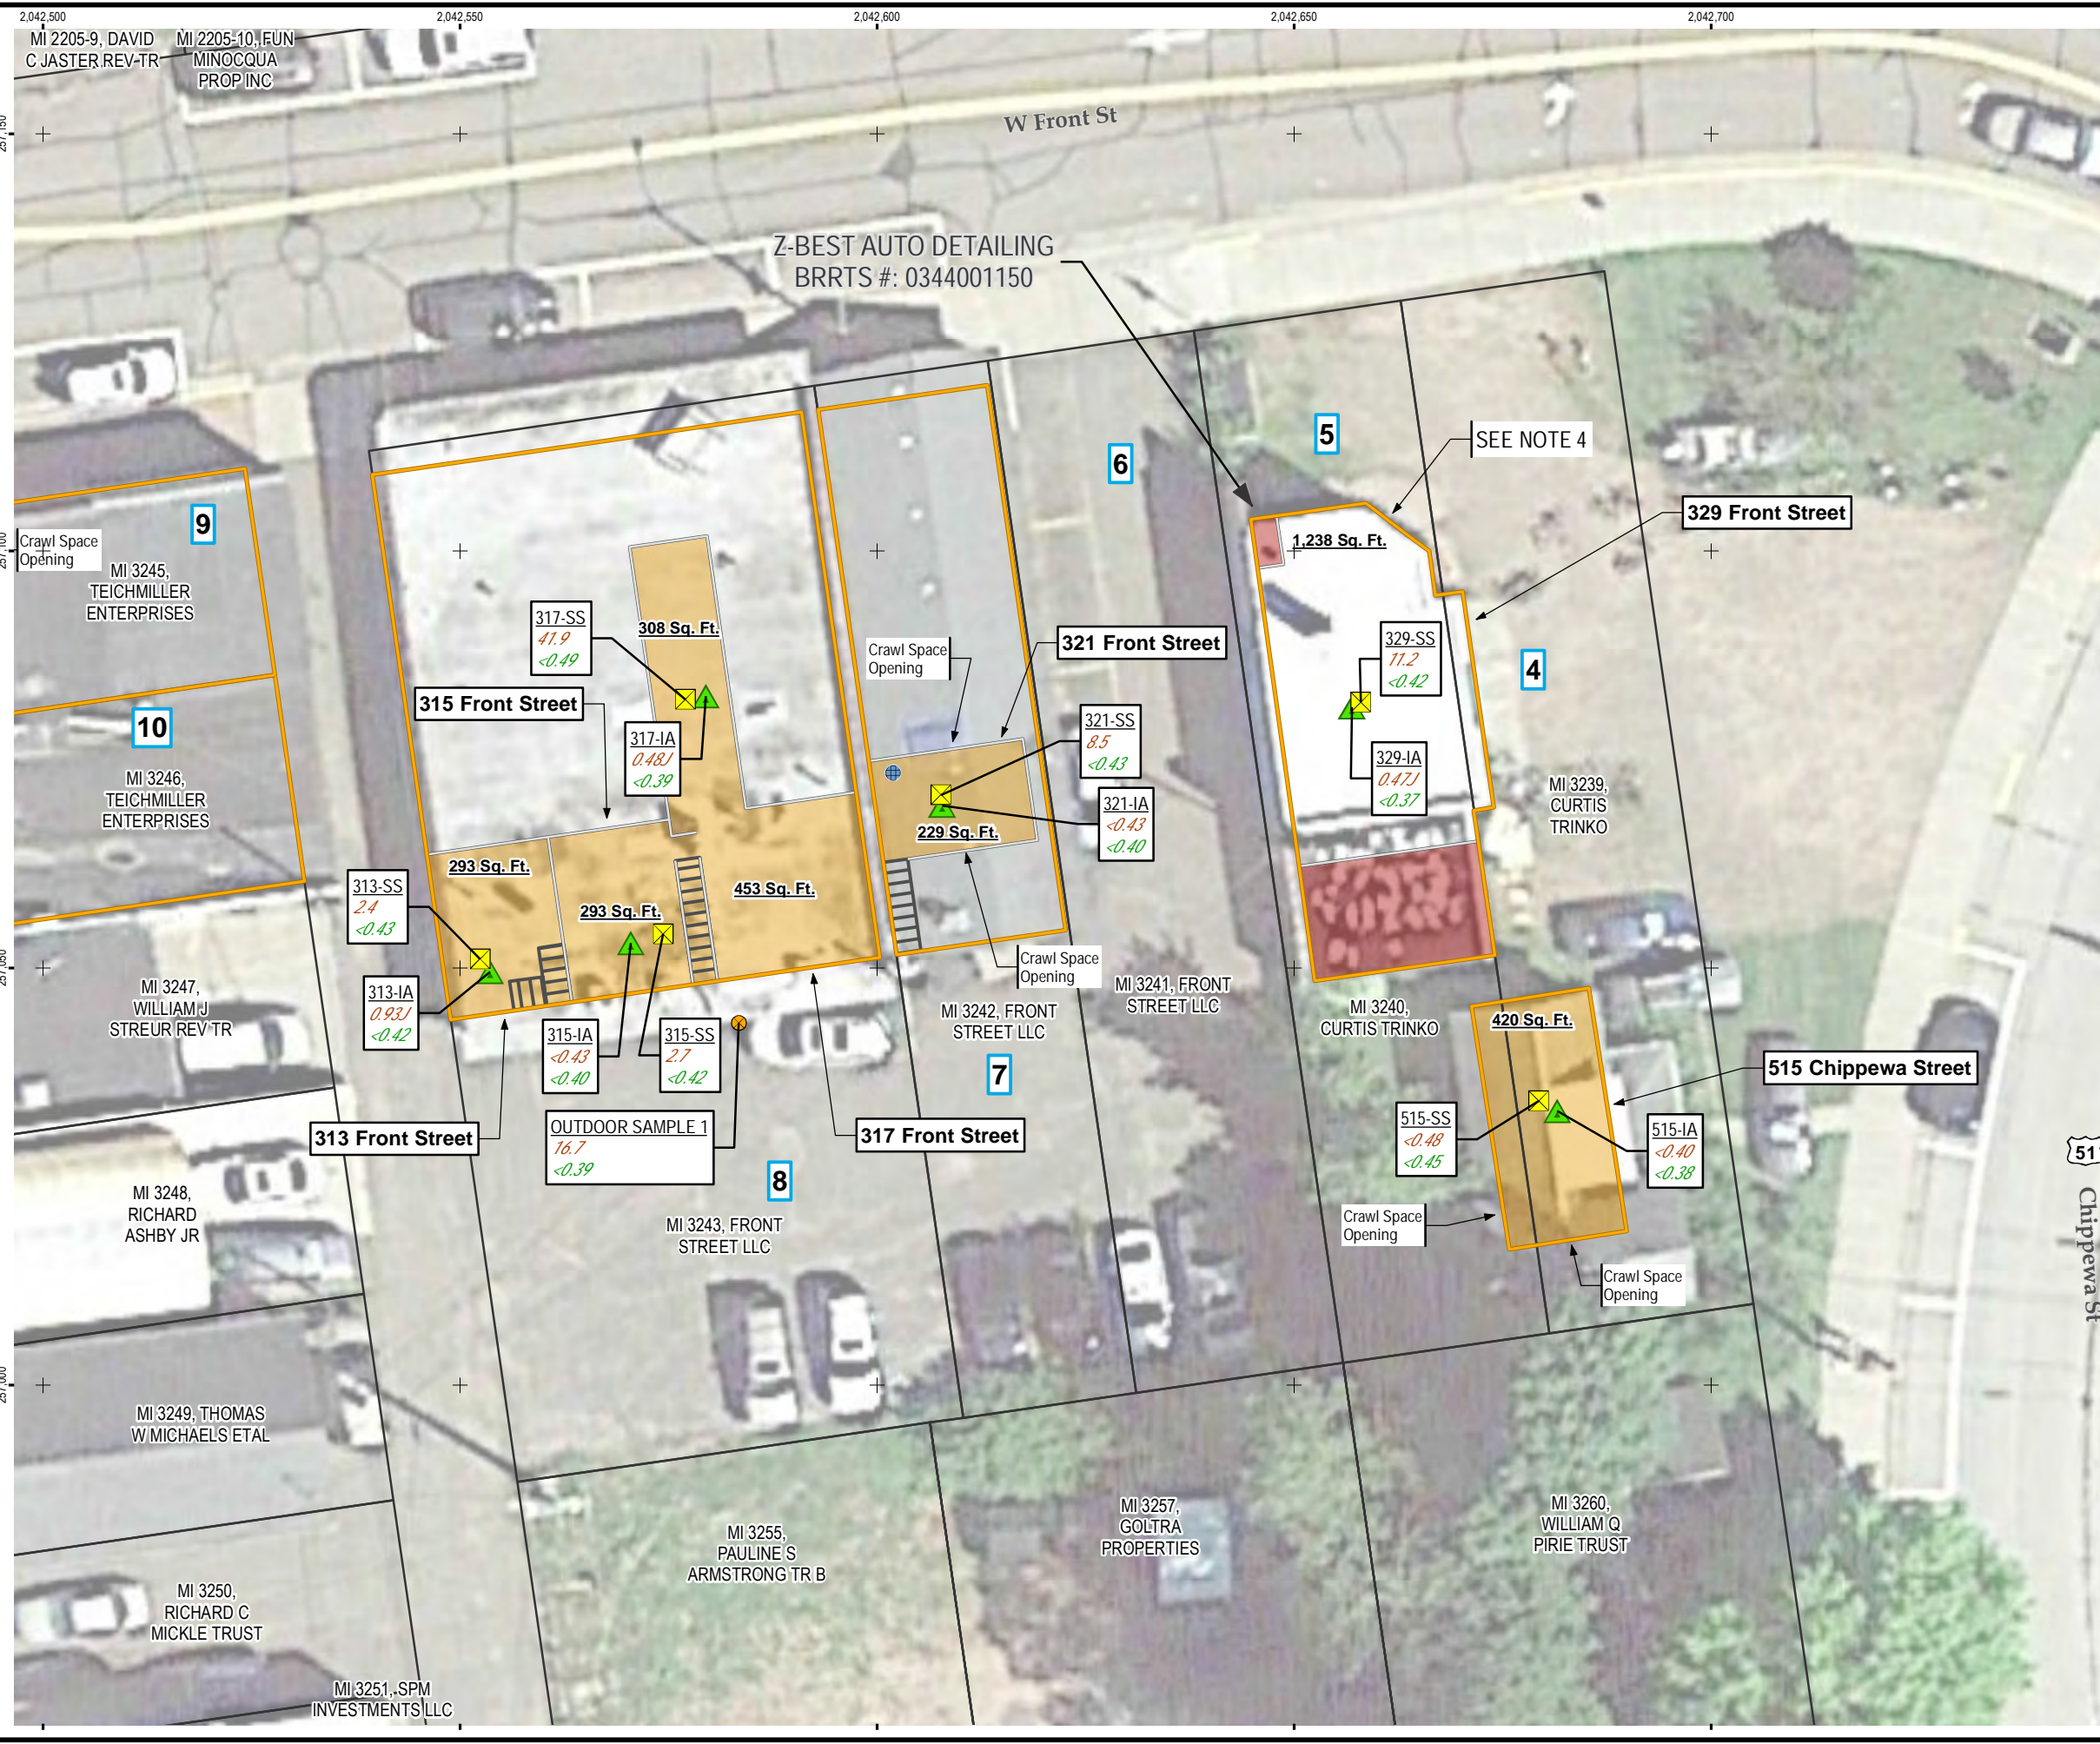
**FIGURE 4**

TITLE: **PROPERTY LAYOUT/RESULTS -**  
**PROPERTY IDs 4 THROUGH 8**

Background ambient air (Outdoor) samples were collected near the properties being investigated to provide additional information about ambient air quality surrounding the properties. Two background air samples (Outdoor 1 and Outdoor 2) were collected over the three-day monitoring event. Outdoor 1 was collected between March 21 and 22 and Outdoor 2 between March 22 and 23. Each background air sample was collected using a 6-liter SUMMA® canister with a 24-hour regulator. The sample duration was shortened from the planned 24-hour period for select samples where canister vacuum had depreciated below 5 inches of mercury (in Hg). Each SUMMA® canister was submitted to PACE Analytical Laboratory for EPA Method Toxic Organic (TO) -15 analyses for a select list of CVOCs (PCE, TCE, cis-1,2 dichloroethene, trans-1,2 dichloroethene, and vinyl chloride). The location of the two background samples are shown on Figures 4 and 7.

shortened from the planned 24-hour period for select samples where canister vacuum had depreciated below 5 inches of mercury (in Hg). Each SUMMA<sup>®</sup> canister was submitted to PACE Analytical Laboratory for EPA Method TO -15 analyses for a select list of CVOCs (PCE, TCE, cis-1,2 dichloroethene, trans-1,2 dichloroethene, and vinyl chloride). The locations of the indoor air samples are shown on Figures 4 through 7.

Background sample Outdoor 1 was collected from the parking lot area along the south side of 317 Front Street. PCE was the only CVOc detected in the sample at a concentration of 16.7 µg/m<sup>3</sup>. The second background sample, Outdoor 2, was collected from the southeast

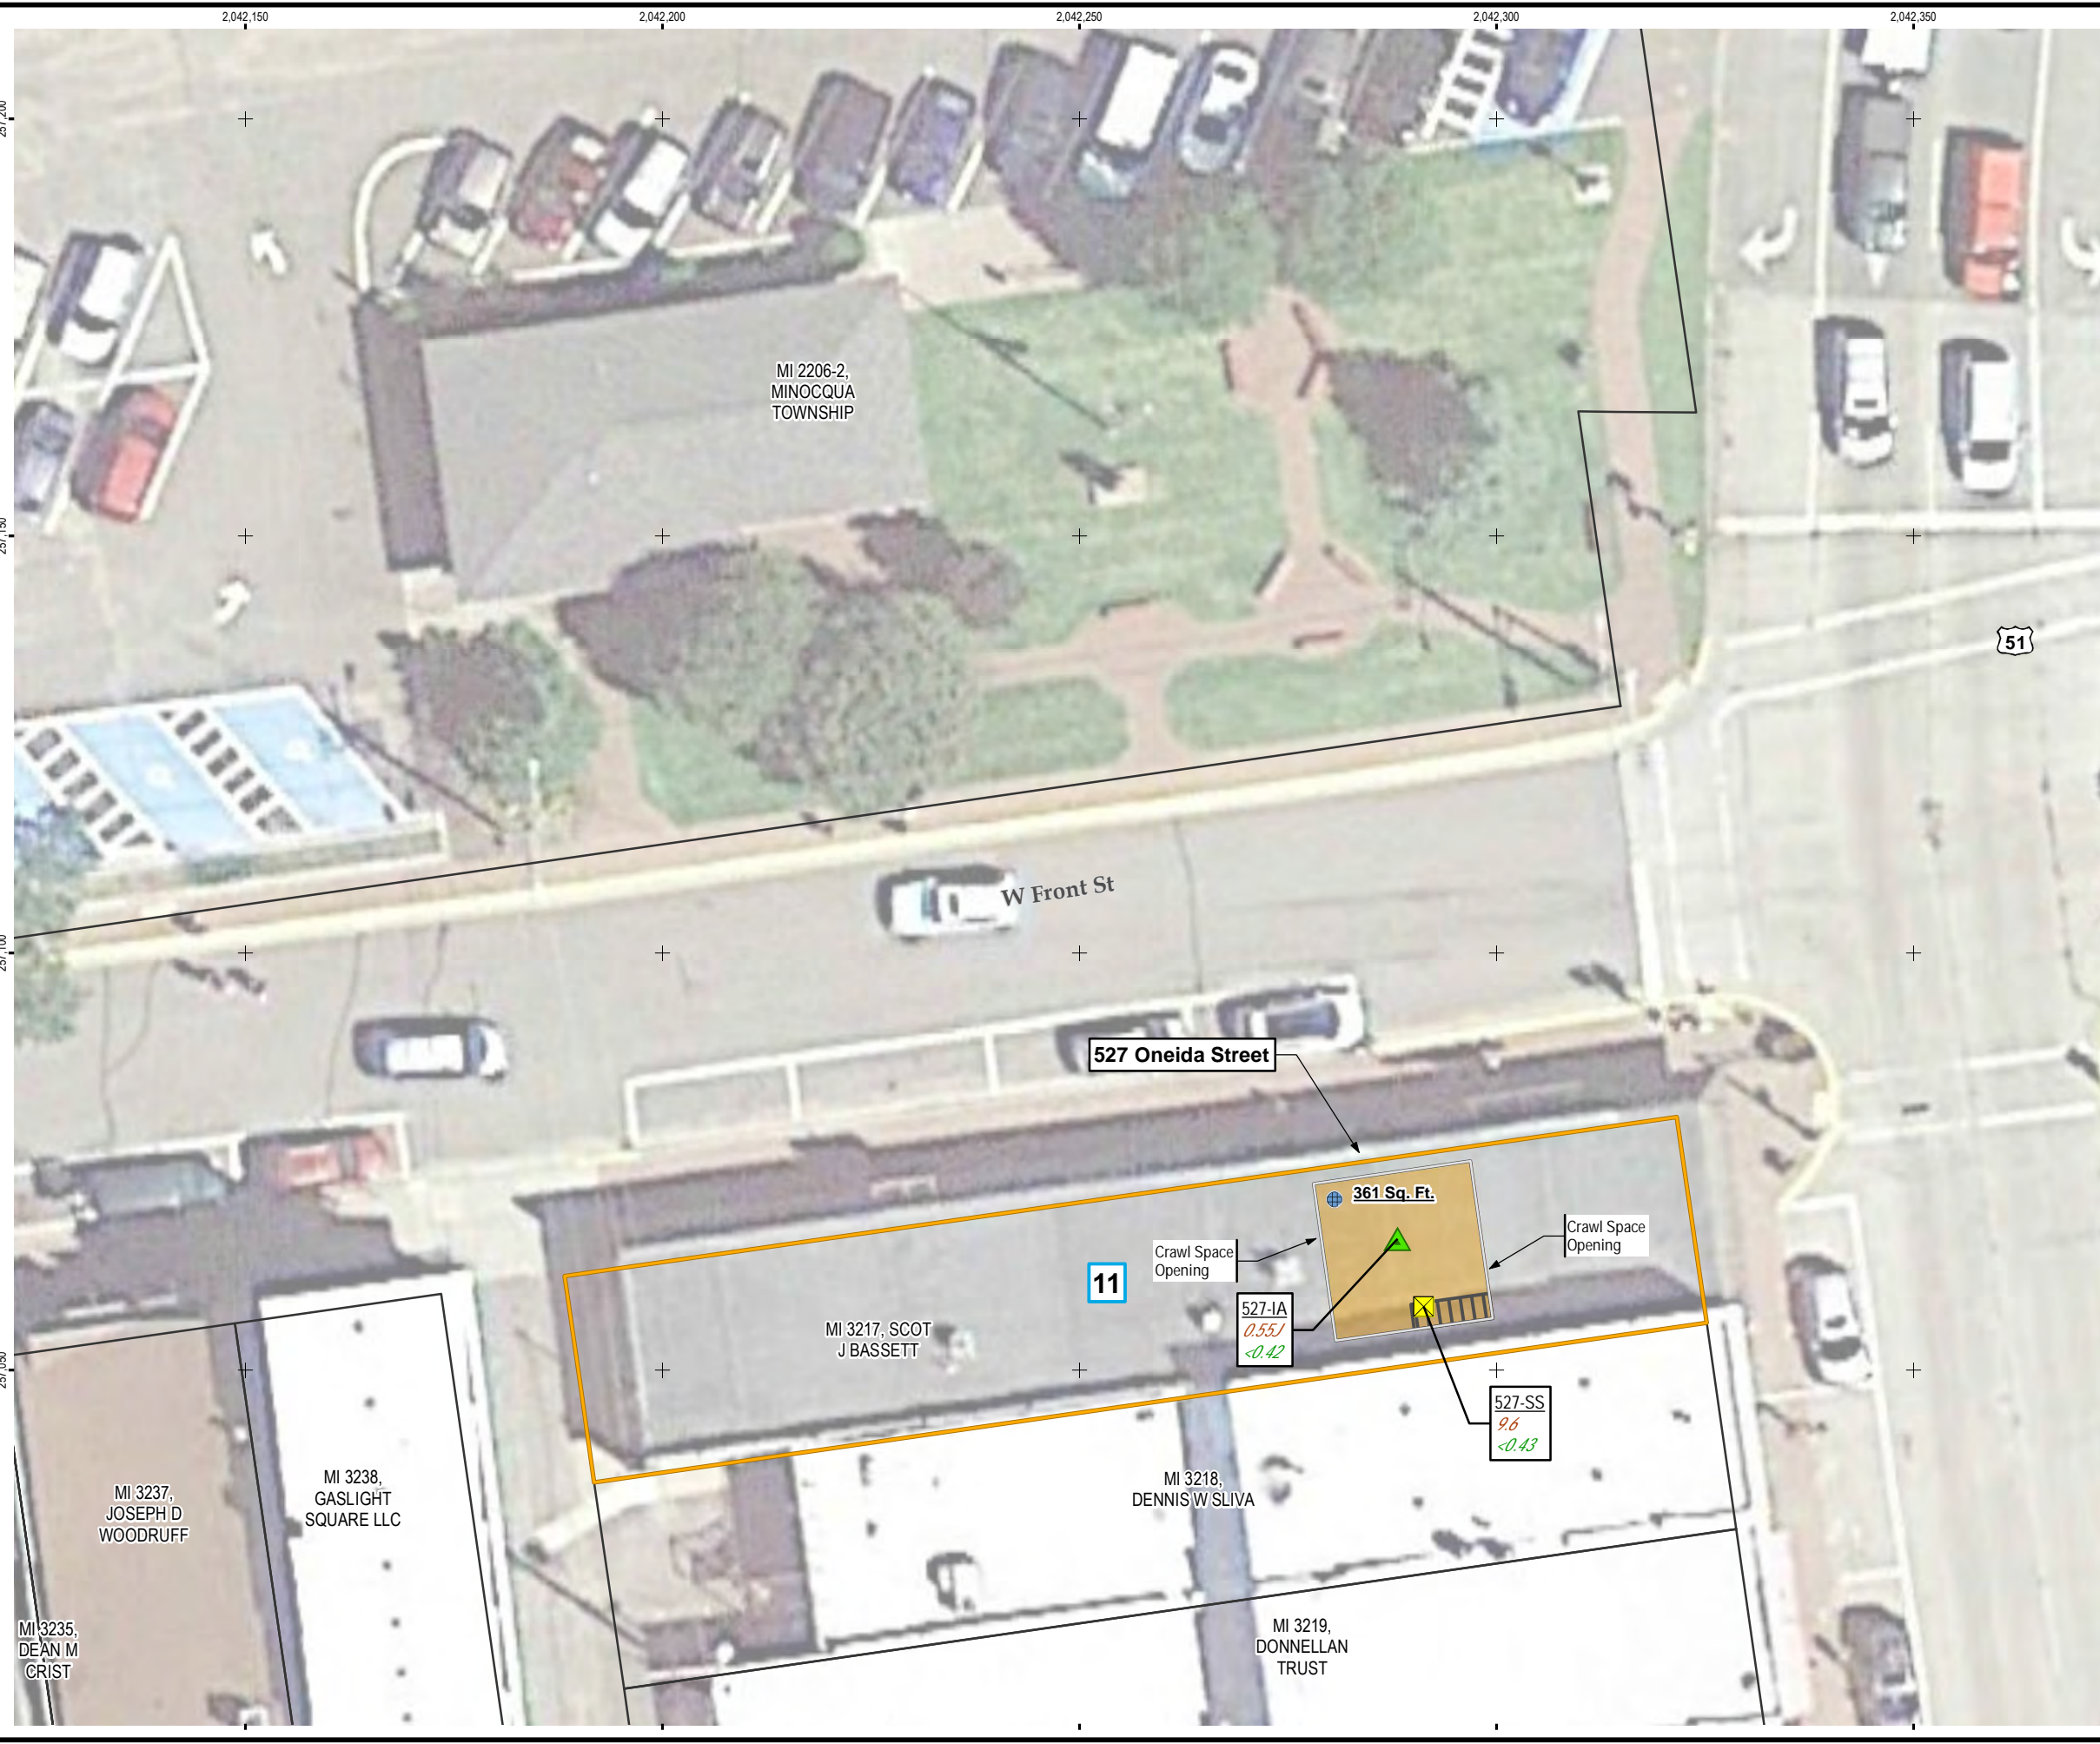
TITLE: **PROPERTY LAYOUT/RESULTS -  
 PROPERTY ID 11**

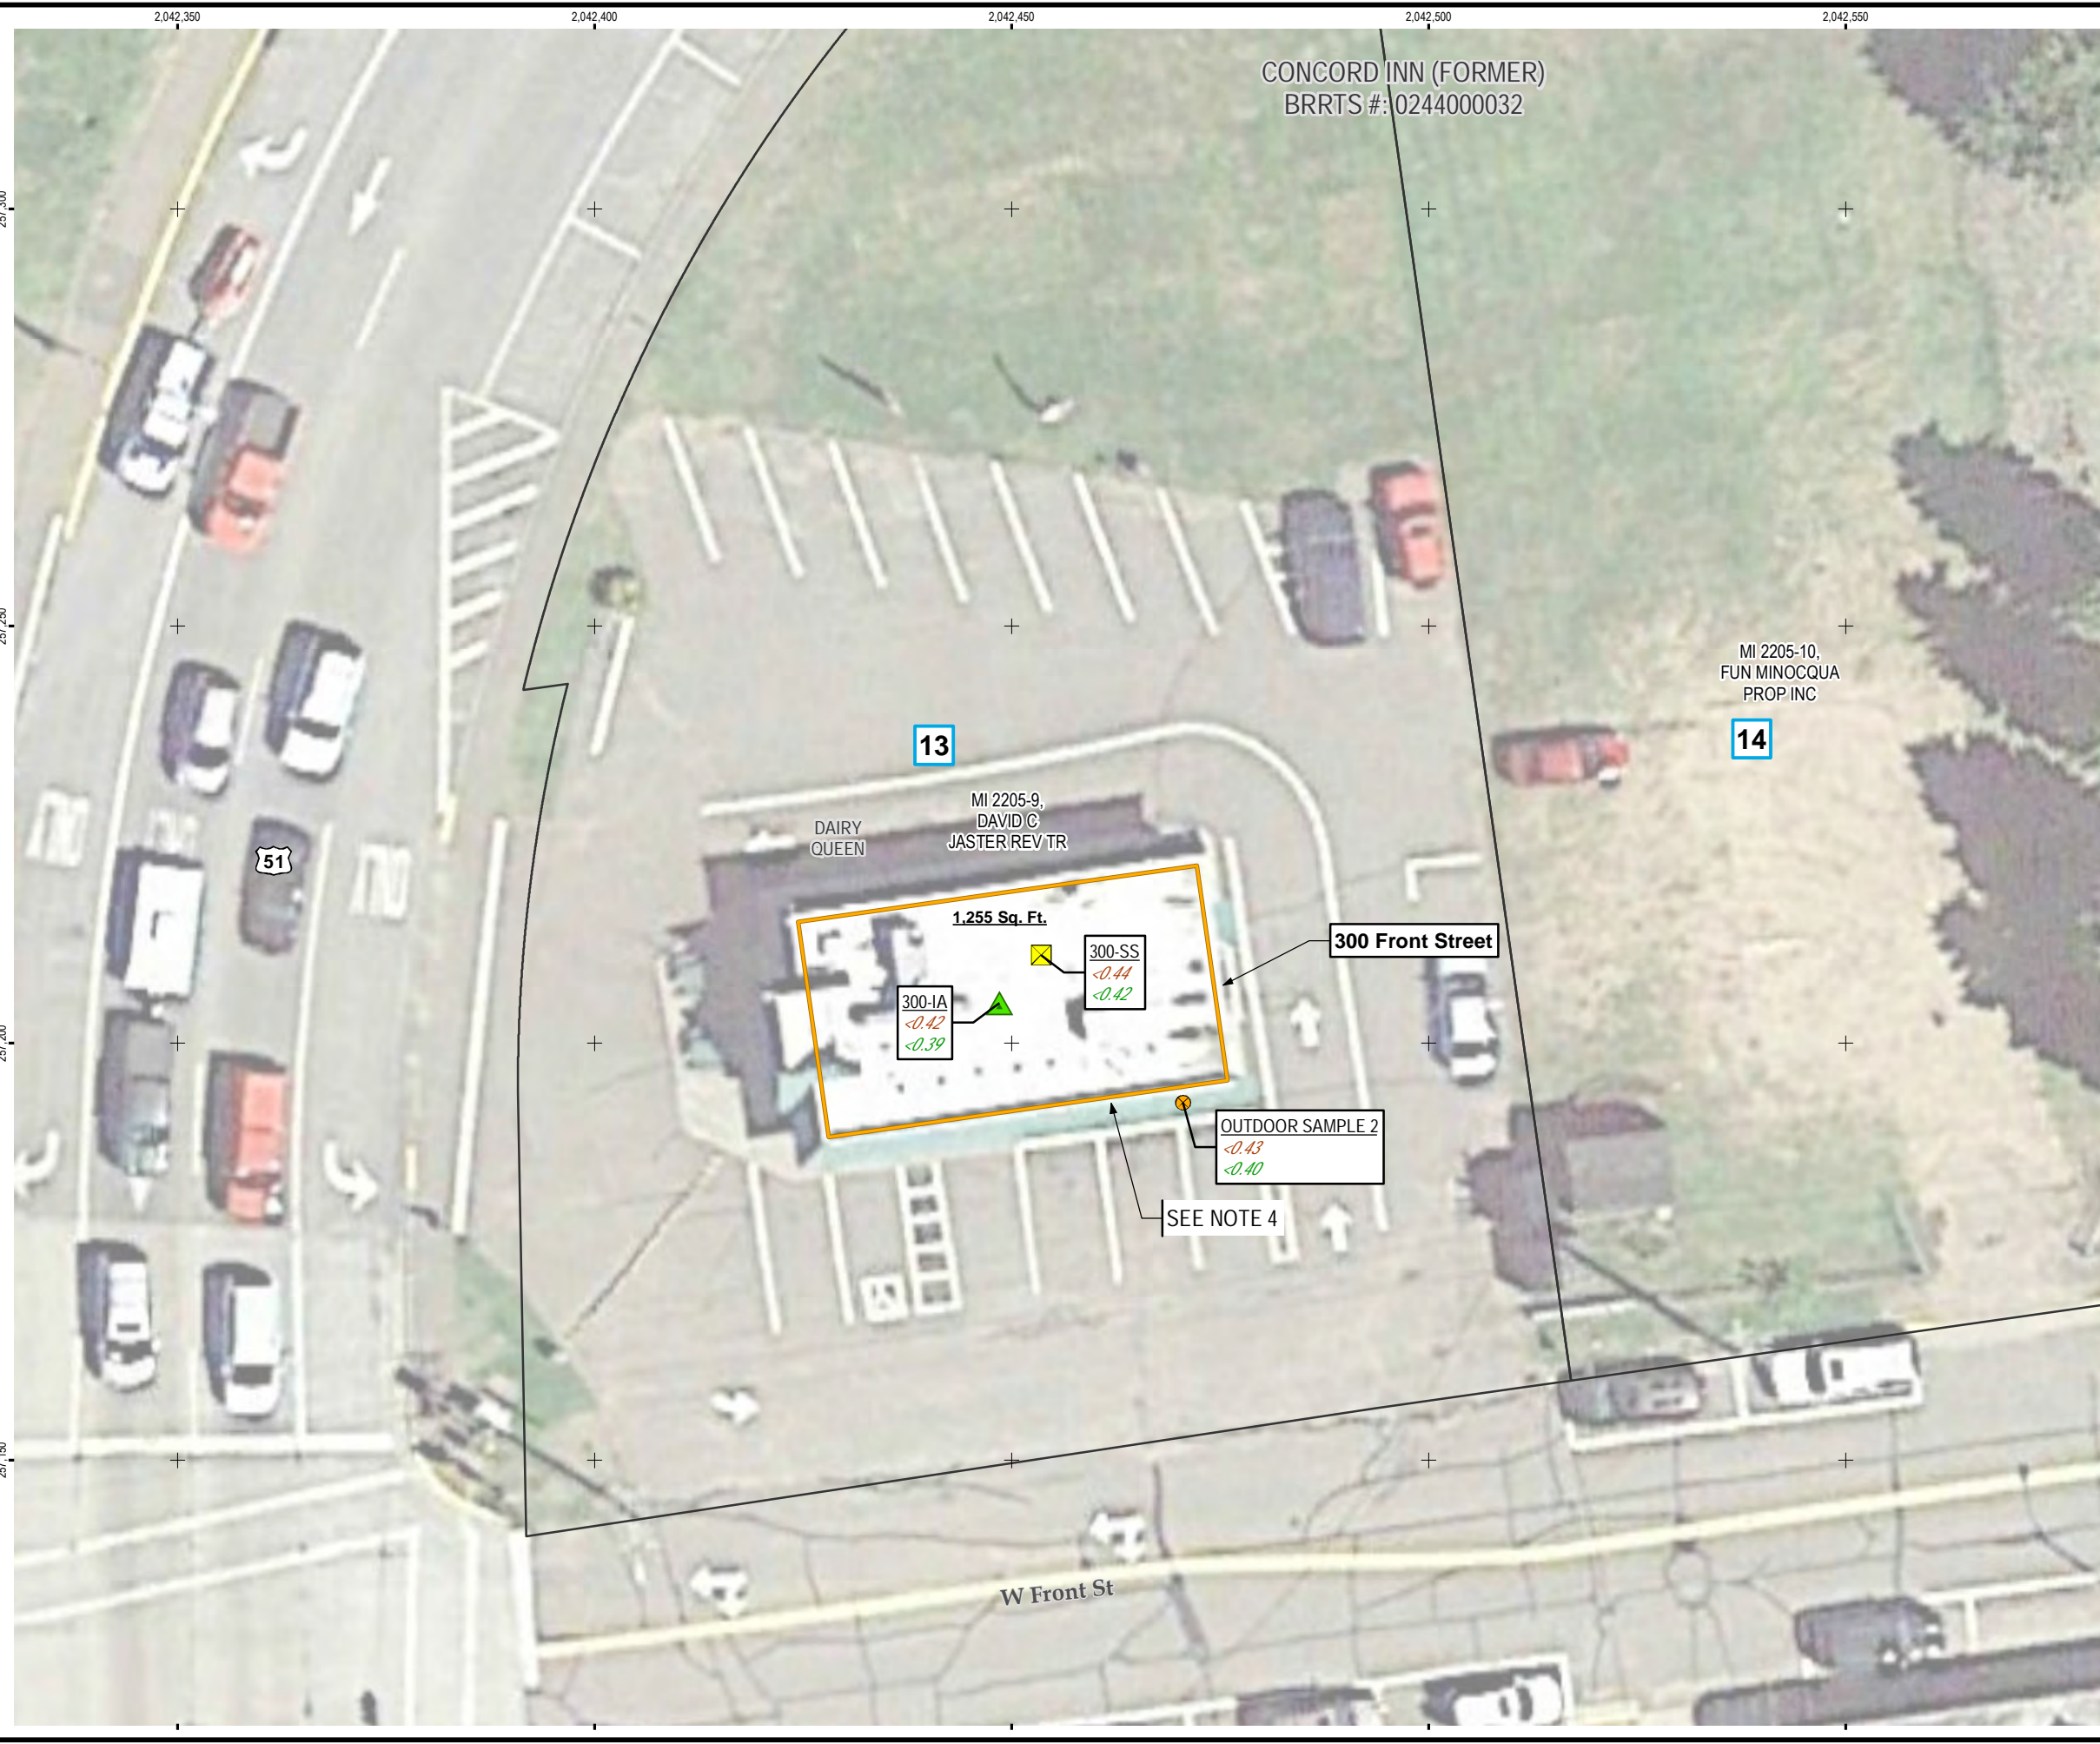
<b>PROJECT:</b> WISDOT ID# 0656-50-31 FORMER NORTHWOODS LAUNDRY MINOCQUA, ONEIDA COUNTY, WISCONSIN	
<b>TITLE:</b> PROPERTY LAYOUT/RESULTS - PROPERTY ID 13	
DRAWN BY: R. SUEMNICHT CHECKED BY: T. O'CONNELL APPROVED BY: D. HAAK DATE: MAY 2018	PROJ NO.: 298526  <b>FIGURE 7</b>
<div style="display: inline-block; vertical-align: middle; font-size: small;">           708 Heartland Trail, Suite 3000            Madison, WI 53717            Phone: 608.826.3600            www.trcsolutions.com         </div>	
FILE NO.: 298526-016mb.mxd

corner of the building located at 300 Front Street. There were no detections of CVOCs in the background Outdoor 2 sample.
