Subject: Vapor Monitoring Results – Second Sampling Event
527 Oneida Street, Minocqua, WI 54548
WisDOT ID #0656-50-31
WDNR BRRTS #02-44-000517

Attachments: Figure 1 – Air Sampling Locations
Table 1 – Air Sampling Results Table
Attachment 1 – Laboratory Report

PROJECT:		WISDOT ID# 0656-50-31 FORMER NORTHWOODS LAUNDRY MINOCQUA, ONEIDA COUNTY, WISCONSIN	
TITLE:		PROPERTY LAYOUT WITH SAMPLE LOCATIONS	
DRAWN BY:	R. SUEMNICHT	PROJ NO.:	298526
CHECKED BY:	A. SCHROEDER		
APPROVED BY:	T. O'CONNELL	FIGURE 1	
DATE:	APRIL 2018		
		708 Heartland Trail, Suite 300 Madison, WI 53717 Phone: 608.826.3500 www.trcwi.com	
FILE NO.:	298526-017-L5.mxd

Table 1
Vapor Sampling Results
Former Northwoods Laundry - Minocqua, Oneida County, WI
BRRTS #02-44-000517, WisDOT #0656-50-31

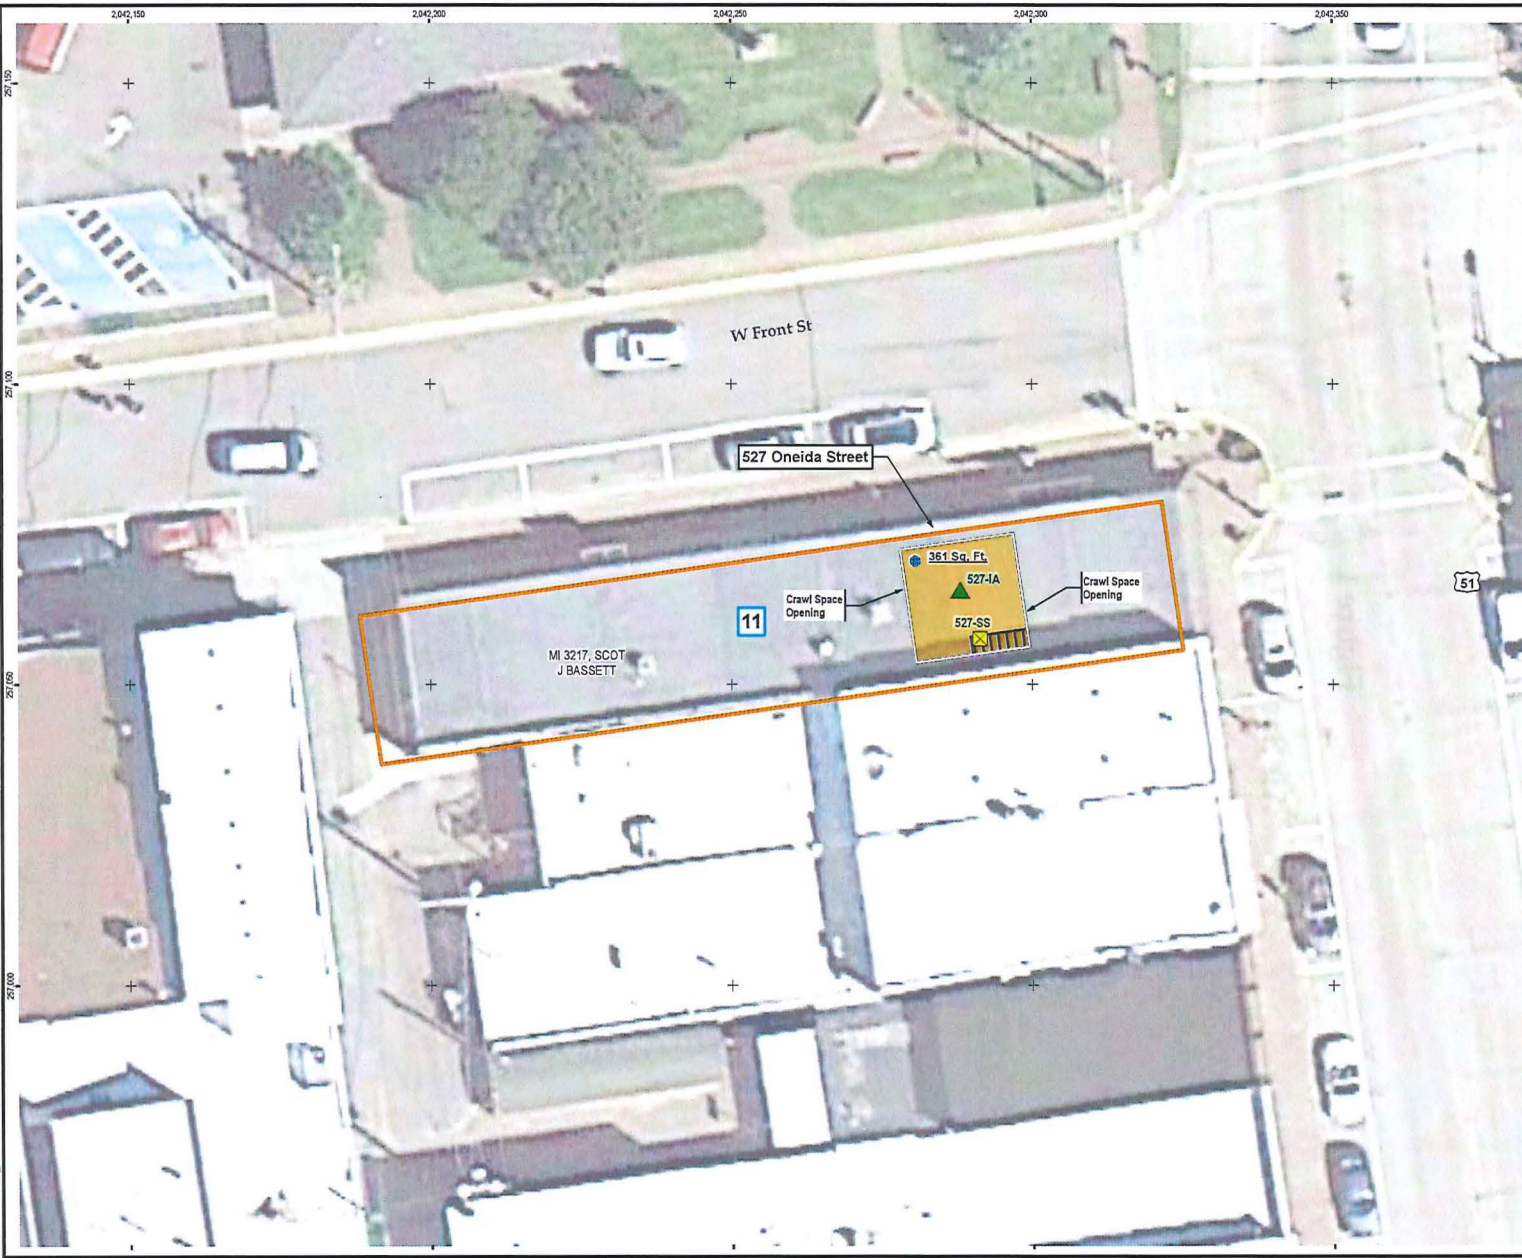
Figure 1
Air Sampling Locations

The attached Figure 1 indicates the location of each air sample collected at your property. The laboratory analytical reports are included in Attachment 1 for your records, and the analytical data are summarized and compared to WDNR screening levels in Table 1.

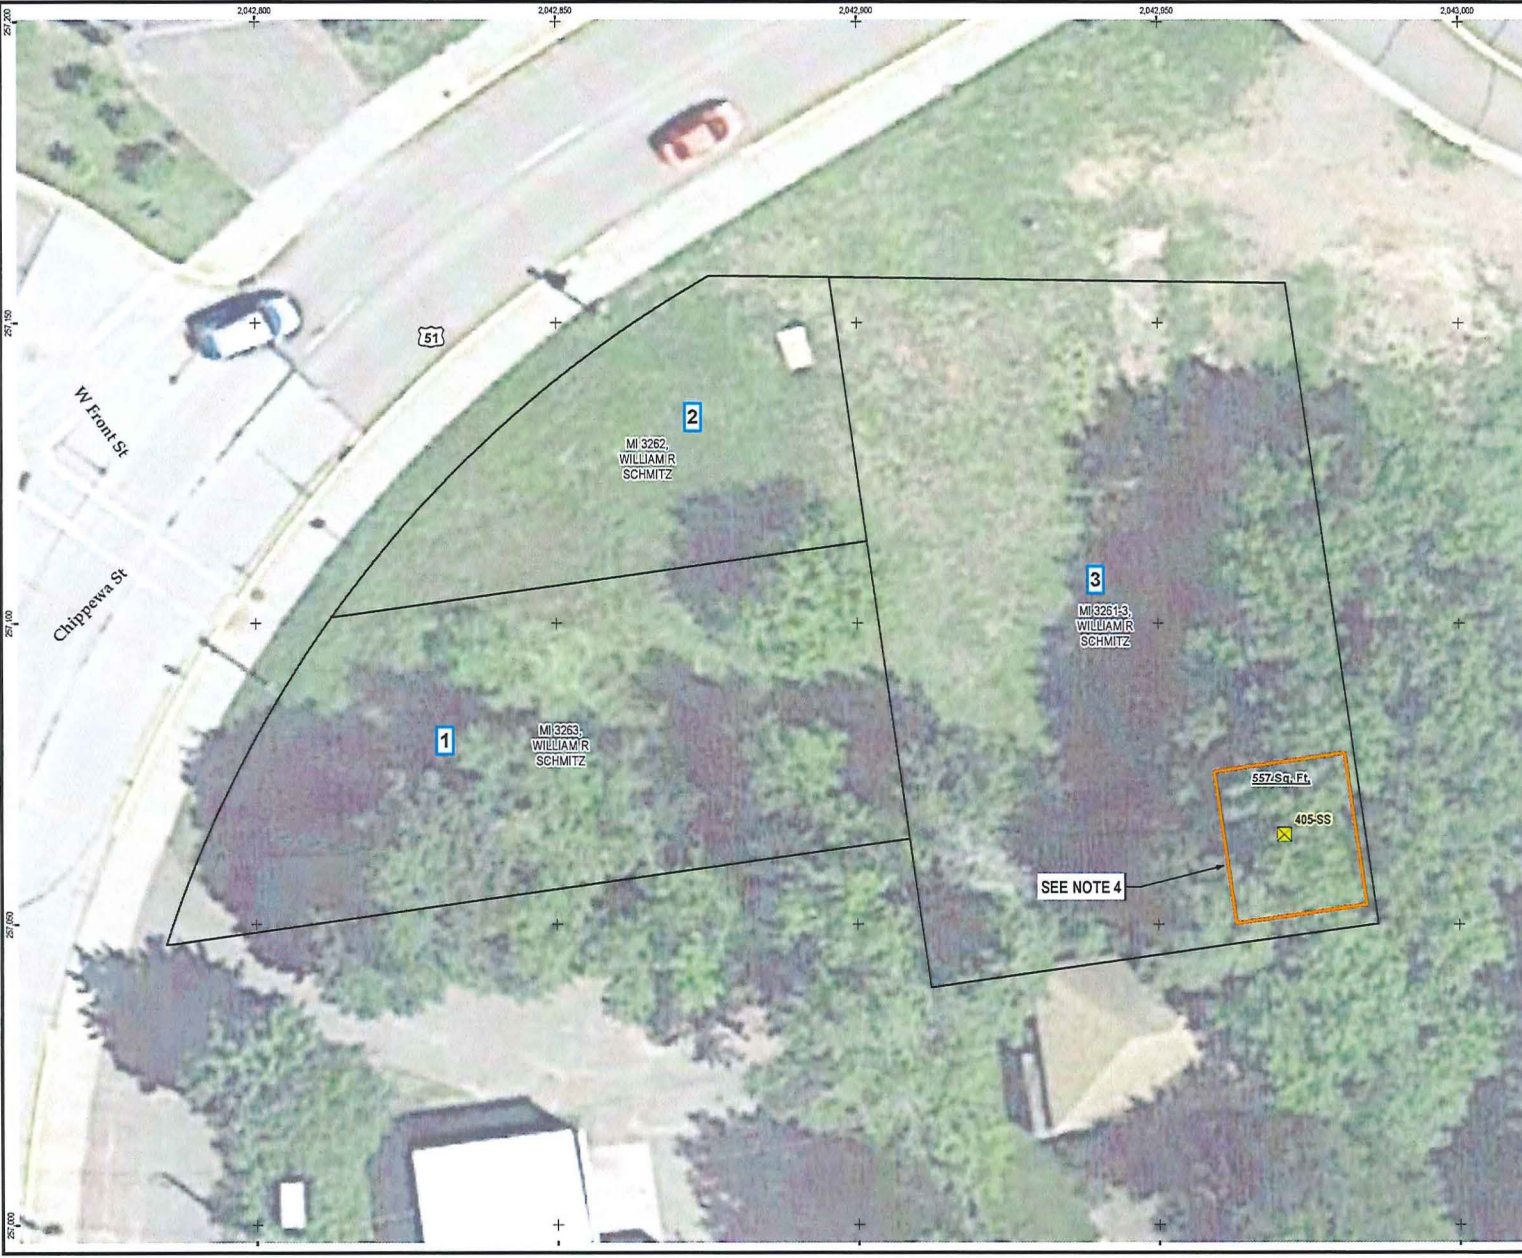
Figure 1
Air Sampling Locations

- NOTES**
1. BASEMAP IMAGERY FROM GOOGLE EARTH PRO & PARTNERS, JULY 2015.
 2. MAP PROJECTION AND GRID COORDINATES ARE NAD83 STATE PLANE WISCONSIN-NORTH (US SURVEY FEET).
 3. ALL MAP FEATURE LOCATIONS AND SIZES ARE APPROXIMATE.
 4. BUILDING CONTAINS A SLAB CONSTRUCTED ON GRADE, NO LOWER LEVEL PRESENT.
 5. NO INDOOR AIR SAMPLE WAS INSTALLED BASED ON THE BUILDING CONDITION.
