BRRTS ID No. 02-45-000563

Review Date: 07/19/2016

Site Name: American Toy & Furniture - LGU

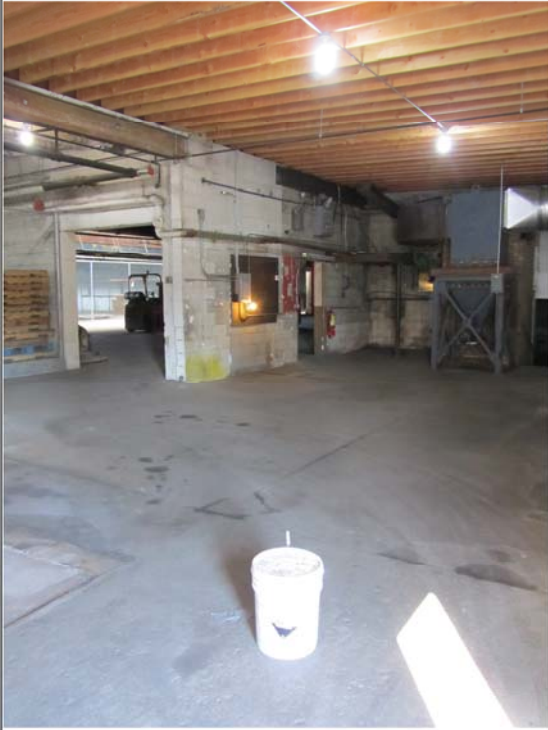
Title: Interior of maintenance building maintained over TW-3 (not yet abandoned), located immediately to left of 5-gal bucket.

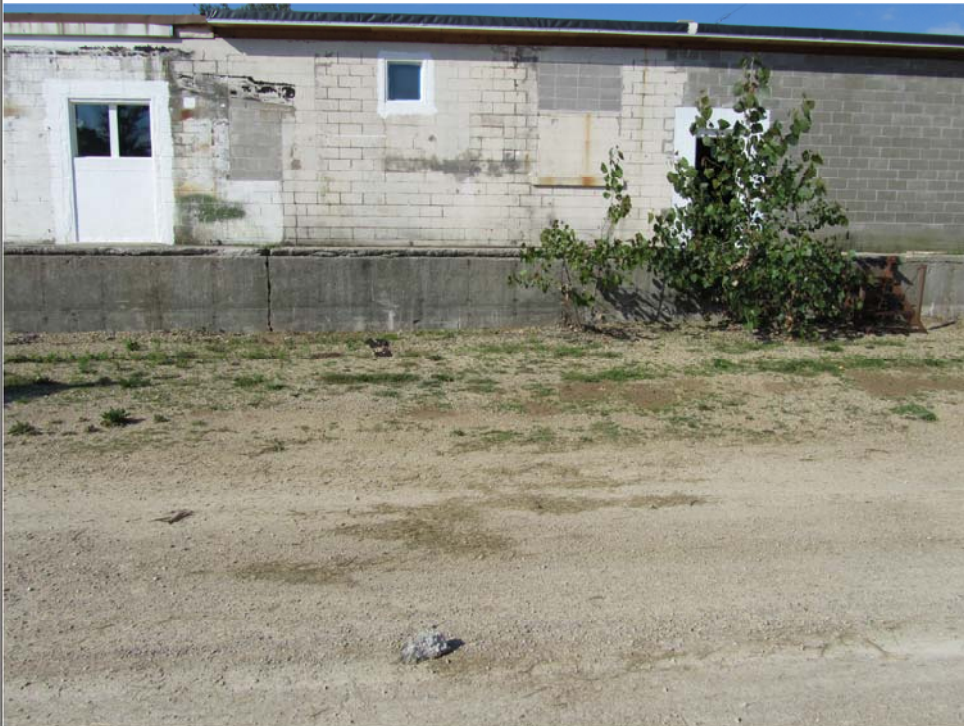
Title: Exterior of maintenance building maintained over TW-3 (not yet abandoned). Location of TW-2 (not yet abandoned) noted by rock in foreground. Railroad tracks behind photographer.
