Re: Dun-Rite Cleaners
1008 Union Street
Stevens Point, Wisconsin
WDNR BRRTS No. 02-50-000577

Subject: Groundwater, Soil, and Vapor Results

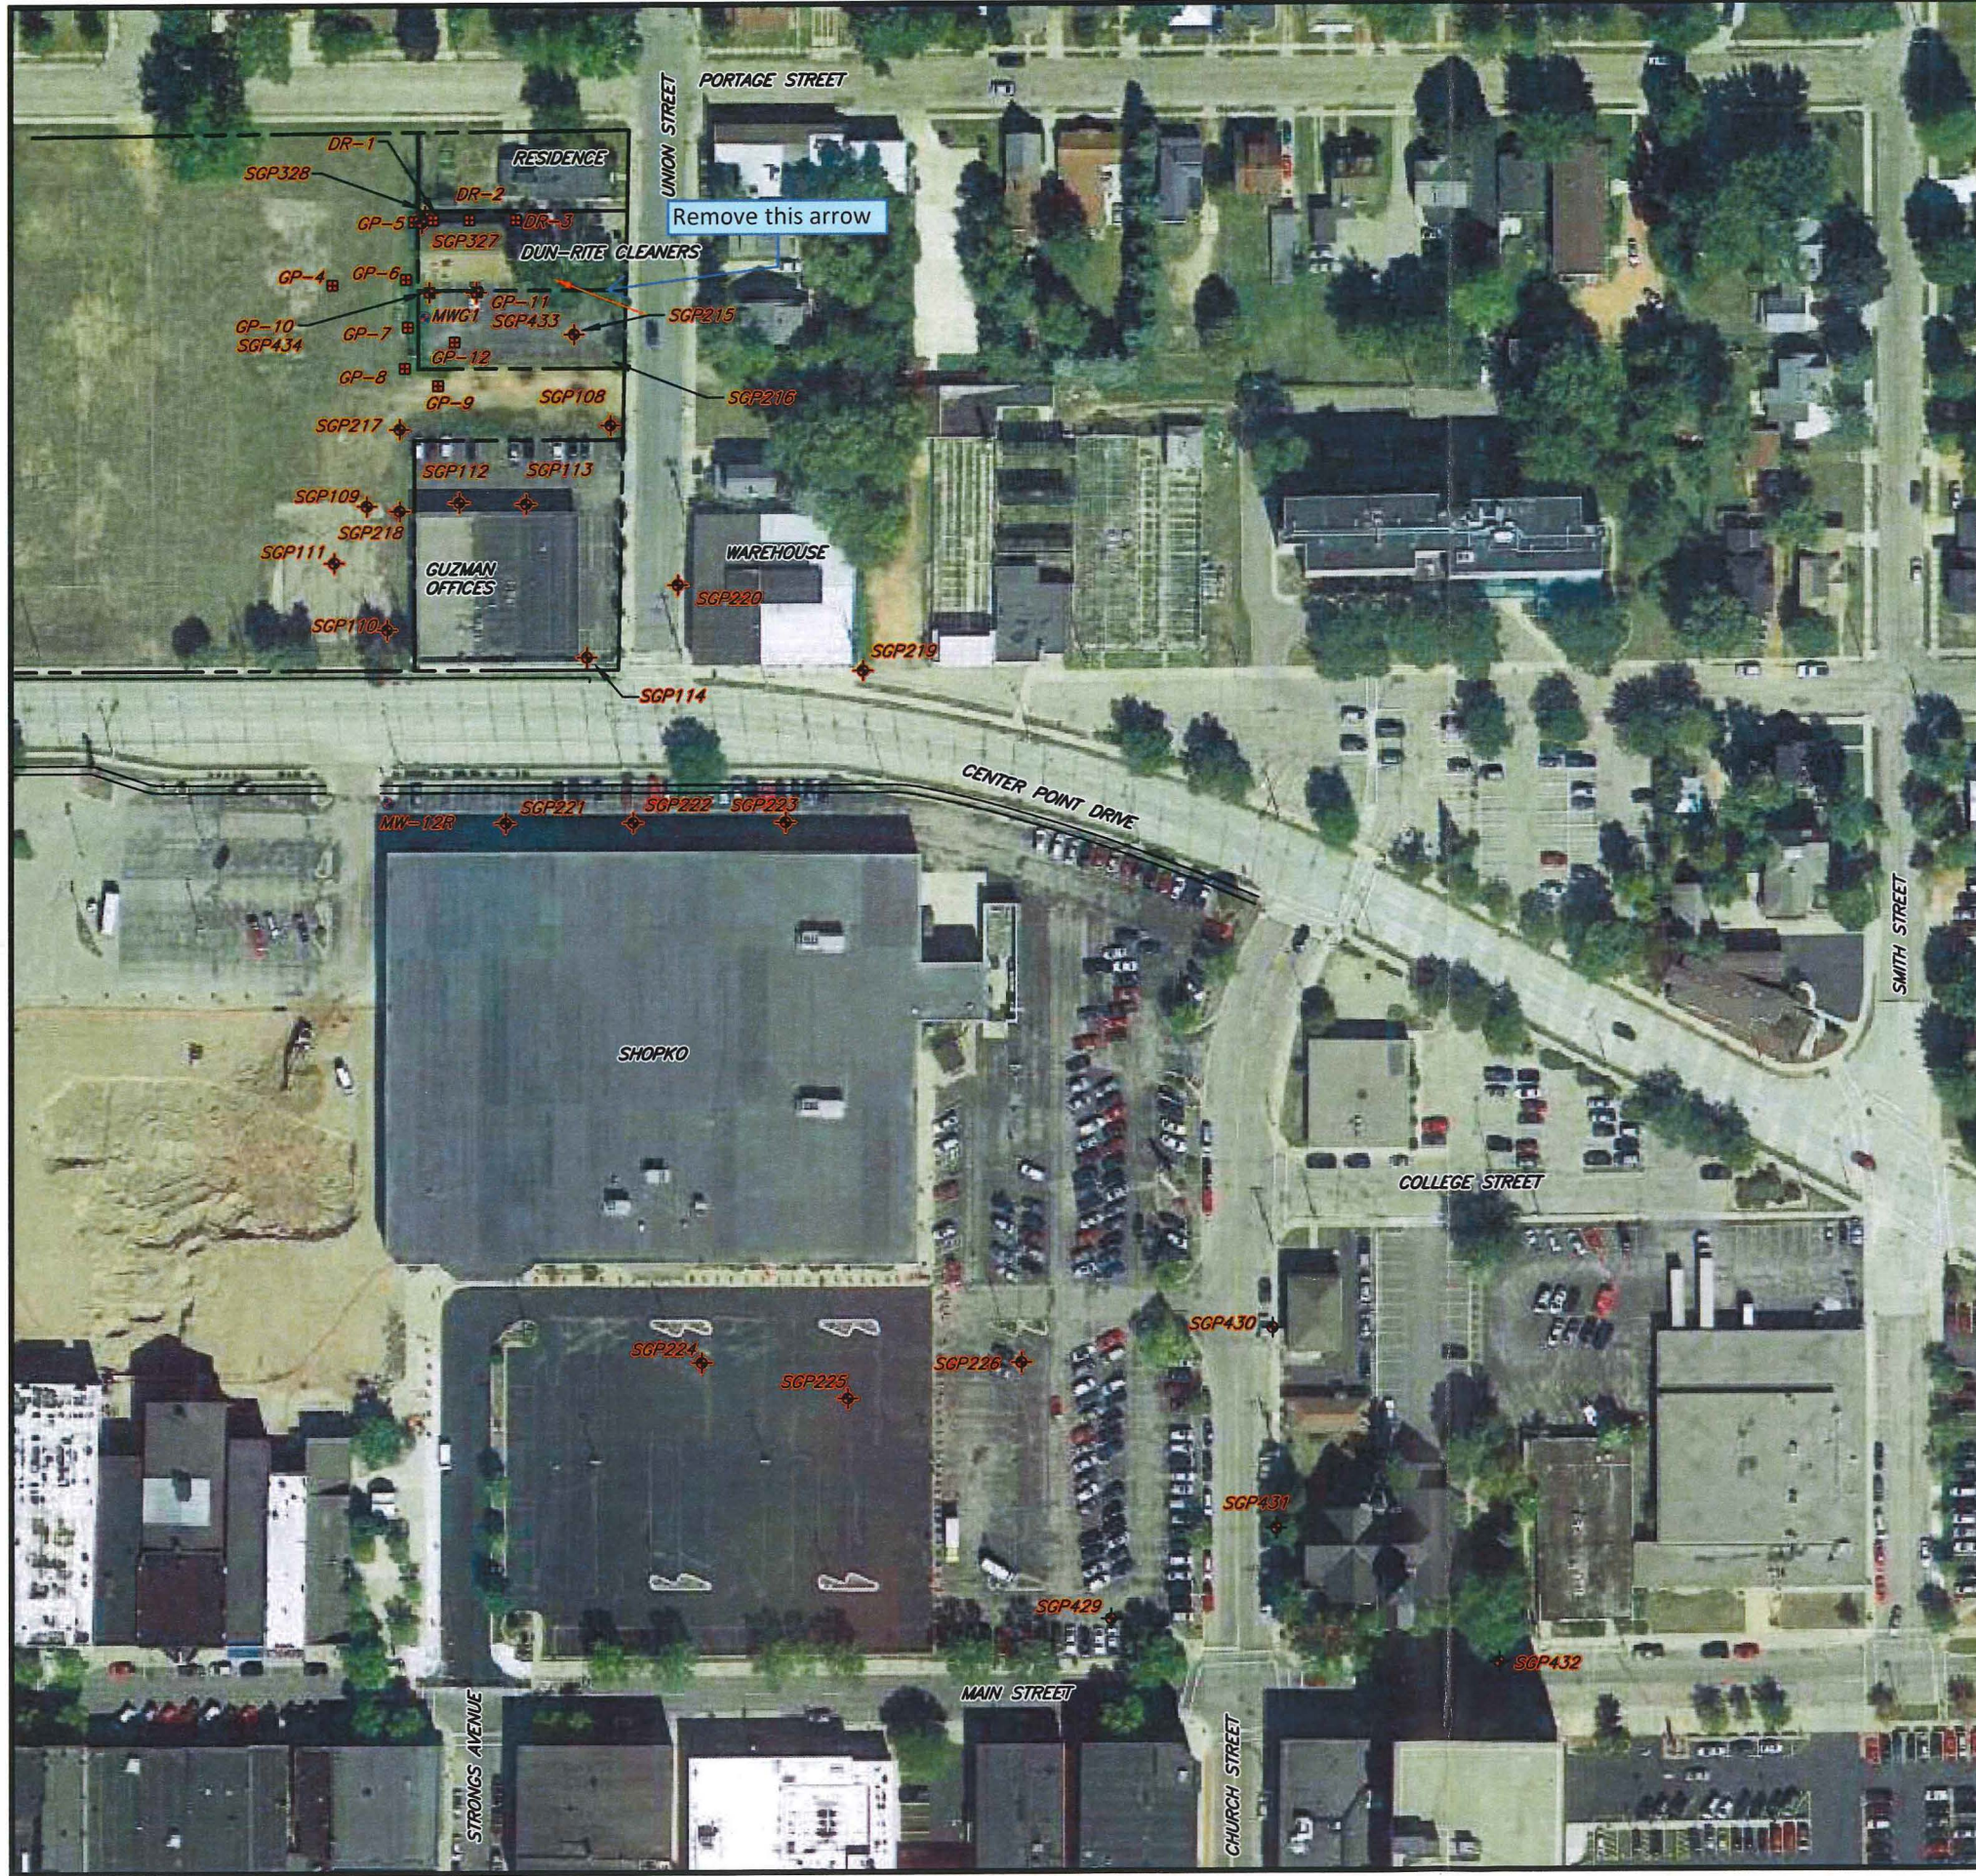
FIGURE 2

**SITE LAYOUT
AND SAMPLE
LOCATIONS**

03/30/2010	DR-2, DR-3 (AECOM)
10/02/2013	GP-4, GP-5 (AECOM)
12/13/2013	GP-6, GP-7, GP-10, GP-11 (AECOM)
09/19/2014	SGP108 THRU SGP114
09/23/2014	GP-8, GP-9, GP-12
03/03/2015	SGP216 THRU SGP226
04/07/2015	SGP327, SGP328
10/09/2015	SGP429 THRU SGP434
