Subject: Closure Status Report
Tecumseh Products Company – Grafton, Wisconsin
BRRTS # 02-46-0000751

Closure Status Report

Tecumseh
Grafton, Wisconsin

BRRTS #02-46-0000751

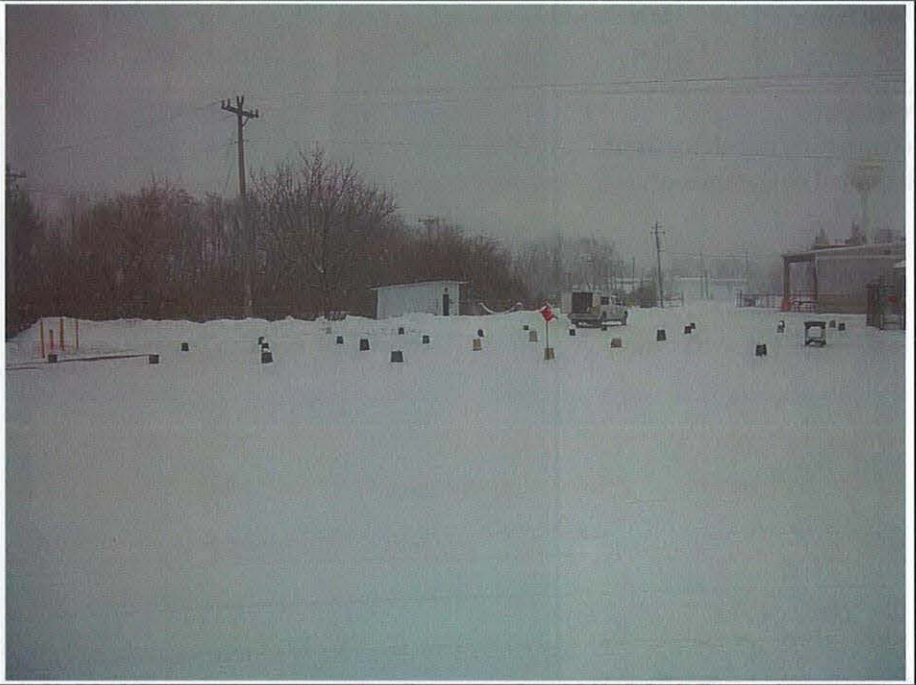
1	1/27/11		
Description			
Looking south at the injection field near MW-9.			
Photo No.	Date

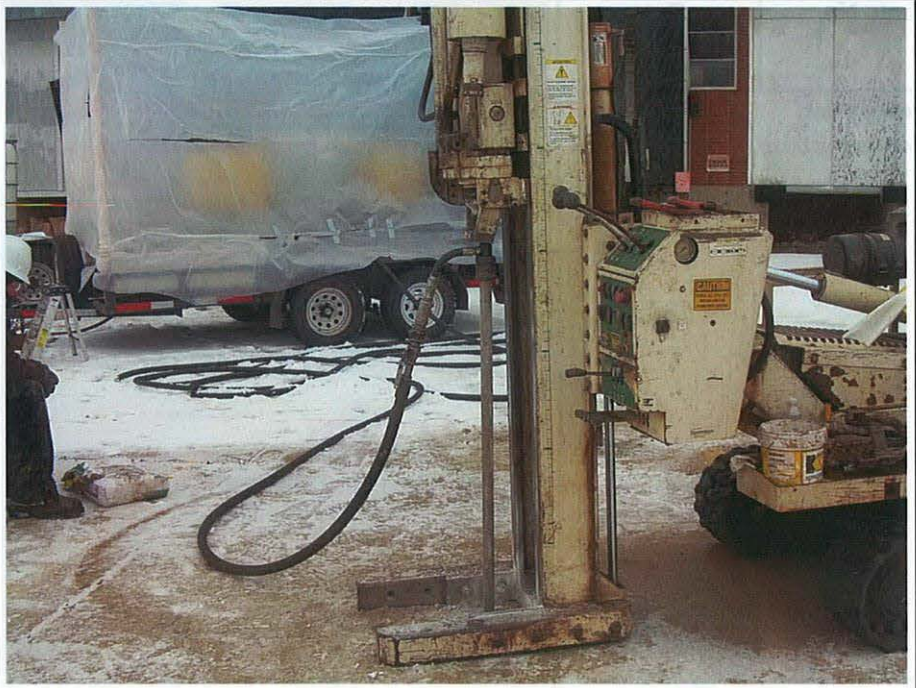
2	1/30/11		
Description			
Subsurface injection near MW-9.

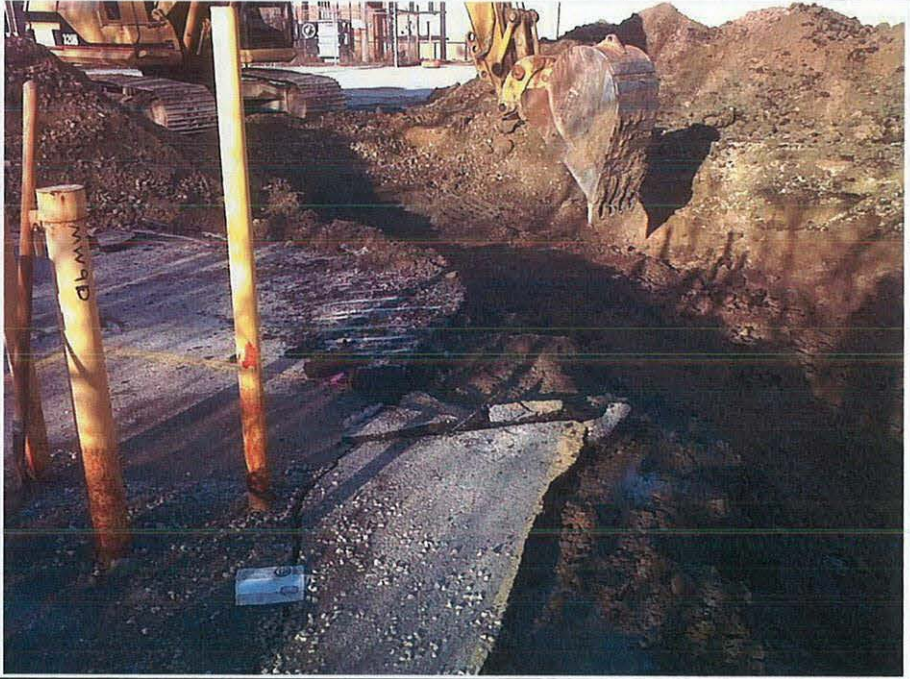
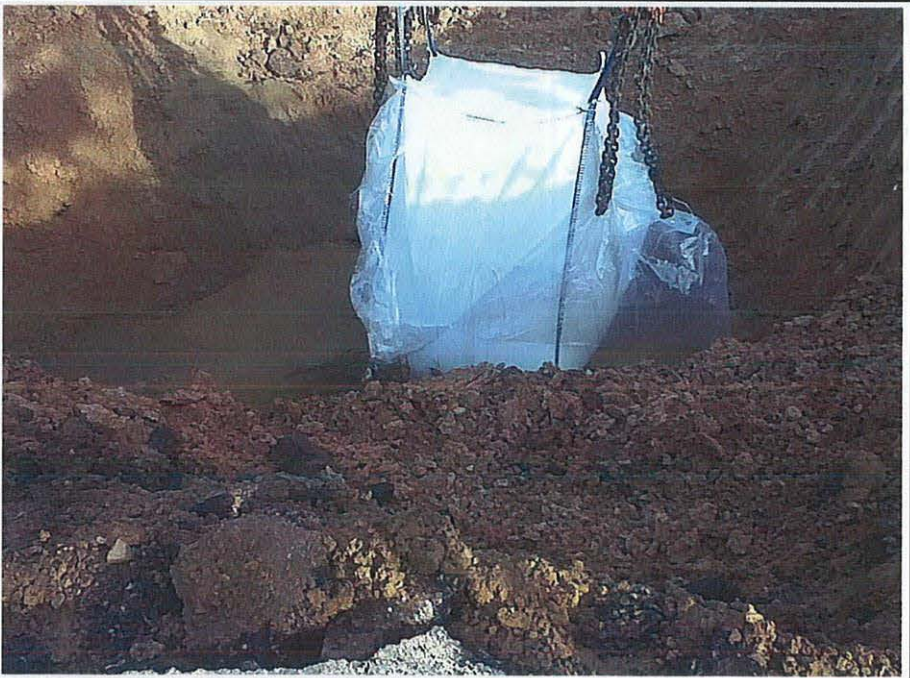
Constructing trench for in situ placement of Daramend®.			
Photo No.	Date

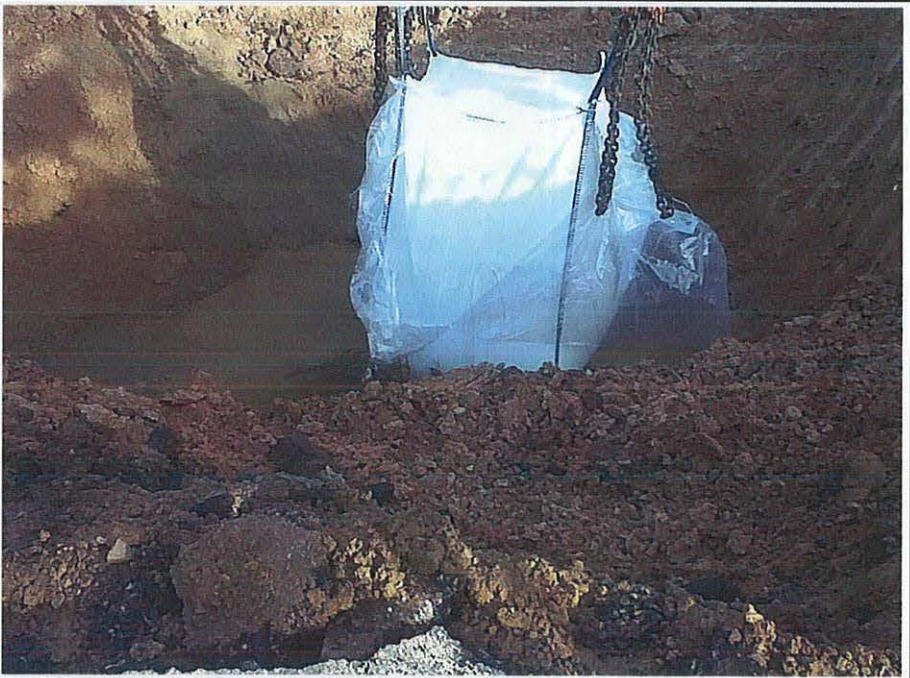
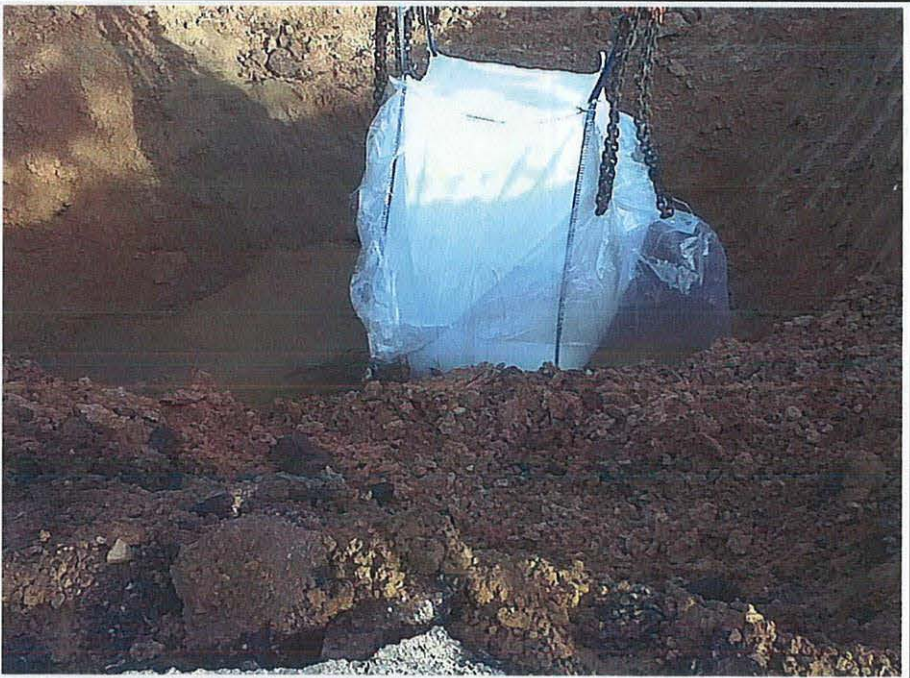
Blending in the Daramend® near MW-9.

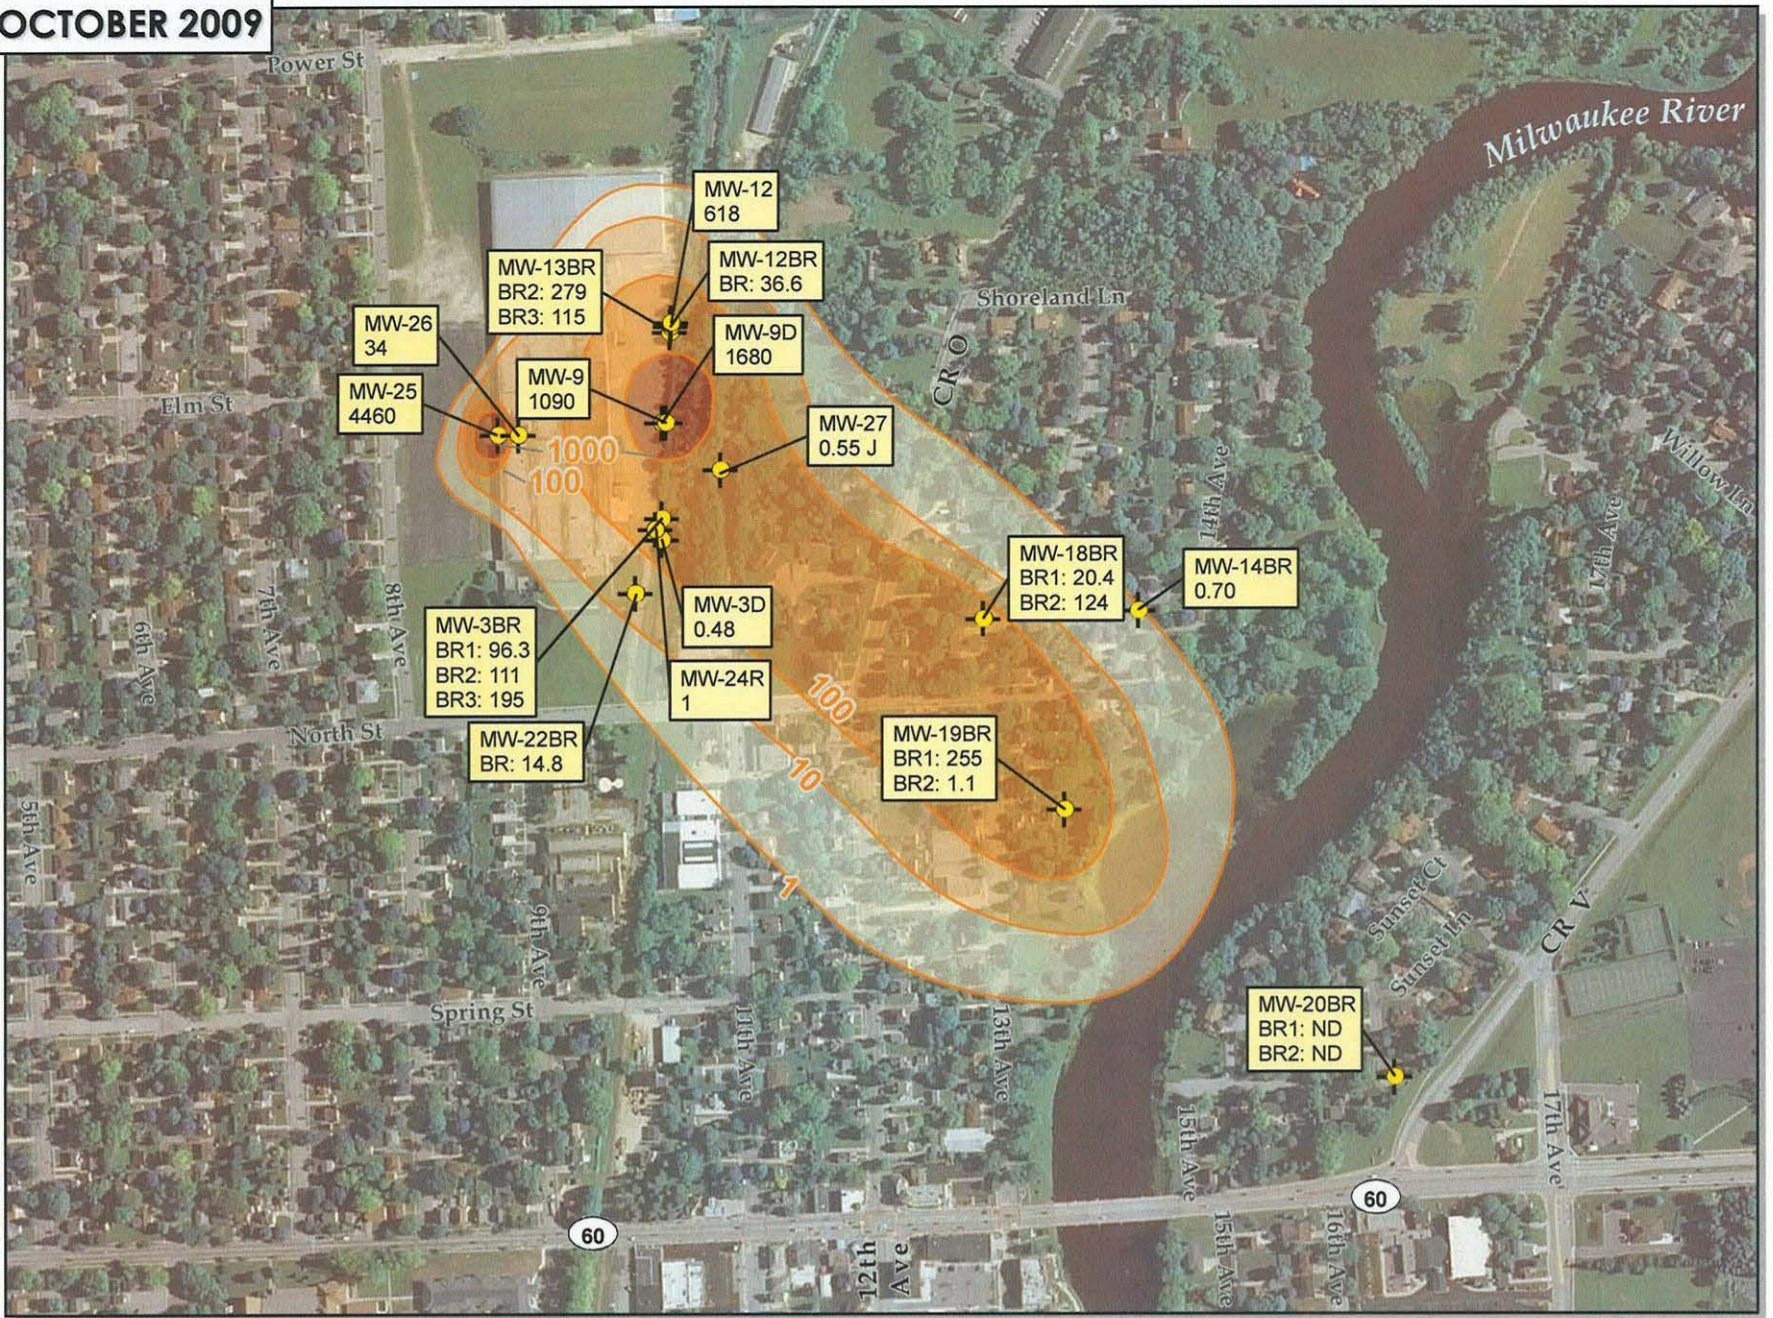
OCTOBER 2009

- WELL LOCATION WITH TCE RESULTS (ug/L)
- GROUNDWATER TCE CONCENTRATION CONTOUR (ug/L)
