TS-AMD-82005f
November 1982

AERIAL PHOTOGRAPHIC ANALYSIS OF
HAZARDOUS WASTE DISPOSAL AREAS

Wisconsin

*Freeman
Chemical*

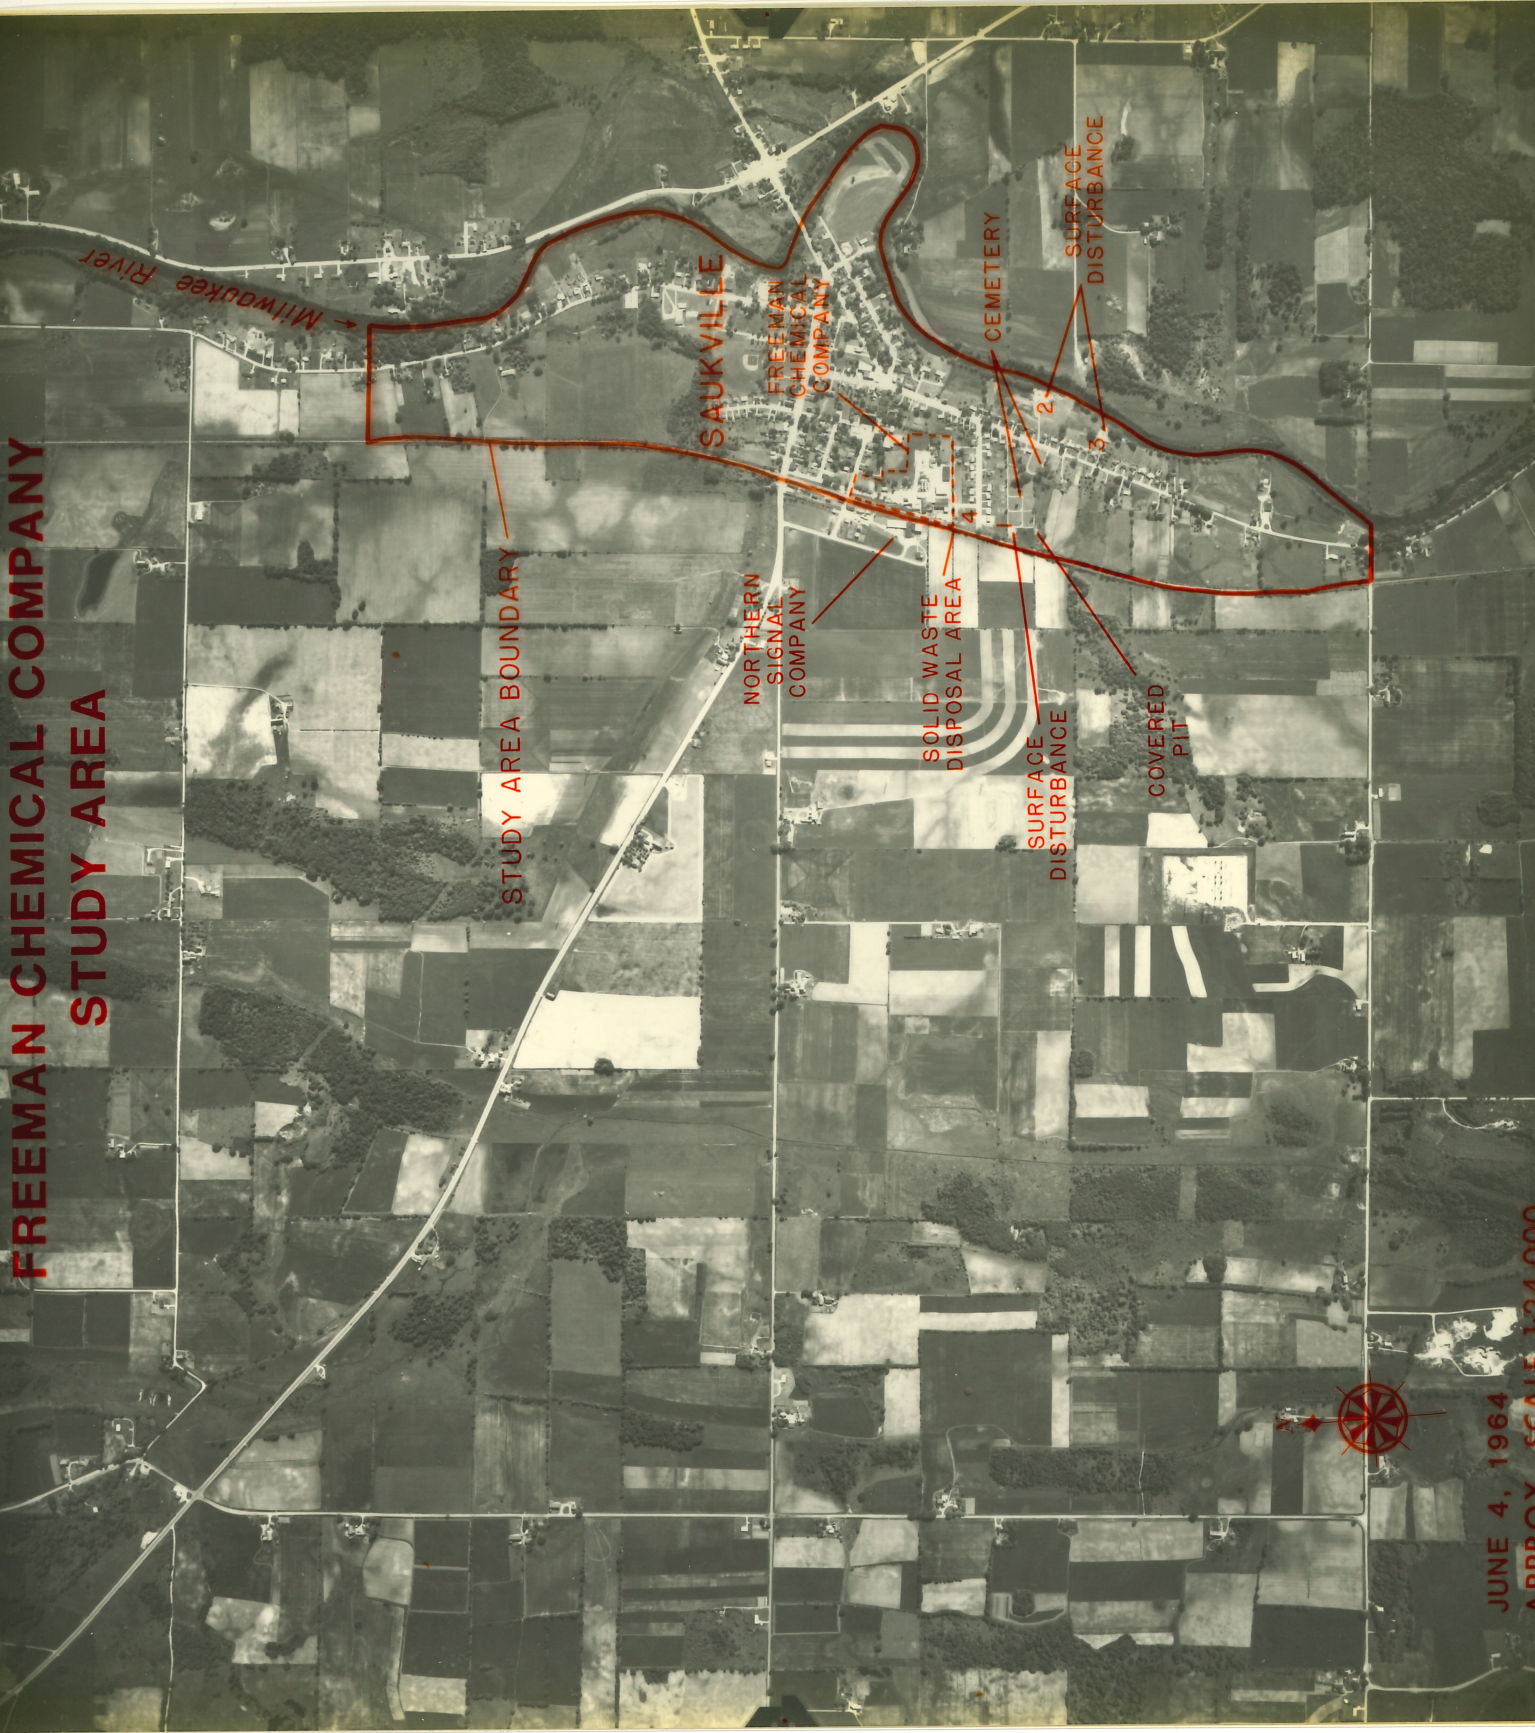
FREEMAN CHEMICAL COMPANY STUDY AREA

JUNE 4, 1964 FREEMAN CHEMICAL FACILITY PRESENT

By 1964, Freeman Chemical Company had expanded substantially over its size in 1950 to include a main processing area, tank farm, a storage building, and a parking area. Although the site is now fenced, the physical plant has not expanded to the property limit (Figure 9) it will occupy by 1981.

Four areas of non-specific surface disturbances and a gravel pit were noted in the 1964 photography. Disturbed Area 1 is located between the rail line and a small cemetery south of the Freeman facility. It is characterized by simple vegetation removal and soil exposure. No indication of excavation or burial was apparent in the photography. South of this area, a very small gravel pit has been developed into the hillside cemetery. A portion of the hillside has been excavated and the ground surface in the immediate area disturbed. Disturbed Areas 2 and 3 are both located on the west bank of the Milwaukee River, east of County Trunk Road O. Area 2 is slightly larger than 3 and appears to involve construction of some type. Area 3, more suspicious in terms of being a waste disposal site, appears to be a small landfill-like deposition of light-colored material. Disturbed Area 4 is located immediately adjacent to Freeman Chemical Company (southwest corner), and is characterized by dark ground coloration, possibly resulting from liquid waste disposal. Area 4, by virtue of its close proximity to the plant facility and its appearance in the aerial photography during a period when untreated reactor distillate rejects from the plant were allegedly disposed of to the ground, appears particularly likely to be a waste disposal site.

At the Northern Signal site, five small vertical storage tanks, two large vertical storage tanks, and nine small horizontal storage tanks were located north of the plant buildings. Although no indication of uncontrolled waste disposal was noted

in the photography, the presence of the bulk liquids storage tanks suggests that the Northern Signal facility was handling large quantities of potentially hazardous substances. The lack of adequate secondary containment around some of the tanks, coupled with the possibility of small releases and/or spills of the liquid, suggests a possible source of groundwater contamination that could be associated with this facility.

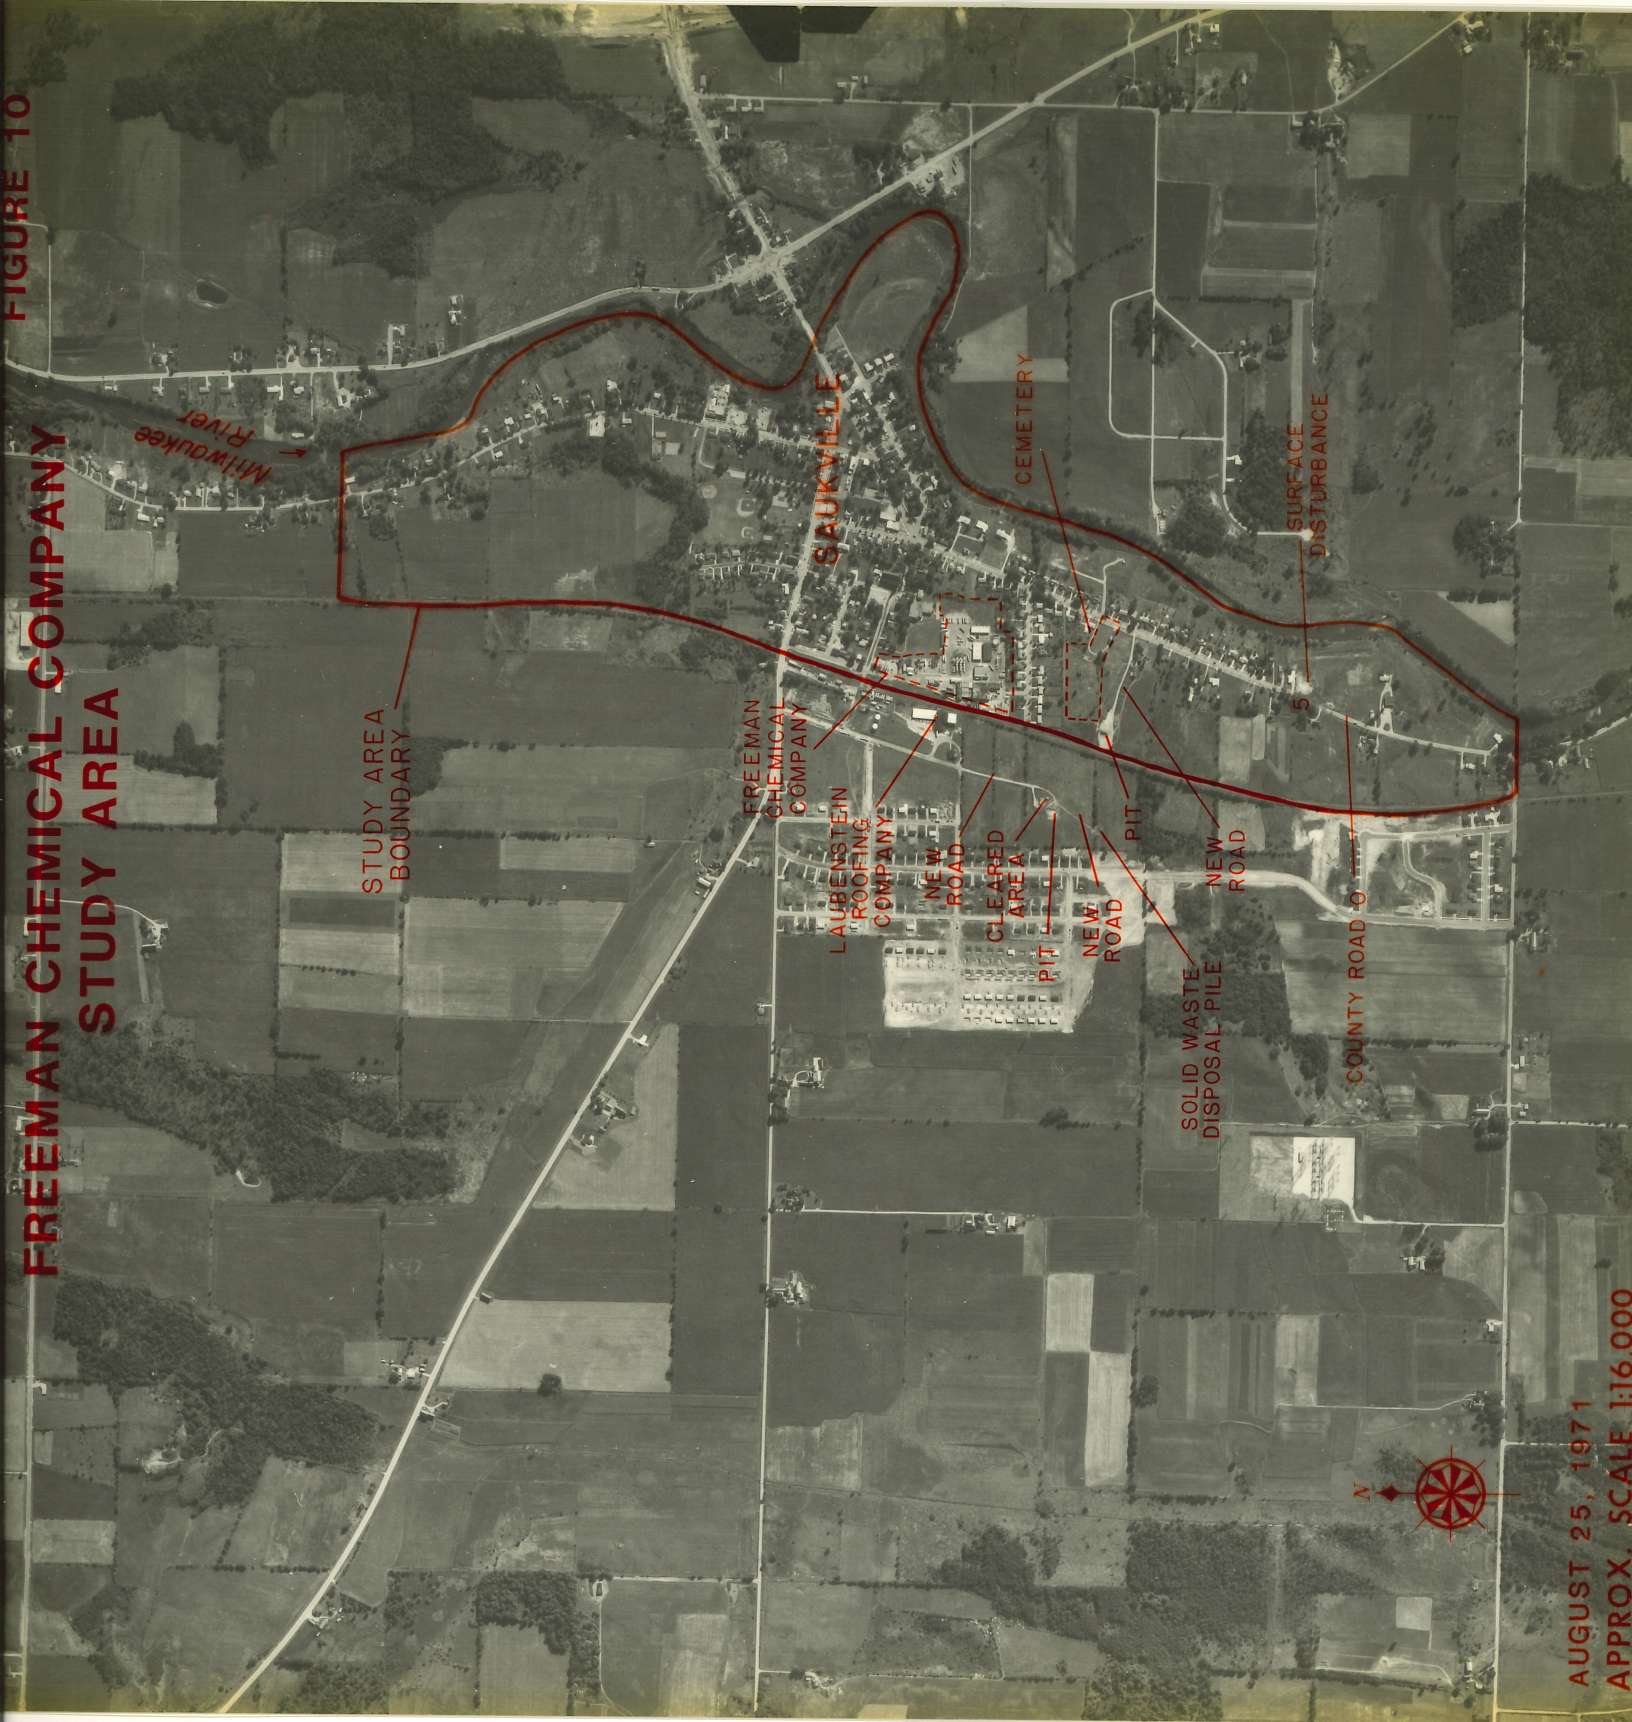
FIGURE 10

AUGUST 25, 1971, NEW SURFACE DISTURBANCES

By 1971, additional areas of surface disturbance indicative of potential waste disposal activities were present both inside and beyond the study area boundary (Figure 10).

Outside the study area to the west, a new road has been established southwest of the former Northern Signal Company (now Laubenstein Roofing Company). The road leads to a small area of cleared agricultural land or possibly a pit. The pit appears to be spatially associated with construction or operation of an offsite incinerator known to have been operated by Northern Signal until about 1972 when it was deactivated by the company. The road then continues beyond the pit to a small area of solid waste disposal. The material covers less than 2,000 square feet, is piled from 1-8 feet high, and is rather dark in coloration.

Inside the study area and southwest of the cemetery, a new road provides access to a large cleared area with a substantial pit in its center. This area occupies the site of a gravel pit first observed in the 1964 photography, and has the potential to receive both liquid and solid wastes. Also inside the study area is an additional area of surface disturbance (Area 5) located adjacent to County Trunk Road O on the east side.

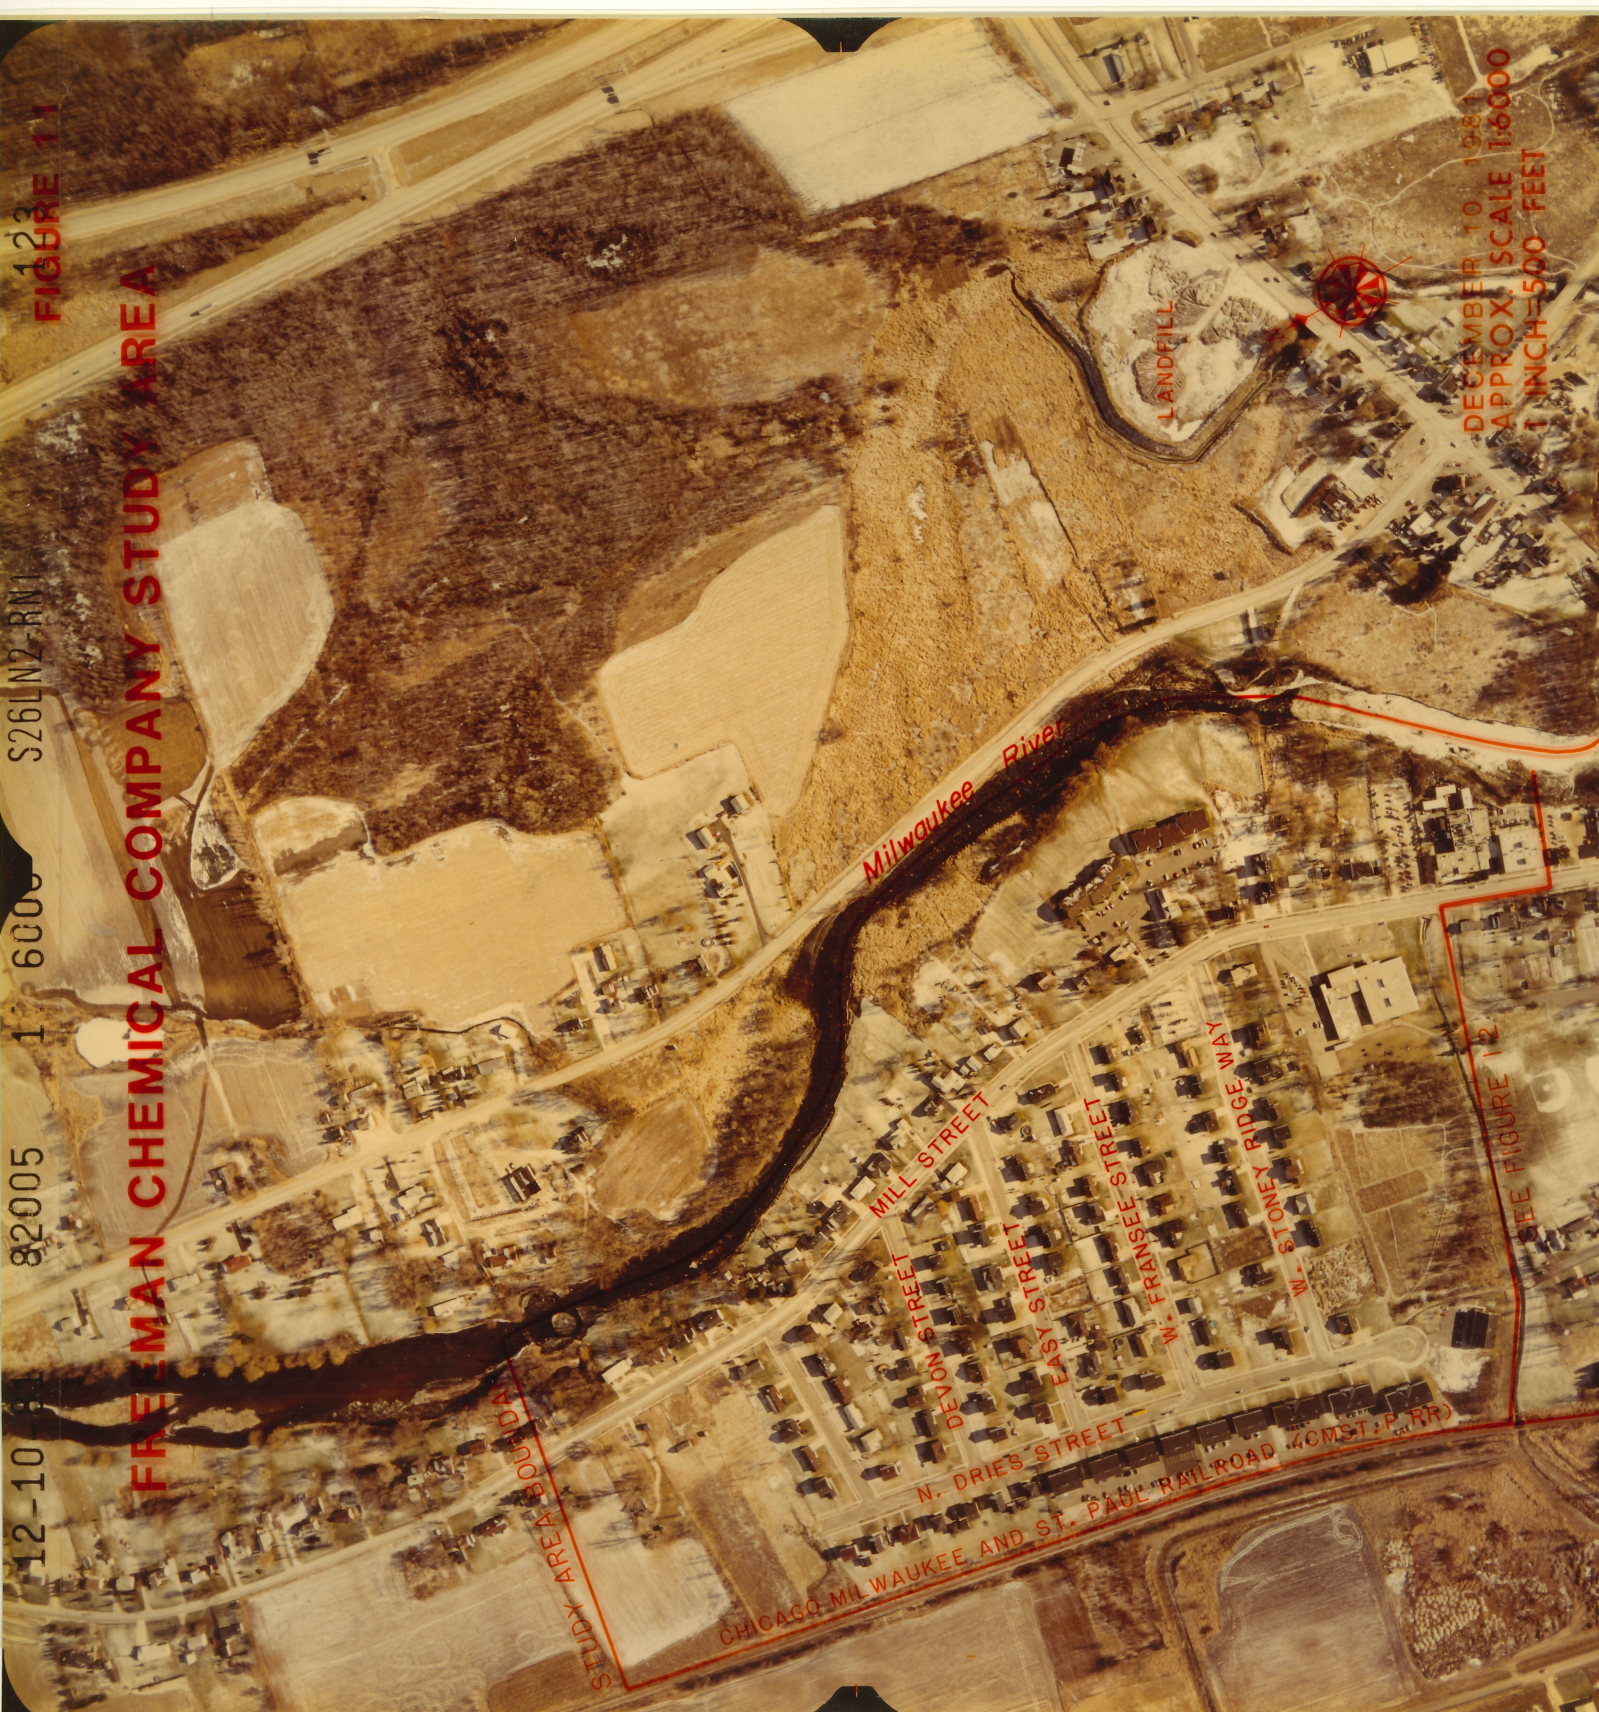
123
FIGURE 11

Figures 11, 12, and 13 provide the first large-scale, color aerial photography over the study area. Figure 14, an enlarged portion of Figure 13, provides a detailed view of the Freeman Chemical Company plant facility. Potential sources of groundwater contamination observed in historical photography are re-established on the recent photography where adequate coverage is available. New potential sources observed in the recent coverage are also annotated. Table 2 lists and summarizes all potential threats observed throughout the photographic study period.

LANDFILL

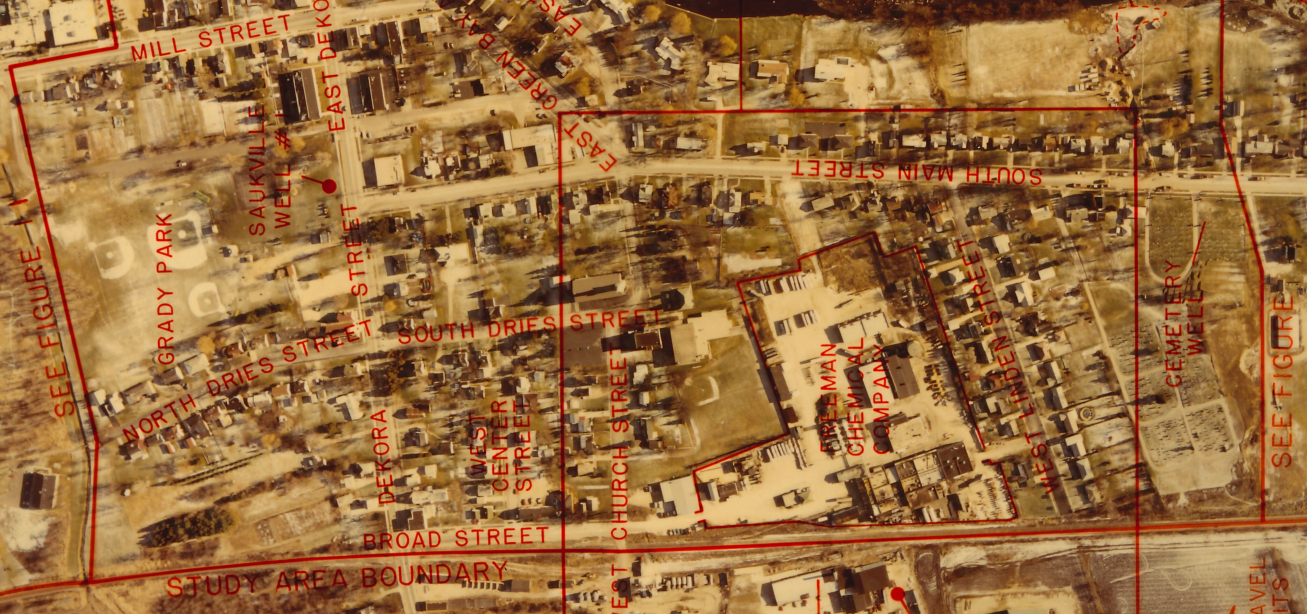
FIGURE 12

OLD SURFACE DISTURBANCE AREA 2

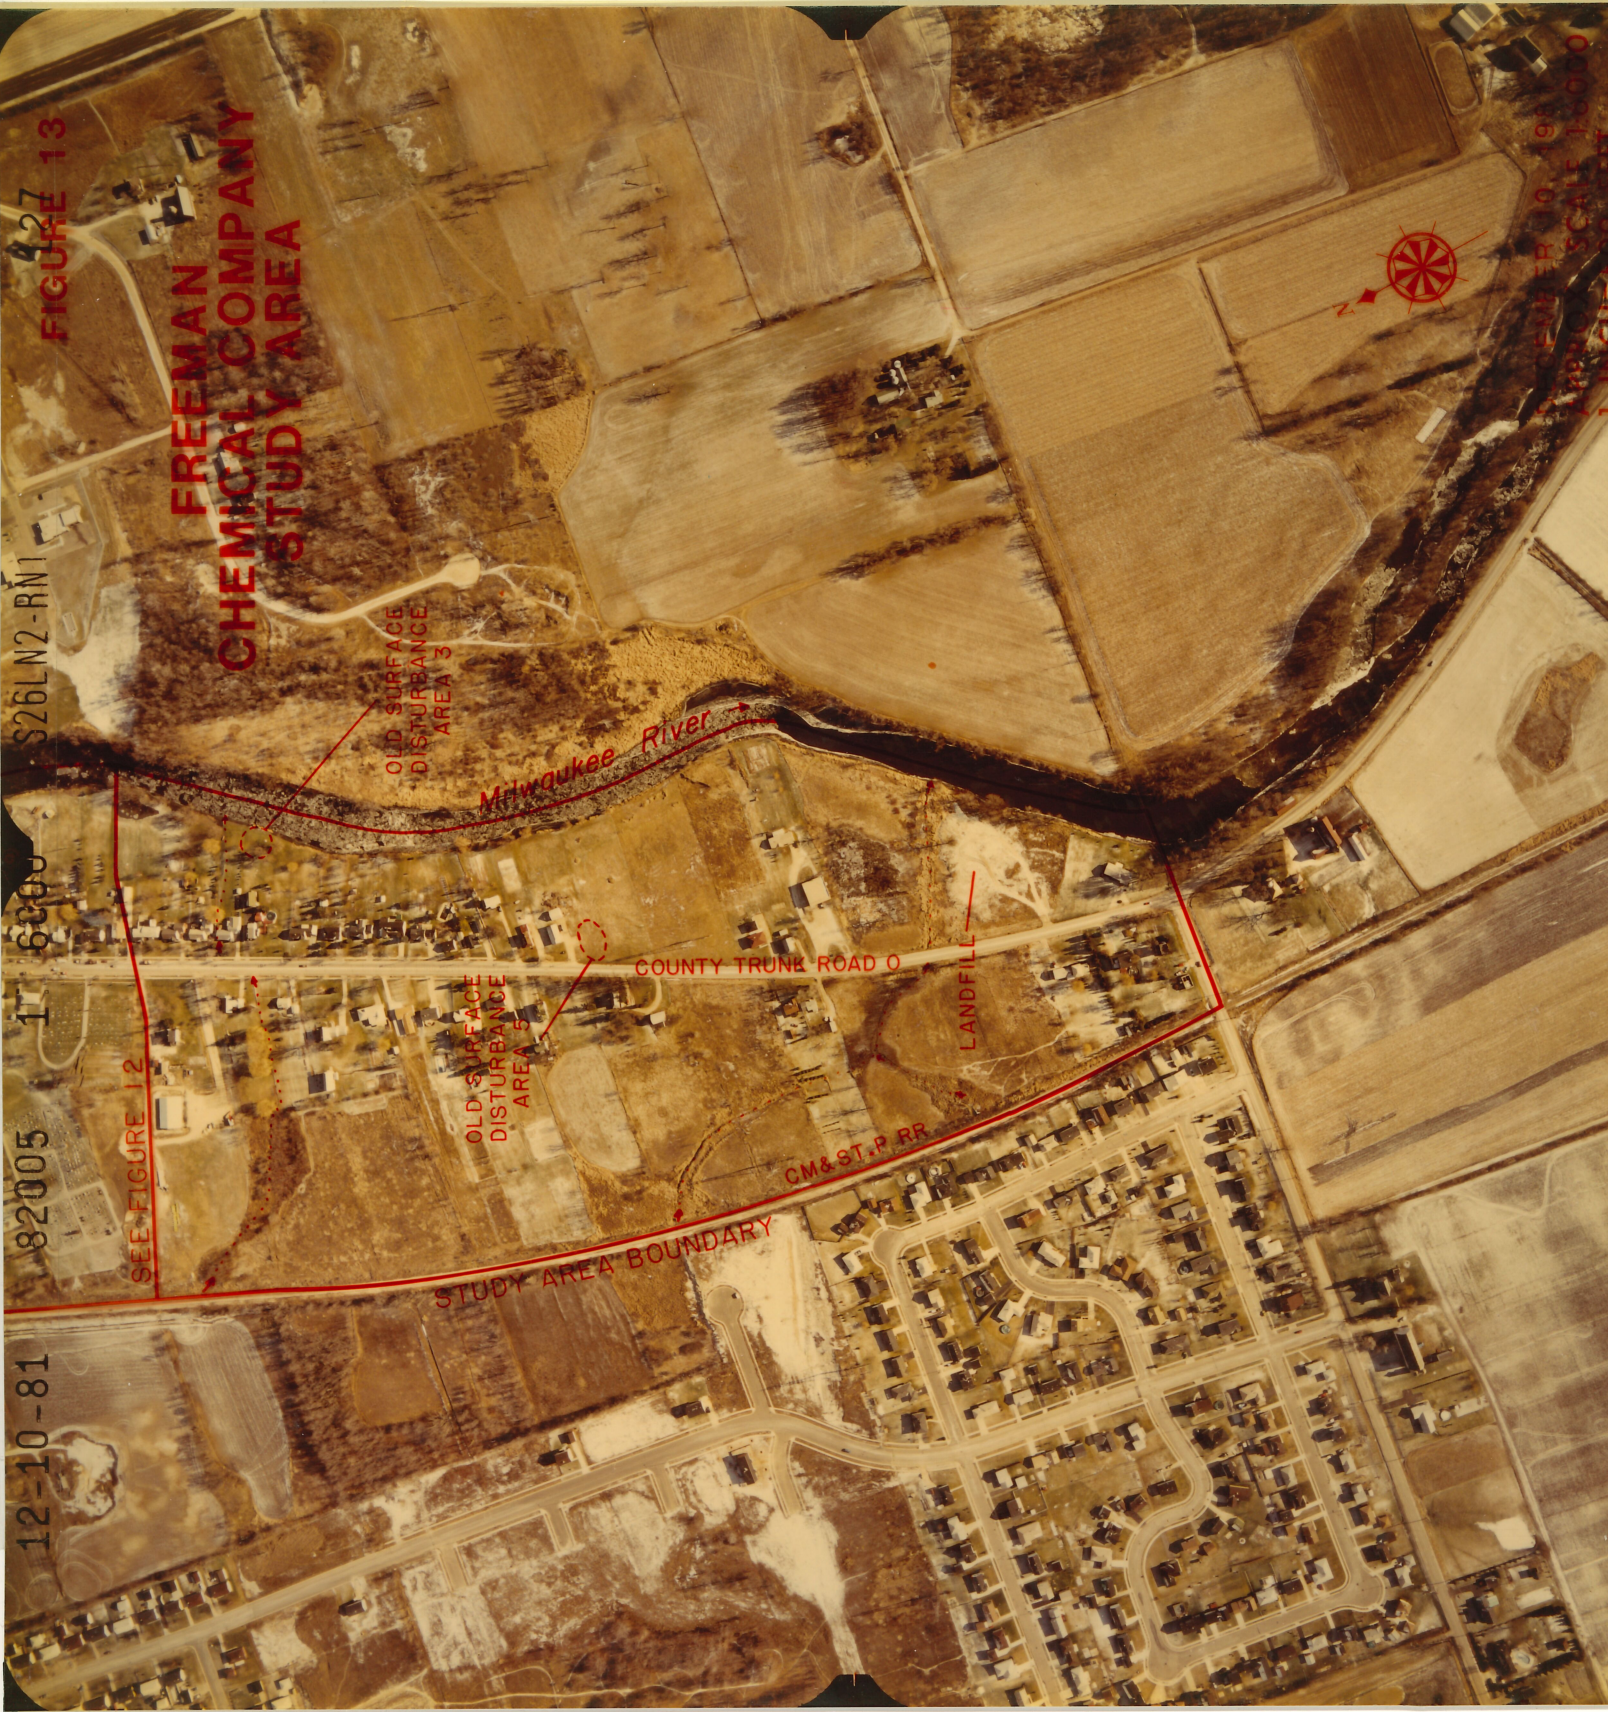
FIGURE 13

OLD SURFACE
DISTURBANCE
AREA 3

OLD SURFACE
DISTURBANCE
AREA 5

LANDFILL

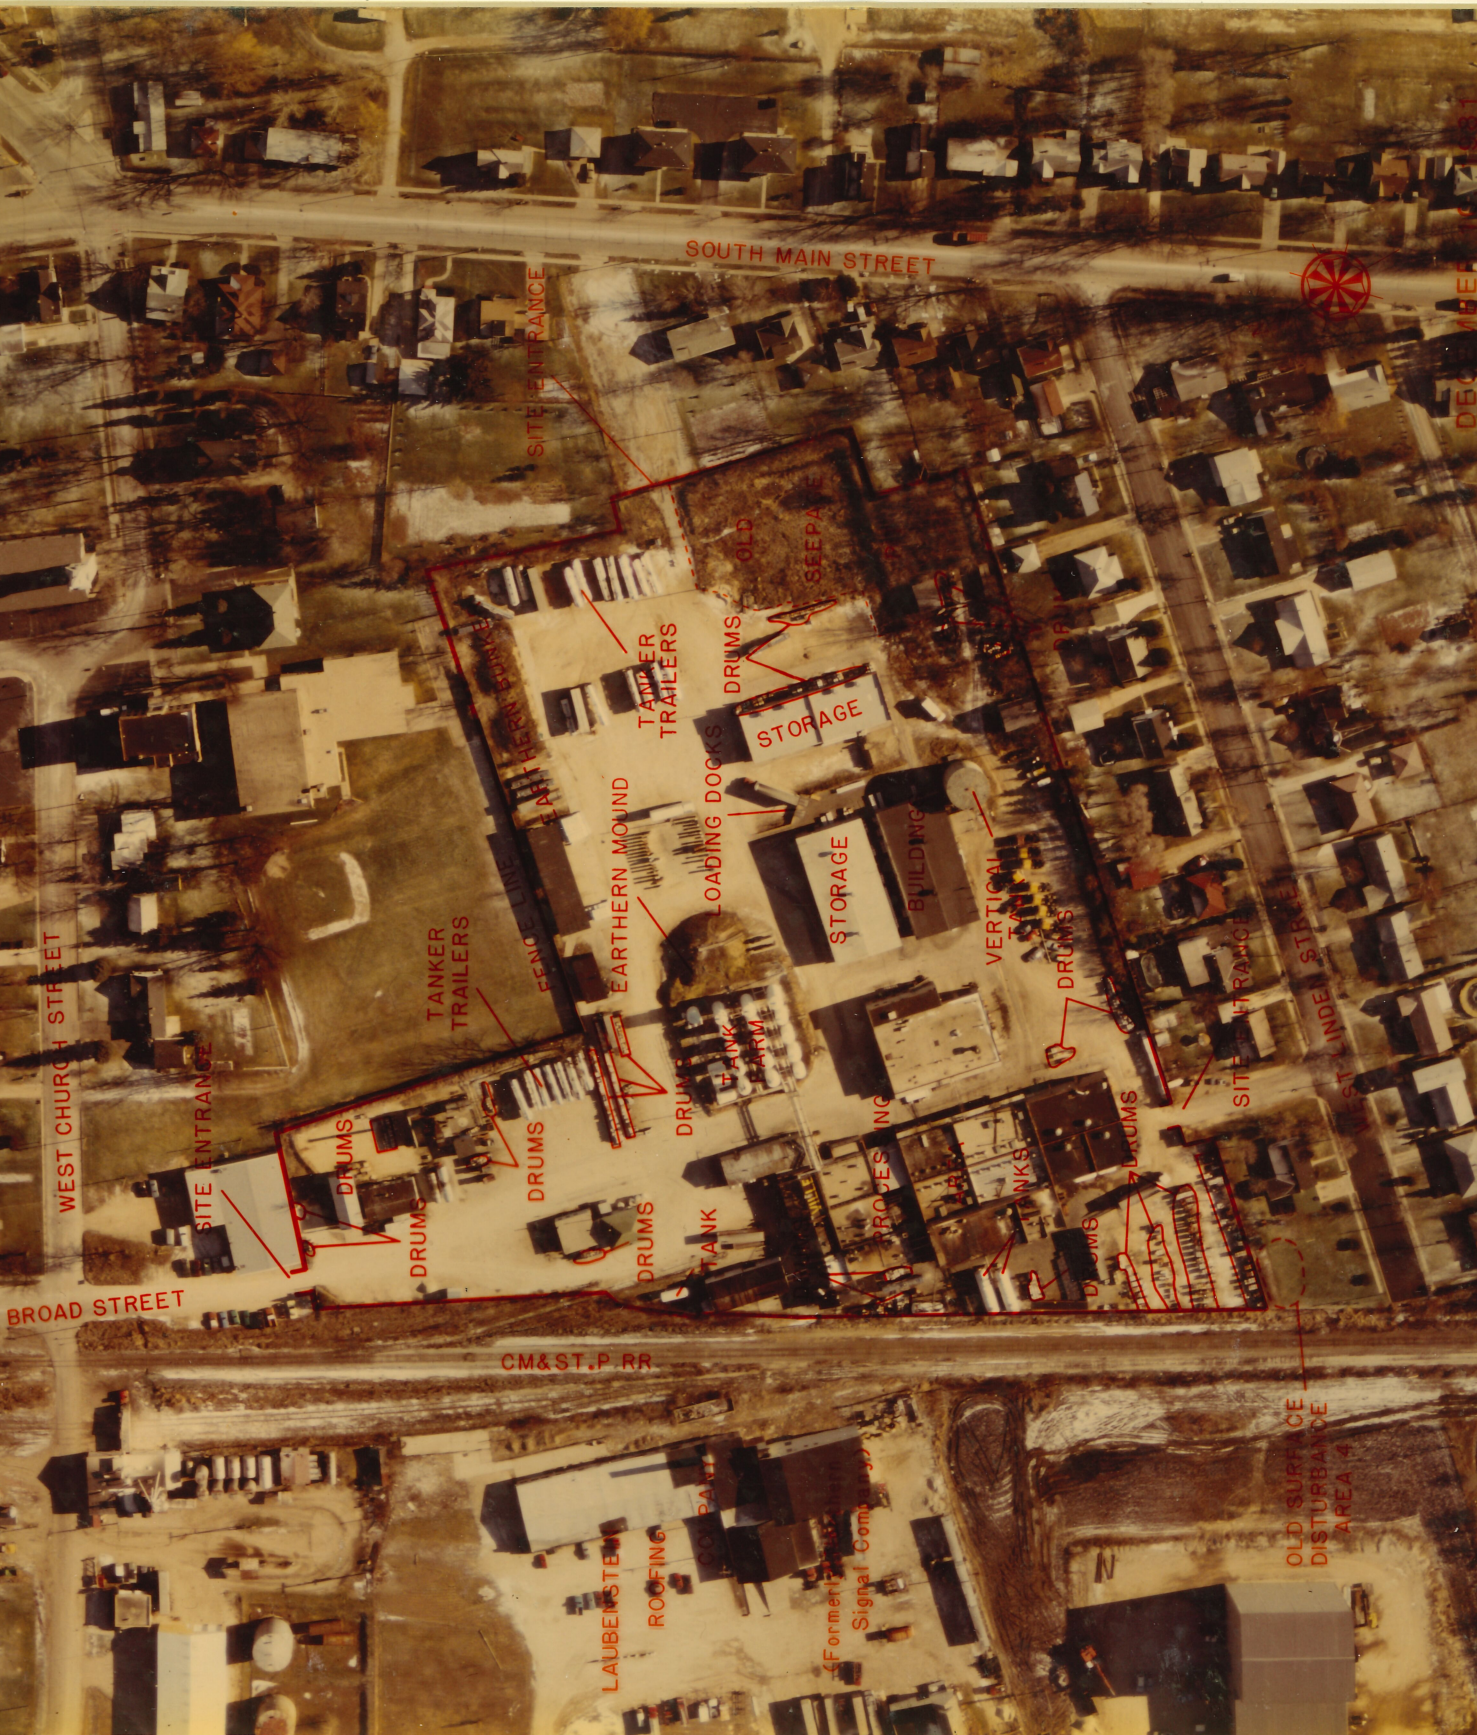
PEEMAN CHEMICAL COMPANY
(ENLARGED VIEW)

By 1981, an old seepage pit was located on Freeman plant property. This pit, suspected to have been used for direct ground disposal of wastes from plant operations, was developed sometime between 1971 and 1981.
