LETTER REPORT

Date: January 26, 2018

**Re: Saxony Village Development
Village of Germantown
Washington County, Wisconsin
CMC Heartland (BRRTS #02-67-000341) and Jacobus Oil Company (BRRTS #02-67-000801)**

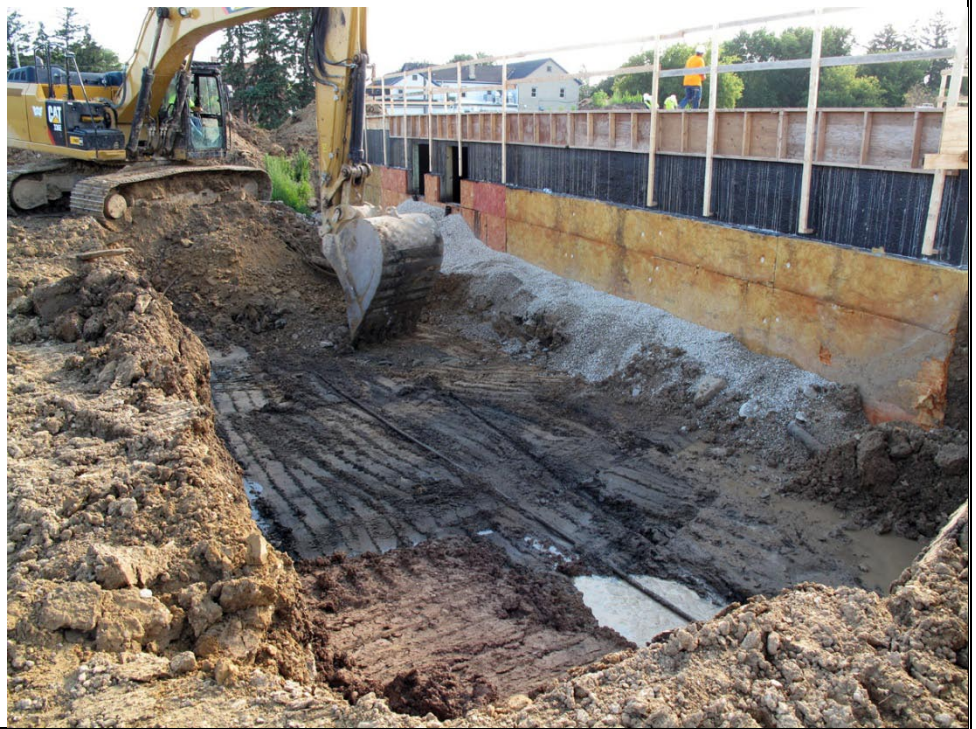
Description: Excavation and stockpiling of impacted soil along north side of Building #4 (approx. 5 feet bgs).

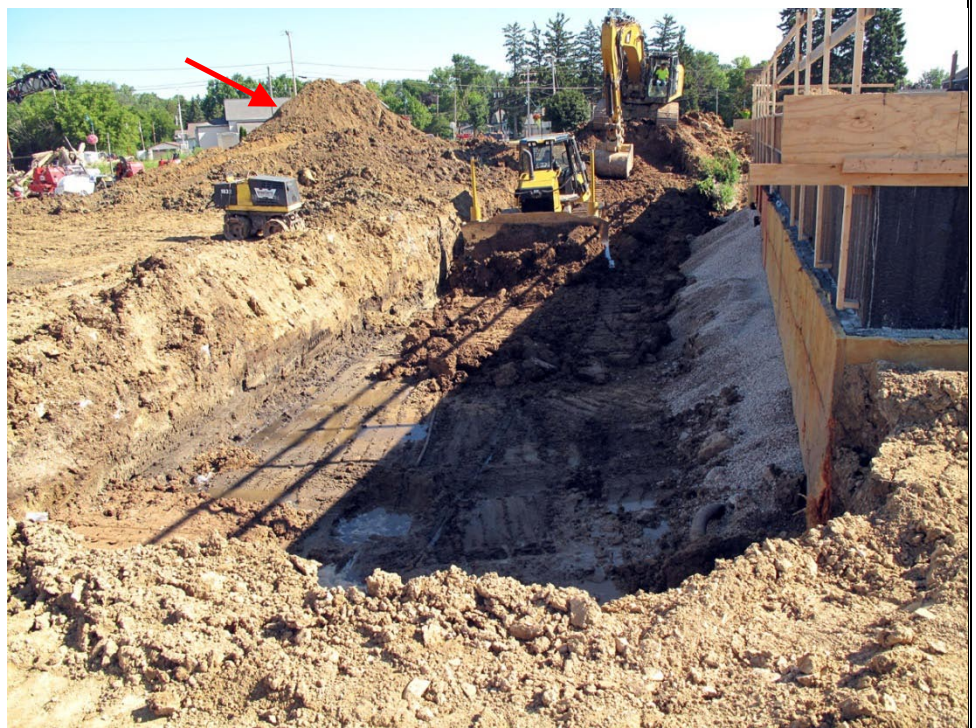
Description: Backfilling of excavation along north side of Building #4 with low permeable clay (note stockpile of impacted soil in background).

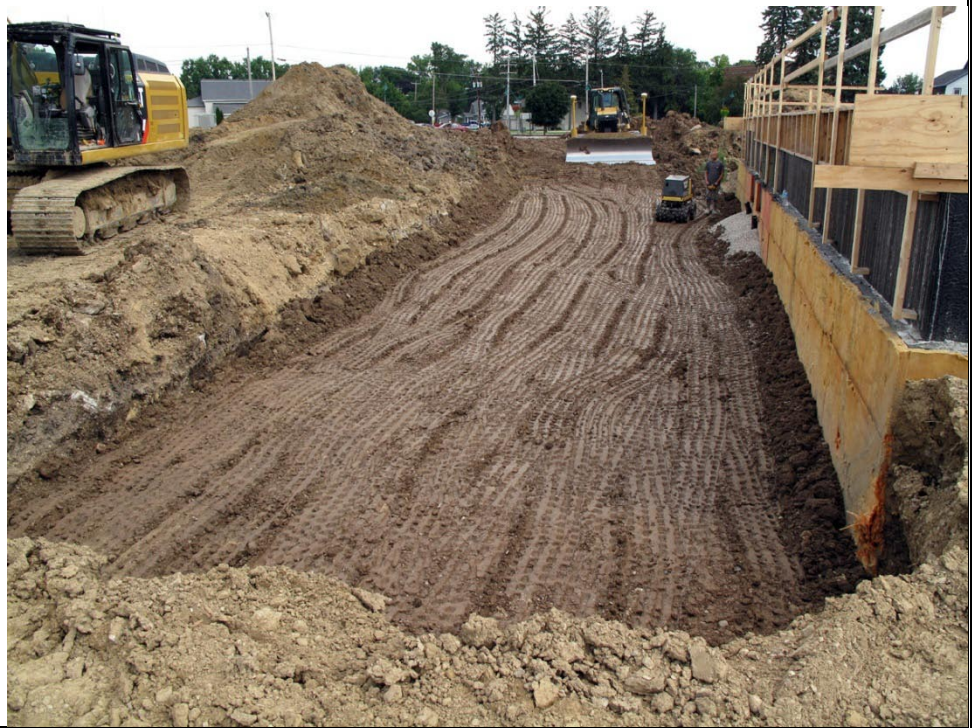
Description: Compaction of low permeable clay along north side of Building #4 (2 to 3 foot thickness).

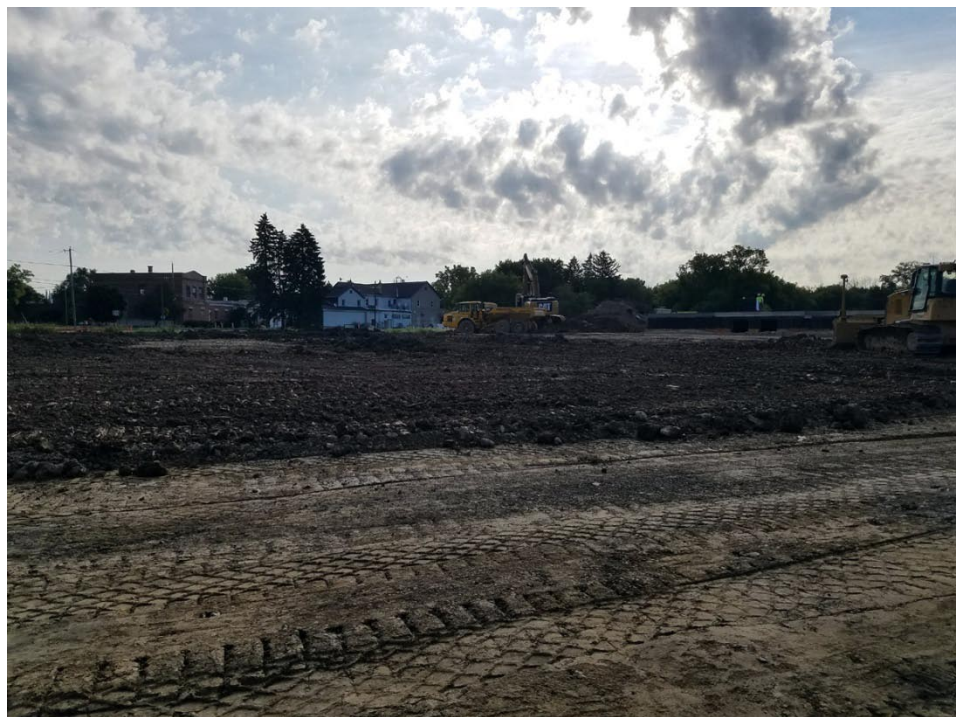
Description: Thin-spreading of previously stockpiled, impacted soil and capping/compaction of low permeable clay (6 inch thickness) along north side of development.

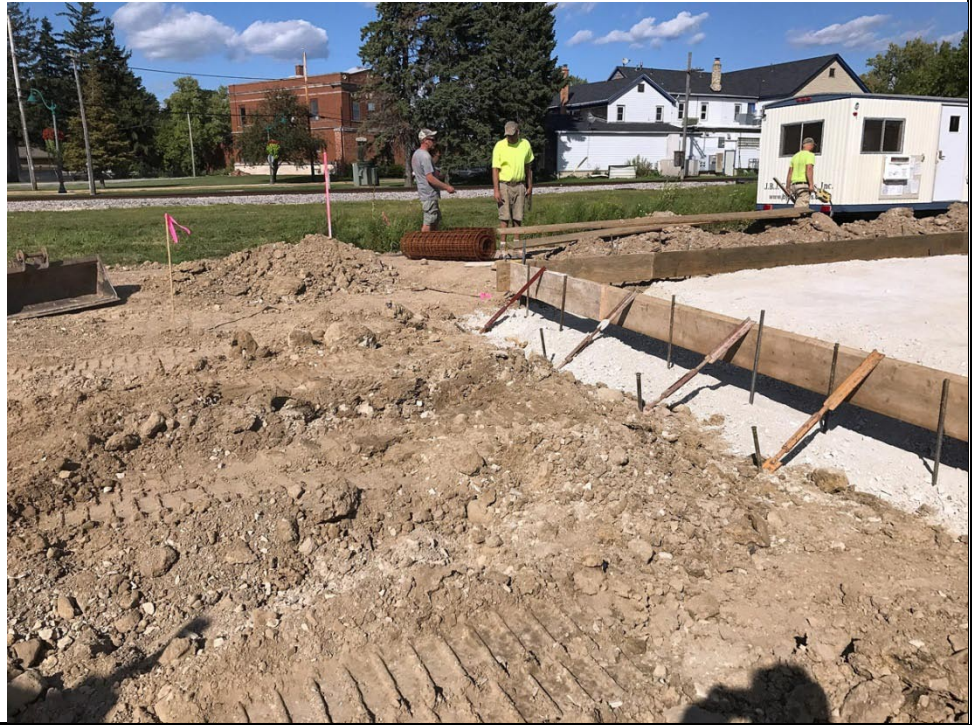
Description: Construction
of surface garages.
Excavation of ~ 4 inches
for the thickened slab
edge on the concrete slab,
placement of stone.

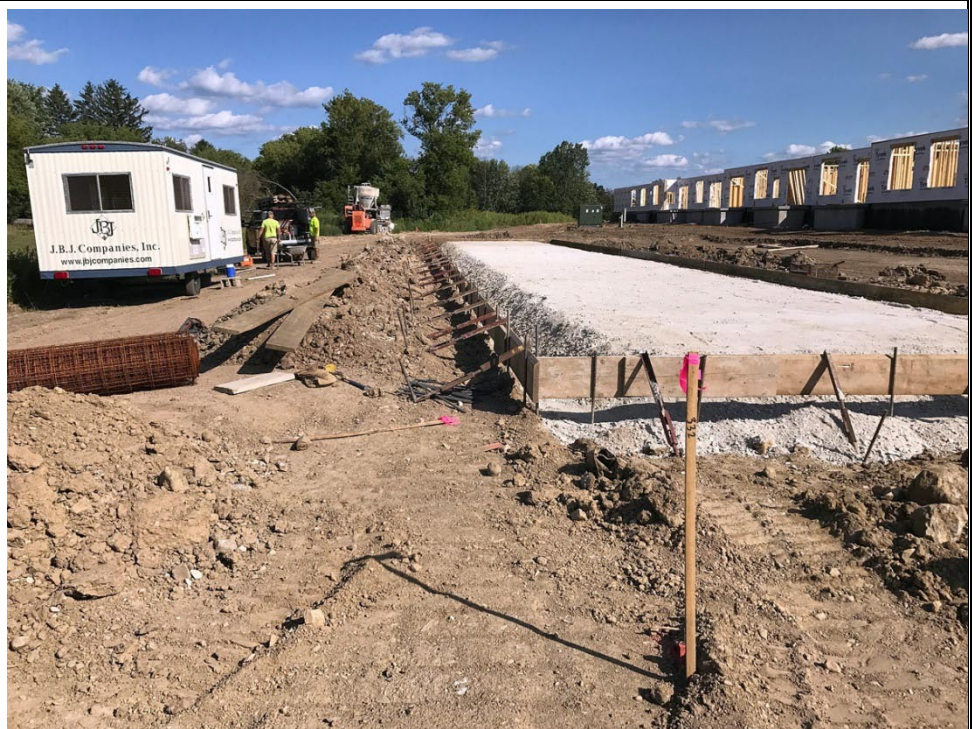
Description: Frames in
place to eventually pour
concrete.

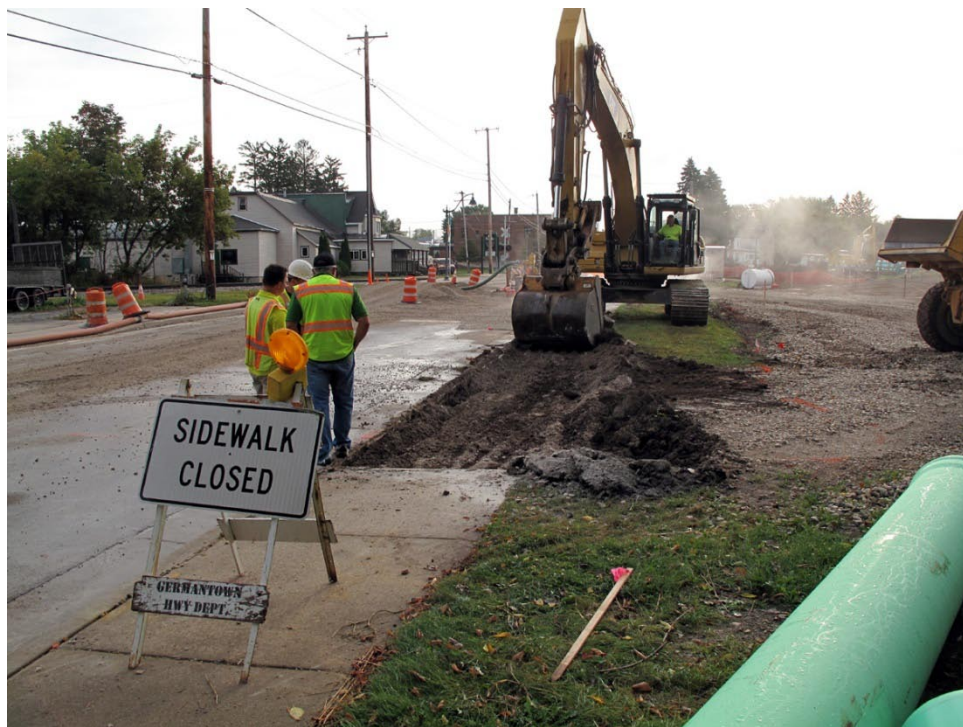
Description: Removal of concrete sidewalk along north side of development (south side of Main Street).

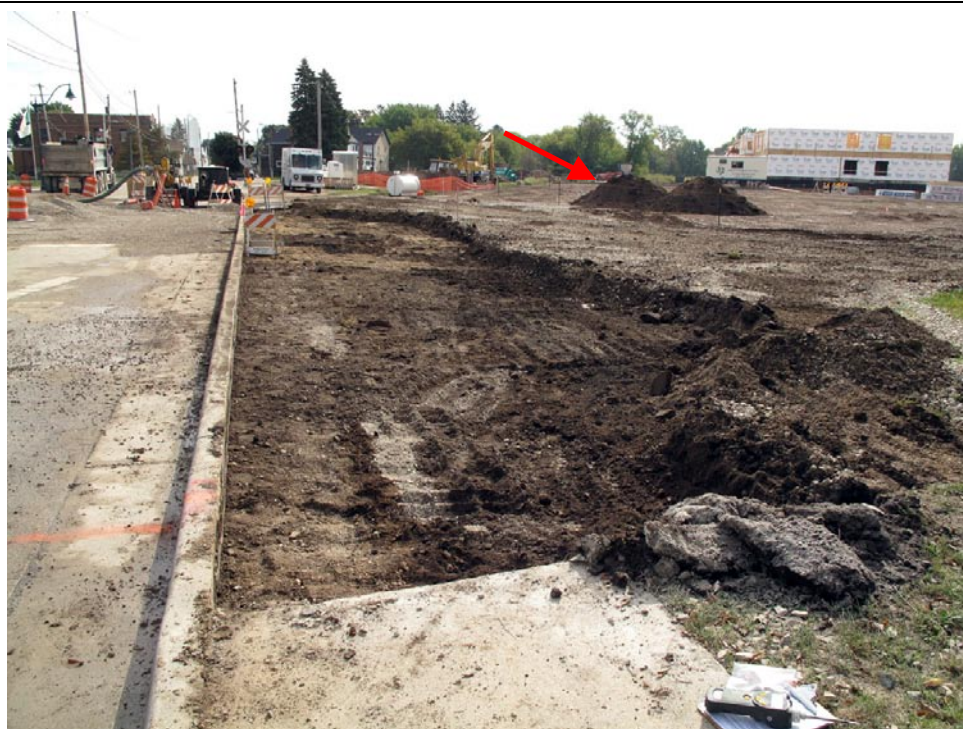
Description: Excavation and stockpiling of fill material below concrete sidewalk and along new driveway entrance (note stockpile of fill material on clay cap in background)

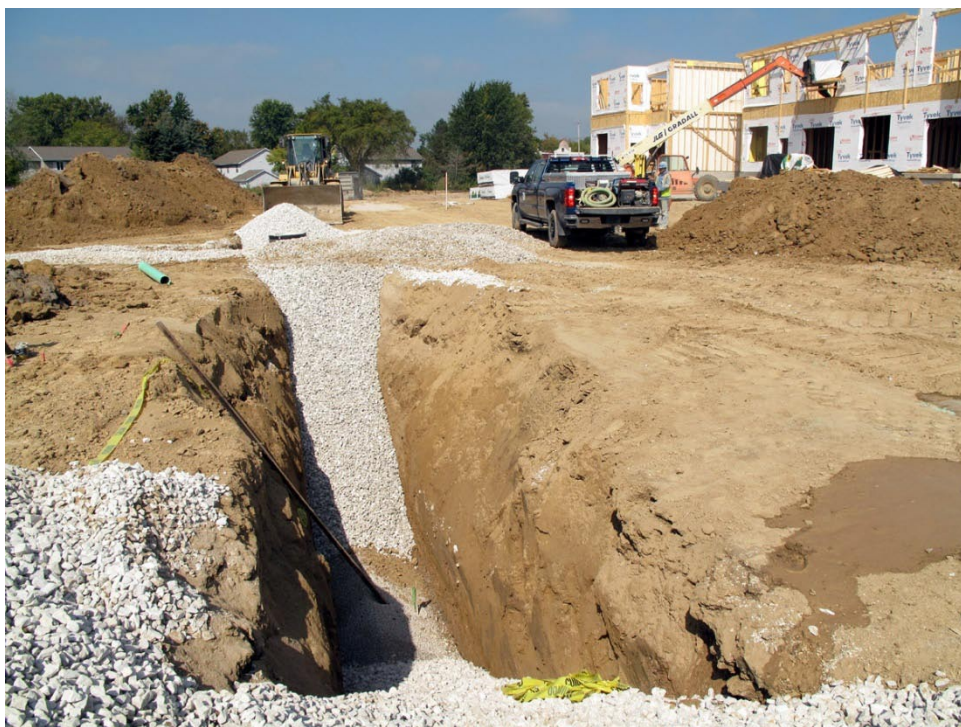
Description: Water line installation along SW side of Building #4. No impacted soil encountered at this time.

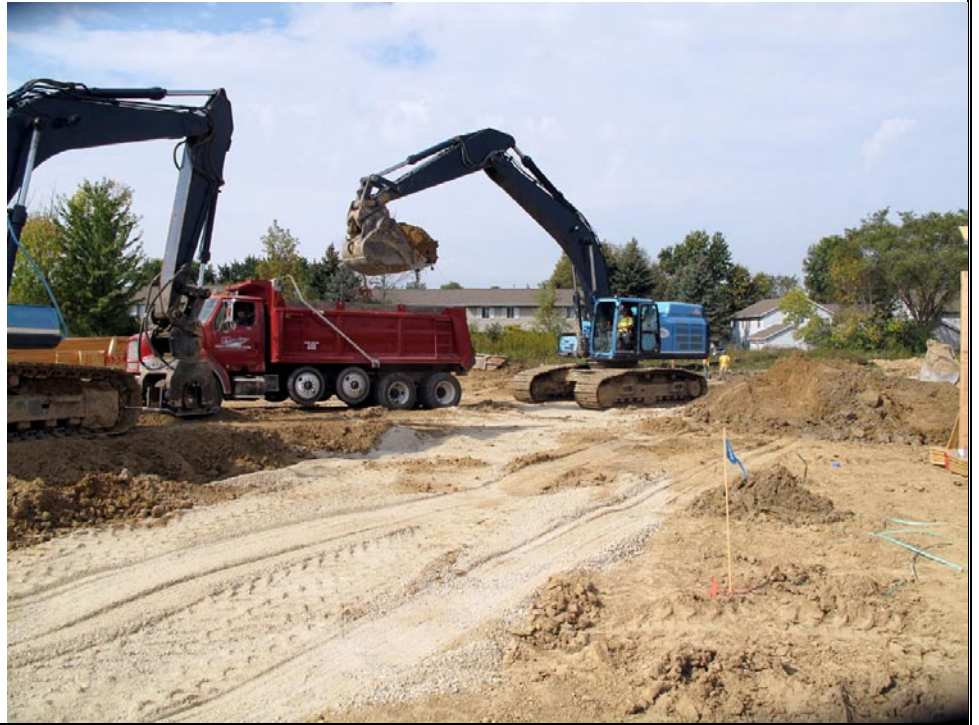
Description: Impacted soil stockpiled adjacent to excavation and hauled to WM landfill.

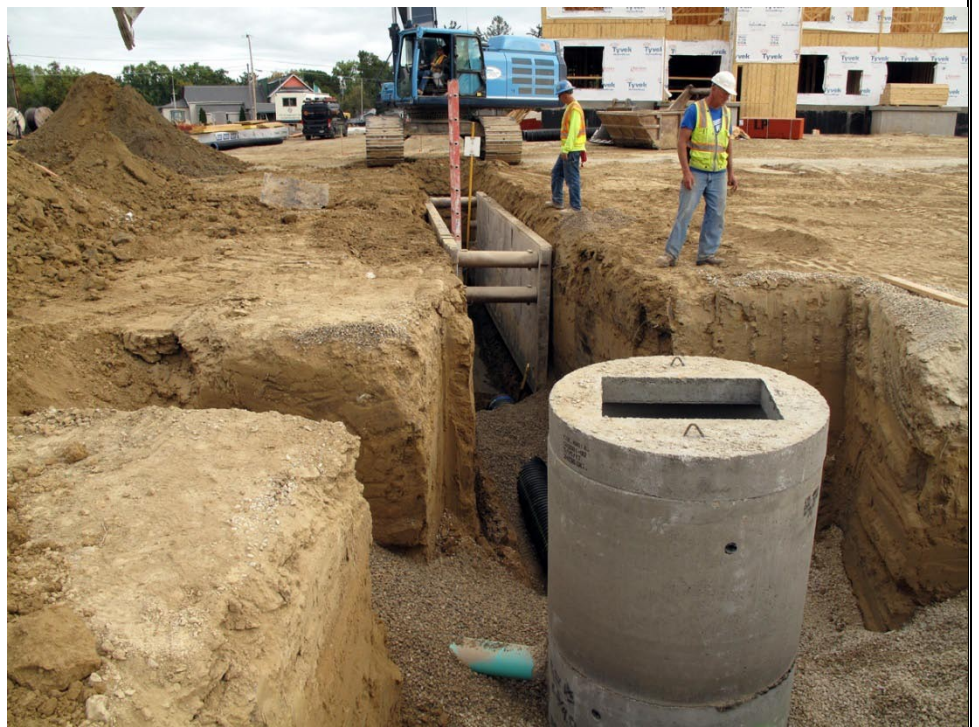
Description: Continued installation of stormwater line, between Building #4 and west side of property. Impacted soil (> 5 ft. bgs) trucked to landfill.

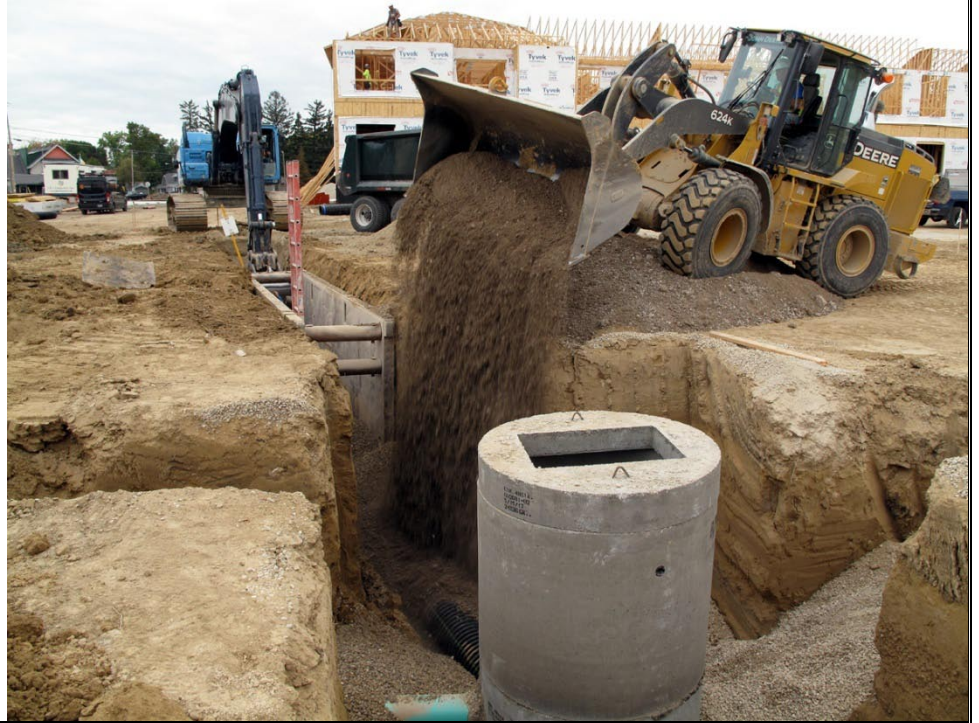
Description: Backfilling
western end of
stormwater line with
crushed recycled
concrete.

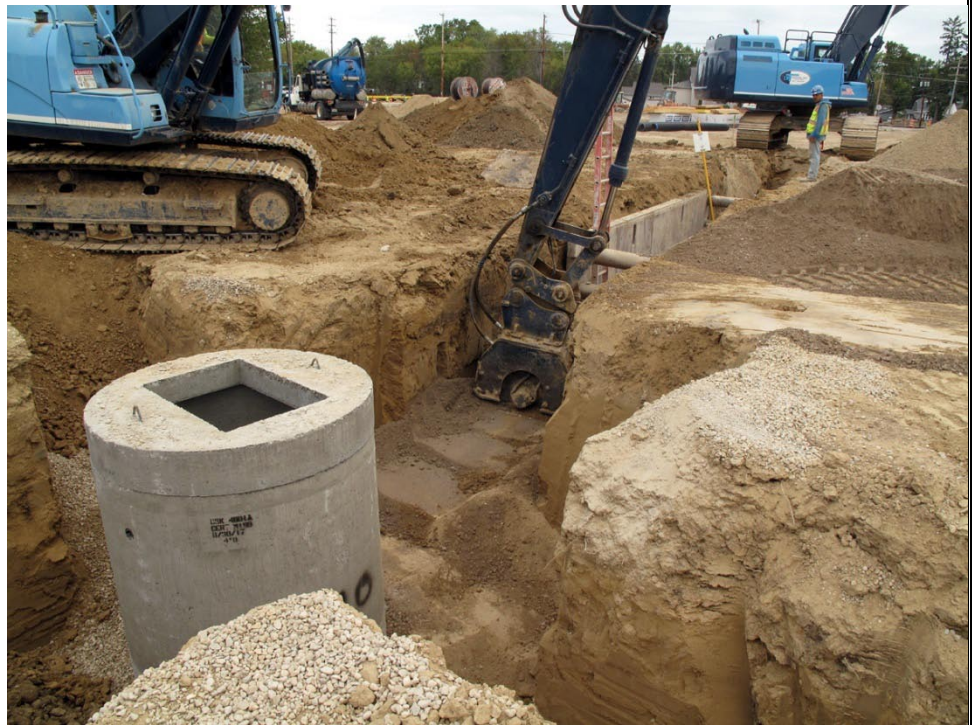
Description: Compaction
of crushed recycled
concrete.

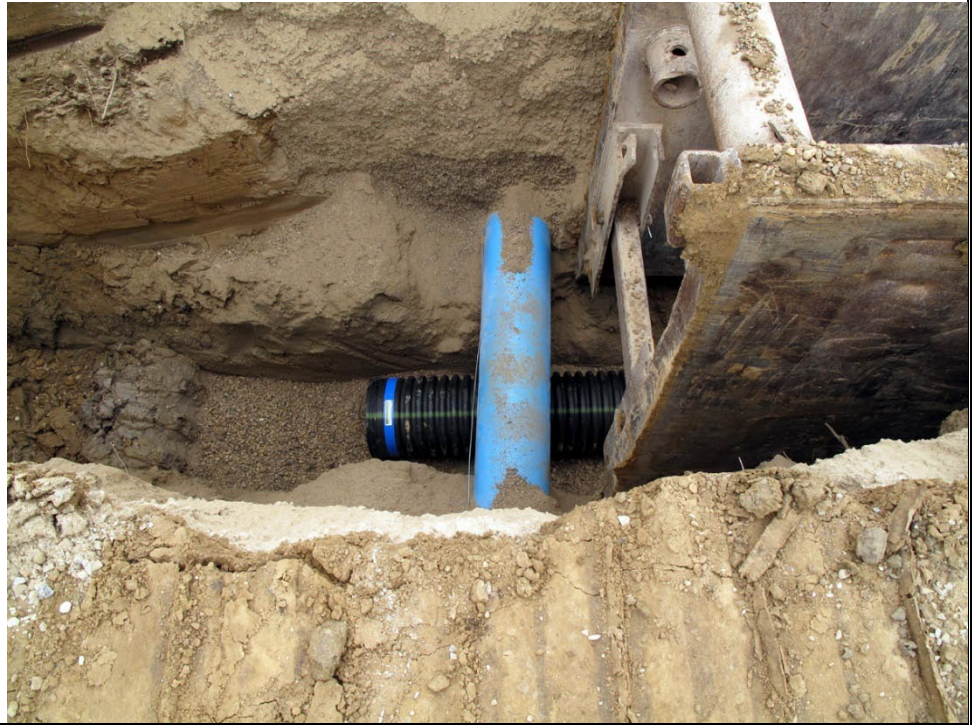
Description: Installation
of storm sewer line
underneath main water
line.

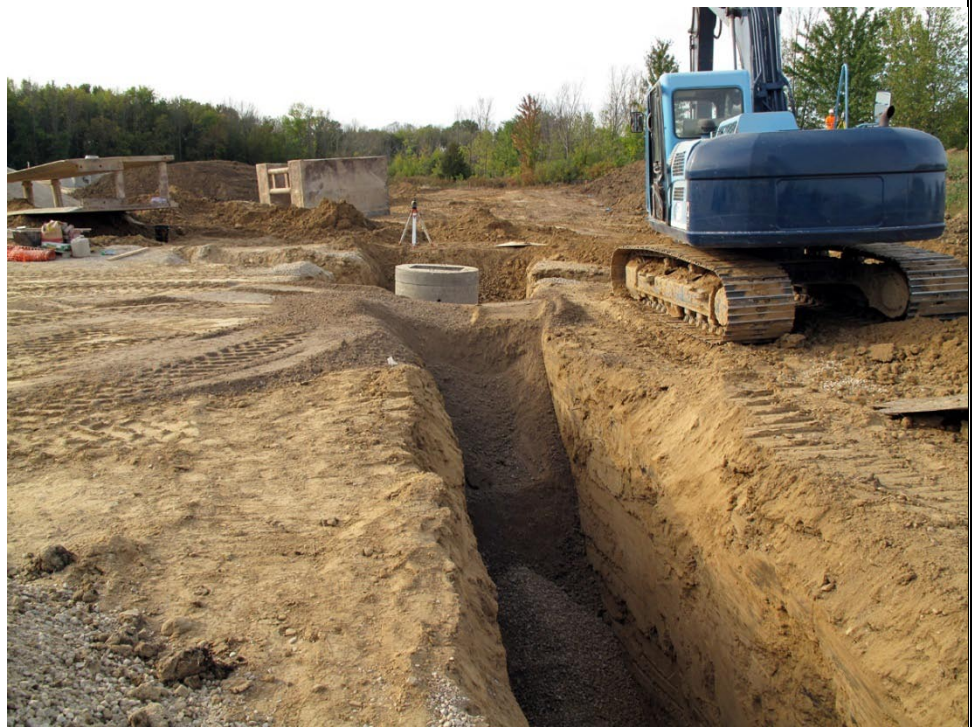
Description: Backfilling
and compaction of
pipeline intersection with
crushed recycled
concrete.

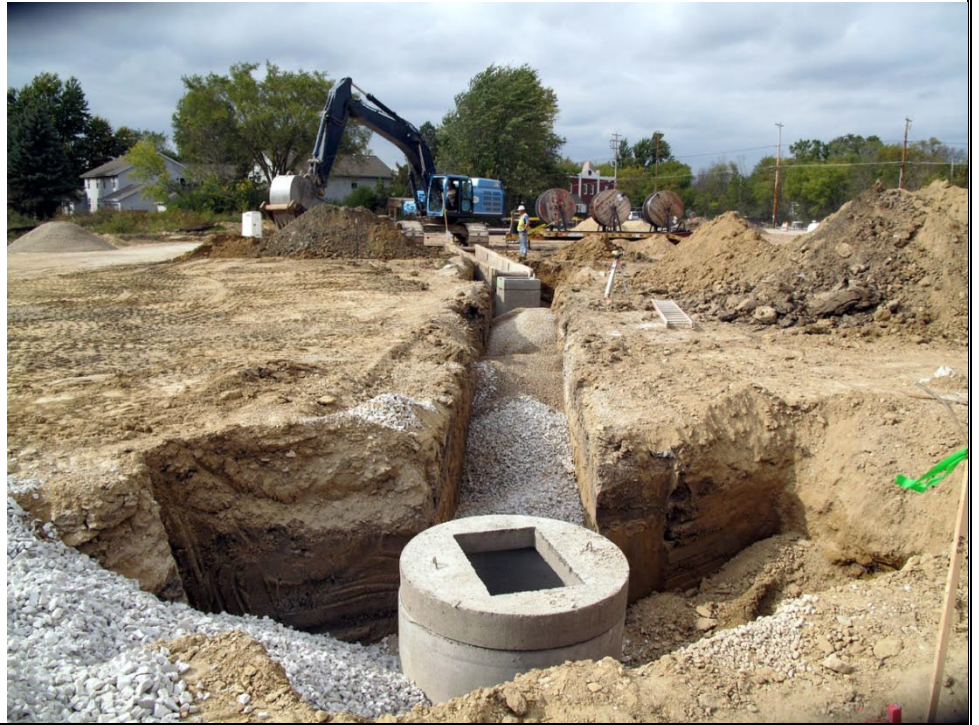
Description: Continued installation of stormwater line along east side of planned driveway. Impacted soil (> 2 ft. bgs) trucked to landfill.

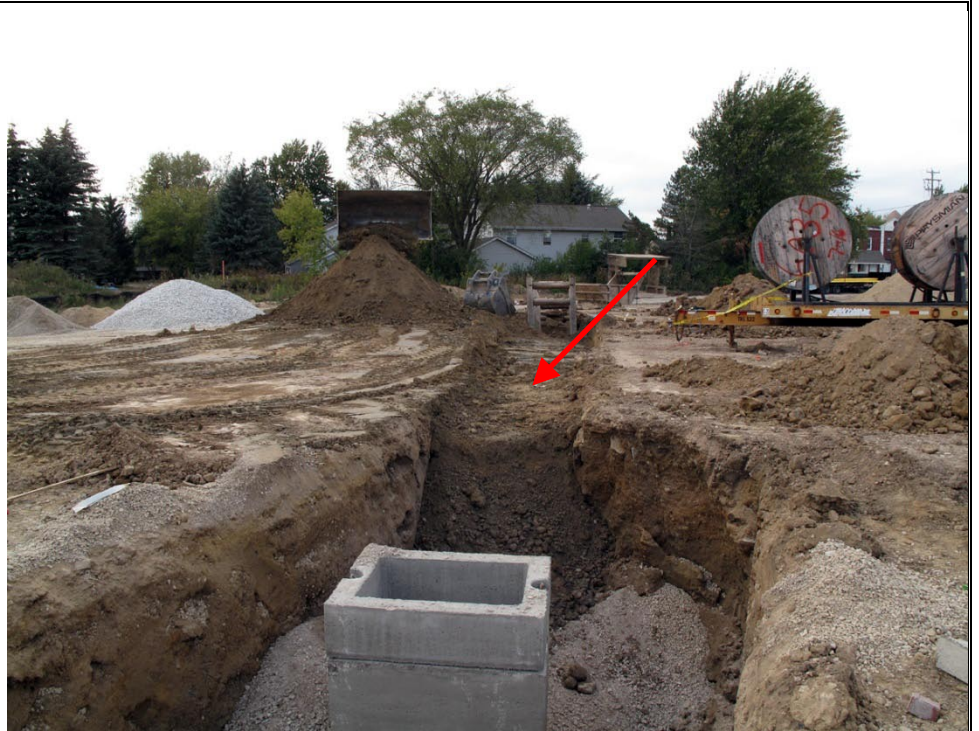
Description: Excavation partially backfilled with impacted soil and clay cap re-established.

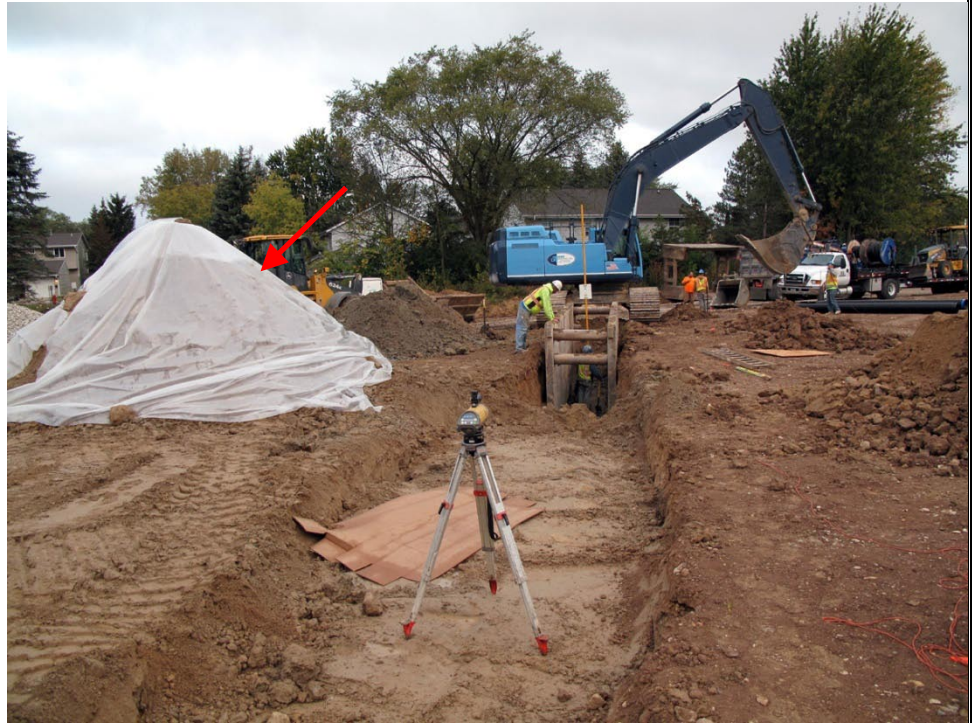
Description: Continued installation of stormwater line underneath planned driveway. Impacted soil (> 2 ft. bgs) stockpiled, covered with plastic, and later trucked to landfill.

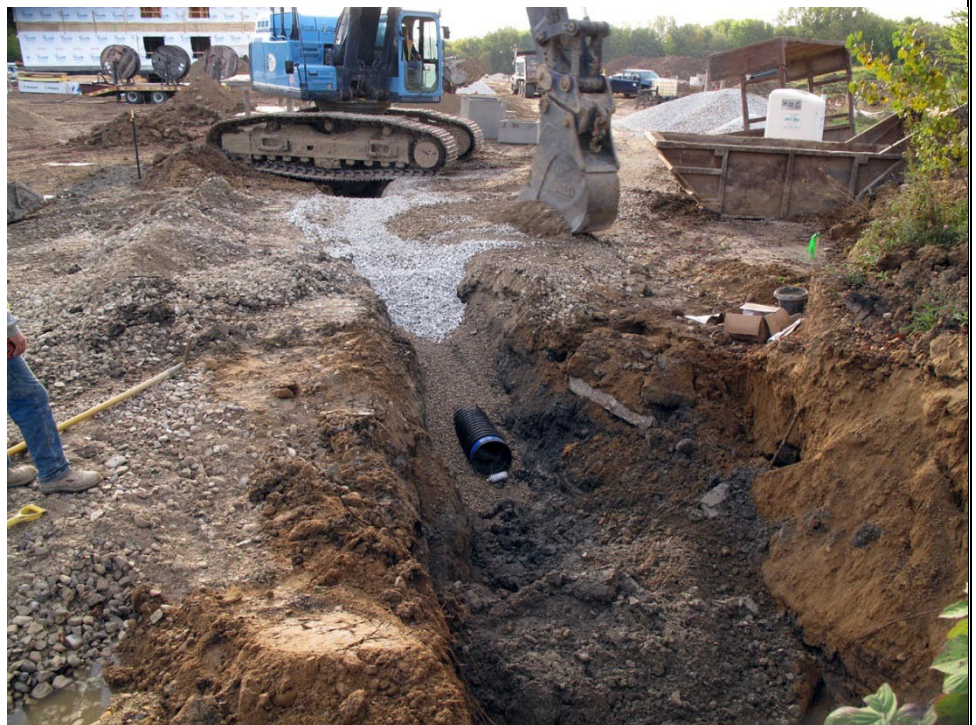
Description: Impacted soil at less than 2 ft. bgs. Note dark staining below pipeline

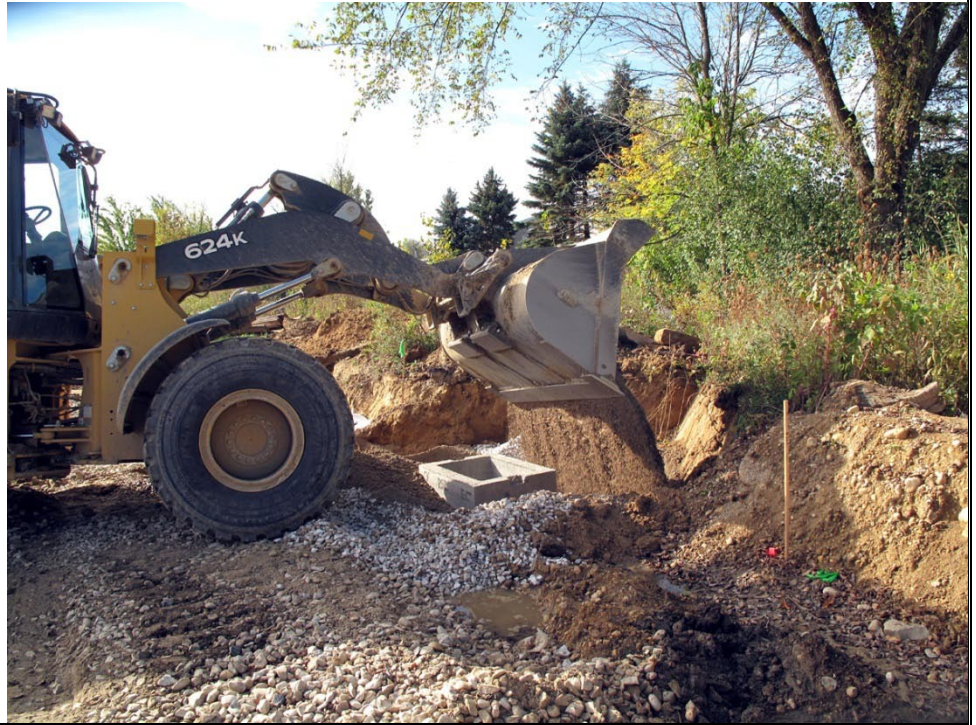
Description: Backfilling and compaction at north end of stormwater basin with crushed recycled concrete.

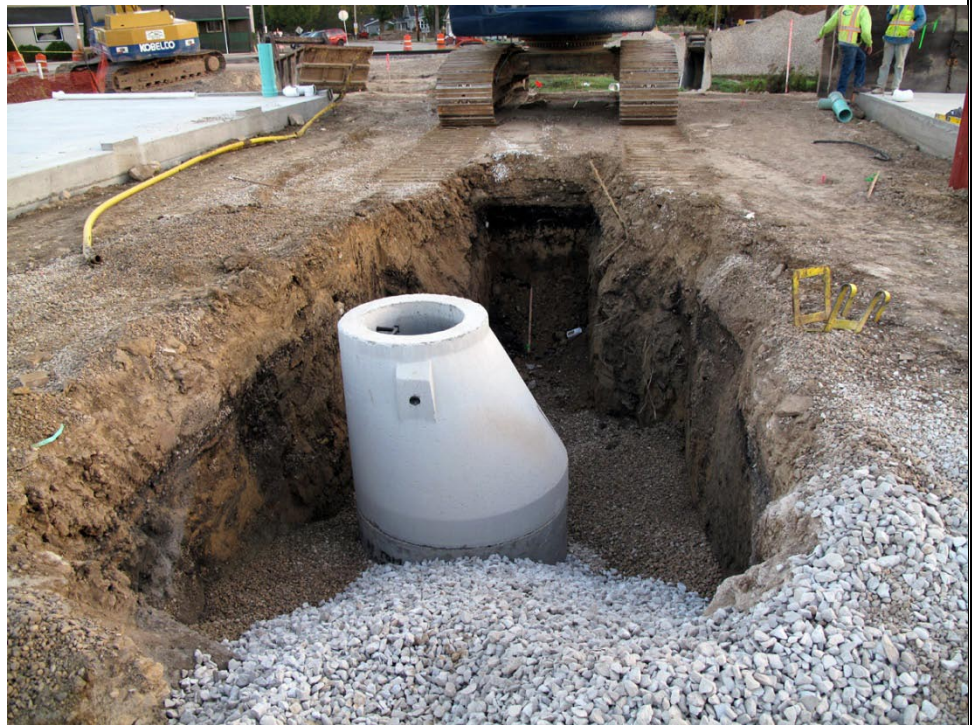
Description: Continued installation of stormwater line along east side of planned parking lot north of Building #4. Impacted soil (> 5 ft. bgs) trucked to landfill.

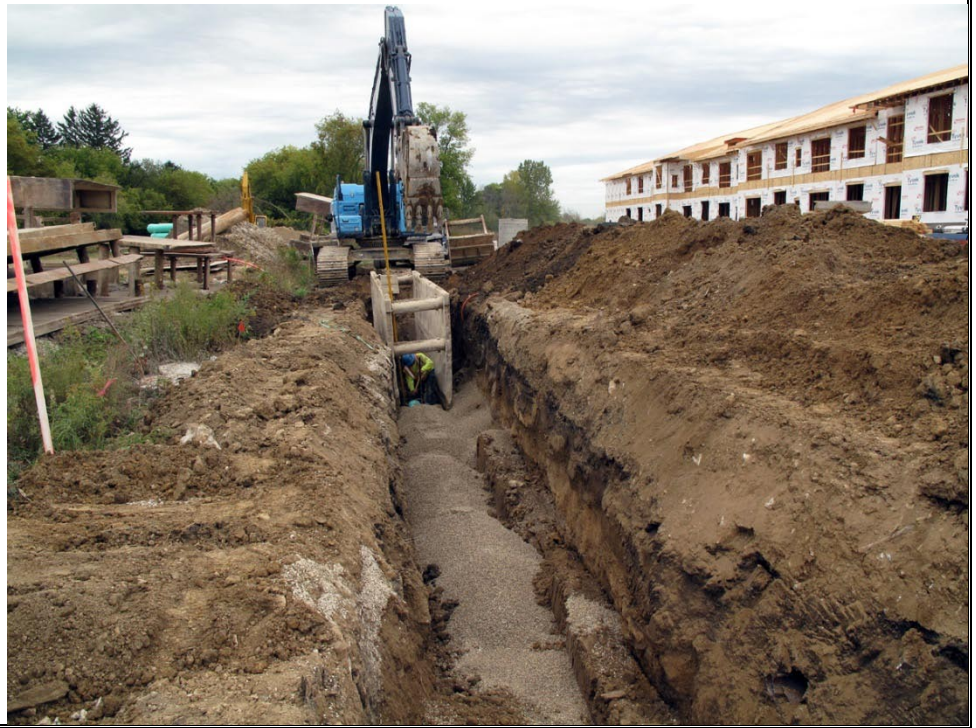
Description: Continued installation of stormwater line along east side of property. Impacted soil (2 to 5 ft. bgs) trucked to landfill.

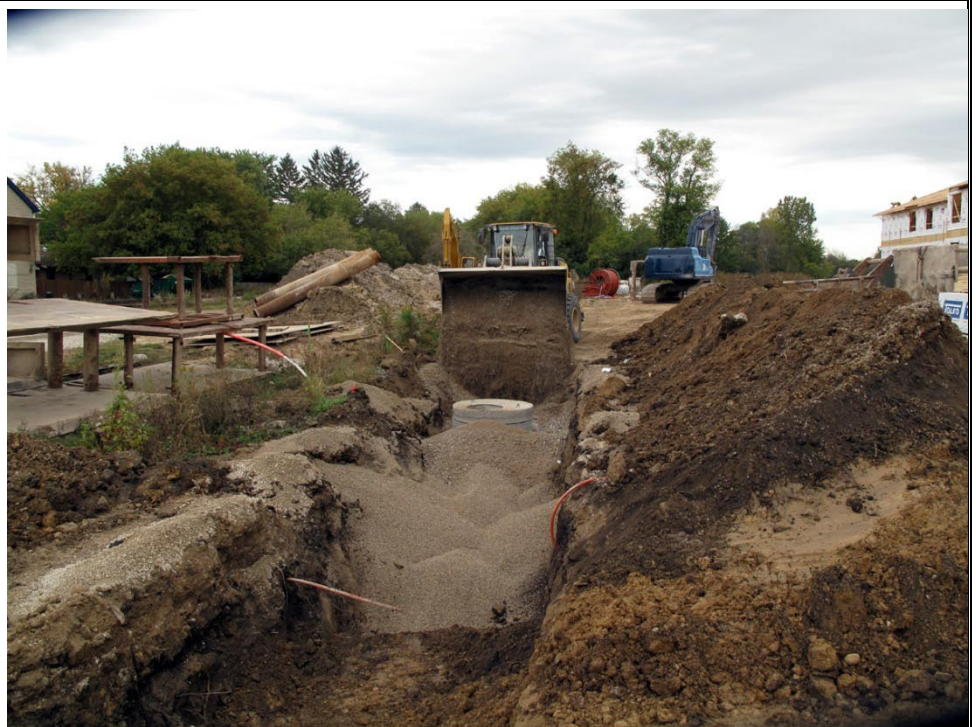
Description: Backfilling and compaction at south end of stormwater basin with crushed recycled concrete.

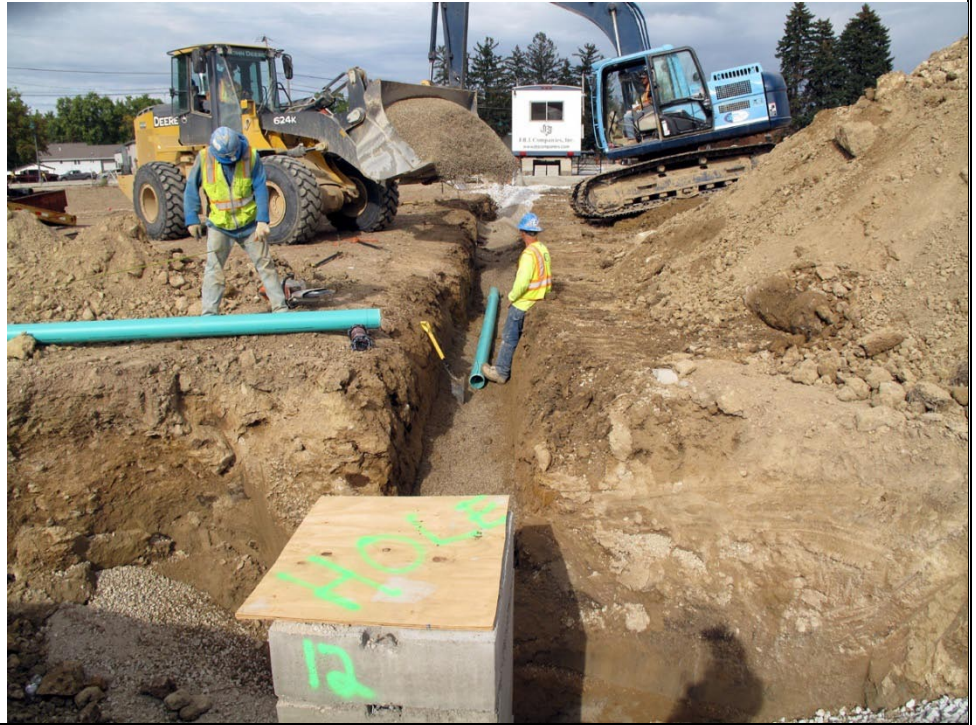
Description: Continued installation of stormwater line extending from northern parking garage. Impacted soil (2 to 5 ft. bgs) trucked to landfill.

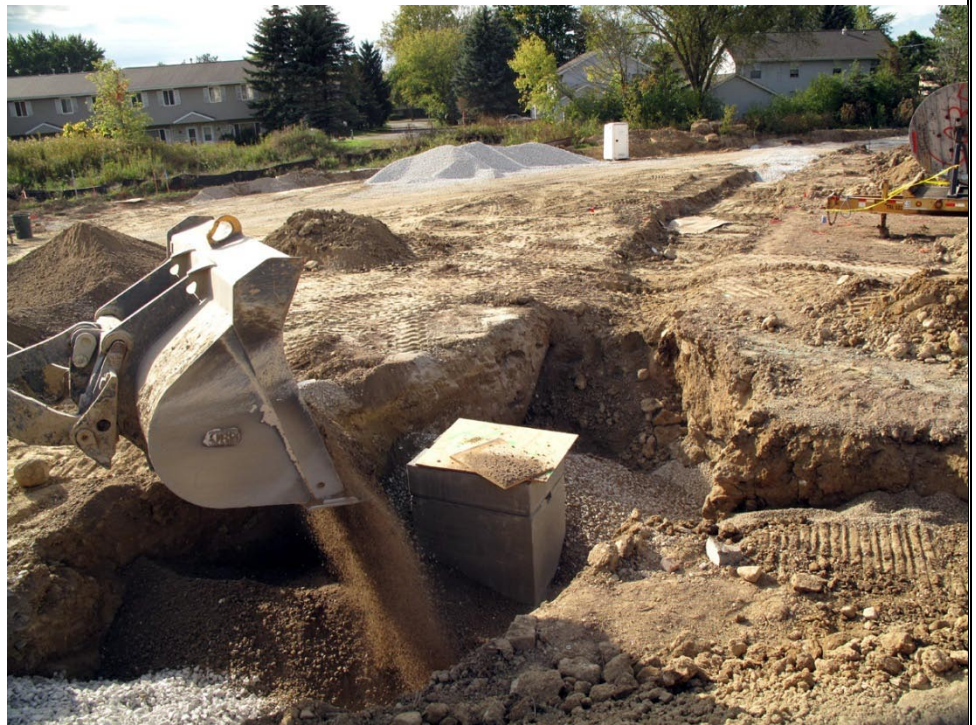
Description: Backfilling and compaction of stormwater basin with crushed recycled concrete located near northwest corner of planned parking lot.

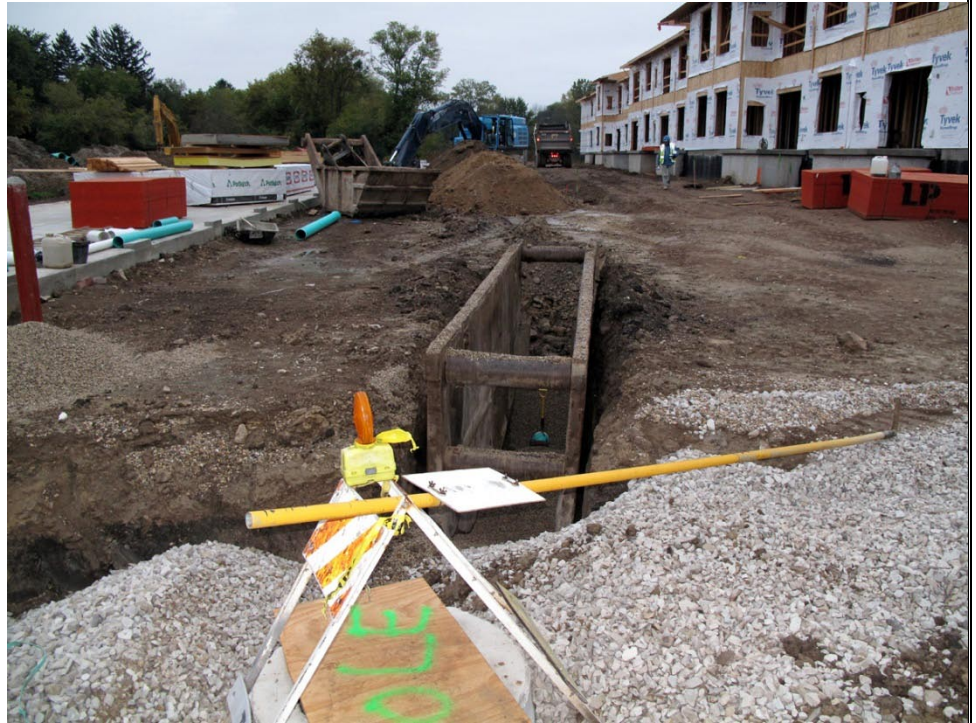
Description: Continued installation of stormwater line along east side of Building #4. Impacted soil (> 4 ft. bgs) trucked to landfill.

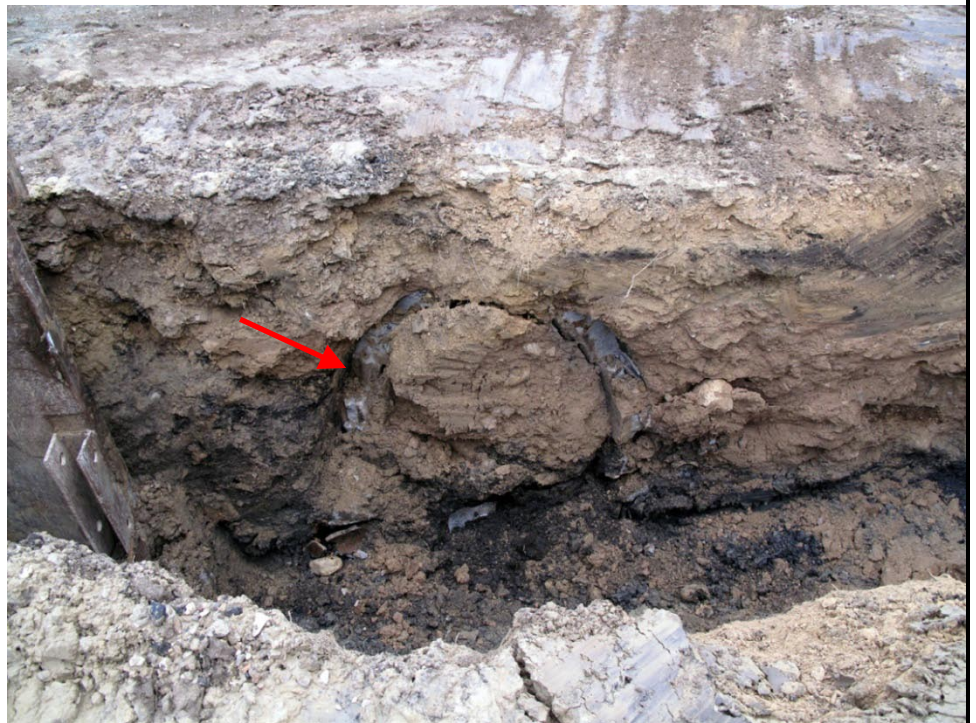
Description: Encountered former catch basin and drain tile along stormwater trench. Note cross-section of brick basin along trench wall. Impacted soil (> 4 ft. bgs) trucked to landfill.

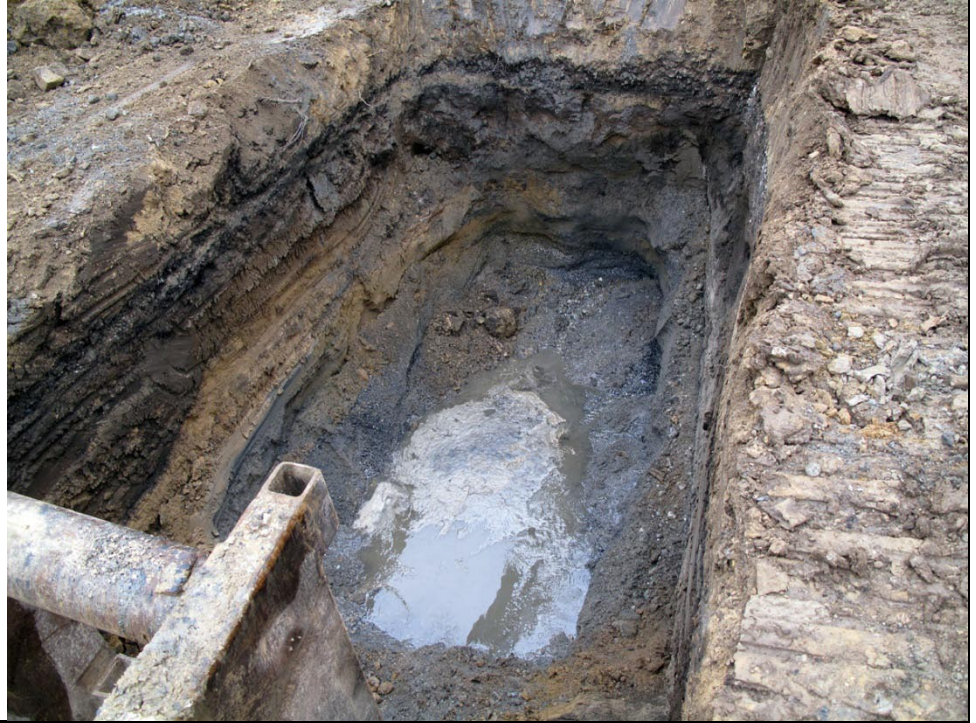
Description: Encountered impacted groundwater in storm water catch basin trench at ~ 11 feet bgs. Significant odor and gray staining noted at > 4 ft. bgs. Impacted soil trucked to landfill.

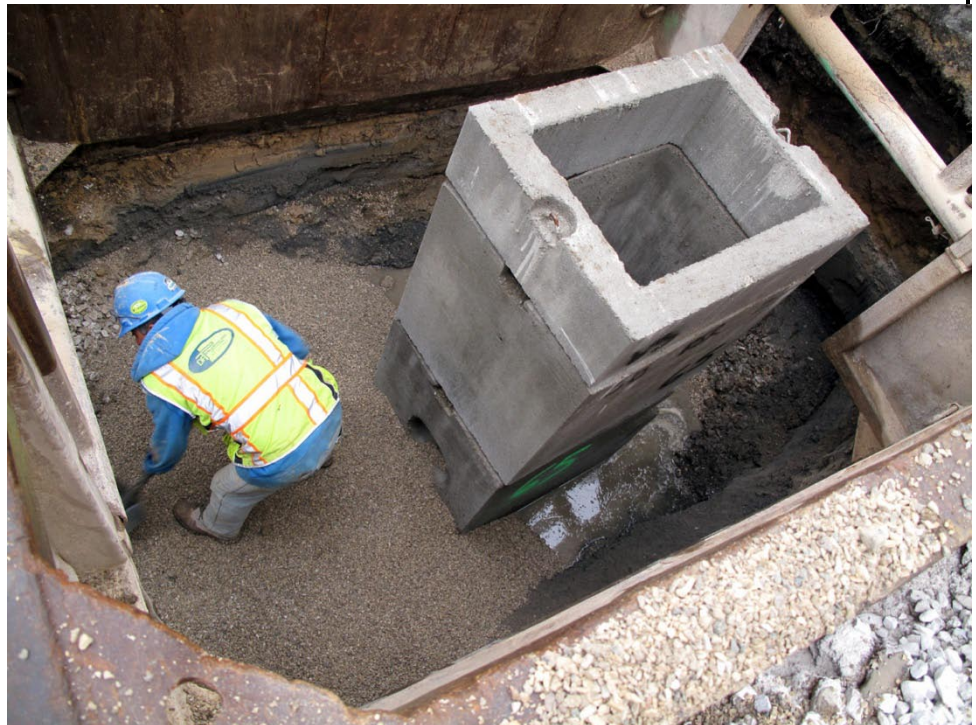
Description: Storm water catch basin installed without dewatering trench excavation.

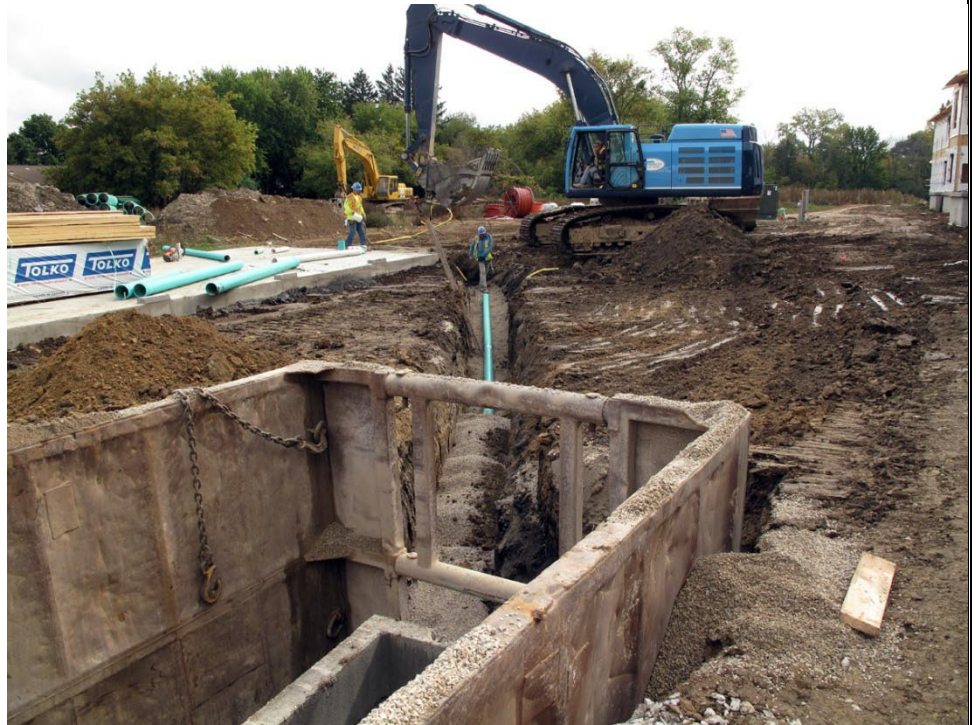
Description: Continued installation of stormwater line extending from eastern parking garage. Impacted soil (3 to 9 ft. bgs) trucked to landfill.

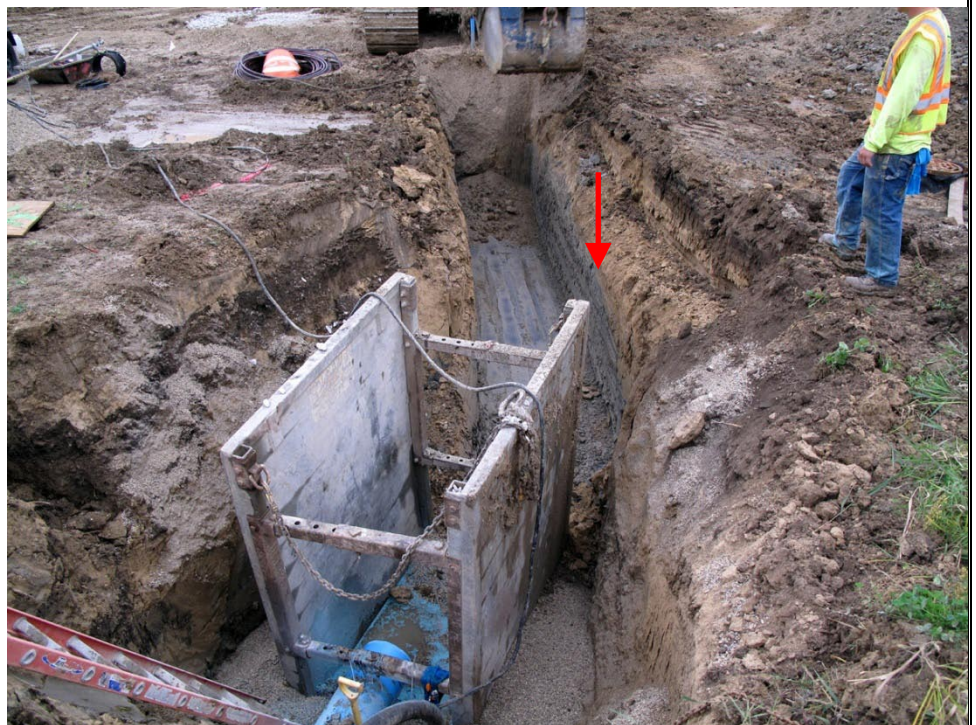
Description: Continued installation of main water line near west side of property. Impacted soil (5 to 9 ft. bgs) trucked to landfill. Note gray staining along trench walls.
