LETTER REPORT

Date: January 26, 2018

**Re: Saxony Village Development
Village of Germantown
Washington County, Wisconsin
CMC Heartland (BRRTS #02-67-000341) and Jacobus Oil Company (BRRTS #02-67-000801)**

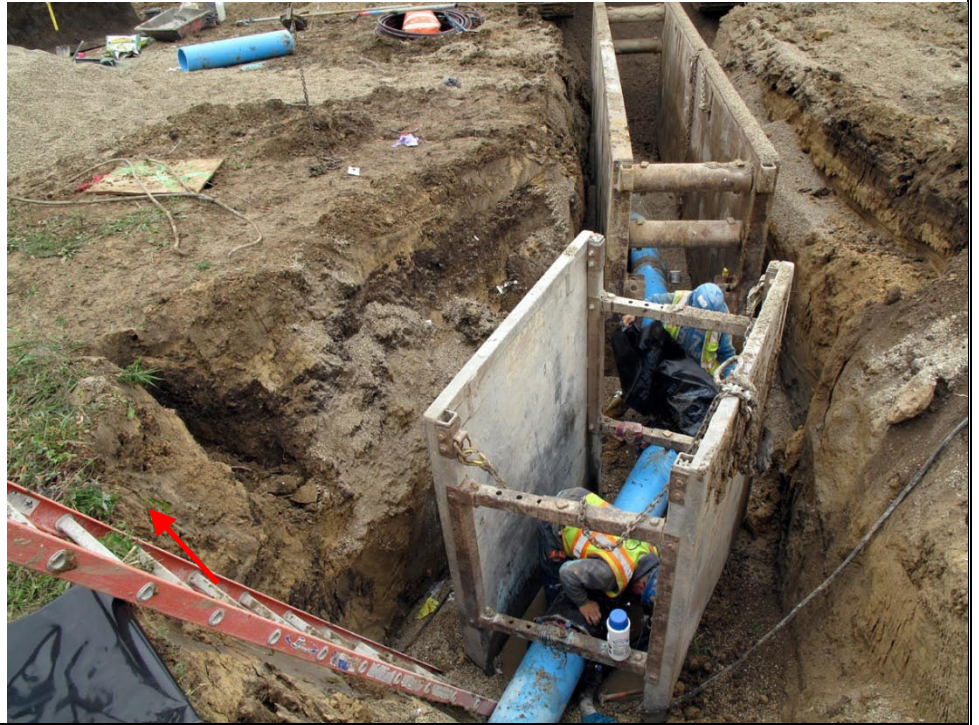
Description: Main water
line connection to
municipal water line
completed.

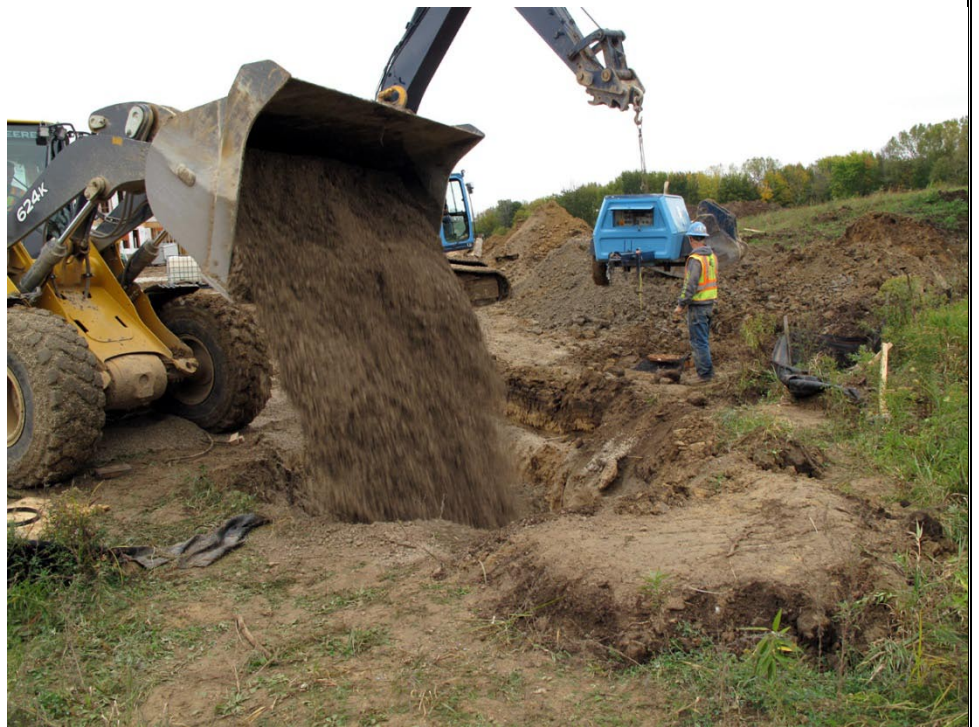
Description: Main water
line trench backfilled and
compacted with crushed
recycled concrete.

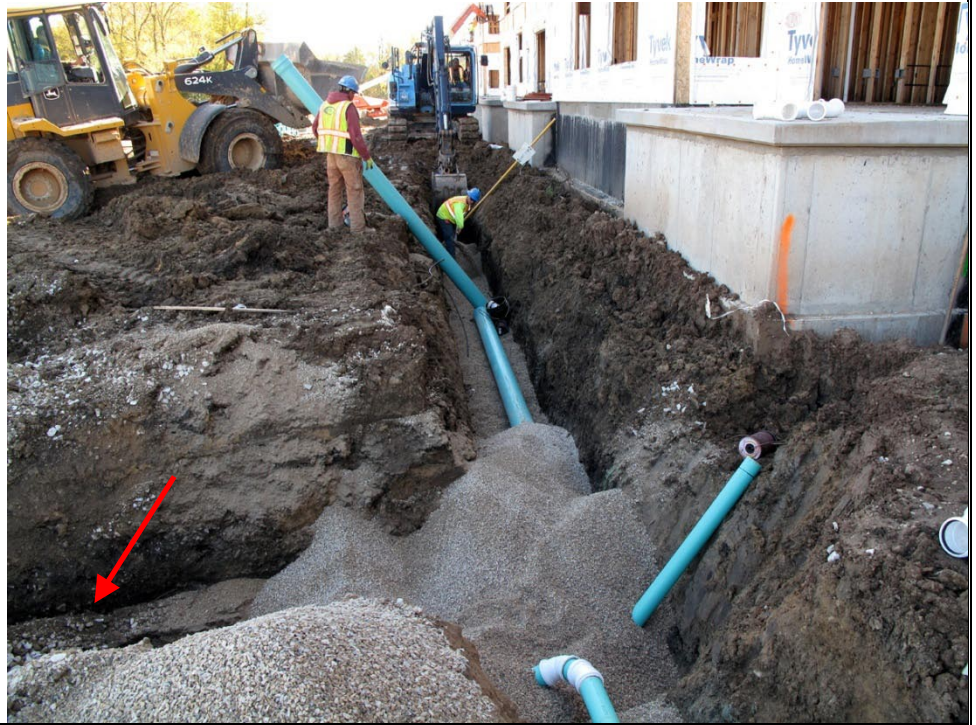
Description: Continued installation of stormwater line adjacent to east side of Building #4. Impacted soil at 8 to 10 ft. bgs, near catch basin, stockpiled adjacent to excavation.

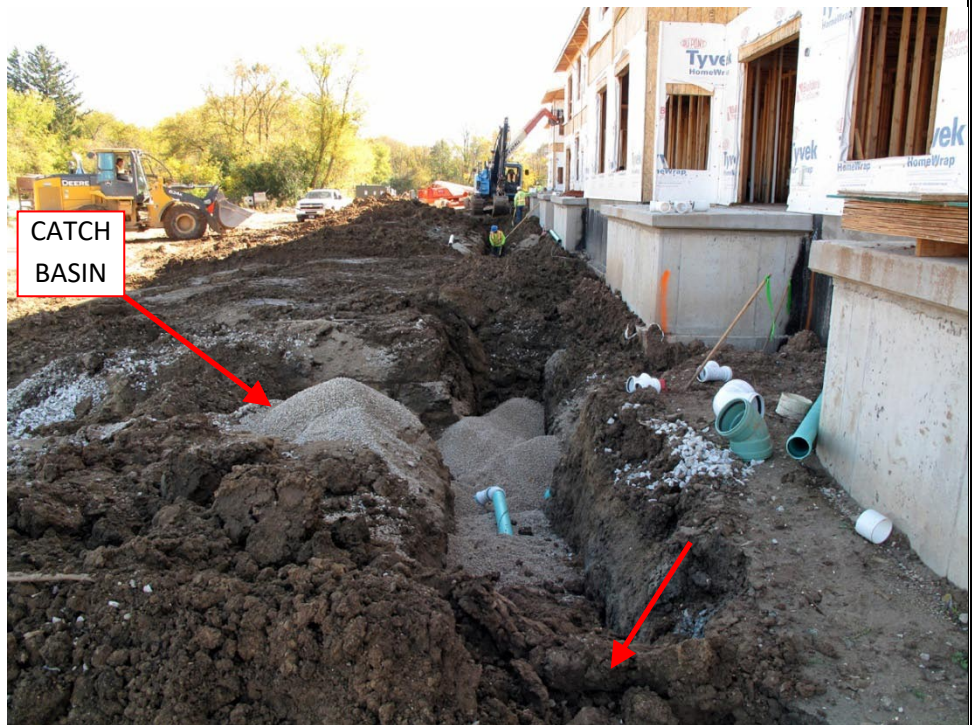
Description: No impacted soil detected south of catch basin. Excavation north of catch basin partially backfilled with impacted soil. Catch basin excavation backfilled and compacted with crushed recycled concrete.
