Subject: Refuse Hideaway Landfill  
March 2023 Operation Monitoring and Maintenance Activities

TRC completed the following operation, monitoring, and maintenance activities at the Refuse Hideaway Landfill (the Site) in Middleton, WI in March 2023.

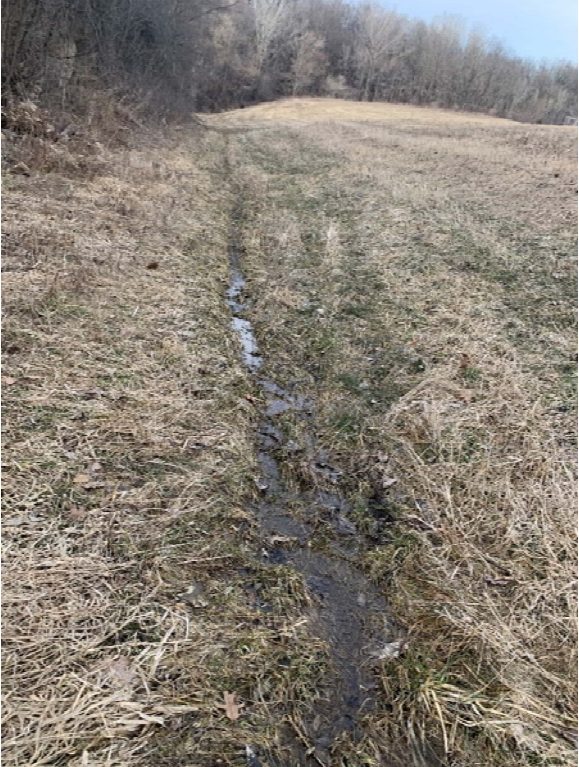
<b>Client Name:</b> Wisconsin Department of Natural Resources (WDNR)		<b>Site Location:</b> Refuse Hideaway Landfill Middleton, WI	<b>Project No.:</b> TRC # 457573
<b>Photo No.</b> 1	<b>Date</b> 3/20/2023

<b>Description</b> <u>Western Drainage Ditch:</u> Surface water was observed at the north portion of the drainage ditch. Surface water is flowing naturally towards the southernly riprap area.

West Drainage Ditch - During the March inspection, standing/slow to drain water was observed at the surface to the north. This area was previously identified as having less positive slope than its surrounds and was regraded during 2020-2021 grading work at the Site. The final post construction survey showed positive slope.

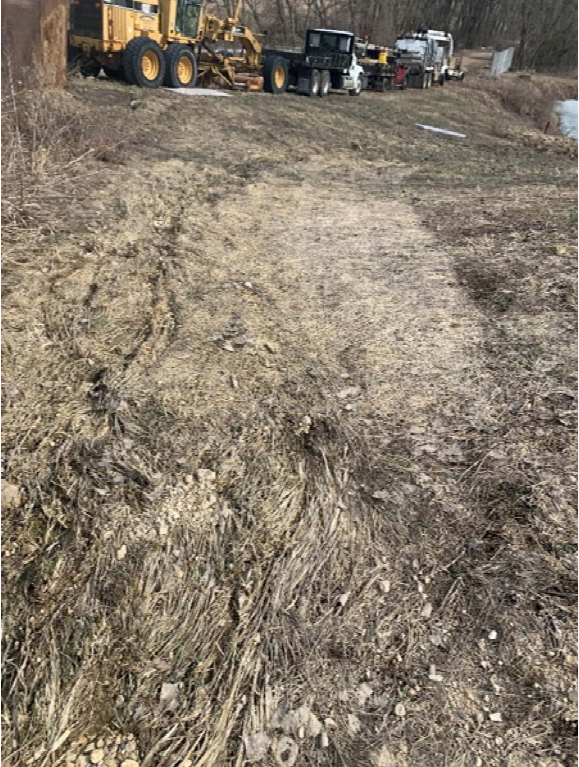
<b>Client Name:</b> Wisconsin Department of Natural Resources (WDNR)		<b>Site Location:</b> Refuse Hideaway Landfill Middleton, WI	<b>Project No.:</b> TRC # 457573
<b>Photo No.</b> 3	<b>Date</b> 3/20/2023

<b>Description</b> <u>Eastern Drainage Ditch:</u> Areas were reseeded and erosion mat was applied cover in the fall of 2022 and remains in place.

Evidence of light erosion at the eastern drainage ditch was previously observed and reseeded in the fall of 2022. Ground cover remains in place and TRC will continue to monitor the area for vegetation regrowth and any additional evidence of erosion.

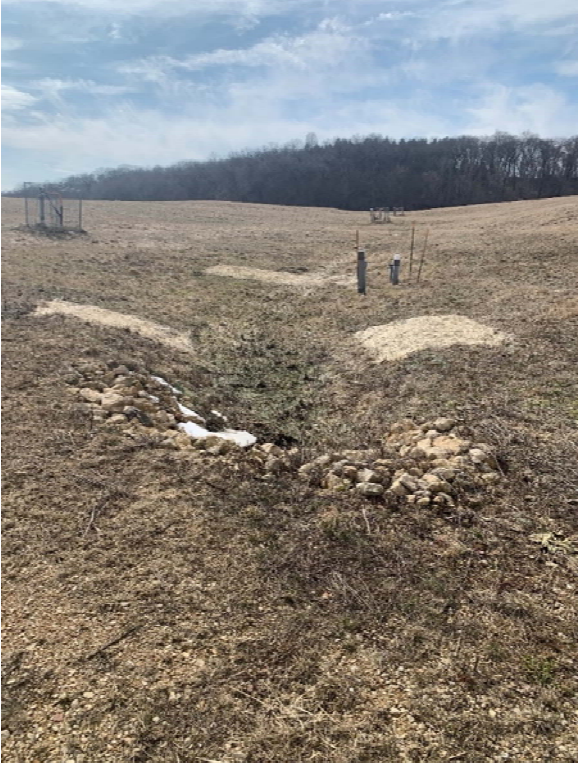
<b>Photo No.</b> 4	<b>Date</b> 3/20/2023

<b>Description</b> <u>Eastern Landfill Extents</u> Reseeding and ground cover was previously applied in the Fall of 2022 and remains in place.

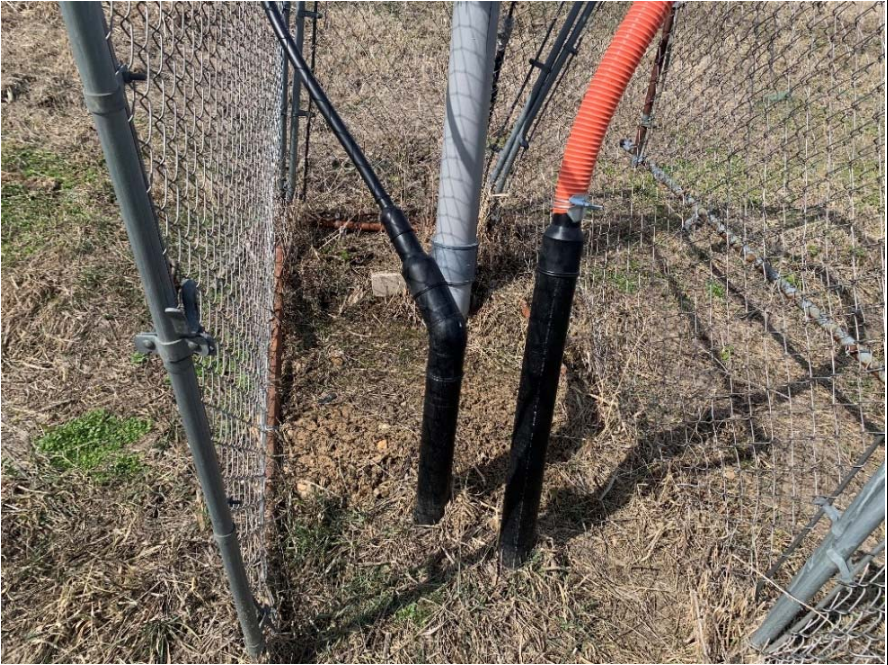
<b>Client Name:</b> Wisconsin Department of Natural Resources (WDNR)		<b>Site Location:</b> Refuse Hideaway Landfill Middleton, WI	<b>Project No.:</b> TRC # 457573
<b>Photo No.</b> 5	<b>Date</b> 3/20/2023

<b>Description</b> <u>Southern Landfill Extents:</u> Evidence of burrowing around GW-2 (and other Site wells) was observed in 2022. These areas were filled with soil in the Fall of 2022 and remain in good condition.			
<b>Photo No.</b> 6	<b>Date</b> 3/20/2023

Vegetation cover is acceptable over the majority of the Site. Various areas were reseeded and ground cover was applied in the fall of 2022 and remains in place. Burrowed areas were filled in with soil at gas extraction wells GW-2, GW-4, and GW-12 and remain in good condition.

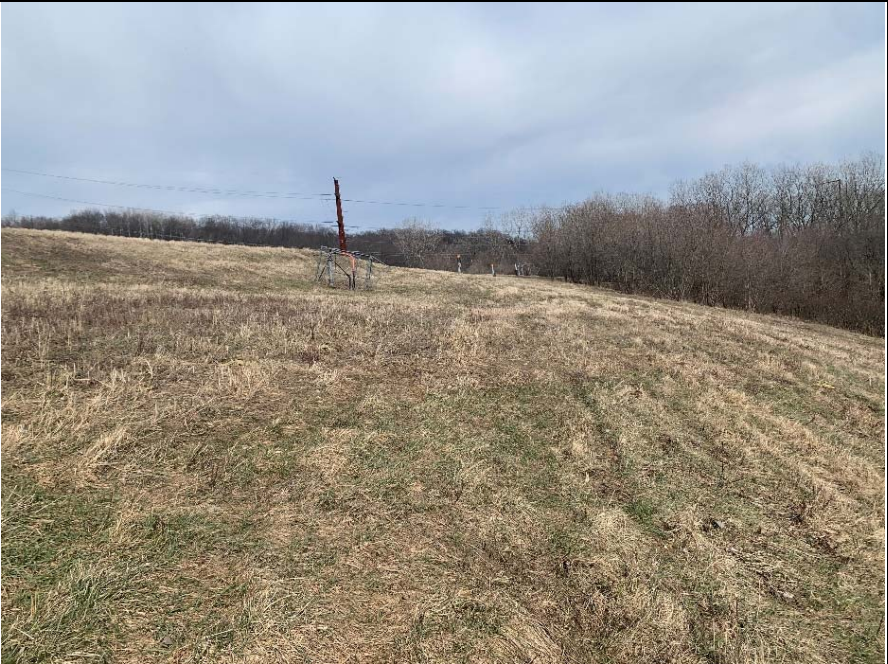
<b>Description</b> <u>Southern Landfill Extents:</u> Based on TRC's observations post-snow melt, the Site cap appears to be in good condition.
