Subject: Refuse Hideaway Landfill
June 2023 Operation Monitoring and Maintenance Activities

TRC completed the following operation, monitoring, and maintenance activities at the Refuse Hideaway Landfill (the Site) in Middleton, WI in June 2023.

Photographic Log

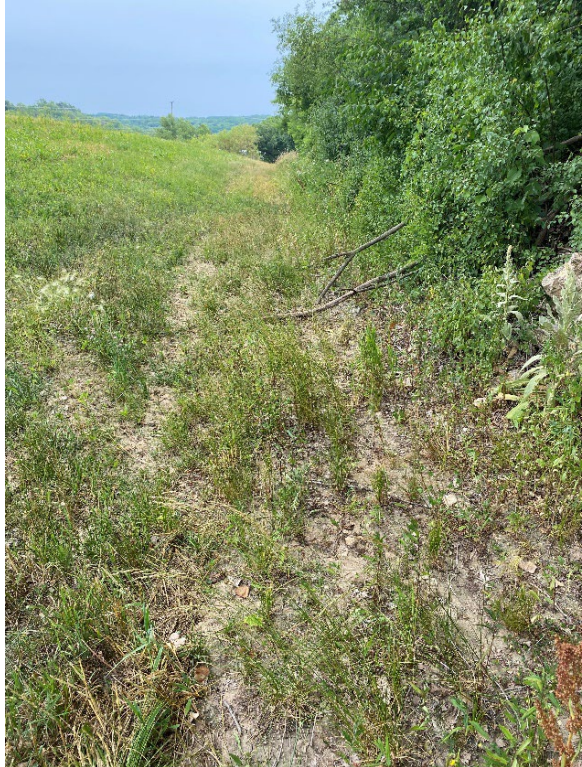
Client Name: Wisconsin Department of Natural Resources (WDNR)		Site Location: Refuse Hideaway Landfill Middleton, WI	Project No.: TRC # 457573
Photo No. 1	Date 6/30/2023

Description <u>Western Drainage Ditch:</u> Vegetation die off was observed at the north portion of the drainage ditch.

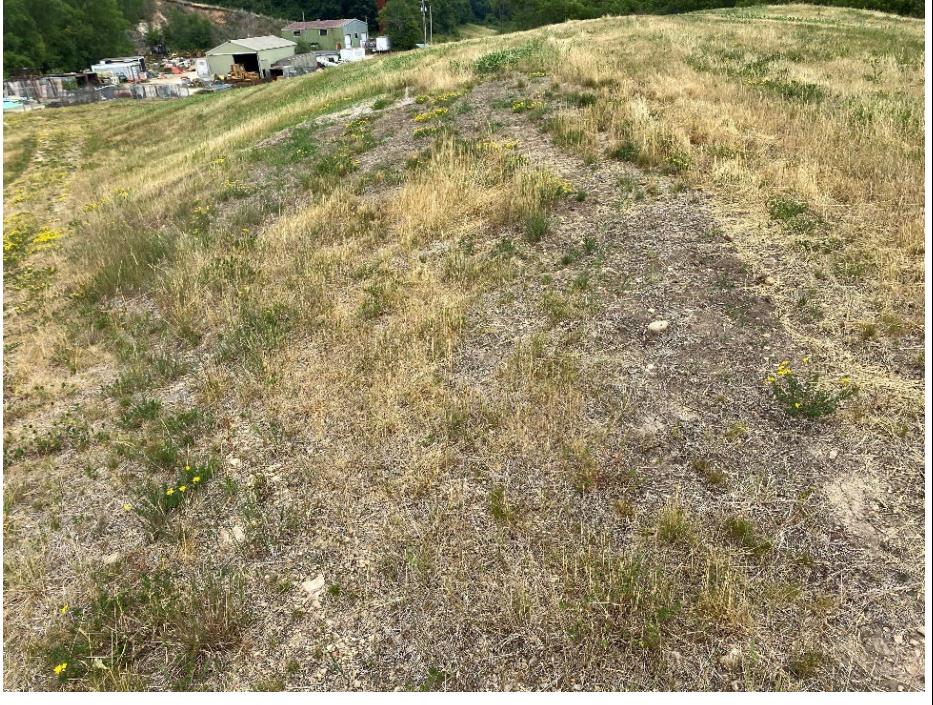
Client Name: Wisconsin Department of Natural Resources (WDNR)		Site Location: Refuse Hideaway Landfill Middleton, WI	Project No.: TRC # 457573
Photo No. 3	Date 6/30/2023

Description <u>Eastern Landfill Extents</u> Reseeding and ground cover was previously applied in the Fall of 2022. Some bare spots remain and likely need reseeding.			
Photo No. 4	Date 6/30/2023

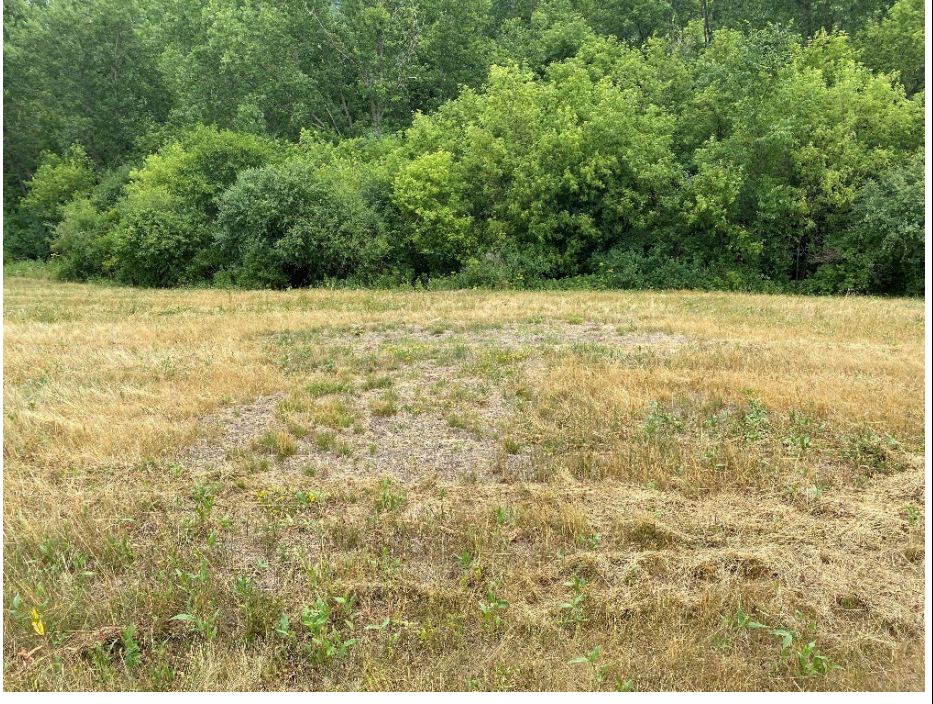
Description <u>Southern/Eastern Landfill Extents</u> Reseeding and ground cover was previously applied in the Fall of 2022. Some bare spots remain and likely need reseeding.
