Subject: Refuse Hideaway Landfill
September 2023 Operation Monitoring and Maintenance Activities

TRC completed the following operation, monitoring, and maintenance activities at the Refuse Hideaway Landfill (the Site) in Middleton, WI in September 2023.

Photographic Log

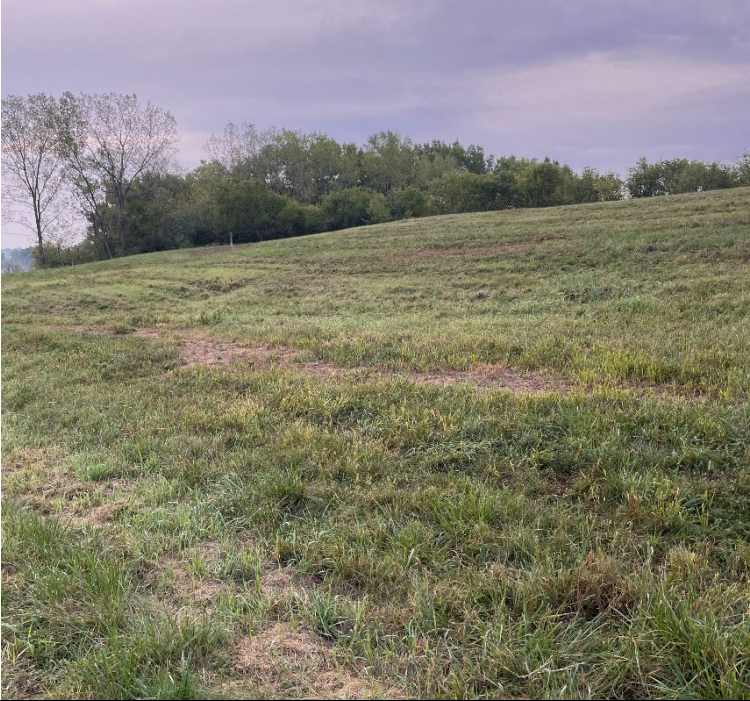
Photo No. 1	Date 9/21/2023	<div style="display: flex;"> <div style="flex: 1; padding: 5px;"> <p>Description</p> <p><u>Eastern Drainage Ditch:</u> Bare spots are present to the north, above the drainage way and will likely require reseeding.</p> </div> <div style="flex: 2;">

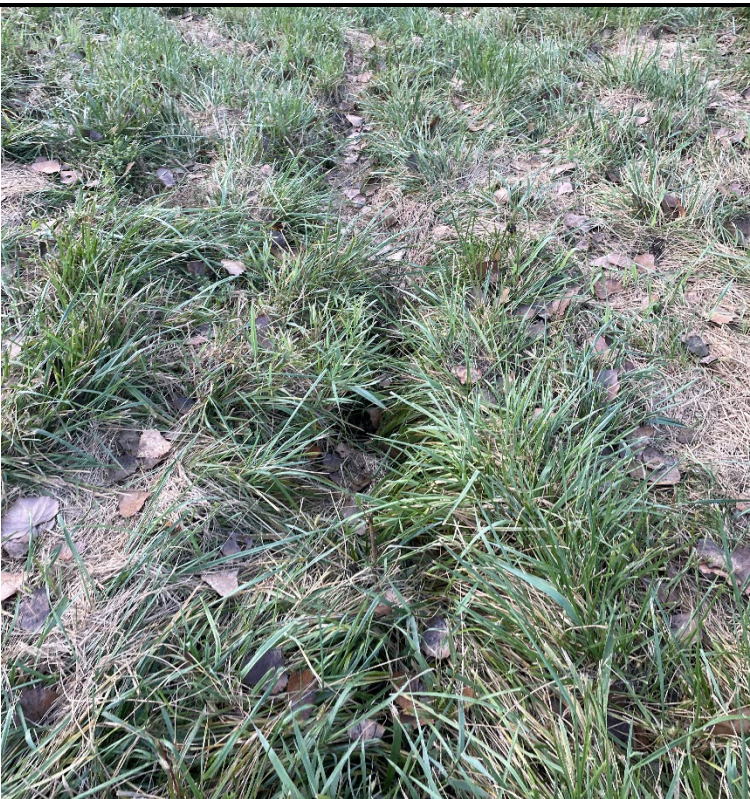
Photo No. 2	Date 9/21/2023	<div style="display: flex;"> <div style="flex: 1; padding: 5px;"> <p>Description</p> <p><u>Eastern Drainage Ditch:</u> Evidence of erosion starting to occur was observed at the north portion of the eastern drainage ditch leading to the sediment basin. Vegetation is still intact but ruts are starting to form.</p> </div> <div style="flex: 2;">

<p>Extent of vegetation cover:</p> <p>Vegetation cover is acceptable over the majority of the site. Various areas were reseeded and ground cover was applied in the fall of 2022 and remains in place (see photo #3 and #4).</p>
<p>Significant erosion:</p> <p>No evidence of significant erosion was observed at the site.</p>
<p>Repeated erosion:</p> <p>No evidence of significant erosion was observed at the site.</p>
<p>Vegetation die-off:</p> <p>Areas at the west drainage ditch and east drainage ditch previously showed signs of vegetation die-off and were reseeded in the fall of 2022. Ground cover in these areas remains and TRC will continue to monitor regrowth. (see photo #1).</p>
<p>Maintain surface water conveyances and the sedimentation basin by completing the following:</p> <p>Inspect drainage ditches for erosion, blockages, and vegetation, describe and note any issues:</p> <p>Evidence of erosion at the eastern drainage ditch above the sediment basin was observed. Vegetation is in place, but ruts are starting to form (See photo #2). TRC will continue to monitor the area.</p>

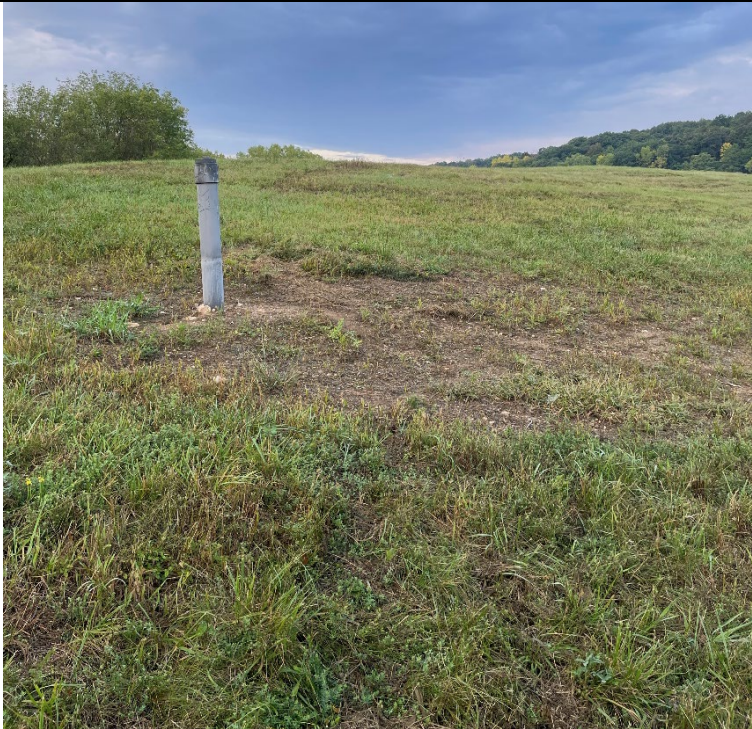
Client Name: Wisconsin Department of Natural Resources (WDNR)		Site Location: Refuse Hideaway Landfill Middleton, WI	Project No.: TRC # 457573
Photo No. 3	Date 9/21/2023

Description <u>Eastern Landfill Extents</u> Reseeding and ground cover was previously applied in the Fall of 2022. Some bare spots remain and will likely require reseeding.

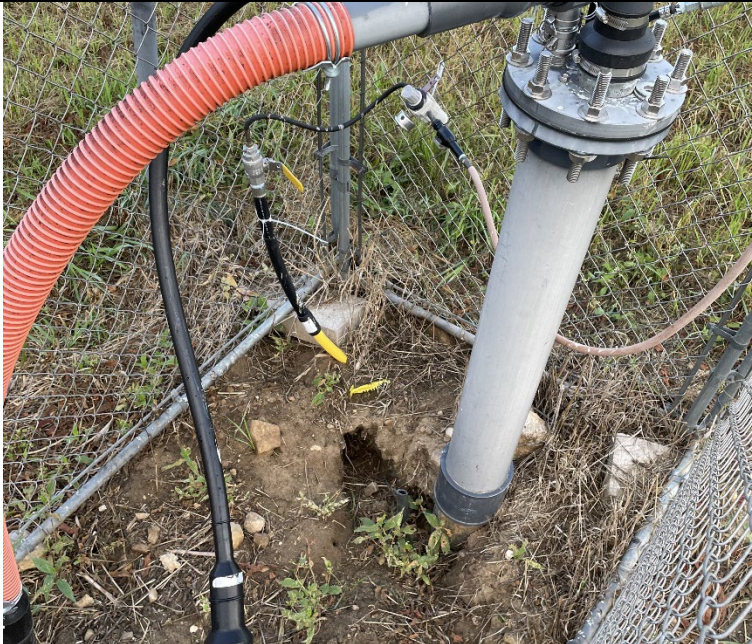
Client Name: Wisconsin Department of Natural Resources (WDNR)		Site Location: Refuse Hideaway Landfill Middleton, WI	Project No.: TRC # 457573
Photo No. 5	Date 9/21/2023

Description <u>Southern Landfill Extents</u> GW-2 and GW-4 have burrowing from wildlife inside fencing.

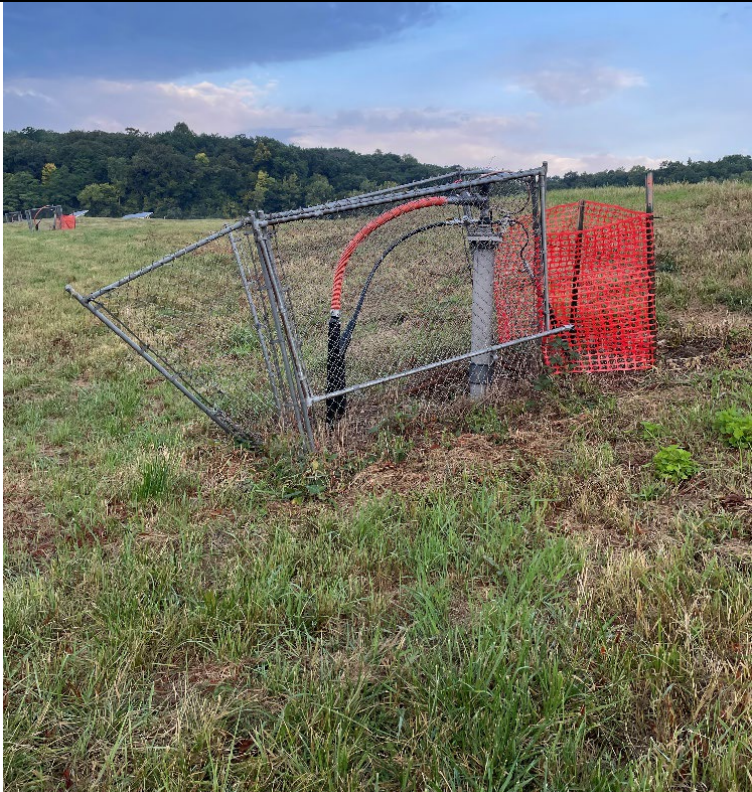
Photo No. 6	Date 9/21/2023

Description <u>Southern Landfill Extents:</u> GW-2 protective fencing is falling apart. Fencing still provides protection during mowing operations. GW-1 protective fencing is in the same condition as GW-2.

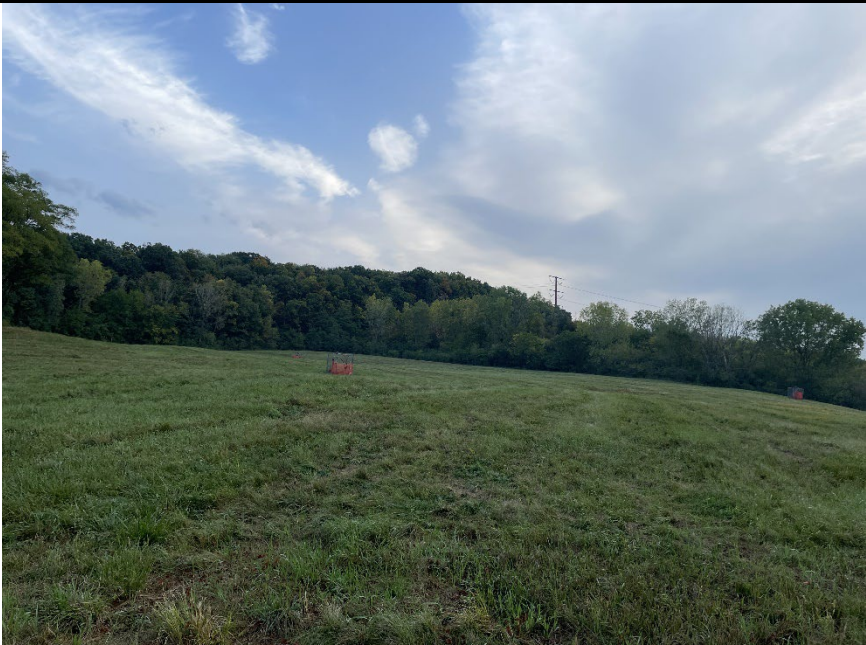
Client Name: Wisconsin Department of Natural Resources (WDNR)		Site Location: Refuse Hideaway Landfill Middleton, WI	Project No.: TRC # 457573
Photo No. 7	Date 9/21/2023

Description <u>Northern Landfill Extents:</u> Cap remains in good condition with vegetation cover.
