Subject: Refuse Hideaway Landfill  
December 2023 Operation Monitoring and Maintenance Activities

TRC completed the following operation, monitoring, and maintenance activities at the Refuse Hideaway Landfill (the Site) in Middleton, WI in December 2023.

## Photographic Log

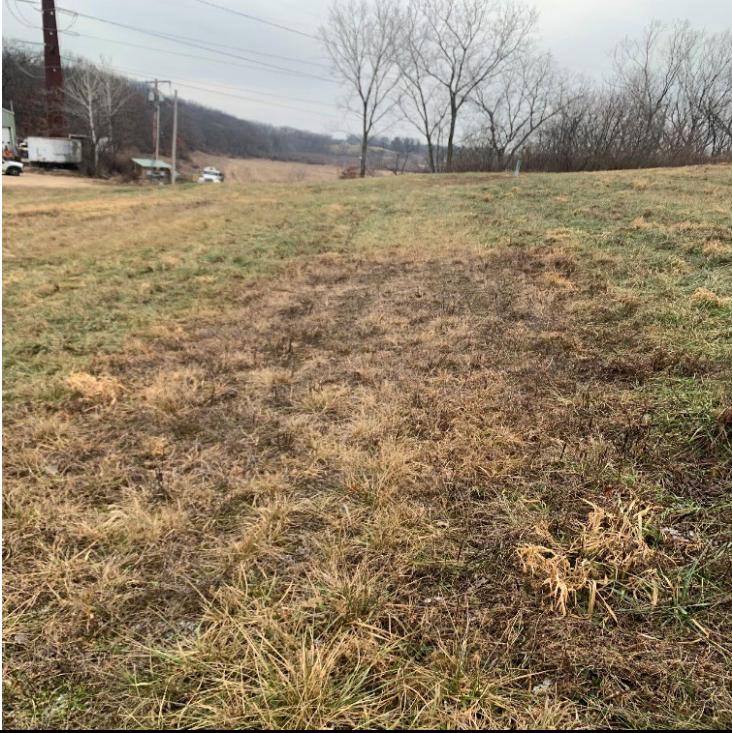
<b>Description</b> <u>Eastern Drainage Ditch:</u> Bare spots are present to the north, above the drainage way and may require reseeding in Spring of 2024.			
<b>Photo No.</b> 2	<b>Date</b> 12/21/2023

Areas at the west drainage ditch and east drainage ditch previously showed signs of vegetation die-off and were reseeded in the fall of 2022. Ground cover in these areas remains and TRC will continue to monitor and apply seed as needed in 2024. (see photo #1).

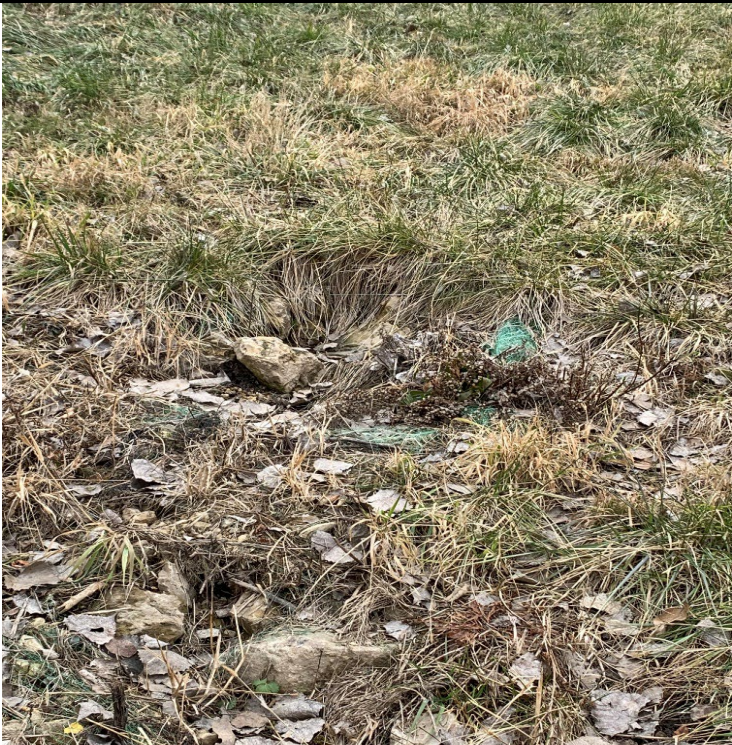
<b>Description</b> <u>Eastern Drainage Ditch:</u> Evidence of erosion starting to occur was observed at the north portion of the eastern drainage ditch leading to the sediment basin. Vegetation is still intact but ruts are starting to form.

Evidence of erosion at the eastern drainage ditch above the sediment basin was observed. Vegetation is in place, but ruts are starting to form (See photo #2). TRC will continue to monitor the area.

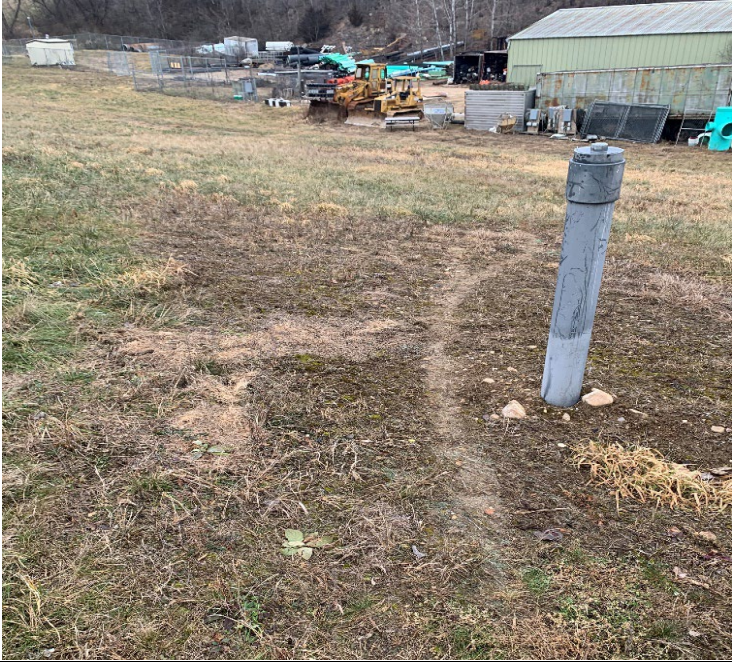
<b>Description</b> <u>Eastern Landfill Extents</u> Reseeding and ground cover was previously applied in the Fall of 2022. Some bare spots remain and will may require reseeding in Spring 2024.			
<b>Photo No.</b> 4	<b>Date</b> 12/21/2023

Vegetation cover is acceptable over the majority of the site. Various areas were reseeded and ground cover was applied in the fall of 2022. Some bare spots were observed (see photo #3 and #4). Per discussion with the WDNR, TRC will evaluate the areas in Spring of 2024 and apply seed as needed at that time.

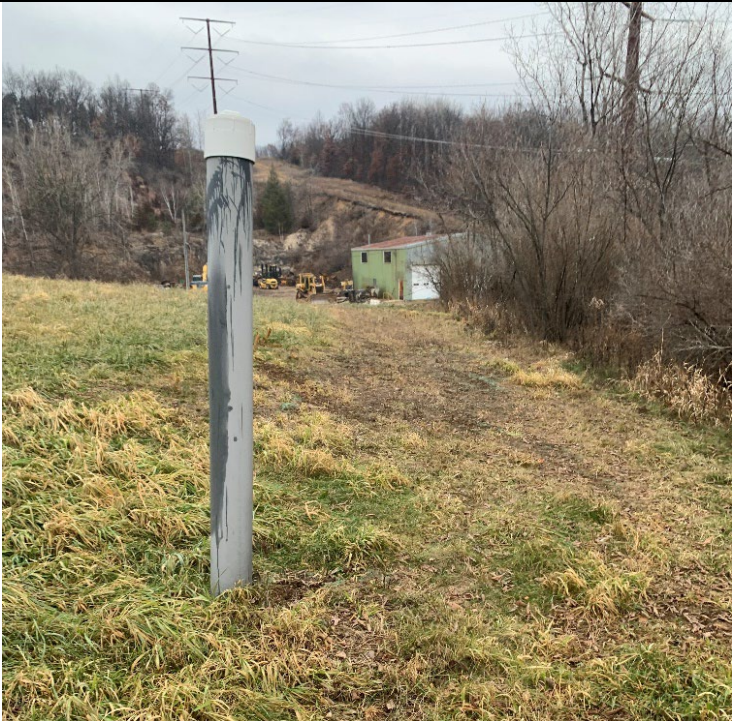
<b>Description</b> <u>Eastern Landfill Extents</u> Reseeding and ground cover was previously applied in the Fall of 2022. Some bare spots remain and may require reseeding in Spring 2024.

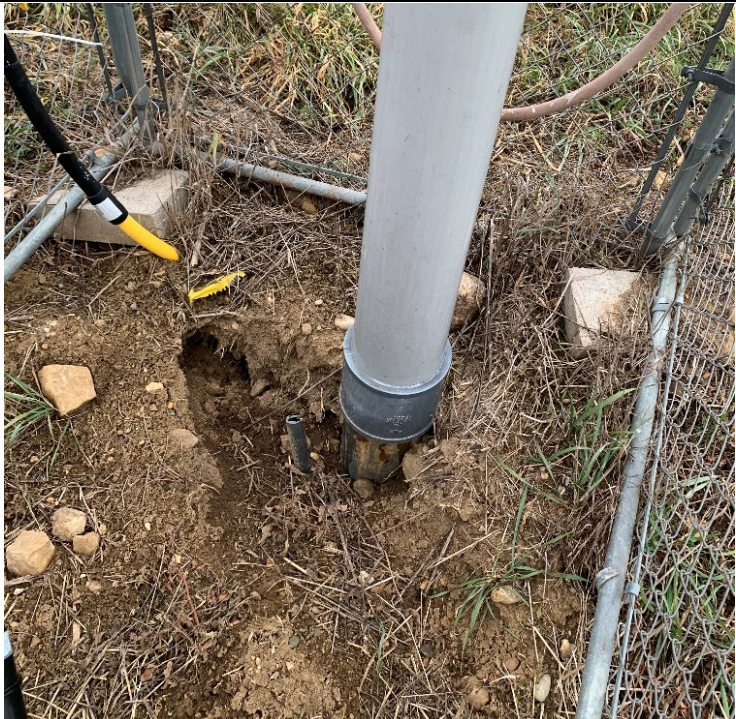
-GW-2 and GW-4 on the south side have wildlife burrowing inside the fencing (see photo #5)

<b>Description</b> <u>Southern Landfill Extents</u> GW-2 and GW-4 have wildlife burrowing inside the fencing.

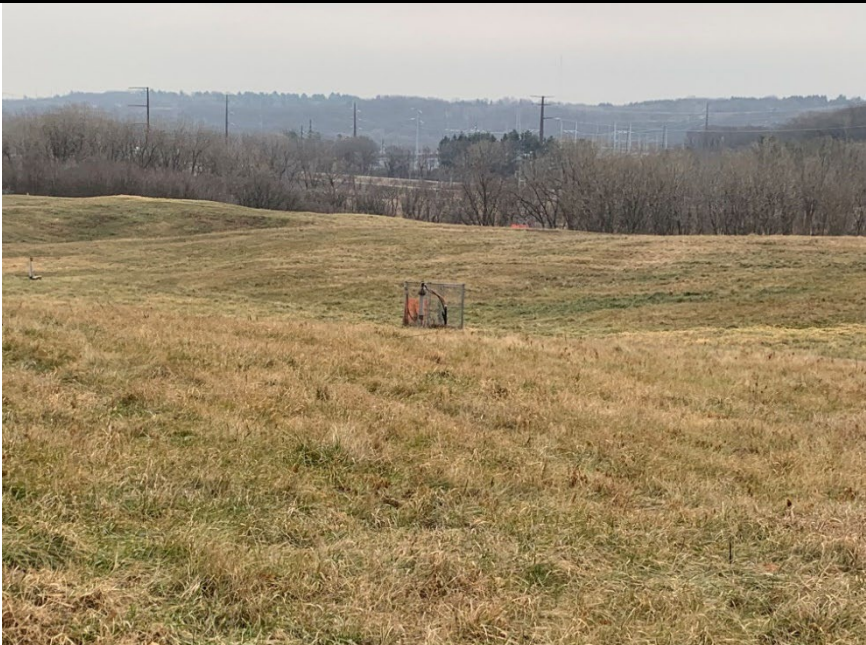
<b>Description</b> <u>Northern Landfill Extents:</u> Cap remains in good condition with full vegetation cover.
