Subject: Refuse Hideaway Landfill
2023 Operation Monitoring and Maintenance Annual Report

Attachment 1
Electrical Repair Documentation

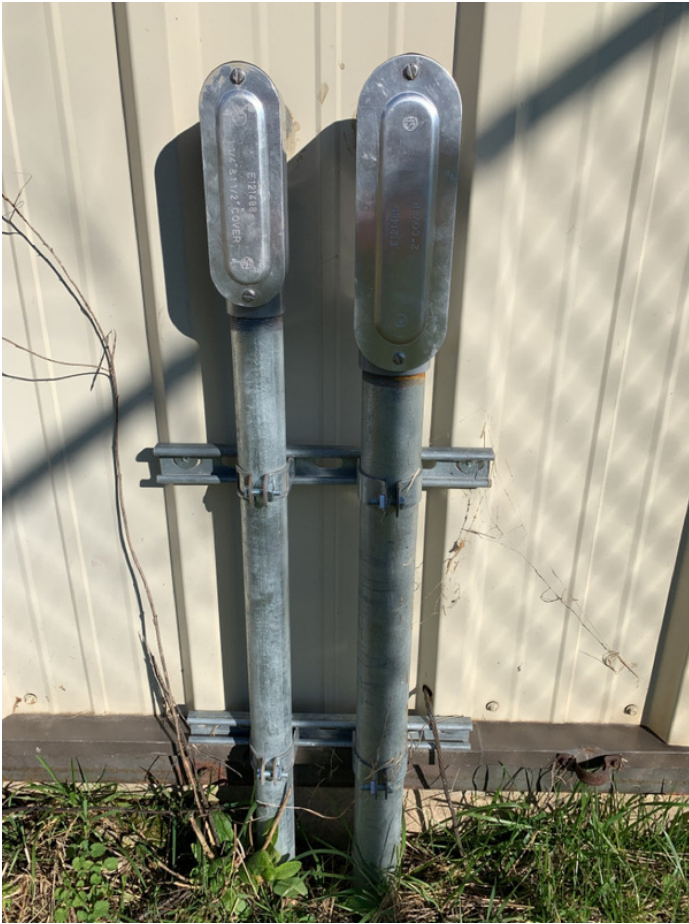
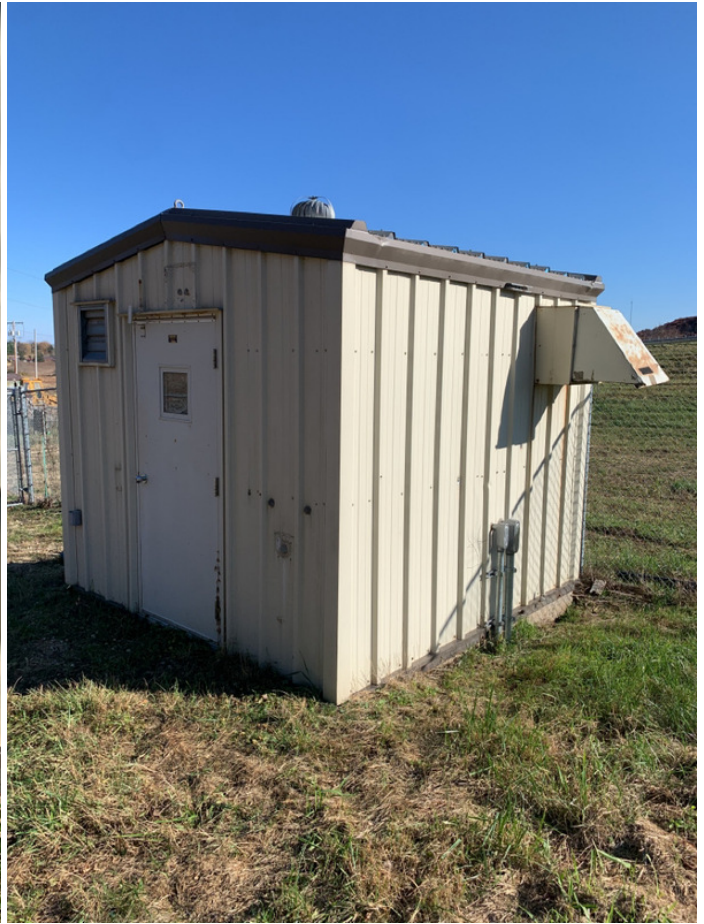
Photo Info - 3. Skid electrical

460 PRI VOLTS

240/120 SEC VOLTS

Photo Date	October 26, 2022
Photo Time	14:58
View Direction	
Description	Shed
Photographers Name	Andrew astehn

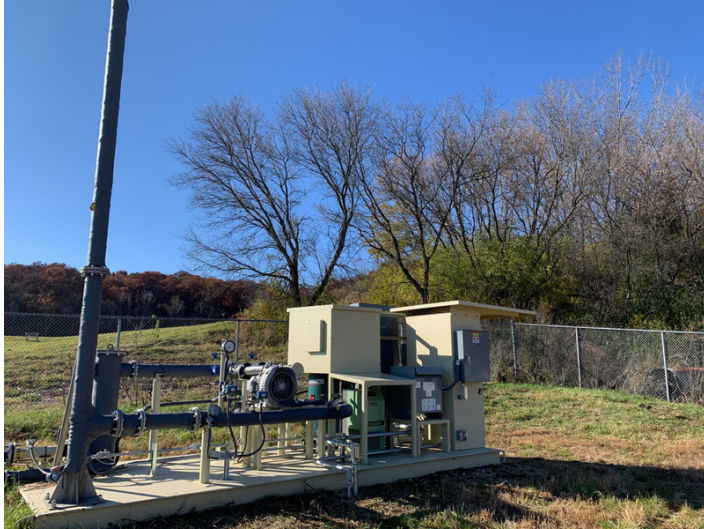
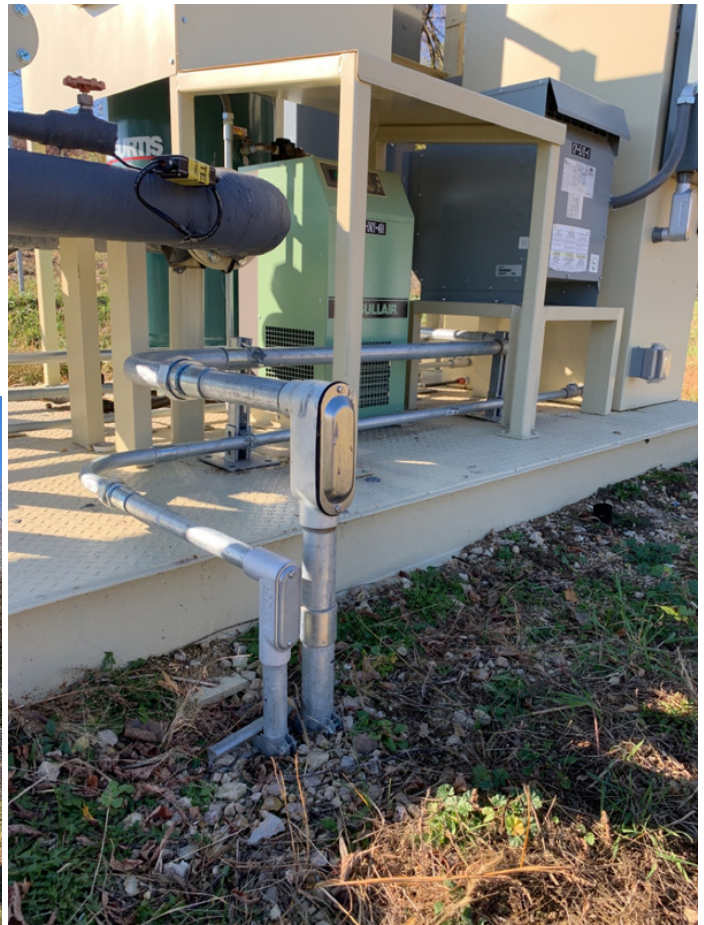
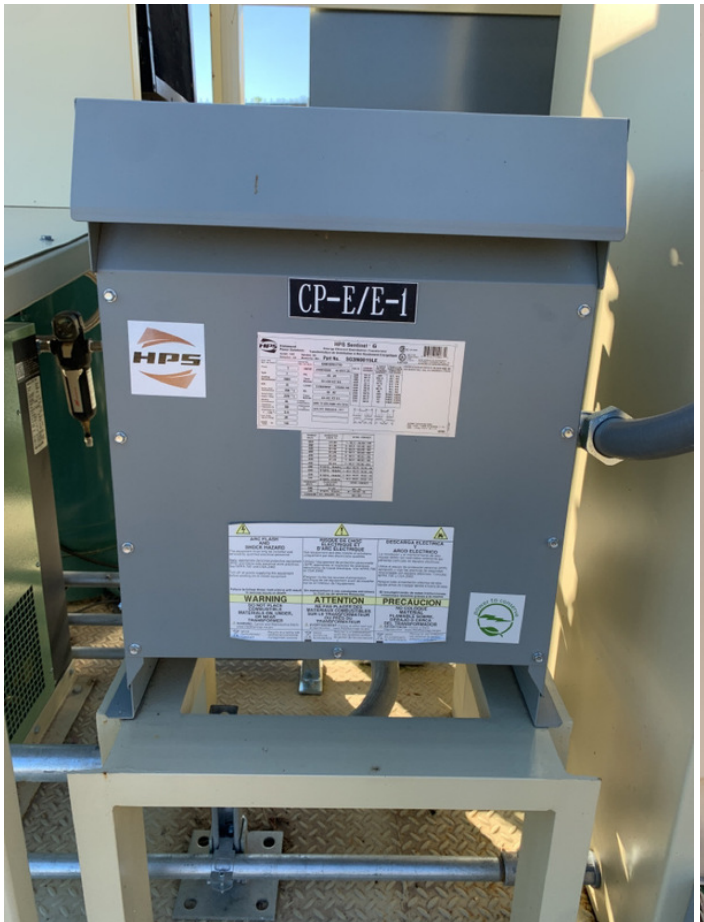
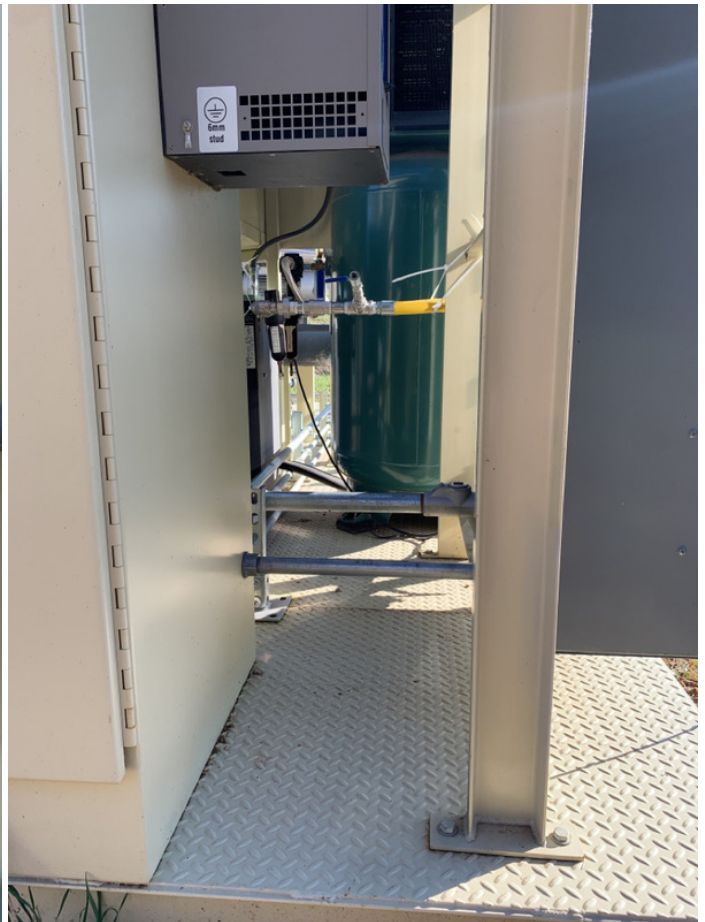
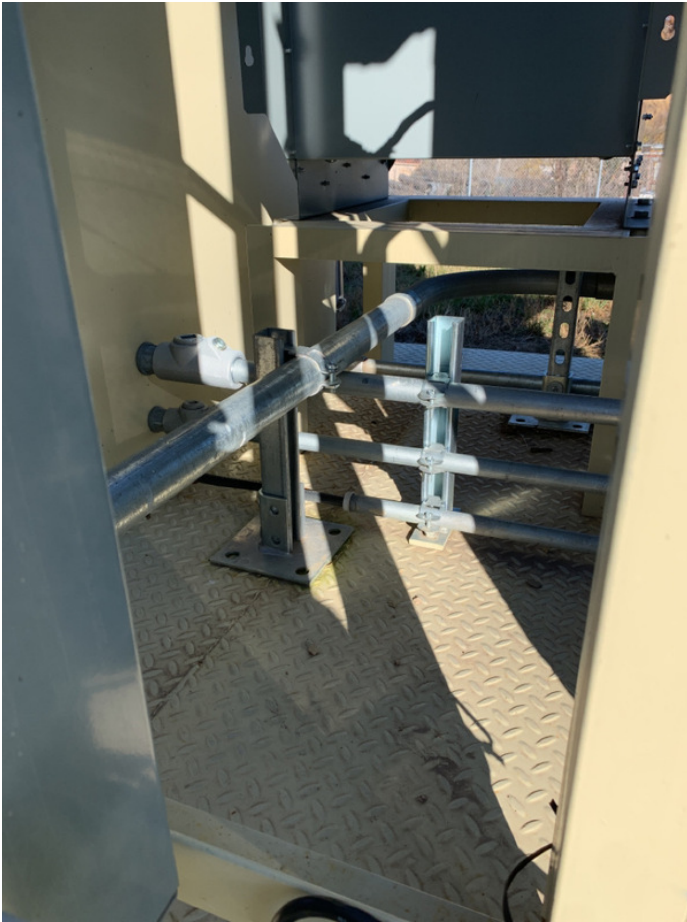
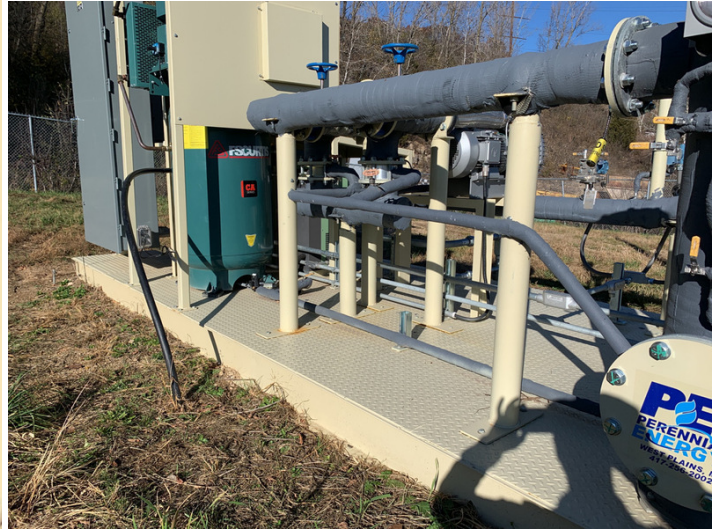
Photo Date	October 26, 2022
Photo Time	
View Direction	
Description	Skid electrical
Photographers Name	Andrew Stehn

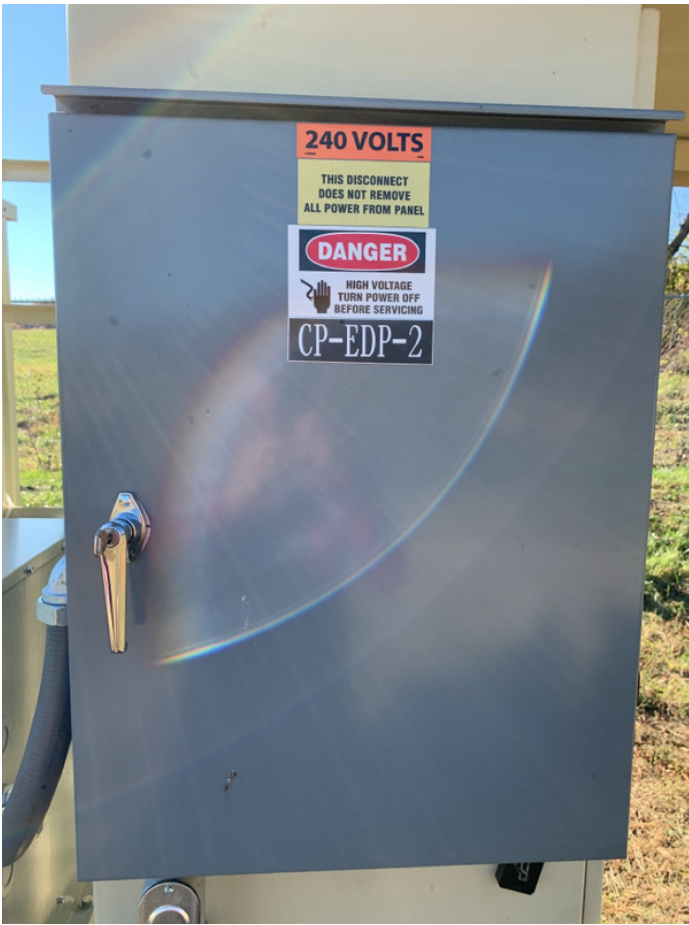
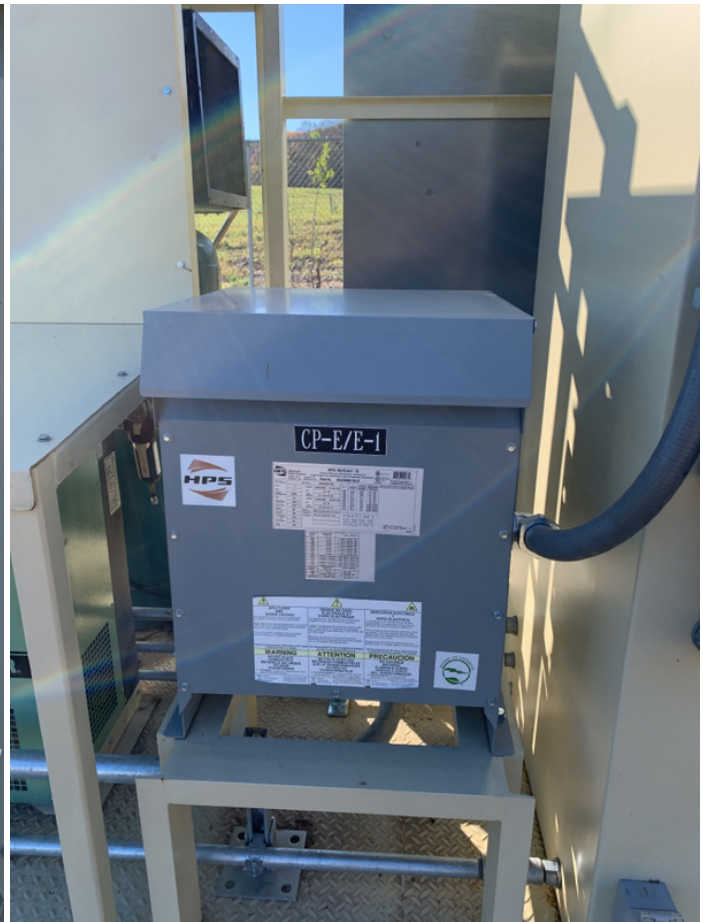
Photo Info - 4. 15:04, 240 volt panel and transformer

Photo Date	October 26, 2022
Photo Time	15:04
View Direction	
Description	240 volt panel and transformer
Photographers Name	Andrew Stehn

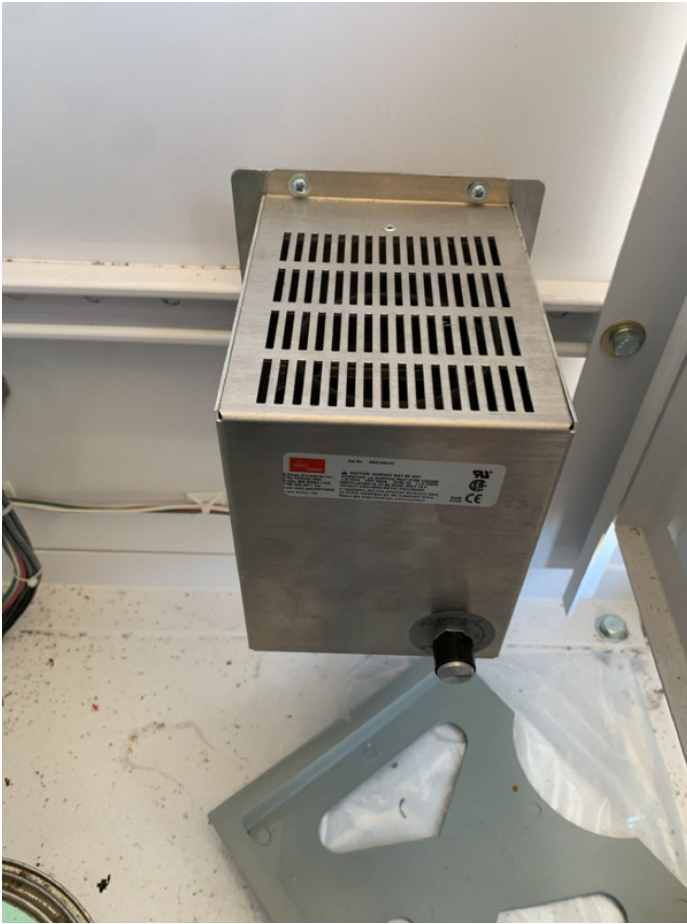
Photo Info - 6. 15:12, 480 Panel

Photo Date	October 26, 2022
Photo Time	15:06
View Direction	
Description	PIC
Photographers Name	Andrew Stehn

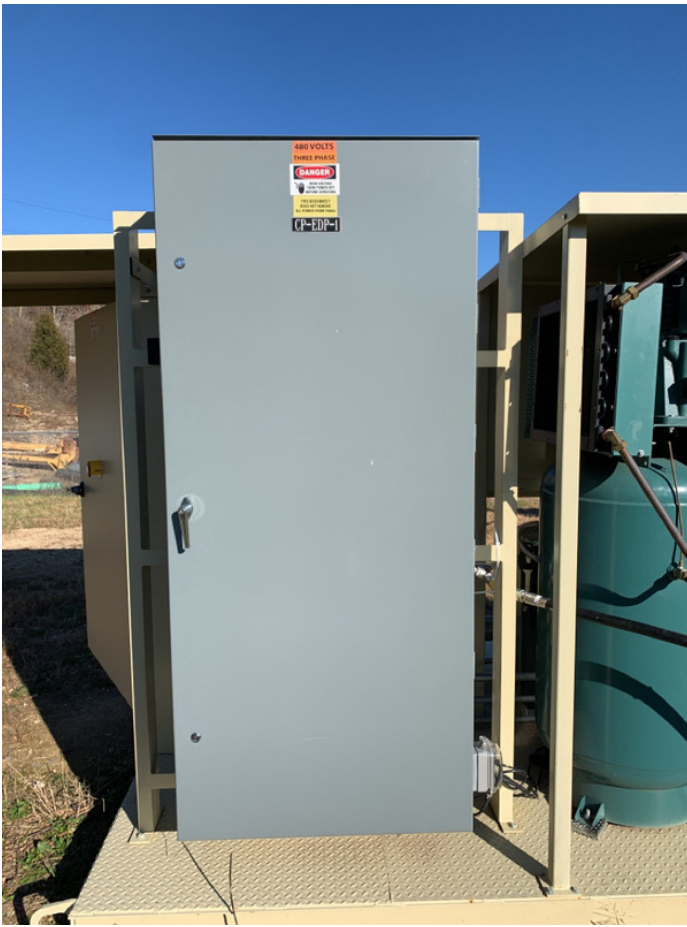
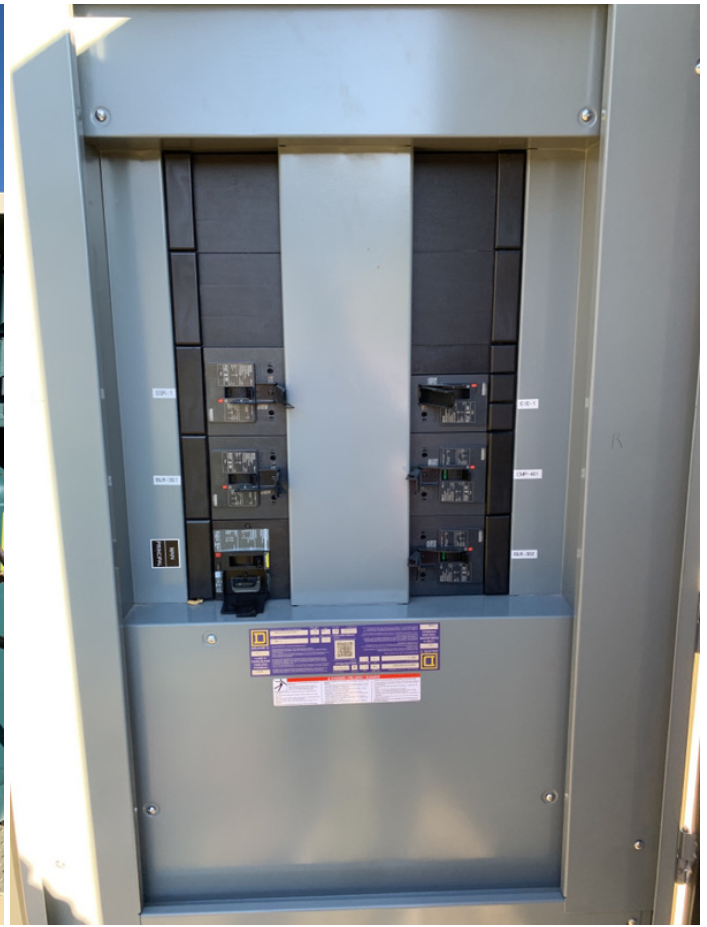
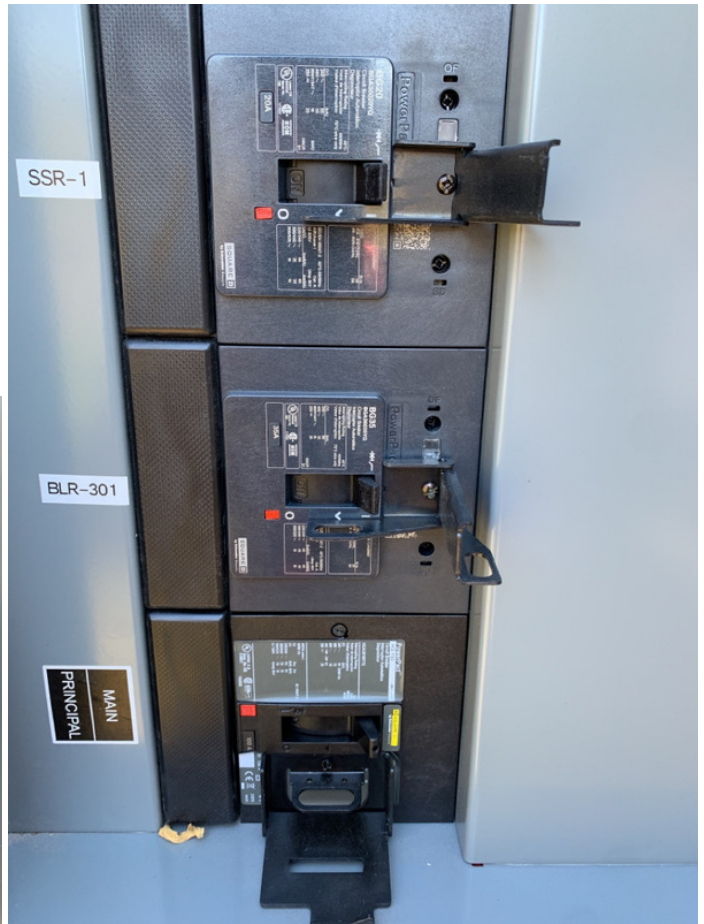
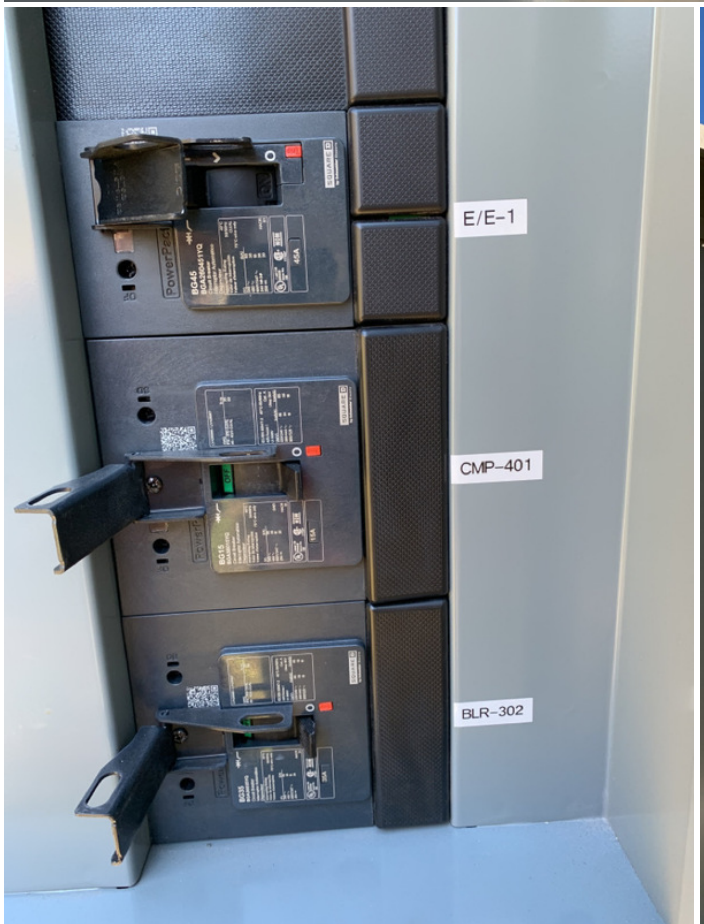
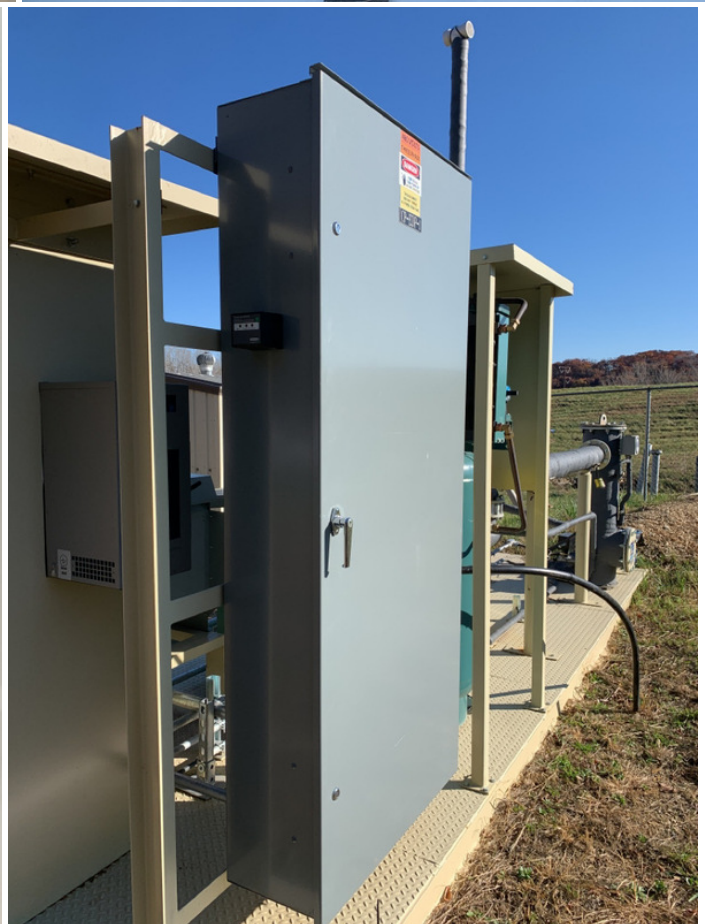
Photo Date	October 26, 2022
Photo Time	15:12
View Direction	
Description	480 Panel
Photographers Name	Andrew Stehn

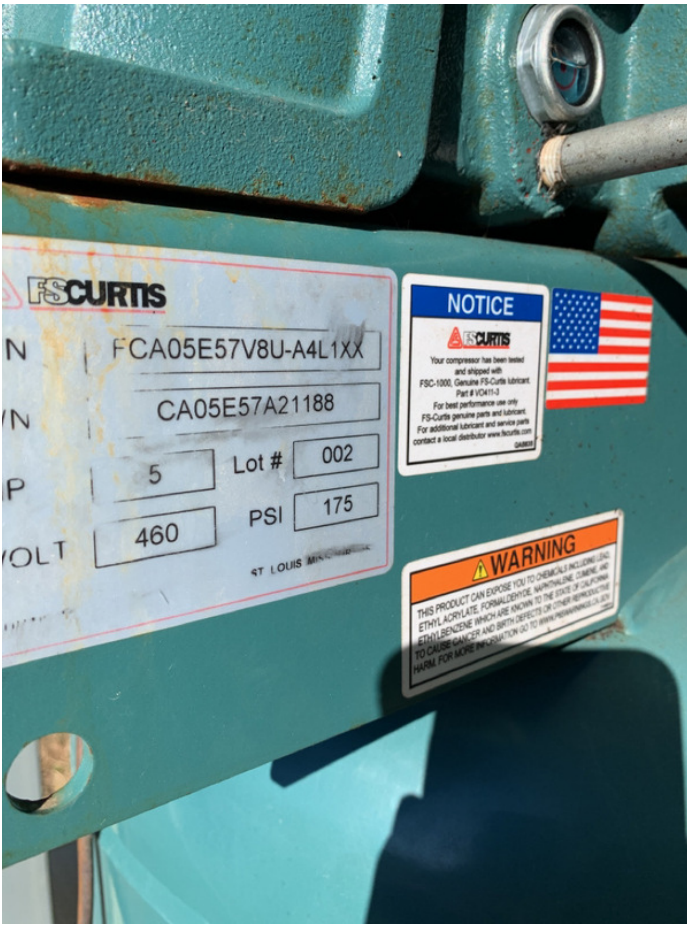
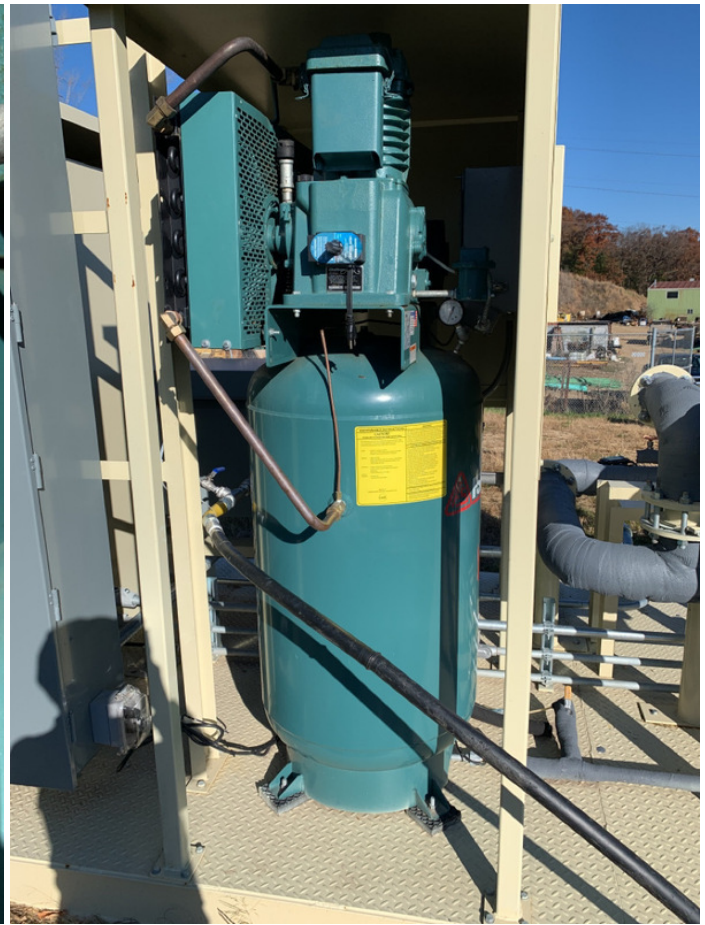
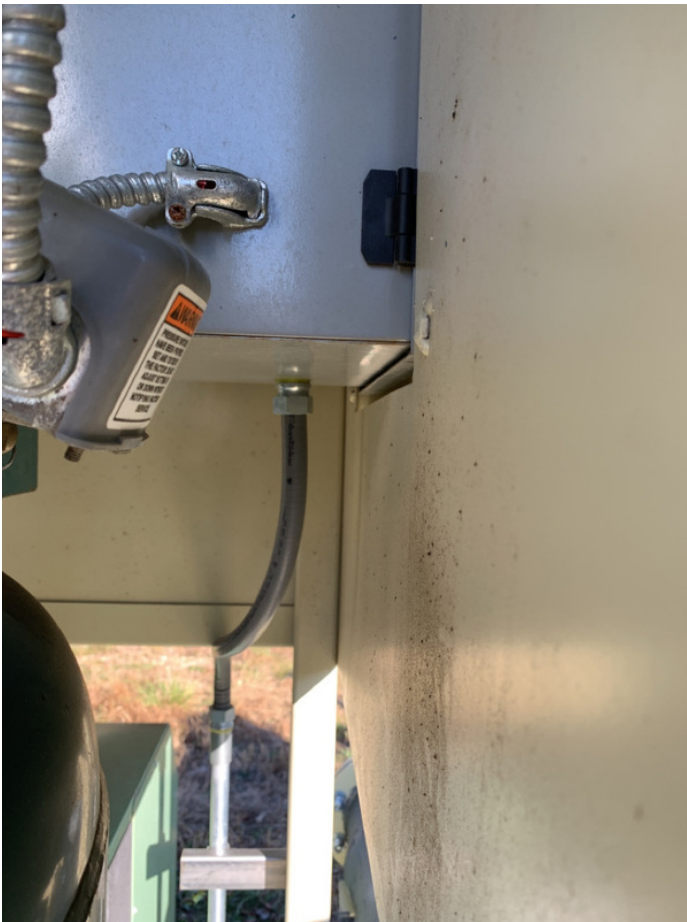
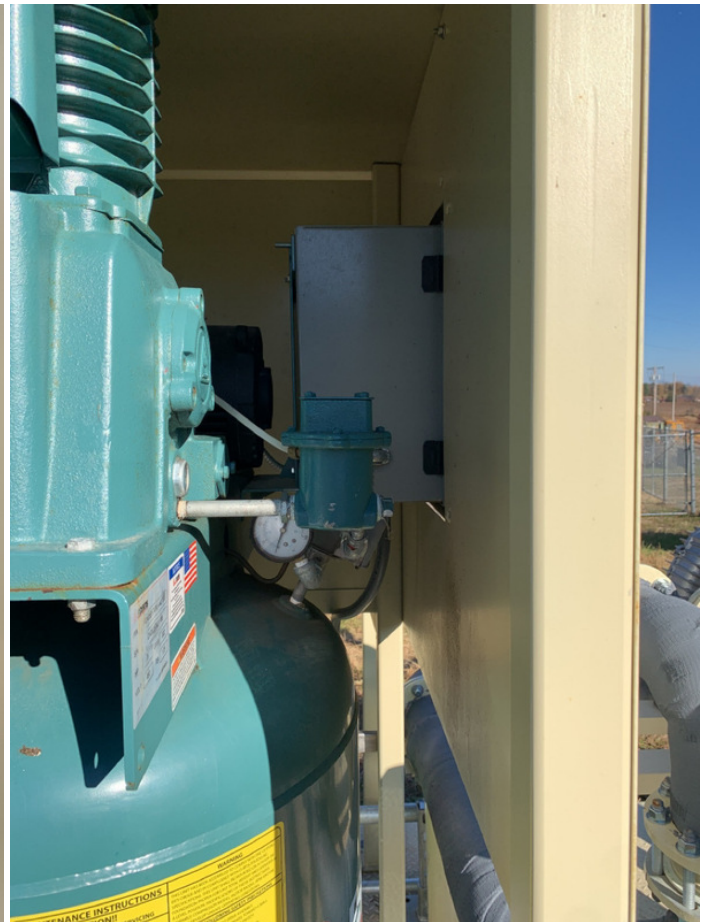
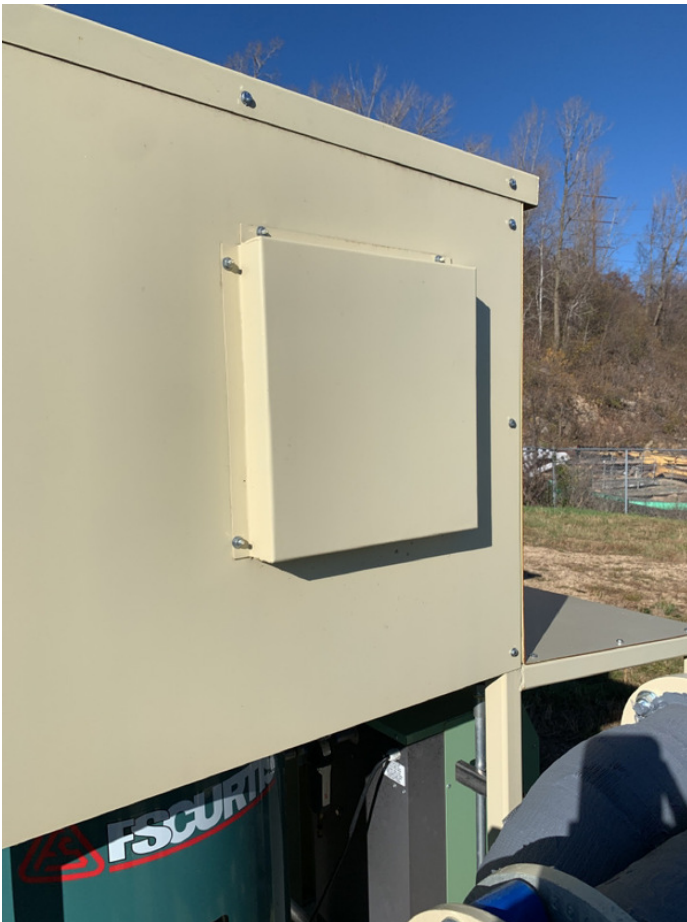
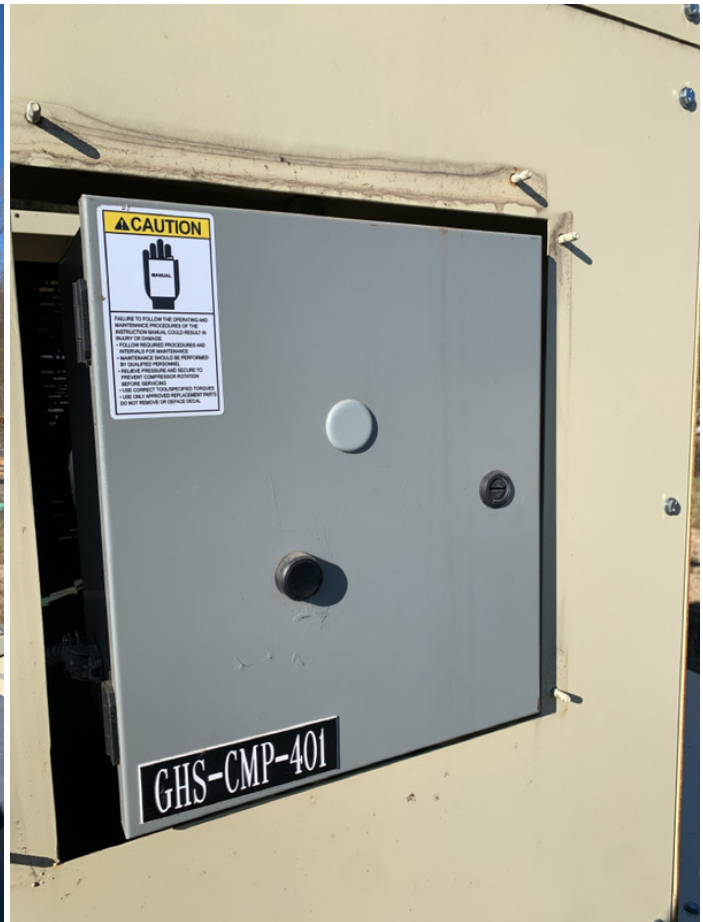
Photo Info - 7. 15:15, Air Compressor

Photo Date	October 26, 2022
Photo Time	15:15
View Direction	
Description	Air Compressor
Photographers Name	Andrew Stehn

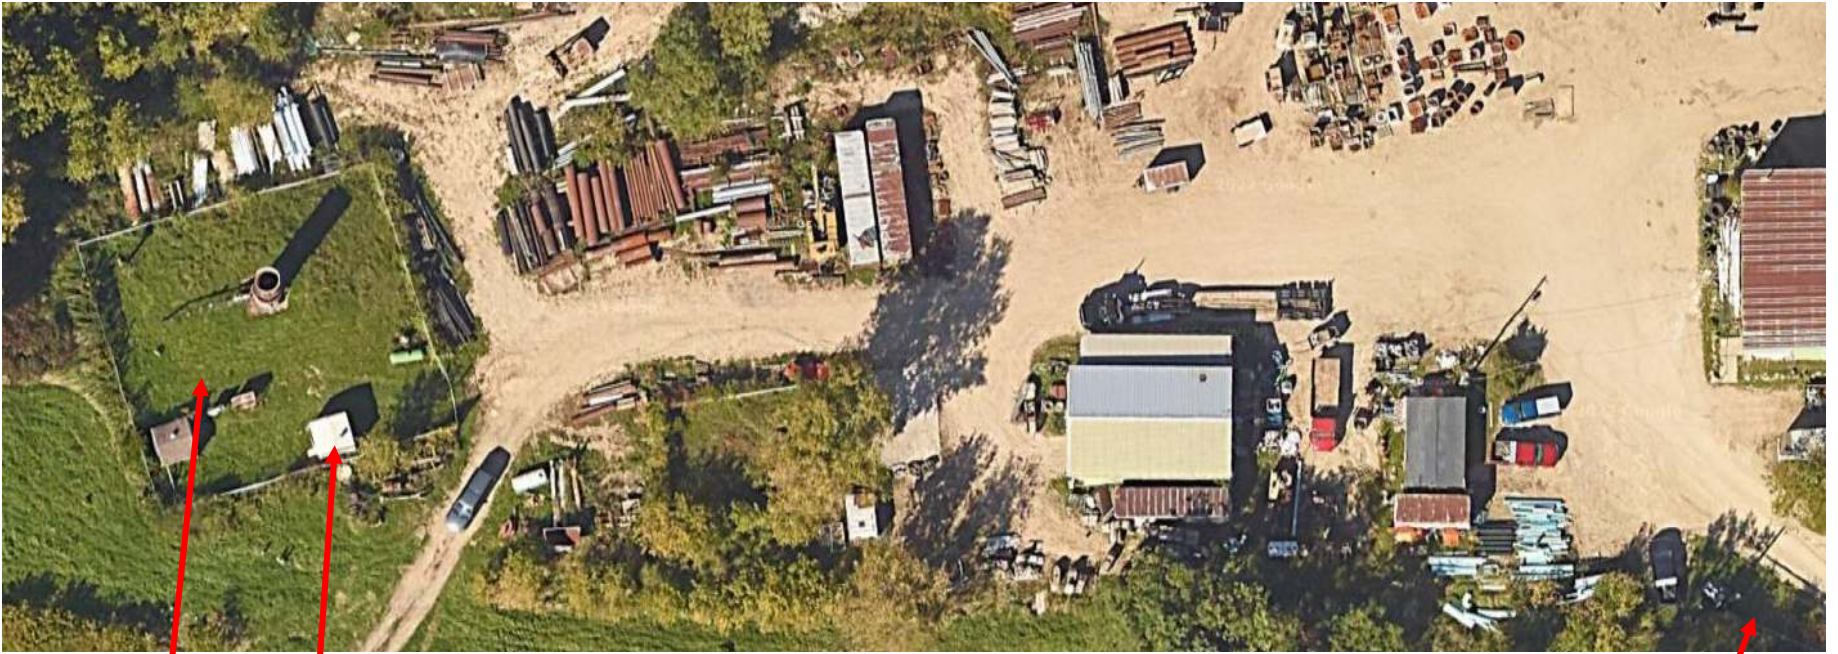
Note MG&E is providing 208/120 3 Phase for the service and the installed transformer steps the voltage up to 480 (closer to 500) V. There is a direct buried cable that runs from the transformer to a shed near the skid system. The shed houses three fused disconnects, one panel, and one small transformer used to step down the supplied 480 3 Ph to 208/120 Single phase to run the lights and electrical outlets in the shed. I found an excerpt from the 1996 OM manual when the old system was installed, and it noted that three buck booster transformers were installed along with 475 feet of larger direct burial cable. I measure the distance on google maps and its approximately 400 ft.

One fused disconnect shuts off the electricity to the shed, a second one shuts off electricity to the skid system, and the third shuts off electricity to the small transformer.

It appears that 480 3 Phase is supplied to the skid system and the air compressor and blower both run off this input. There is another transformer on the skid the steps the voltage down to operate other components on the skid.

Skid (not shown
in aerial)

Shed

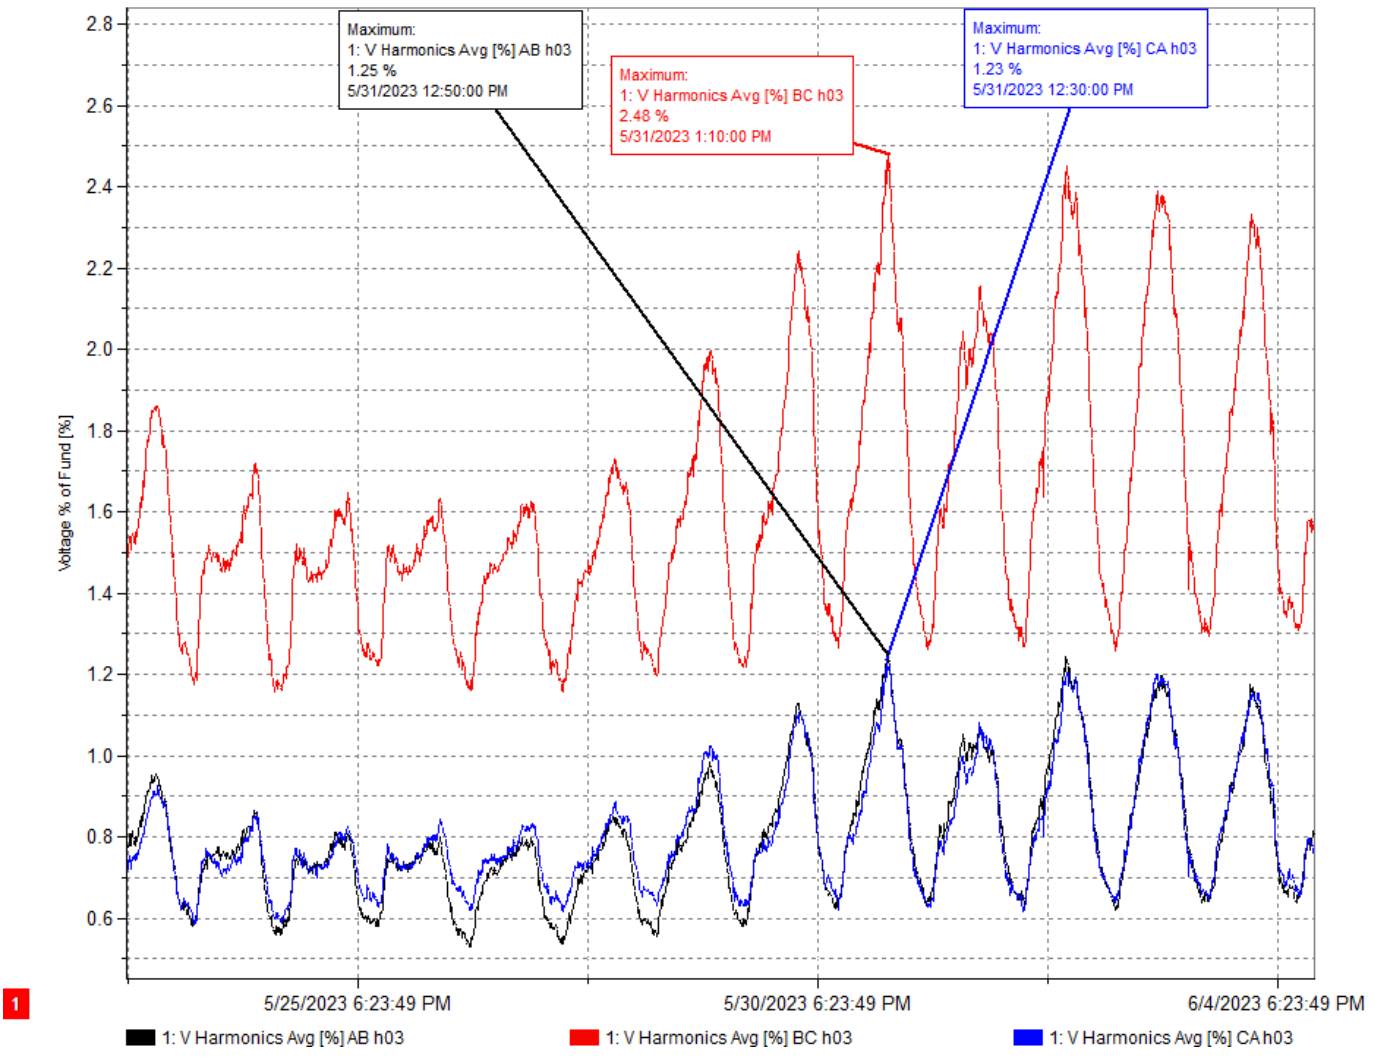
Harmonics Graph

The Total Harmonic Distortion (THD) measures below 5% of the fundamental voltage, 240 volts. This is within the acceptable recommended limit per IEEE Std. 519 "Recommended Practices and Requirements for Harmonic Control in Electrical Power Systems".
