Subject: Refuse Hideaway Landfill
March 2024 Operation Monitoring and Maintenance Activities

Attachment 2
Photographic Log

Photographic Log

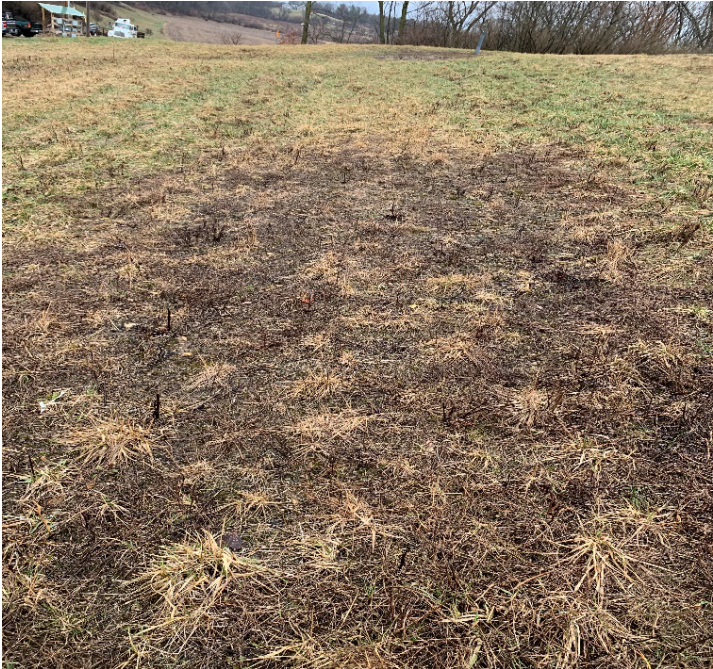
Client Name: Wisconsin Department of Natural Resources (WDNR)		Site Location: Refuse Hideaway Landfill Middleton, WI	Project No.: TRC # 457573
Photo No. 1	Date 3/26/2024

Areas at the west drainage ditch and east drainage ditch previously showed signs of vegetation die-off and were reseeded in the fall of 2022. Ground cover in these areas remains and TRC will continue to monitor and apply seed as needed in 2024. (see photo #1).

Description <u>Eastern Drainage Ditch:</u> Bare spots are present to the north, above the drainage way and will likely require reseeding.			
Photo No. 2	Date 3/26/2024

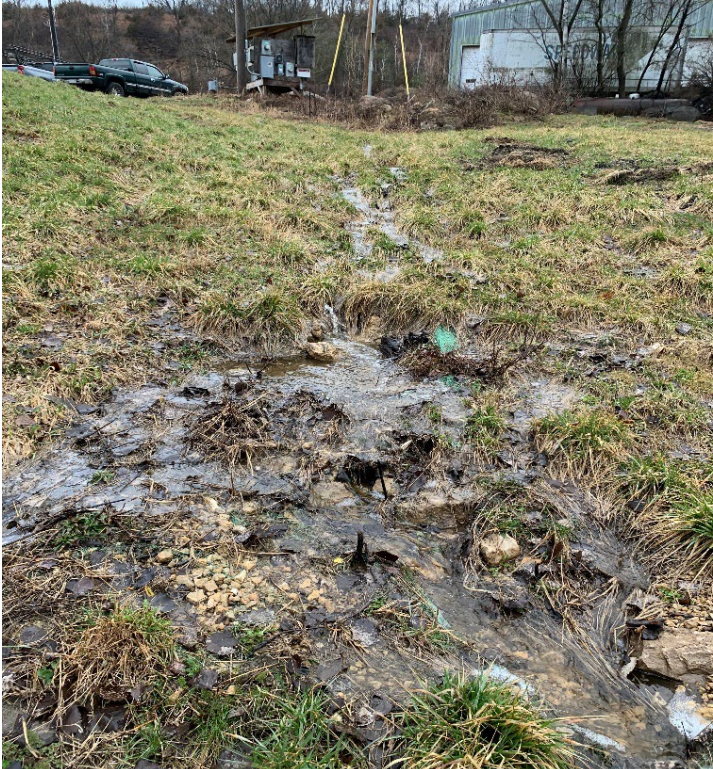
Evidence of erosion at the eastern drainage ditch above the sediment basin was observed. Vegetation is in place, but ruts are present (See photo #2). TRC will continue to monitor the area.

Description <u>Eastern Drainage Ditch:</u> Evidence of erosion starting to occur was observed at the north portion of the eastern drainage ditch leading to the sediment basin. Vegetation is still intact but ruts are present.

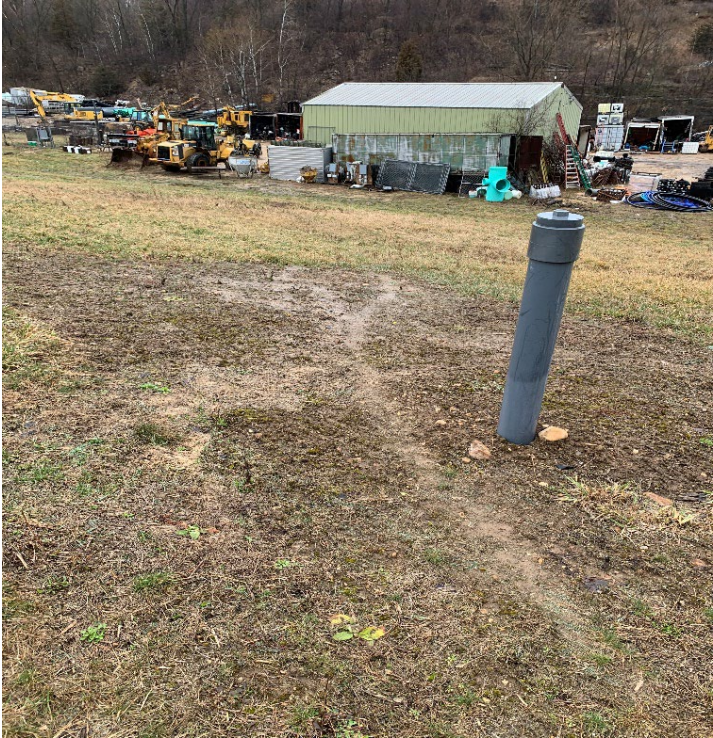
Client Name: Wisconsin Department of Natural Resources (WDNR)		Site Location: Refuse Hideaway Landfill Middleton, WI	Project No.: TRC # 457573
Photo No. 3	Date 3/26/2024

Some bare spots were observed (see photo #3 and #4).

Description <u>Eastern Landfill Extents</u> Reseeding and ground cover was previously applied in the Fall of 2022. Some bare spots remain and will likely require reseeding.

Per discussion with the WDNR, TRC will evaluate the areas in Spring of 2024 and apply seed as needed at that time.

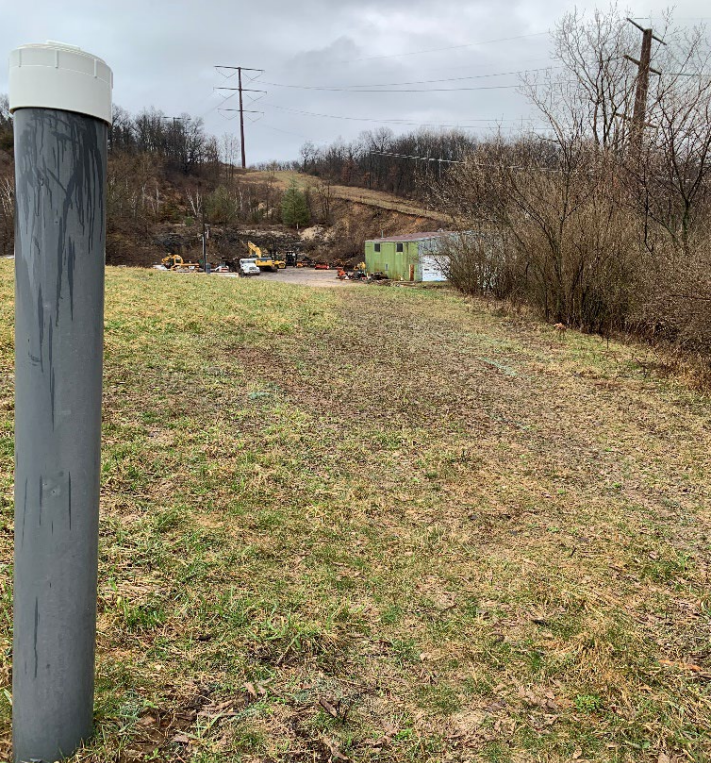
Photo No. 4	Date 3/26/2024

Description <u>Eastern Landfill Extents</u> Reseeding and ground cover was previously applied in the Fall of 2022. Some bare spots remain and will likely require reseeding.

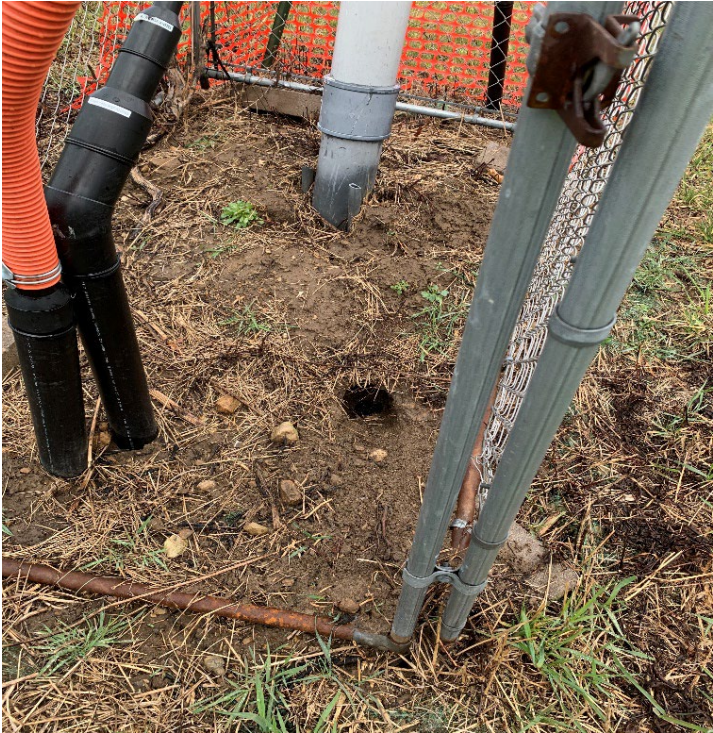
Client Name: Wisconsin Department of Natural Resources (WDNR)		Site Location: Refuse Hideaway Landfill Middleton, WI	Project No.: TRC # 457573
Photo No. 5	Date 3/26/2024

-GW-2 GW-3, and GW-4 on the south side have wildlife burrowing inside the fencing. GW-13 on the north side has burrowing outside the fence. (see photo #5)

Description <u>Southern Landfill Extents</u> GW-2, GW-3 and GW-4 have burrowing from wildlife inside fencing. GW-13 has burrowing from wildlife outside fencing.

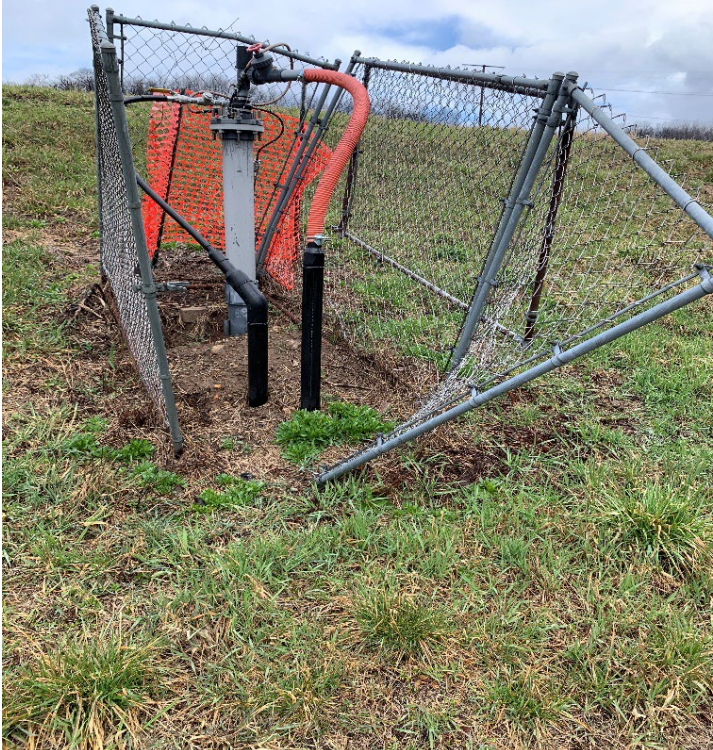
Photo No. 6	Date 3/26/2024

-Fencing around GW-1 and GW-2 is damaged but still provides well protection from mowing operations (see photo #6).

Description <u>Southern Landfill Extents:</u> GW-2 protective fencing is falling apart. Fencing still provides protection during mowing operations. GW-1 protective fencing is in the same condition as GW-2.

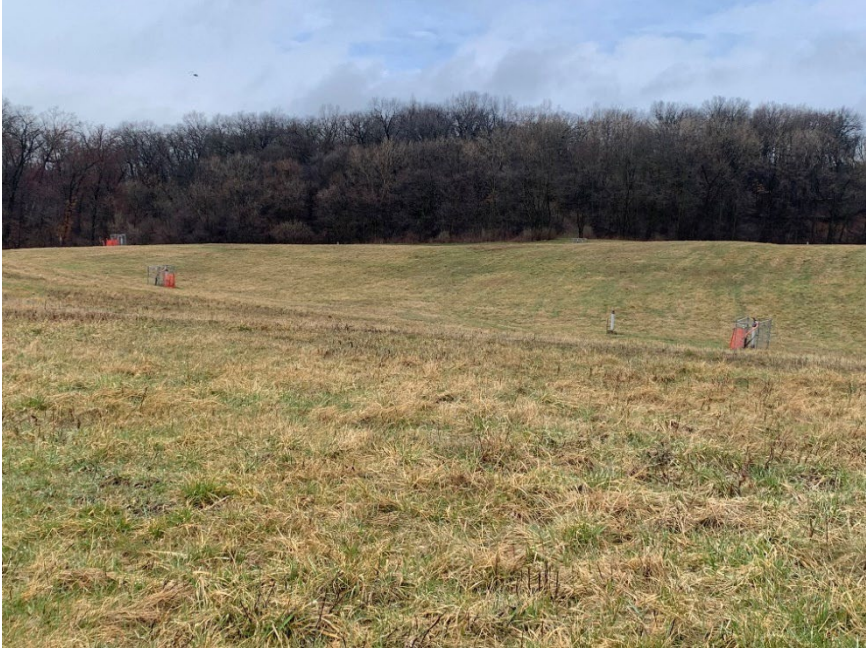
Client Name: Wisconsin Department of Natural Resources (WDNR)		Site Location: Refuse Hideaway Landfill Middleton, WI	Project No.: TRC # 457573
Photo No. 7	Date 3/26/2024

Vegetation cover is acceptable over the majority of the site (see photo #7). Various areas were reseeded and ground cover was applied in the fall of 2022.

Description <u>Northern Landfill Extents:</u> Cap remains in good condition with full vegetation cover.
