RE: Stoughton City LF - 2013 Repair Work

Ayres Associates has completed repair work for the City of Stoughton Landfill, in Stoughton, Wisconsin. Repairs were conducted as authorized under WDNR purchase order number NMC00000665 to correct deficiencies that were noted during the October 2012 Semi-Annual Inspection.

SUBJECT: Completion Report for Repair Work

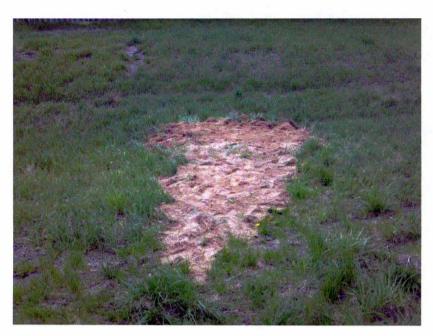
2013-001: Erosion Gulley Backfilled and Compacted

- Displaced final cover materials were placed back in the location where erosion occurred
 on the northwest side of the landfill cap. Following replacement of cap materials, the
 area was manually compacted (by hand) to minimize potential for future recurrence of
 erosion.
- Animal burrows were plugged with topsoil and woody root masses were manually cut and excavated to mitigate future growth of obstructions.

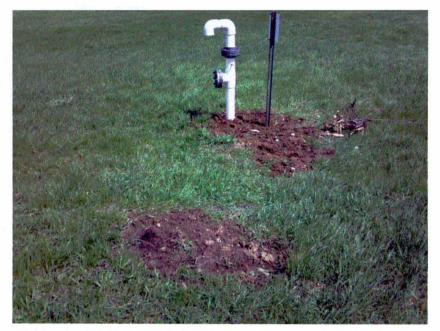
2013-02: GV-9 - Woody Root Mass Removed. Animal

Burrow Plugged Date: 11-May-2013

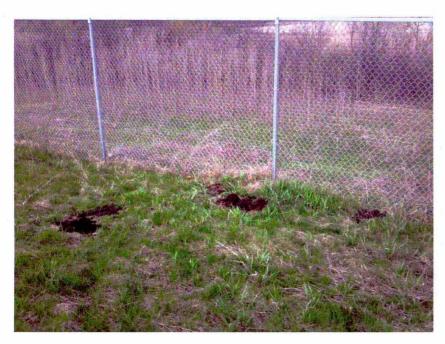
2013-003: GV-5 - Animal Burrow Plugged

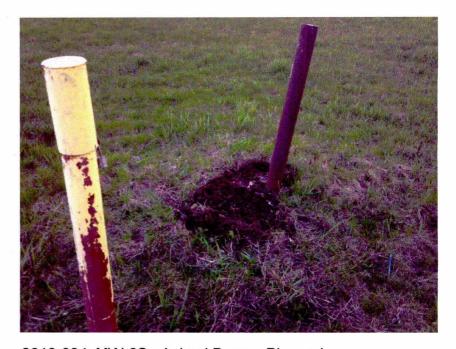
2013-004: MW-6S - Animal Burrow Plugged

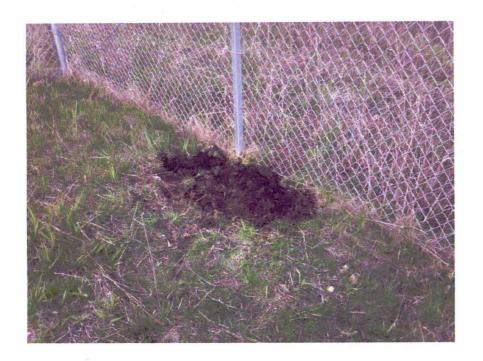
2013-005: MW-6S Near Fence - Animal Burrow

Plugged

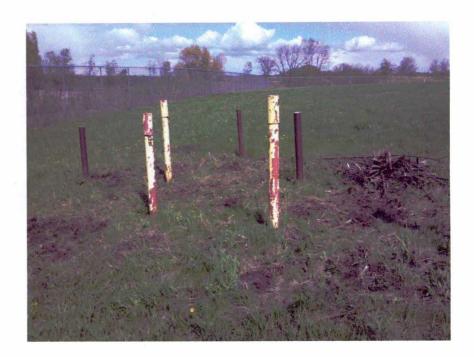
2013-006: MW-11S - Woody Masses Removed

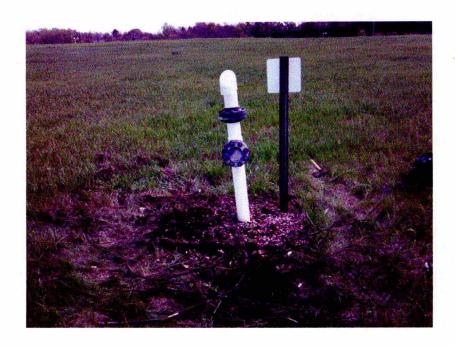
2013-007: GV-16 - Woody Masses Removed

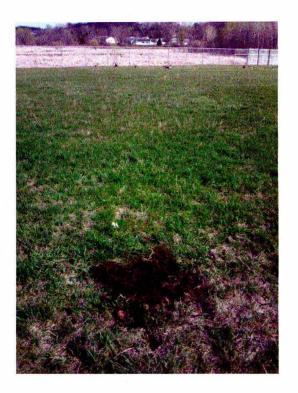
2013-008: SE of GV-9 - Animal Burrow Plugged

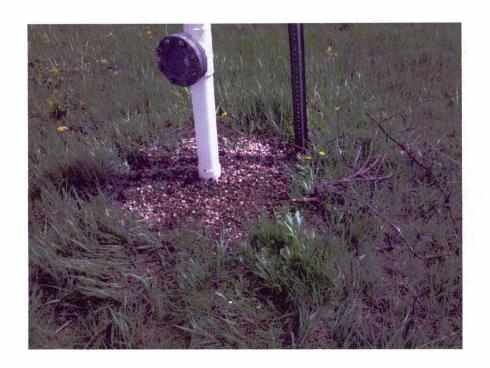
2013-009: GV-13 - Woody Masses Removed

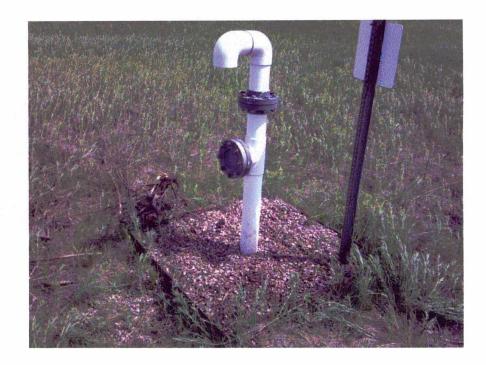
2013-010: GV-19 - Woody Masses Removed

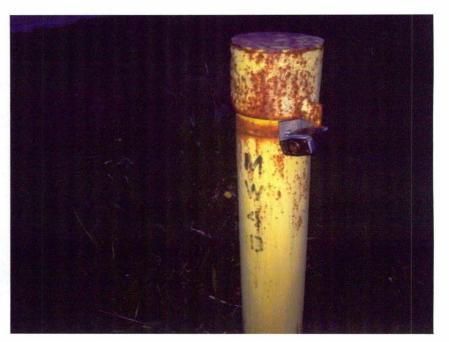
2013-012: MW-4D - New Clasp and Expanding Well

Cap Installed

New locking clasps were installed at MW4D and MW14I to provide sufficient clearance for expandable caps, which were also installed as part of the repair effort. MW13S had a new hinge installed by drilling through the existing protective casing, and was secured with bolted connection to the casing top.

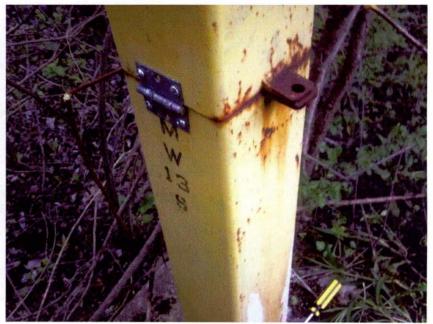
2013-014: MW-13S - New Hinge and Clasp Installed

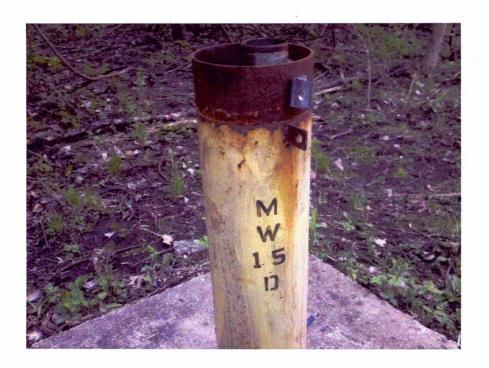
The existing protective casing at MW15D interferes with the well cap installation. During repair work, a new locking clasp was installed but there was not sufficient clearance for cap installation to occur. The position of the new locking clasp did not allow for the protective casing to be secured at the well top.

2013-015: MW-15D - New Clasp Installed. Insufficient

Clearance for Well Cap Installation

Unlike the other two wells, the top of well casing for MW15D is too high in relationship to the top of the protective cover. I installed the new clasp as low as I could with the expanding well cap in place. Even so, the protective casing top/cover does not have enough lower casing to "grab" onto to provide sufficient friction, and maintain a secure enclosure. My recommendation is to:

The intent of the photo in the repair completion report was to show that the new clasp was installed. During the next gas monitoring event, I can take an additional photo of the well with cap in place to show you what it looks like (and the lack of clearance), and include the photo in the semi-annual report.

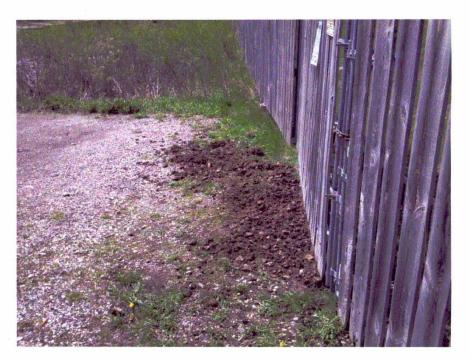
2013-016: South Gate – Warped Boards Repaired.
Gravel Graded in Front of Gate to Allow Unrestricted

Movement

The warped wooden fence slats at the south access gate were repaired by setting new nails in warped boards. Additionally, the gravel which restricts movement of the gate was manually graded to reduce interference during fence operation.

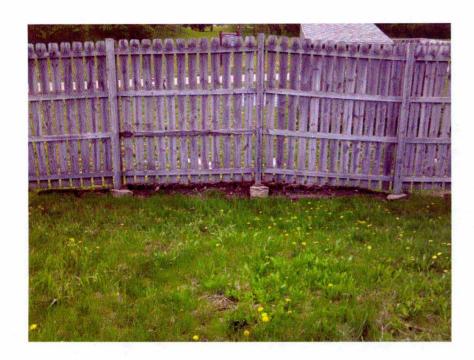
2013-017: SW Perimeter Fence - Soil Placed to Impede

Unauthorized Entry Date: 11-May-2013 Time: 4:28 PM

The location where frost heave caused the concrete fence supports to rise on the southwest perimeter of the landfill, had soil placed in front of the fence to prevent unauthorized access to the landfill. Soil placement was conducted by the City of Stoughton - Parks and Recreation Department.

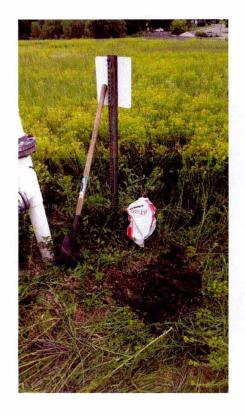
2014-04-002: GV-10 Burrow Repair

Repair activities were conducted in June 2014 at the site to address an animal burrow near GV-10. The animal burrow was plugged with topsoil and seeded with material previously procured and stockpiled at the site. Refer to Photograph 2014-04-002 in Attachment A for a depiction of the repair. Refer to Photograph 2014-04-003 in Attachment A for a depiction of the material procurement.

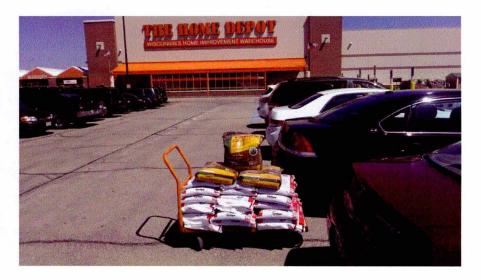
2014-04-003: Grass Seed and Topsoil

Procurement

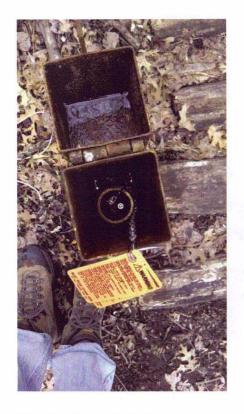
2013-04-004: OW-2 Plugged

One monitoring well (OW-2) was noticeably flowing (artesian) during the October 2013 inspection event. An inflatable plug was installed in April 2014 at this location to mitigate potential flowing condition of the well. The model of inflatable plug was identical to that used at MW-10S and MW-13S, which were installed during historical repair activities. Refer to Photograph 2014-04-004 in Attachment A for a depiction of the repair.

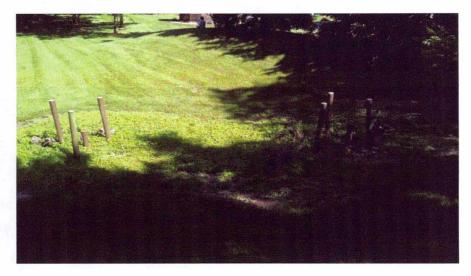
2014-04-005: MW1 Tree Removal

One monitoring well nest (MW1S and MW-1D) was overgrown with decorative/landscaped trees, and access to the wells was restricted based on the results of the October 2013 semi-annual inspection. The trees were removed during April 2014 and the woody vegetation was disposed off-site. Refer to Photograph 2014-04-005 in Attachment A for a depiction of the repair. Ayres Associates coordinated with the City of Stoughton to have the trees removed by the City.

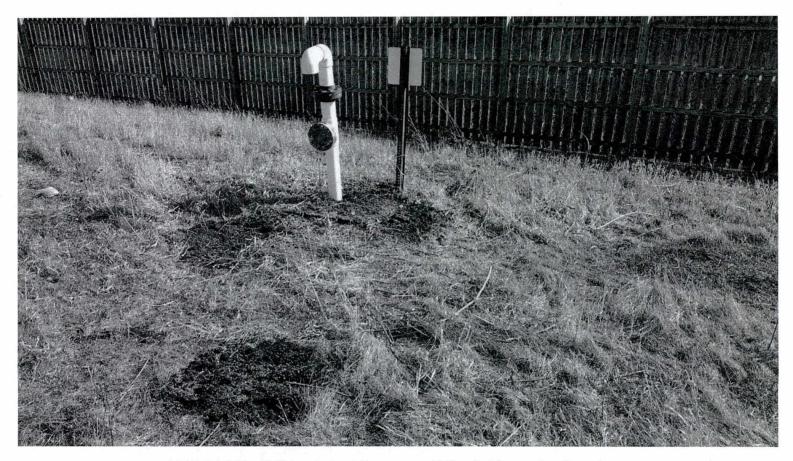
2015-04-006: GV11 - Animal Burrow and Woody Vegetation Repair

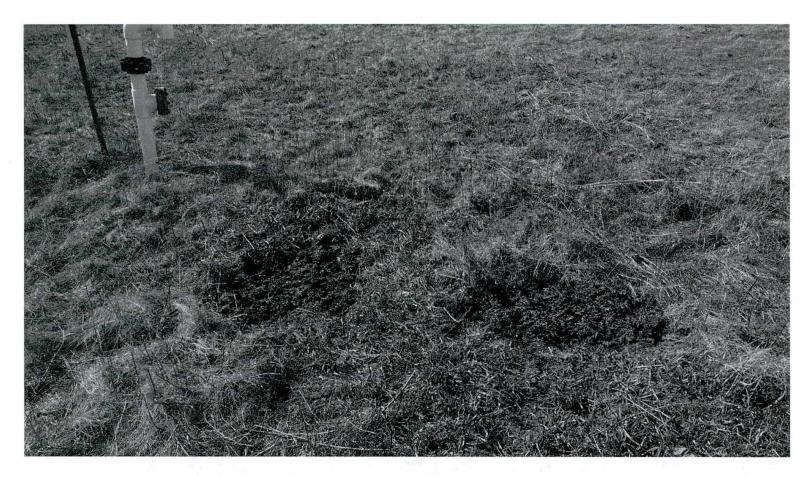
2015-04-007: GV12 - Animal Burrow Repair
