**SIXTH FIVE-YEAR REVIEW REPORT FOR  
HAGEN FARM SUPERFUND SITE  
DANE COUNTY, WISCONSIN**

**U.S. Environmental Protection Agency  
Region 5  
Chicago, Illinois**

7/15/2021

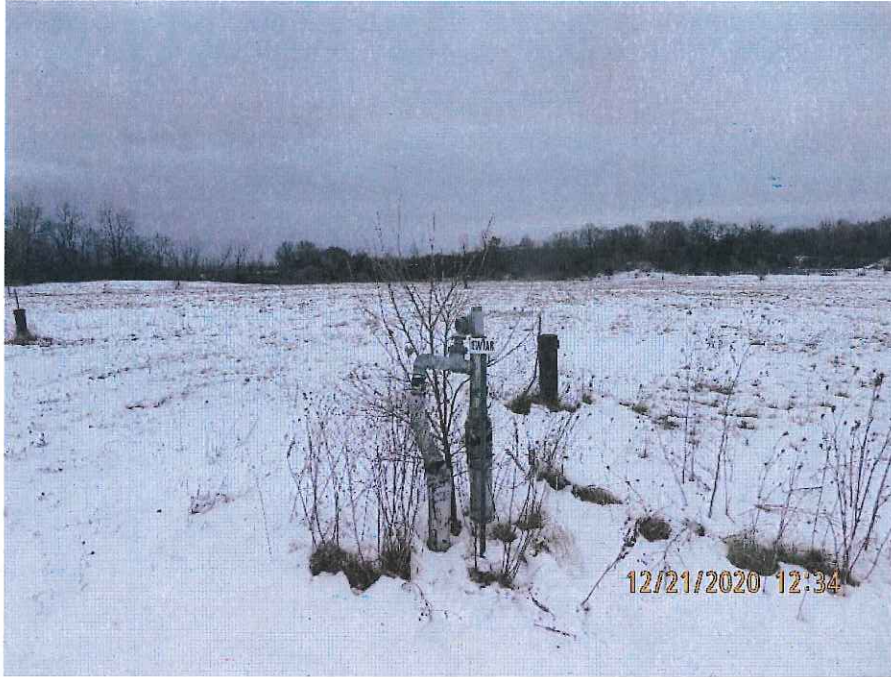
**Photo 19:** SVE well EW1AR, open to atmosphere to promote air flow into the waste mass. View is to the north from atop the landfill cap.

Minor maintenance of the gas EWs (i.e., replacing damaged or broken sample ports and connecting/tightening loose fittings) was performed as needed. During this reporting period, well EW1AR was not operated under vacuum, but remained open to promote airflow into the waste mass. Below are the more notable O&M occurrences that led to system downtime.

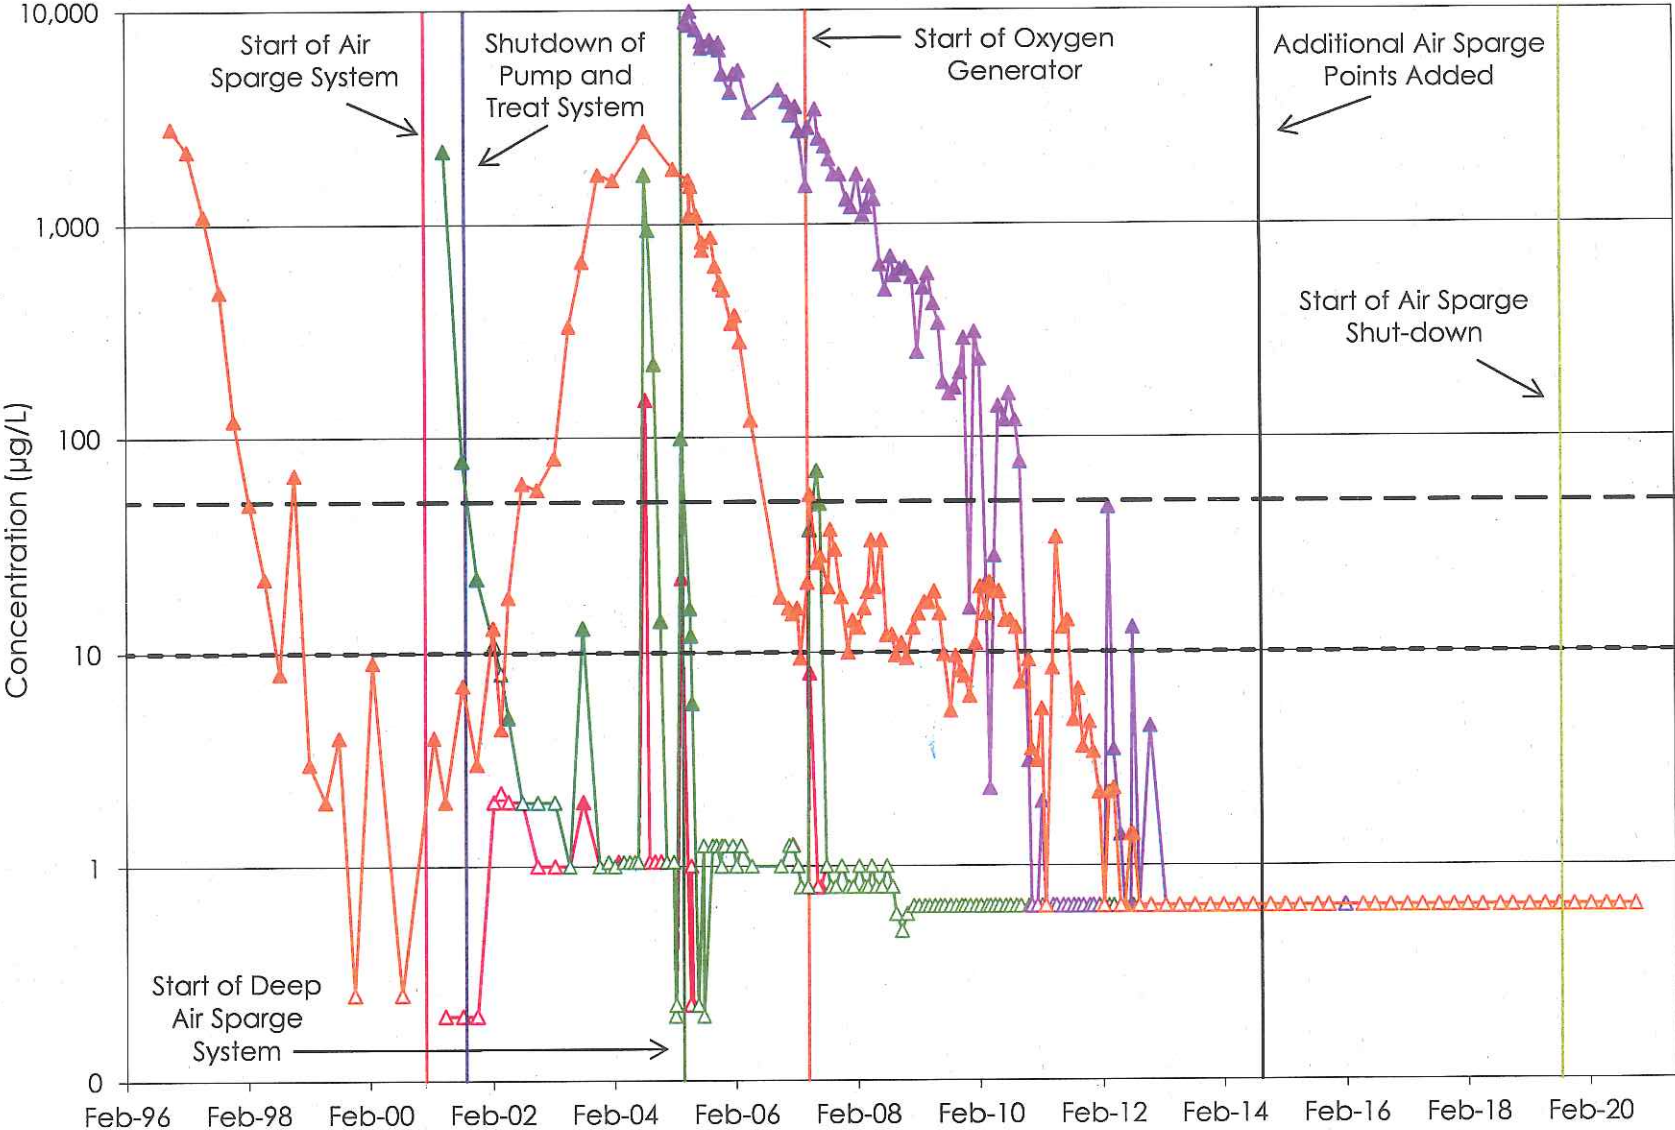
Graph 1  
Tetrahydrofuran  
On-Property Wells - Hagen Farm Site

Note: Non-detects are plotted as 1/2 the Limit of Detection (LOD) with open data markers.

- ▲— OBS1A
- △— OBS1B
- ▲— OBS1C
- - - PAL
- - - ES
- ▲— P17C

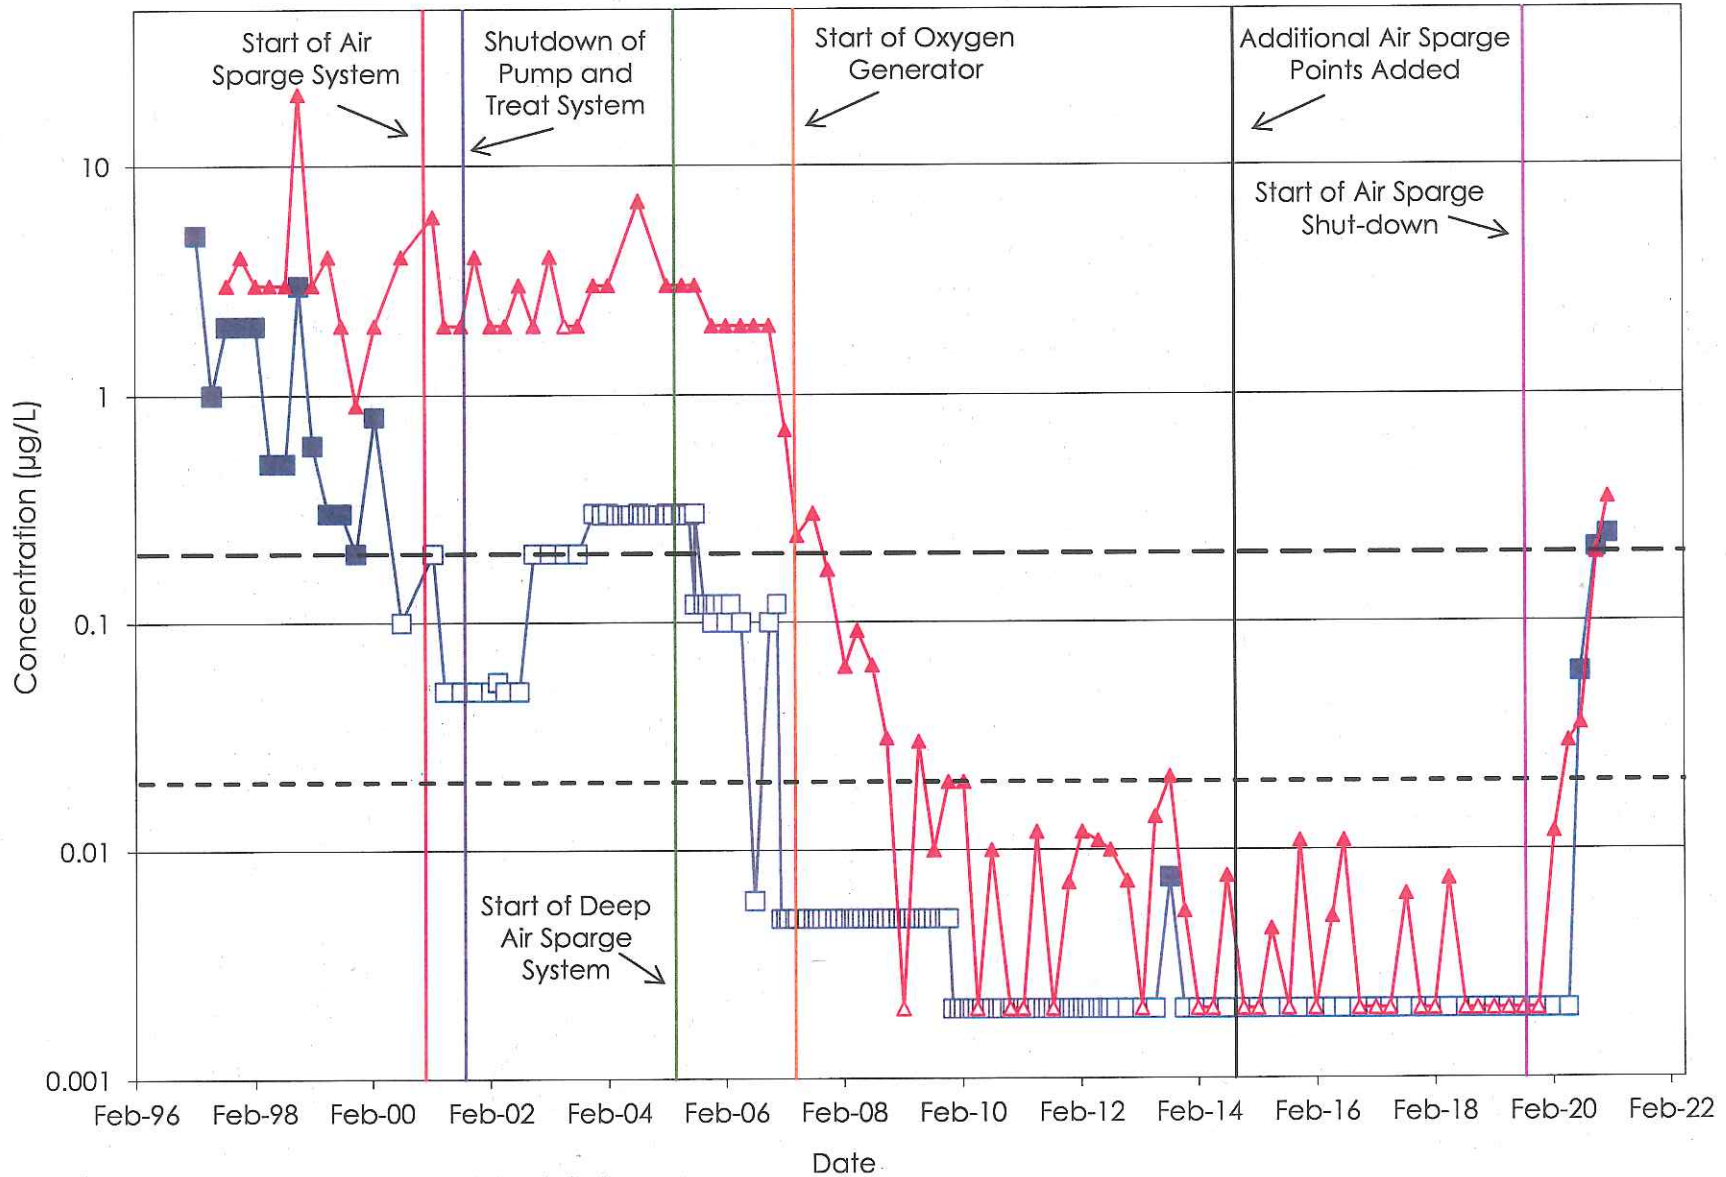
**Graph 4  
Vinyl Chloride  
P22B and MW22 - Hagen Farm Site**

Note: Non-detects are plotted as 1/2 the Limit of Detection (LOD) with open data markers.

—□— MW22    —▲— P22B    - - - PAL (0.02 µg/L)    — — — ES (0.2 µg/L)
