**FIFTH FIVE-YEAR REVIEW REPORT FOR  
RIPON CITY LANDFILL SUPERFUND SITE  
FOND DU LAC COUNTY, WISCONSIN**

**Wisconsin Department of Natural Resources  
Milwaukee, Wisconsin**

**U.S. Environmental Protection Agency  
Region 5  
Chicago, Illinois**

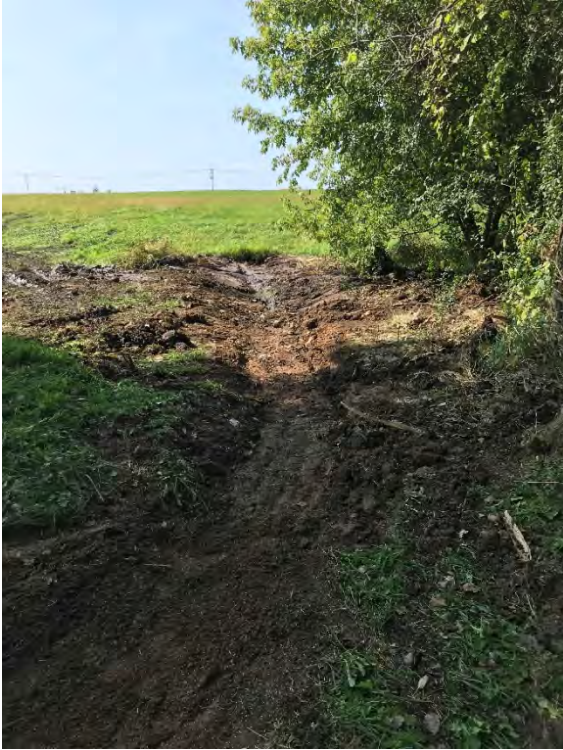
3	9/23/2020		
<b>Description:</b>			
Excavation near drainage pipe outlet to reduce ponding.			
Photo taken facing east.			
<b>Photo No.</b>	<b>Date</b>

In 2019, personnel observed that the drainage layer occasionally created ponding just off the landfill area to the southeast. The PRP group created an additional drainage swale to alleviate the ponding. The swale became established with grass in 2020, and ponding ceased. Appendix D includes photo documentation of the repaired drainage swale. Further information exists in the 2020 3<sup>rd</sup> quarter report.

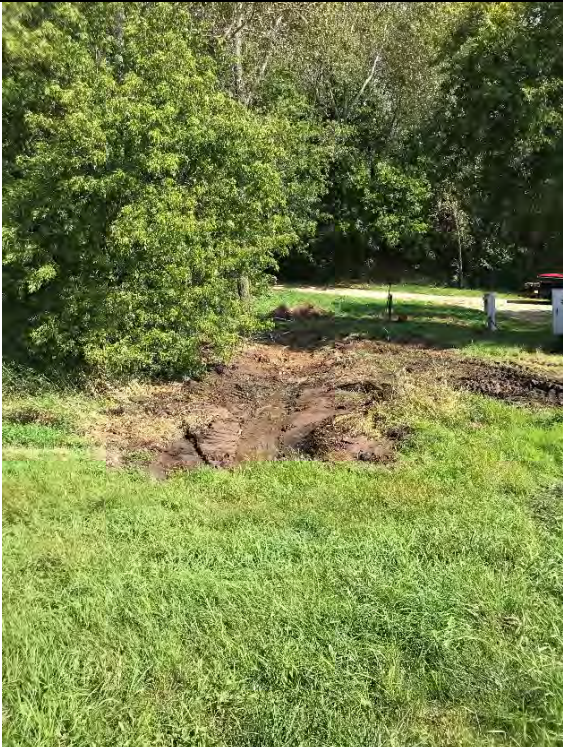
4	9/23/2020		
<b>Description:</b>			
Excavation near drainage pipe outlet to reduce ponding.			
Photo taken facing west.

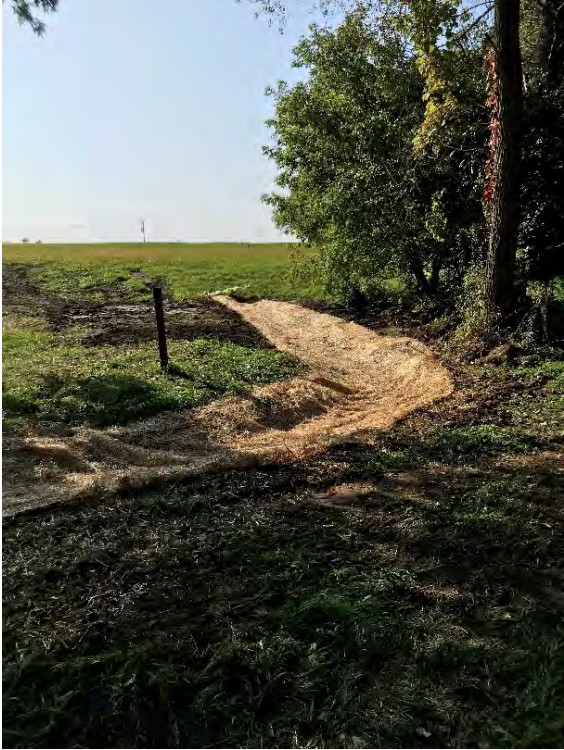
Client Name:		Site Location:	Project No.:
FF/NN Landfill Group		FF/NN Landfill, Ripon WI	378957
Photo No.	Date	Description:	Image
5	9/23/2020		
<p>Drainage swale with topsoil and erosion mat installed.</p> <p>Photo taken facing east.</p>

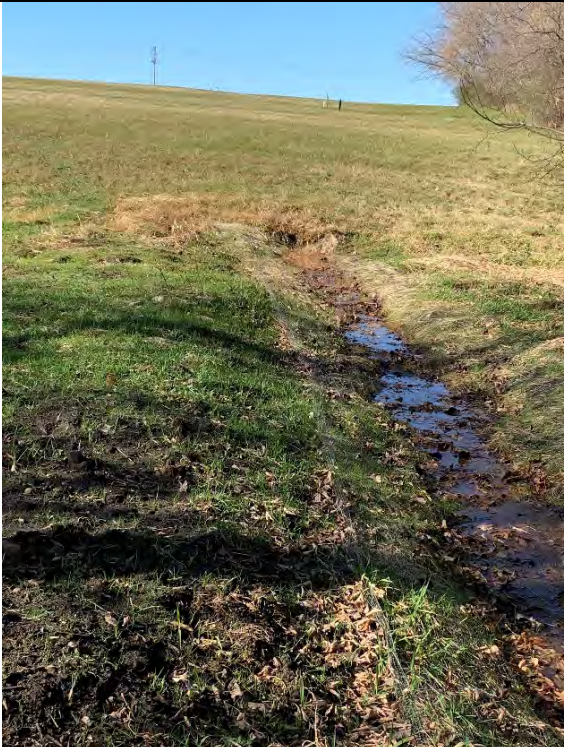
Photo No.	Date	Description:	Image
6	11/11/2020		
<p>Drainage swale after vegetative growth has started.</p> <p>Photo taken facing east.</p>

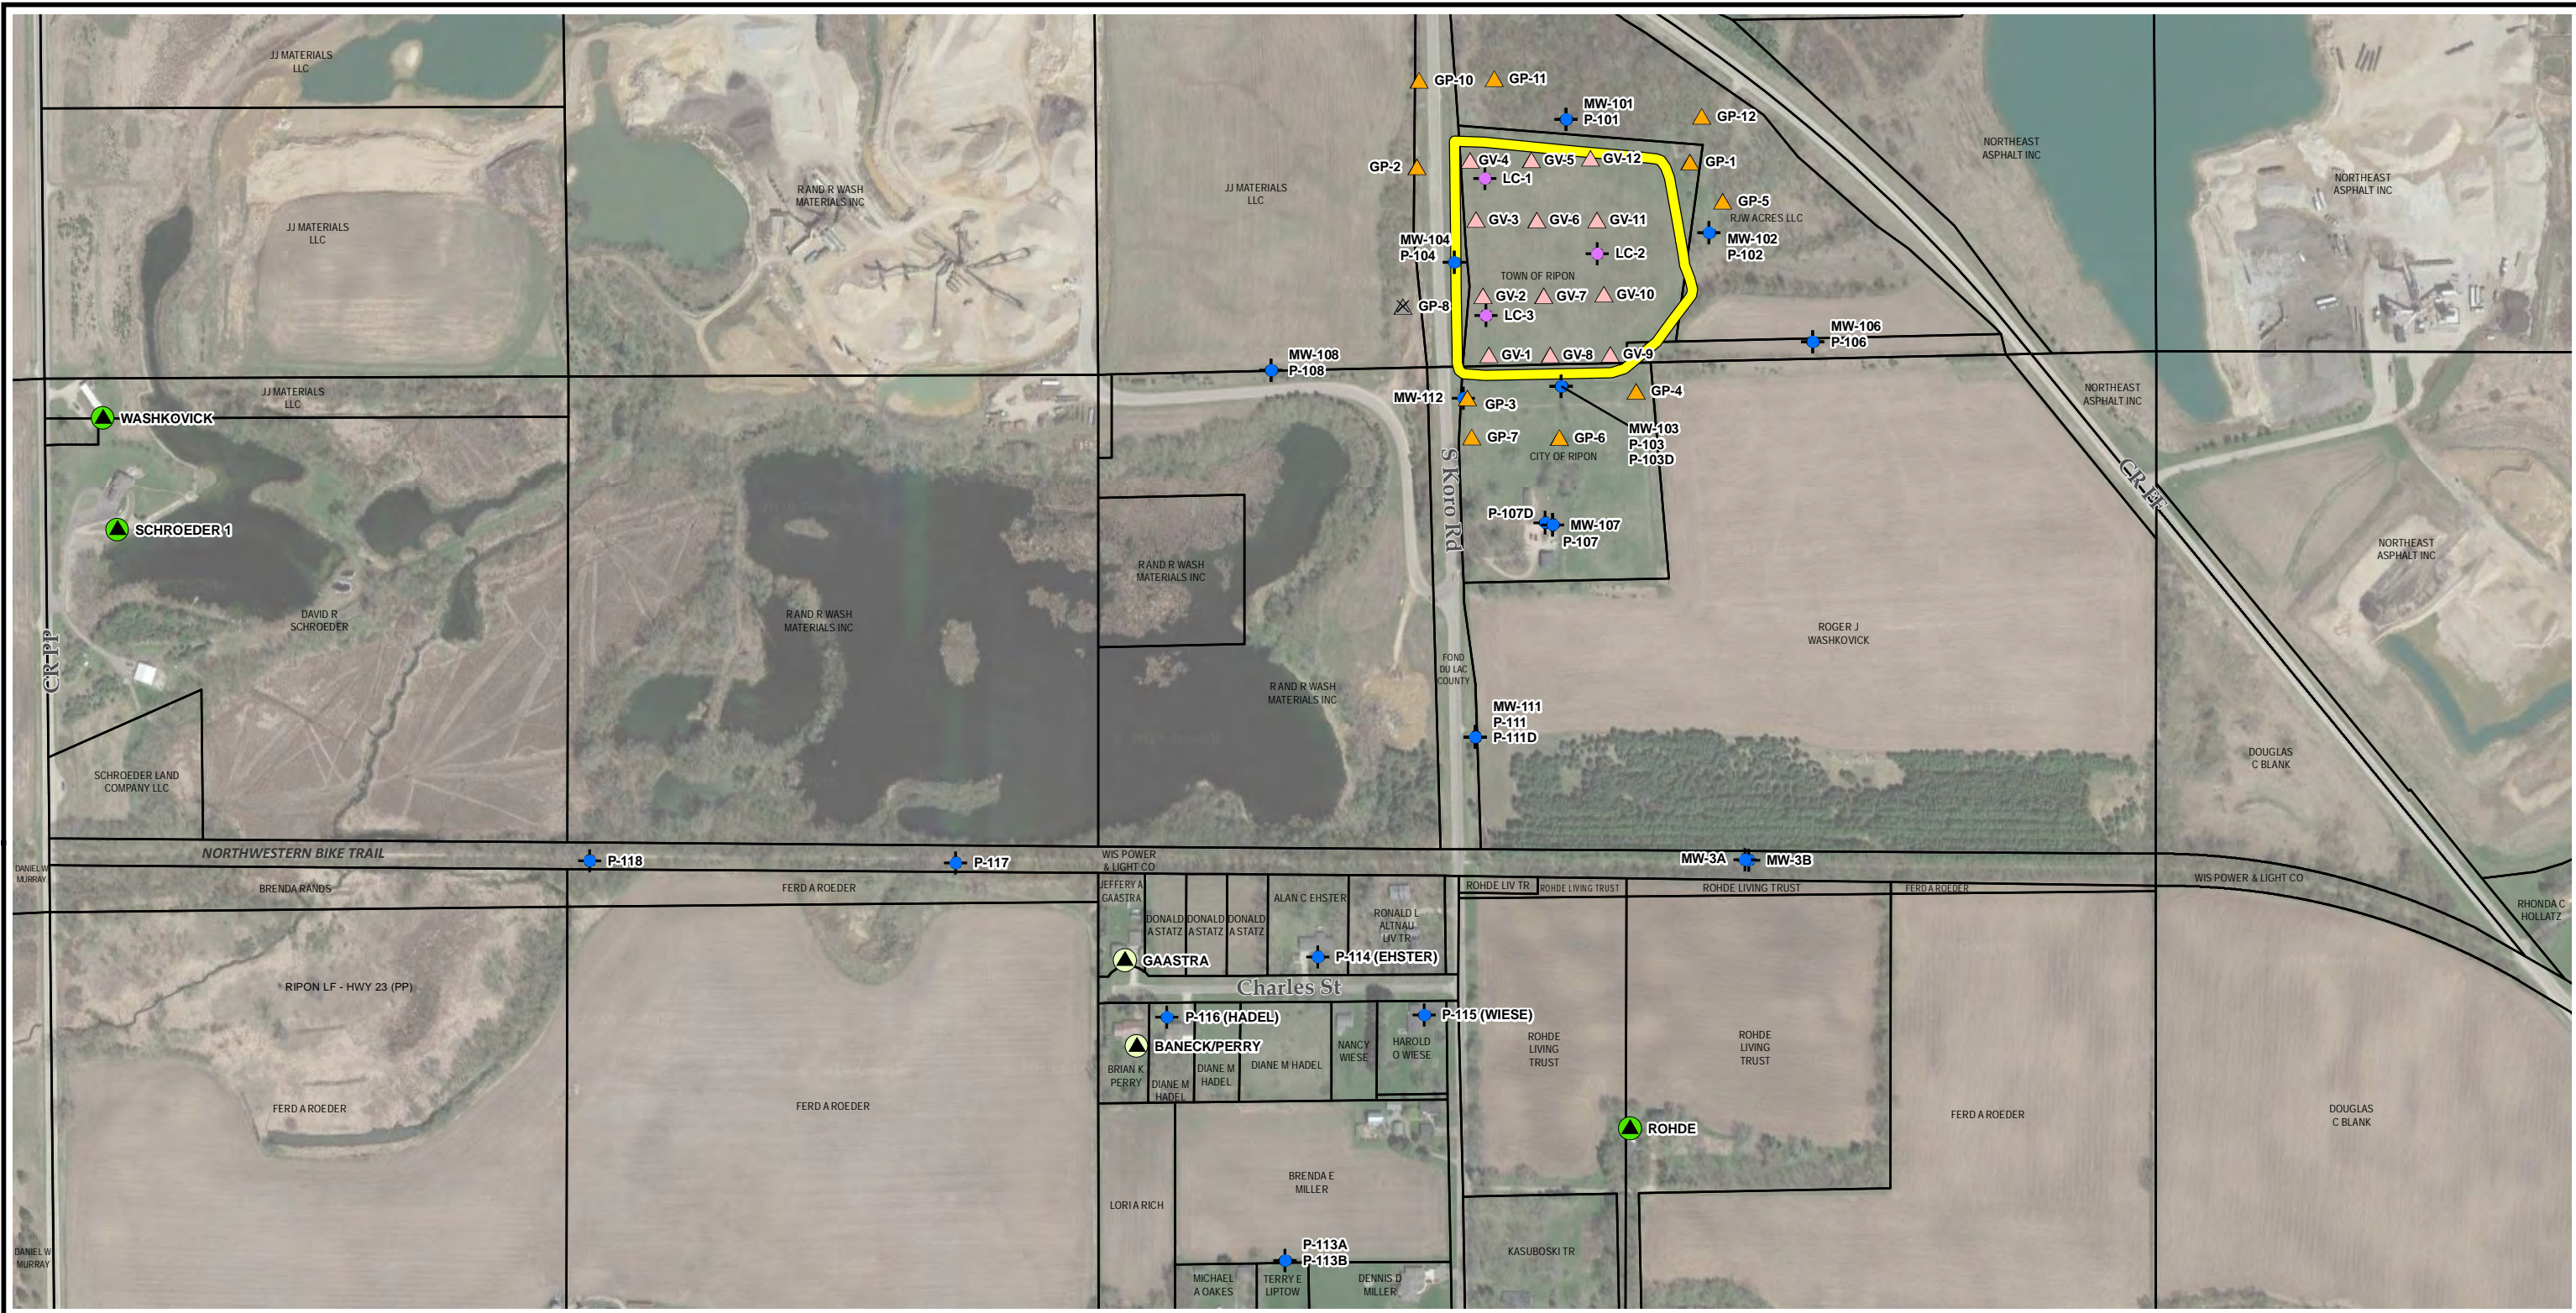
BI-WEEKLY GAS PROBE MONITORING

An active gas extraction system, including gas probes (outside the landfill), gas vents (inside the landfill), leachate wells, piping, and pump house, continues to monitor and remove gas from the waste mass. Figure 2 in Appendix D shows the gas vents and probes in the monitoring system. Appendix D also includes gas monitoring data from 2020. WAC Ch. NR 506.07(4) requires that methane concentrations greater than the lower explosive limit (LEL) (5 percent) should not occur outside the limits of the wastes. During this FYR period, no concentrations of methane above 5 percent were observed in monitoring points outside of the waste limits.
