Technical Assistance, Environmental Liability Clarification or Post-Closure Modification Request

Property Name Ripon City LF (FF-NN) (SF NPL)		FID No. (if known) 420013660	
BRRTS No. (if known) 02-20-000915		Parcel Identification Number	
Street Address N8901 S Koro Road		City Ripon	State WI
		ZIP Code 54971	
County Fond Du Lac	Municipality where the Property is located <input type="radio"/> City <input checked="" type="radio"/> Town <input type="radio"/> Village of	Property is composed of: <input type="radio"/> Single tax parcel <input type="radio"/> Multiple tax parcels	Property Size Acres

**Active Landfill Gas Extraction System Layout and
Gas Monitoring Locations**

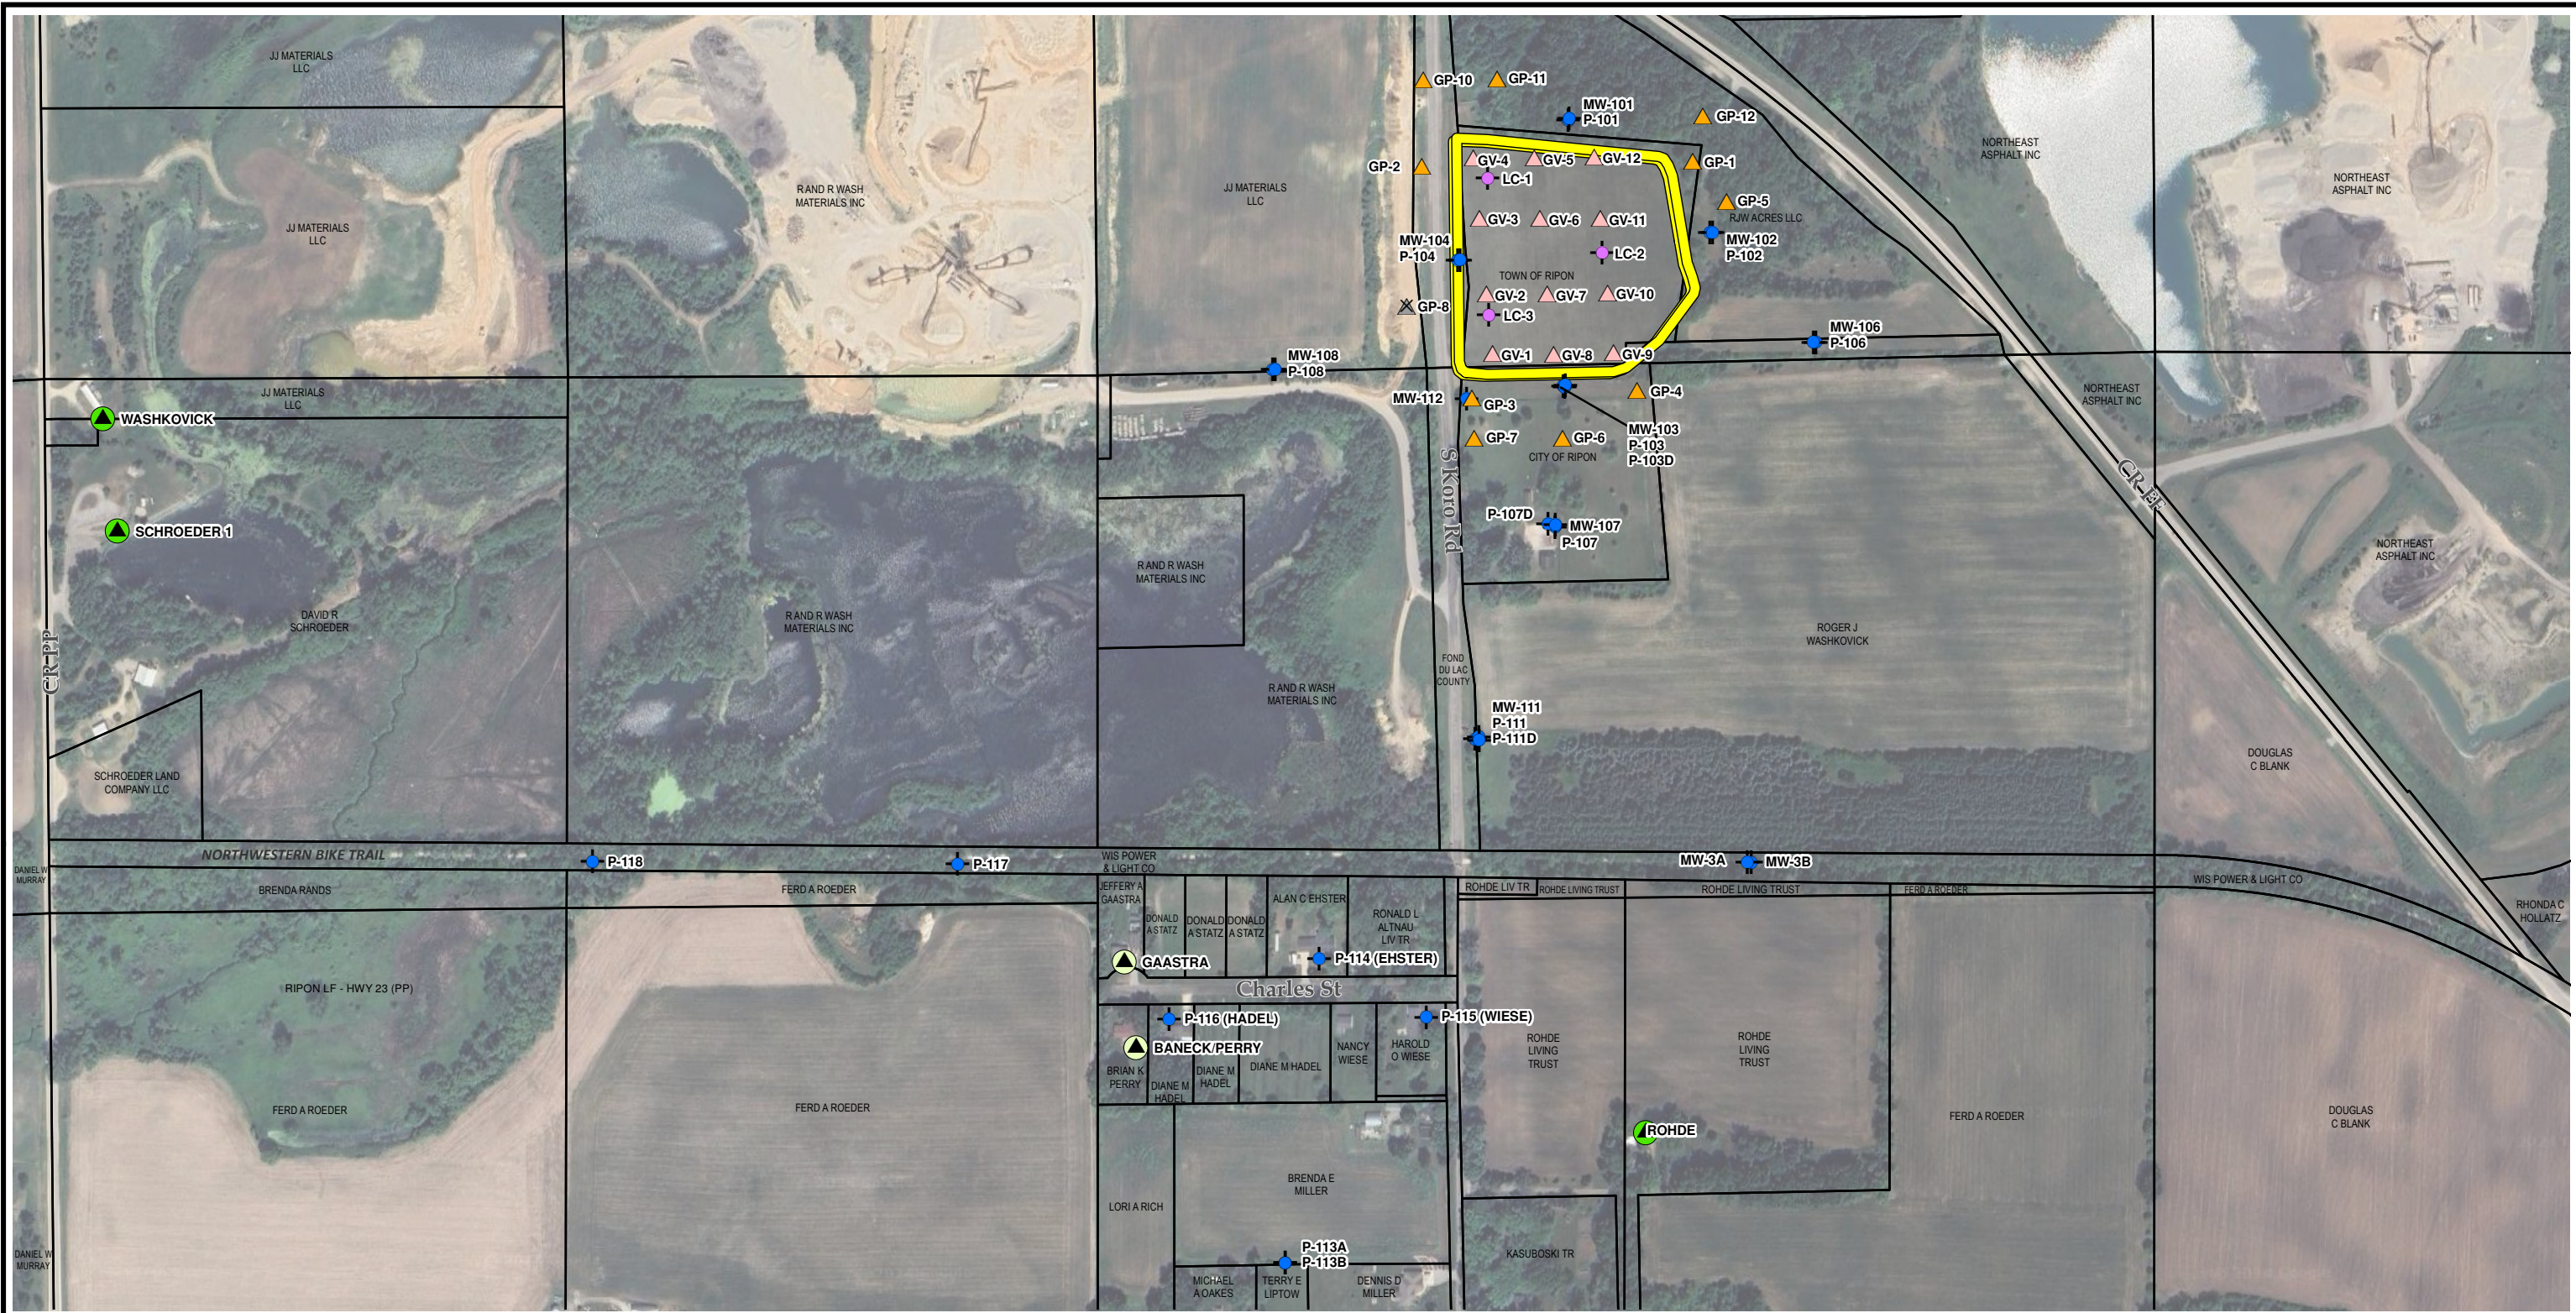
Initially, gas vents (Figure 2) GV-1, GV-4, GV-6, GV-7, GV-9 and GV-12 and leachate head wells LC-1, LC-2, and LC-3 were connected to the system. However, following system startup in 2006, gas vents GV-1, GV-4, GV-7, GV-9, and GV-12 were taken offline between June and August 2007 based on observed methane and oxygen concentrations. Since 2007, landfill gas has primarily been extracted from gas vent GV-6 and the three deeper leachate head wells (LC-1, LC-2, and LC-3). On September 5, 2019, GV-4 was reconnected to the system to reduce methane concentrations observed at gas probe GP-2 located to the west/northwest of the landfill. The other gas vents have remained closed to prevent elevated oxygen levels.

- The methane concentration at gas probe GP-1 (east/northeast of landfill) has showed variability with concentrations above the LEL (5% by volume) prior to operation of the active GES and at times during operation. However, detections above the LEL were last observed in 2012. Methane has been observed at a concentration above 25% of the LEL (1.25% by volume) intermediately with the active GES in operation to date but no trends due to operation were observed. In review of recent data between 2023 and 2024, when system operation was reduced due to water intrusion in the extraction lines, methane within GP-1 showed some variability but concentrations were reported below the LEL and generally below 25% of the LEL.

- The methane concentration at gas probe GP-2 (west/northwest of landfill) was observed above the LEL (5% by volume) around the startup (2006) and operation of the active GES, but concentrations dropped shortly after full-scale operation was implemented. Concentrations remained below 25% of the LEL until 2019 when system operation was limited due to blower issues and extraction line limitations. Following system repairs in 2019, offsite methane in GP-2 was reduced below 25% of the LEL and has remained below that threshold despite current operational limitations. Methane was recorded by the City of Ripon field technician at a concentration of 1.9% by volume (38% of the LEL) with oxygen at 0.1% on April 11, 2024. However, due to instrument complications during the April 11, 2024 event, TRC collected a second reading on April 15, 2024 which reported no methane and an oxygen concentration of 20.6%. The gas probe was again checked on May 8, 2024, and no methane was observed and oxygen was at 19.5%. Based on the results of the follow up readings, the methane reading at GP-2 on April 11, 2024 appears to be an instrument error.

- The methane concentration in gas probes GP-3, GP-4, GP-5, GP-7, GP-8, GP-11, and GP-12 and monitoring well MW-101 was observed either above the LEL or 25% of the LEL in 2006 during initial operation of the active GES; however, since 2006 no exceedances of the 25% LEL threshold have been reported.
