SUBJECT: 2nd Round Vapor Sampling Results - Contaminants Not Detected
PROPERTY: Reedsburg Cleaners, 120 N. Locust Street (PSI A); BRRTS # 02-57-001682

Table 1A
Indoor Air Sub-Slab Analytical Results
 157001460 – Reedsburg Cleaners
 120 N. Locust Street, Reedsburg, WI
 Property Sample Identifier (PSI) - A

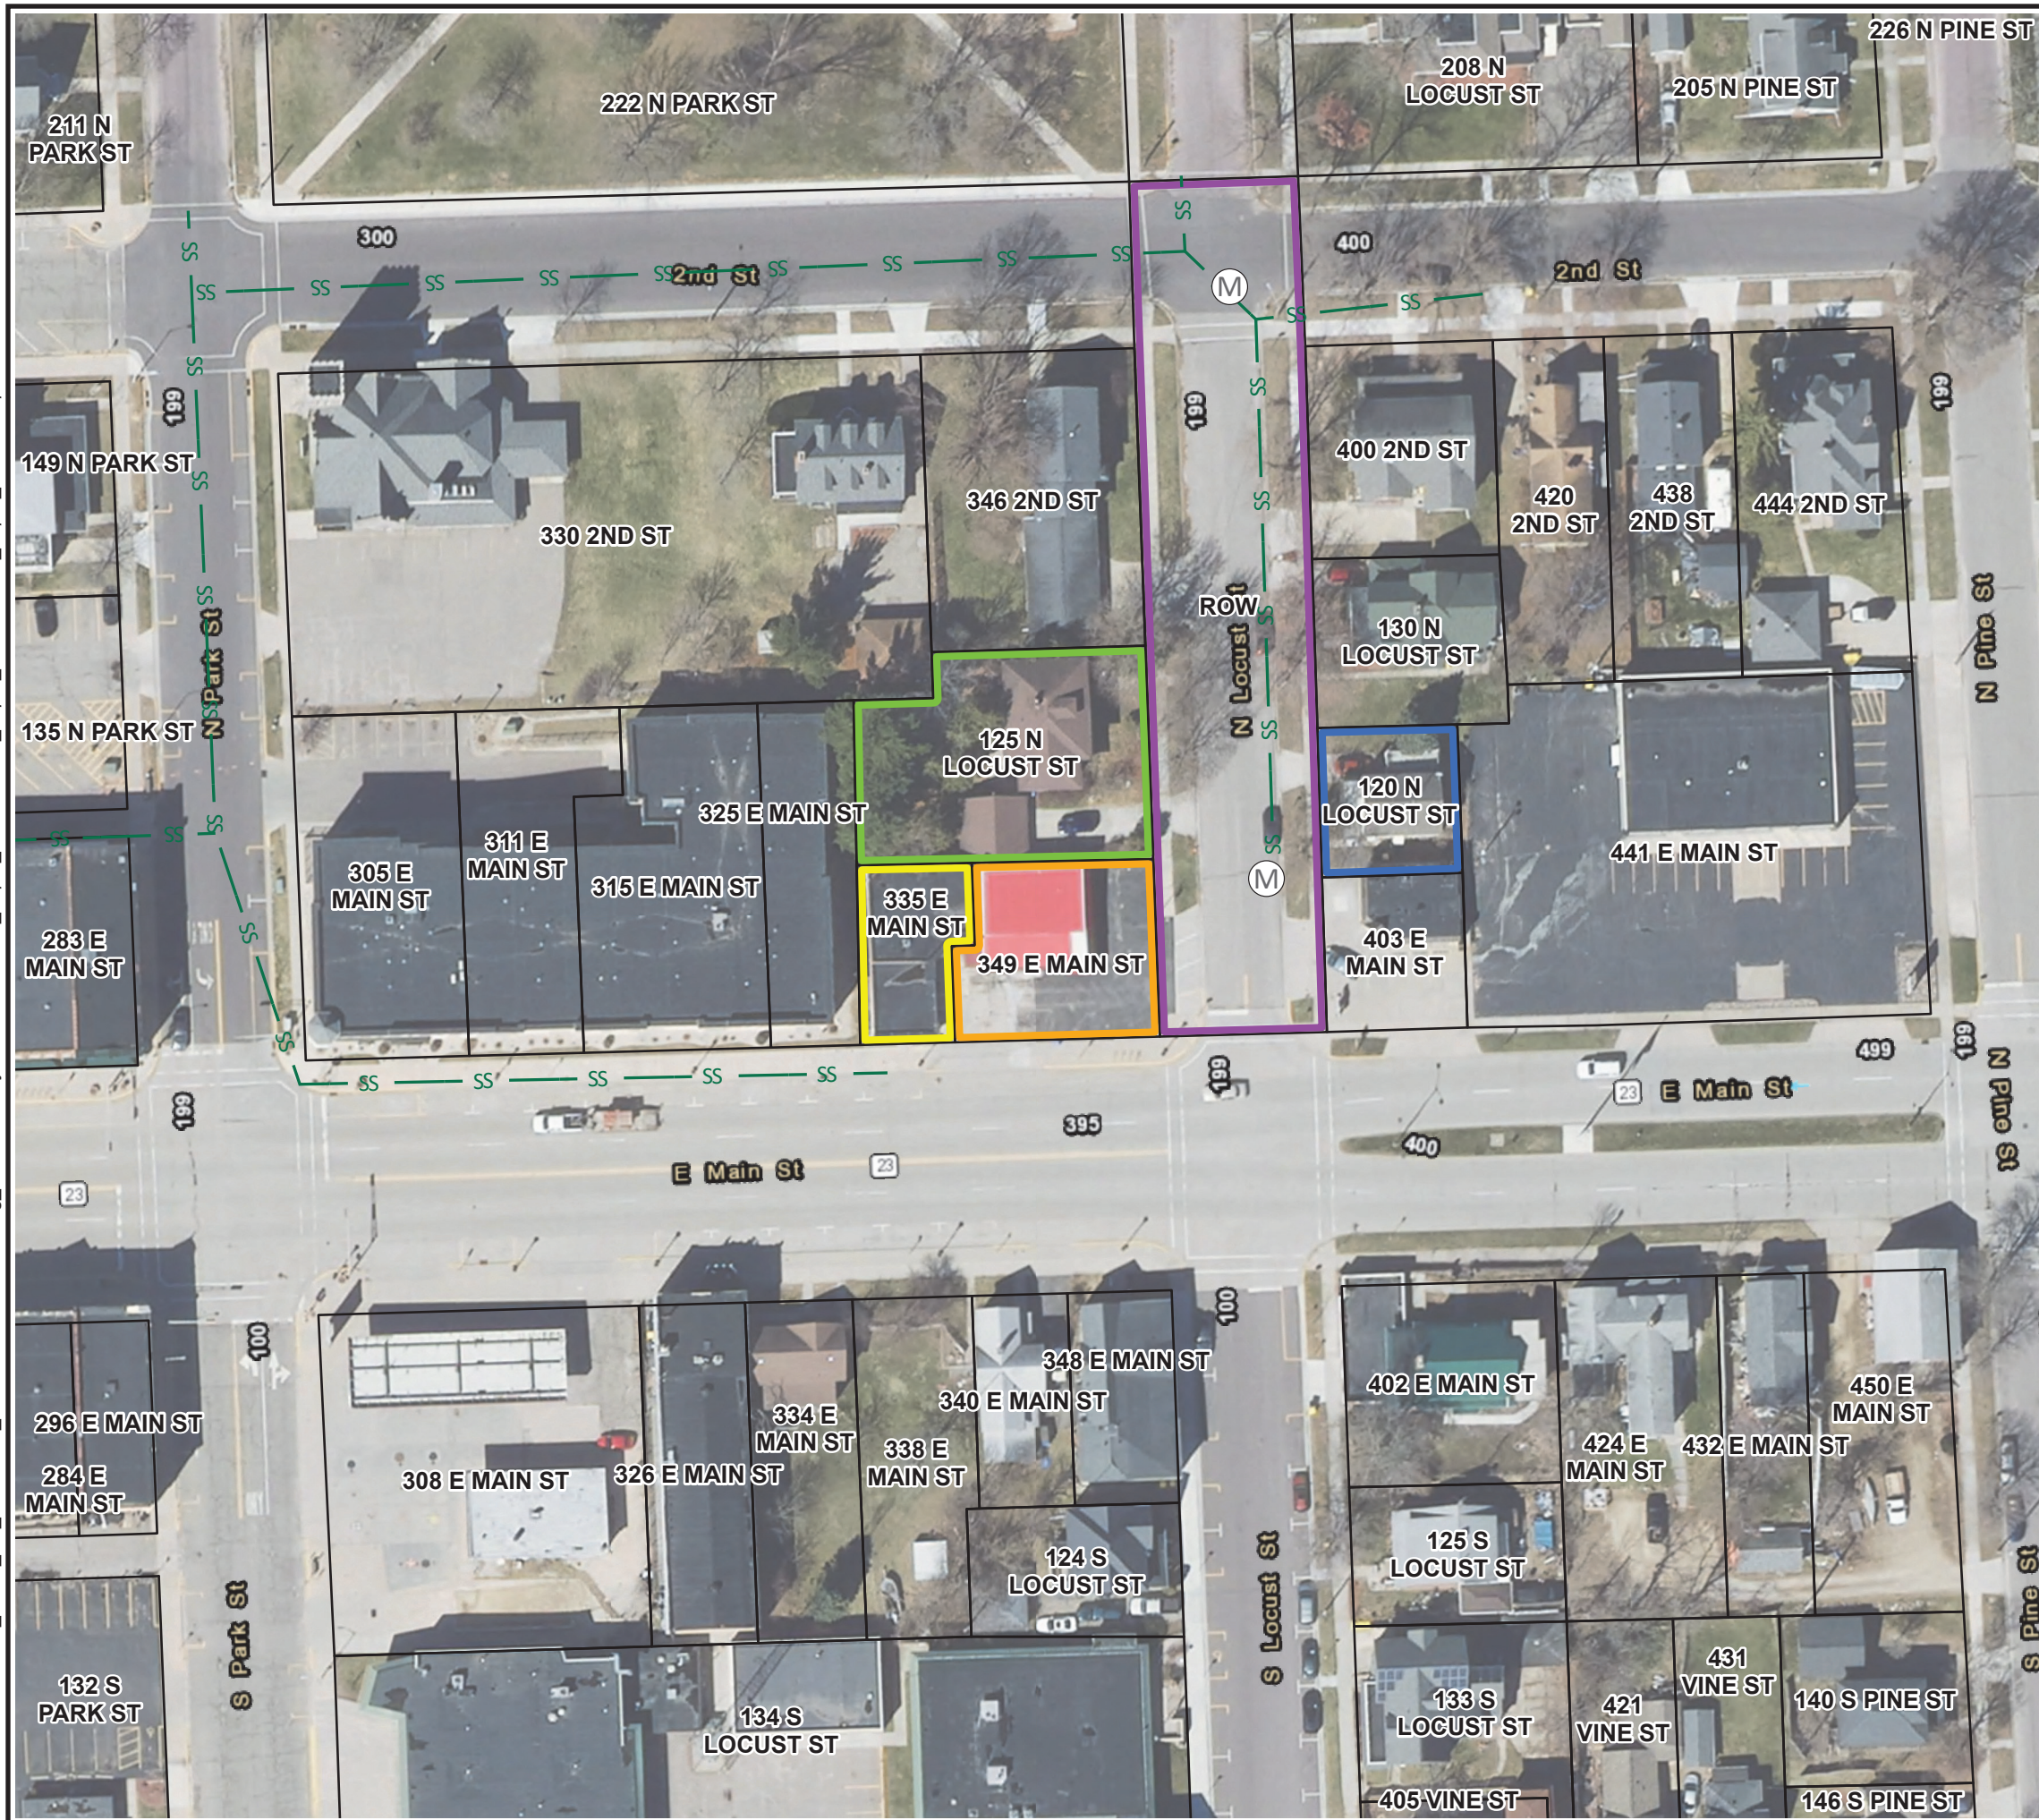
Figure 2 Site Map

- Manhole
- Sanitary Sewers
- 120 N Locust St (PSI A)
- 125 N Locust St (PSI B)
- 335 E Main St (PSI C)
- ROW (PSI R)
- 349 E Main St (Source)
- Parcel Boundaries
