SUBJECT: 2nd Round Vapor Sampling Results - <u>Contaminant Detection Below DNR Screening Level</u> PROPERTY: Reedsburg Cleaners, 125 N. Locust Street (PSI B); BRRTS # 02-57-001682

Included are the findings of our recent 2nd round investigation on your property conducted by Bay West, LLC (Bay West) an environmental consultant hired by the Wisconsin Department of Natural Resources (WDNR).

157001460 – Reedsburg Cleaners 125 N. Locust Street, Reedsburg, WI Property Sample Identifier (PSI) - B

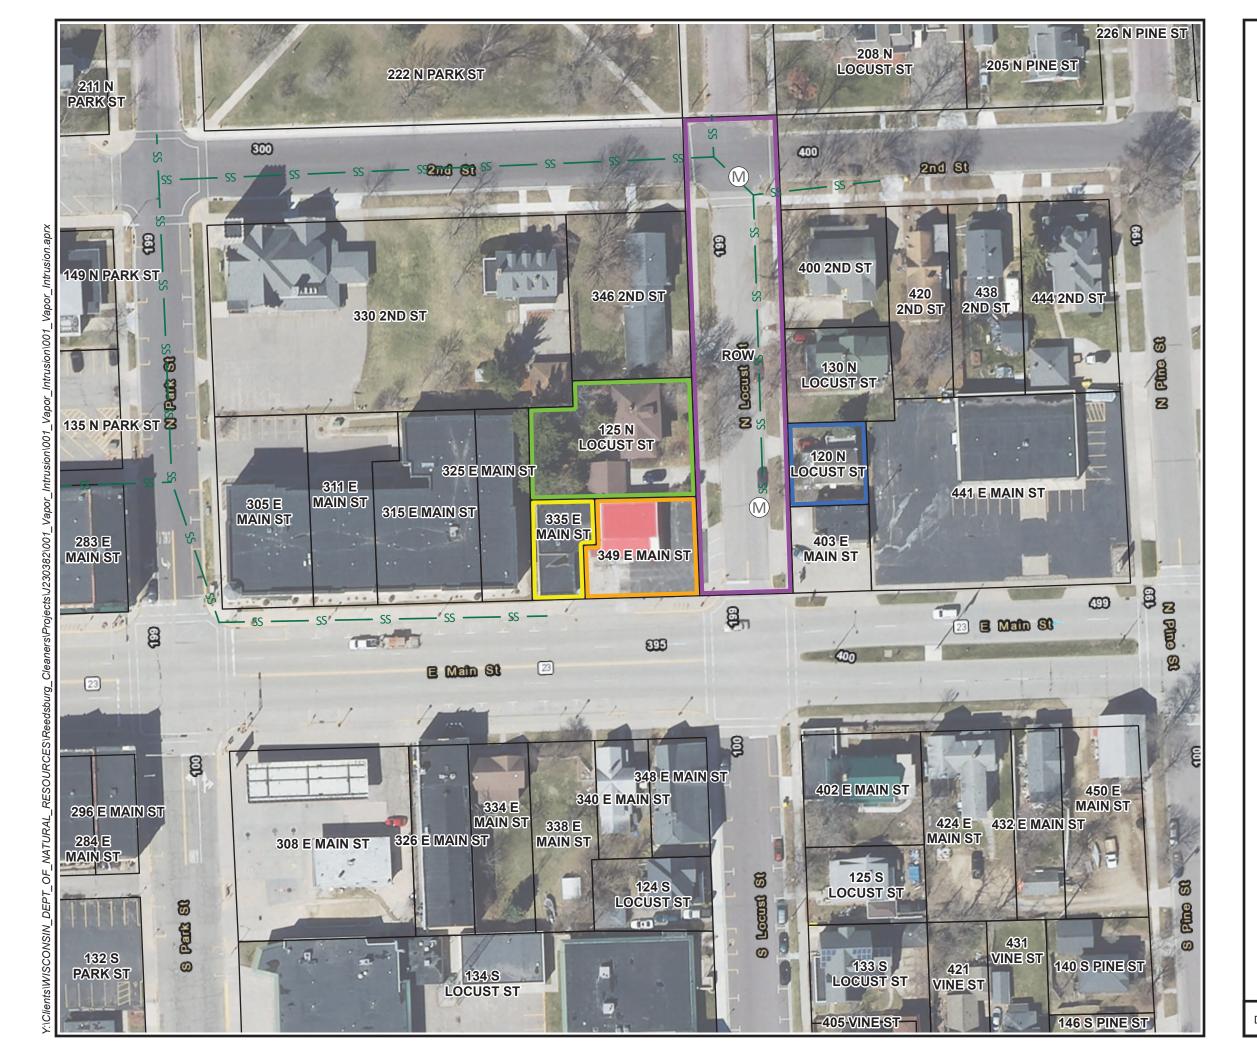
Figure 2 **Site Map**

Figure 2 and 2A – Building Map showing sampling locations.

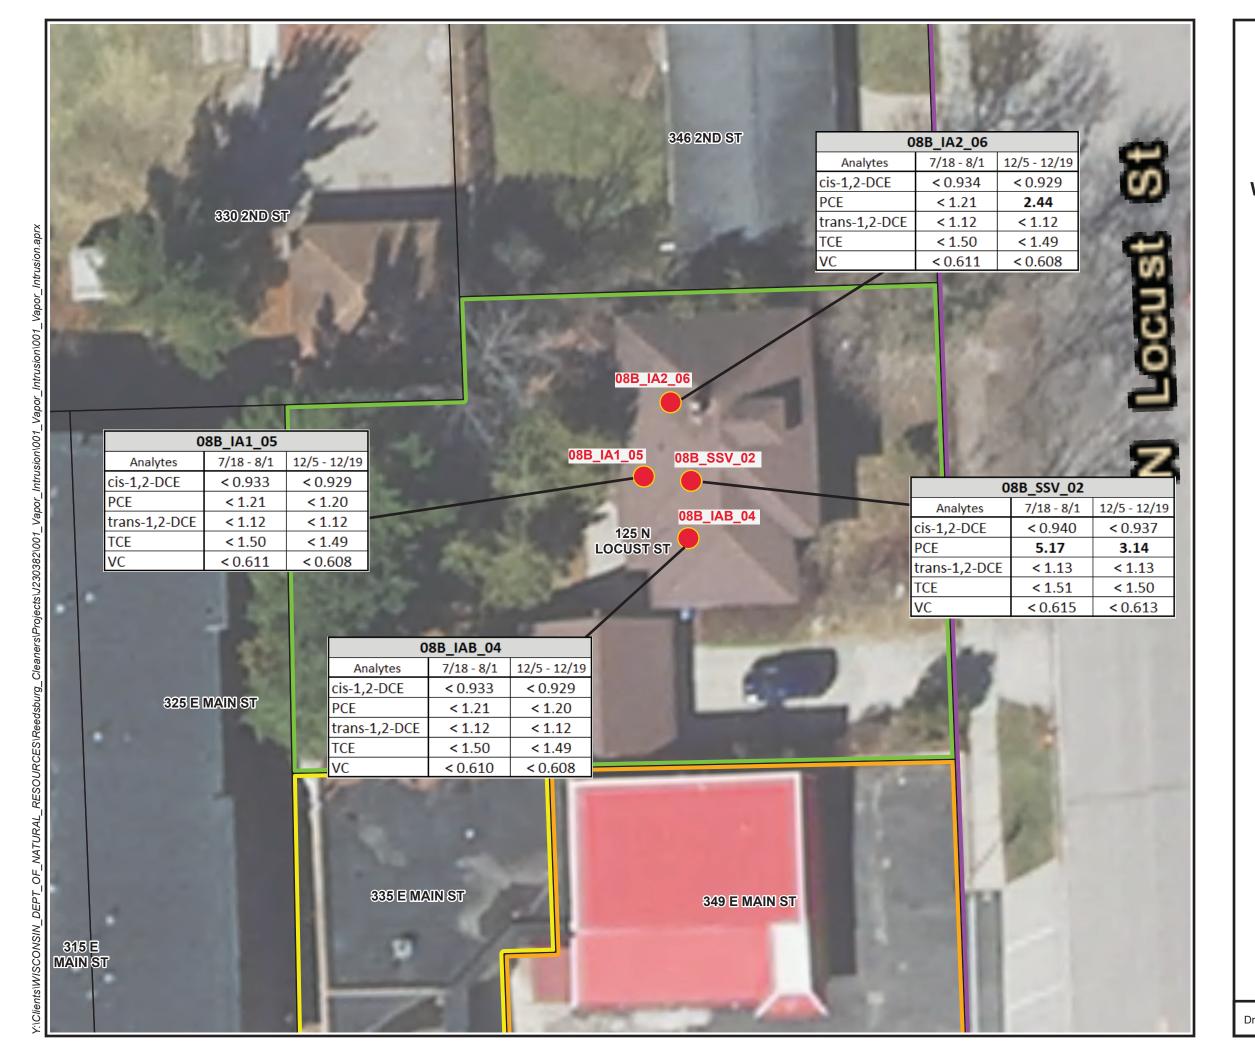
Figure 2B **Site Map**

Passive Vapor Sample Location

All results are in micrograms per cubic meter (µg/m³) < - Less than the laboratory Reporting Limit (RL)
