Subject: Sub Slab Vapor Sampling Update #2  
Former Classic Cleaners, 3918 Monona Drive, Madison  
BRRTS #02-13-368525

Encl. Table 1 – Sub-Slab Soil Vapor Analytical Results Summary  
Figure 1 – Site Plan with Vapor Sample Locations  
Attachment A – Vapor Sampling Procedures  
Attachment B – Photos  
Attachment C – Lab Report

Figure 1 - Site Plan with Vapor Sample Locations  
Former Classic Cleaners  
3918 Monona Drive, Madison  
SCS Project 25221209.00

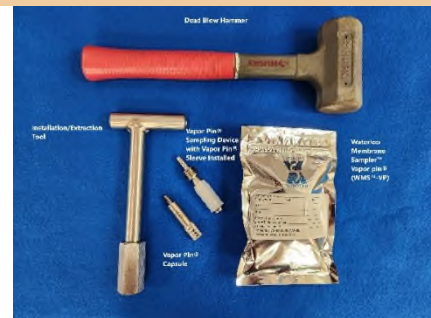
Figure 1

1. Assemble your Vapor Pin® Sampling Device as seen in (Figure 1).

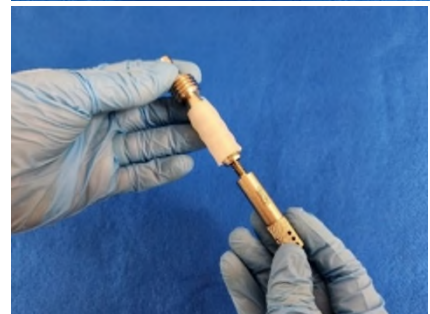
Figure 2

2. Screw the Vapor Pin® Capsule into the base of the Vapor Pin® Sampling Device as seen in (Figure 2).

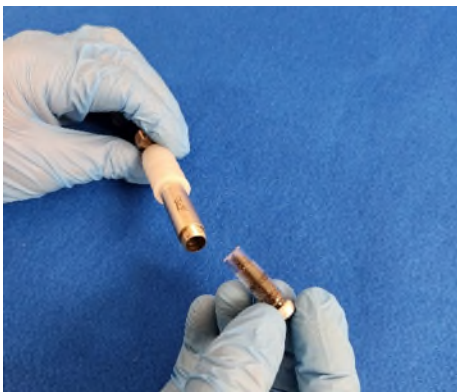
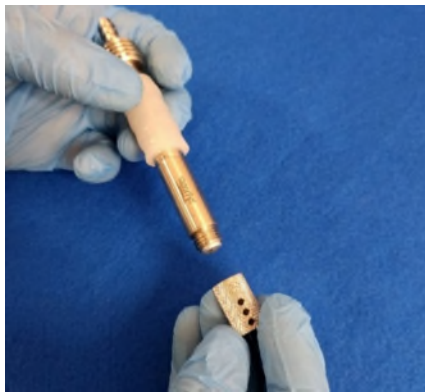
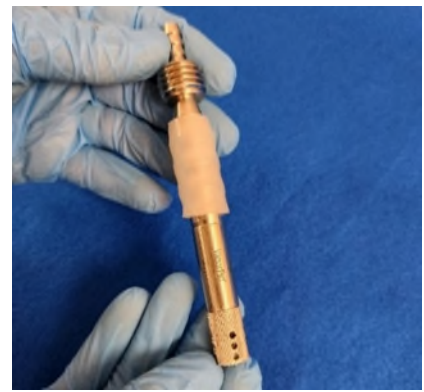
4. For the following instructions please handle the Waterloo Membrane Sampler (WMS™-VP) per manufactures specifications.
5. Remove your WMS™-VP from the packaging. Place the WMS™-VP vial into the Vapor Pin® Capsule. Make sure that the membrane end is facing the open end of the Vapor Pin® Capsule. Re-thread the Vapor Pin® Capsule cap to finger level tightness (Figures 4, 5 & 6).

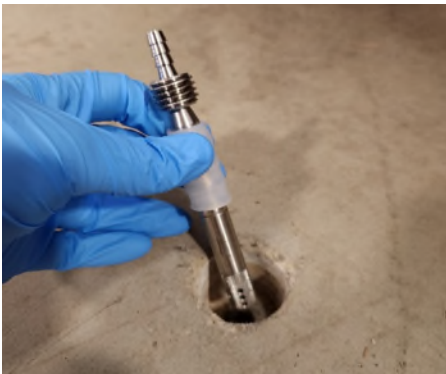
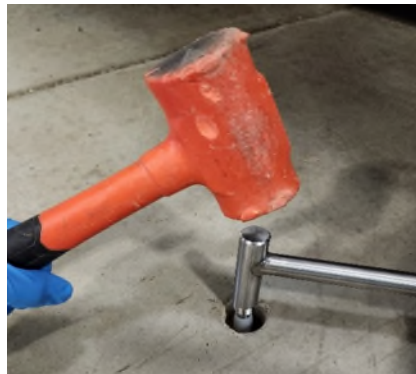
6. Install your Vapor Pin® Sampling Device, with Vapor Pin® Capsule, into your Stick-Up/Flush-Mounted drilled hole (Figures 7 & 8). If Stick-Up Configuration use a cone to cover your pin and if Flush-Mounted Cover be sure to use either the Plastic Flush Mount Cover or Stainless Steel Secure Cover!

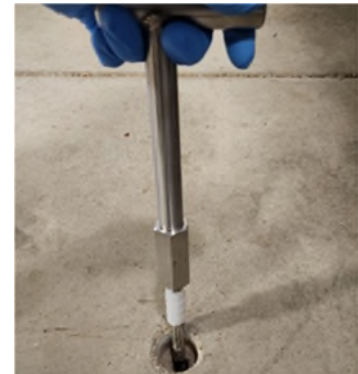
Figure 9

7. Post passive sampling of two to three weeks, use the Installation/Extraction Tool to remove the Vapor Pin® Sampling Device (Figure 9). Use the Spanner tool first if you are using a Flush-Mounted configuration With the Stainless Steel Secure Cover. and retrieve your WMS™-VP to send it back off to the lab. Please follow all handing instructions, per manufactures specifications, when retrieving and packaging up the WMS™-VP.

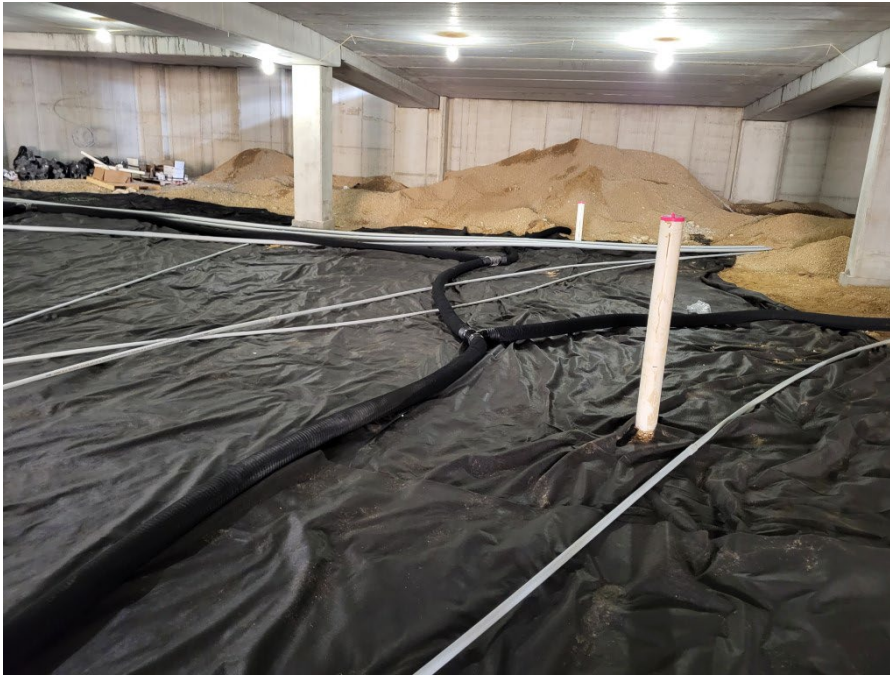
**Photo 1:** Lower level floor with drainage/vapor piping (black), electrical conduit (gray), and rough plumbing (white) (9/18/2023; 14:15).

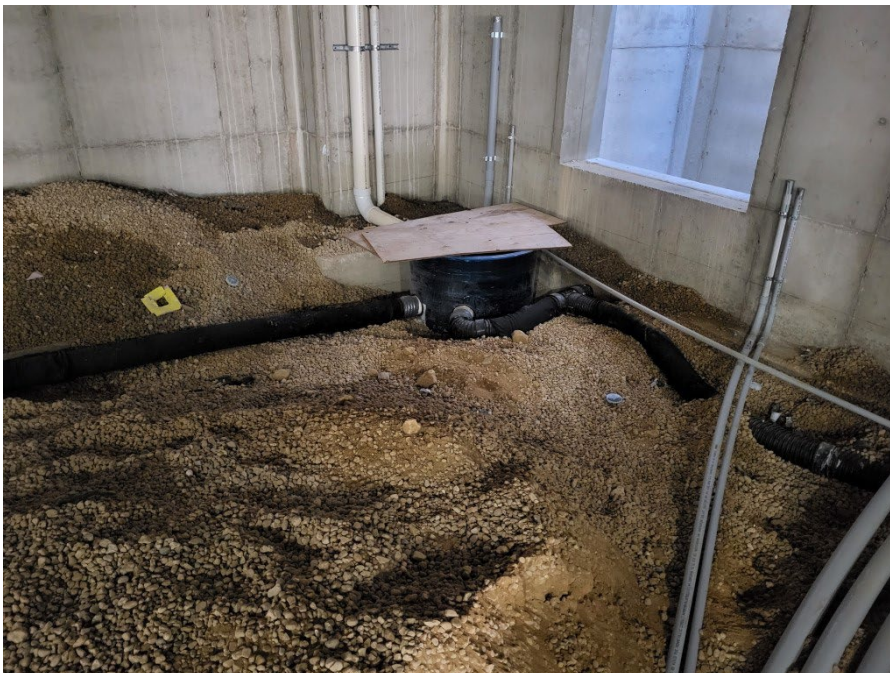
**Photo 2:** Sump at the northeast corner of the lower level with drain/vent pipes connected and opening for ventilation fan visible to the right of the sump (9/18/2023; 14:16).

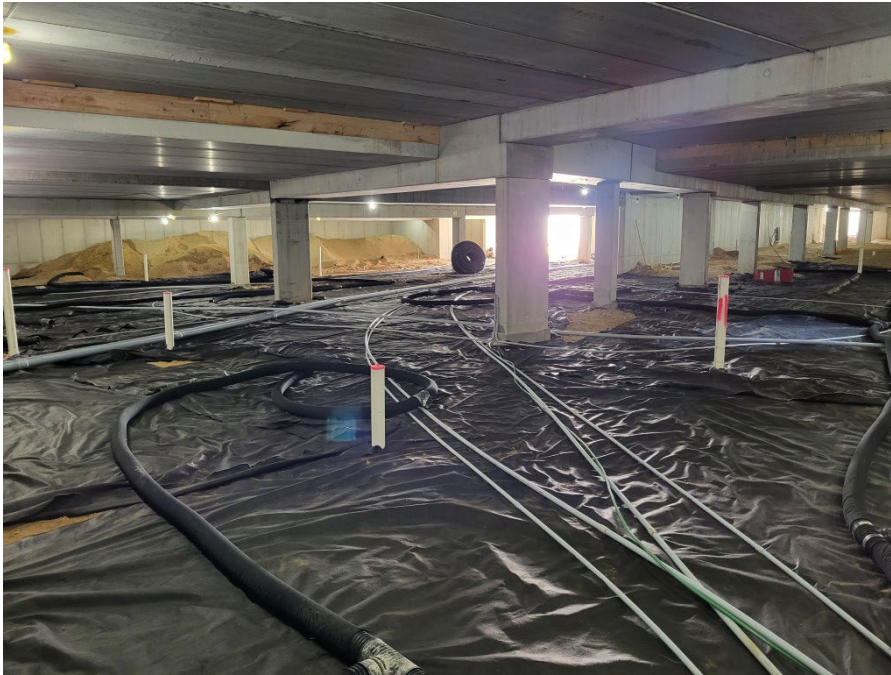
**Photo 3:** Lower level floor/parking area with a partially completed drain/vent piping looking southeast toward parking ramp entrance (9/18/2023; 14:19).

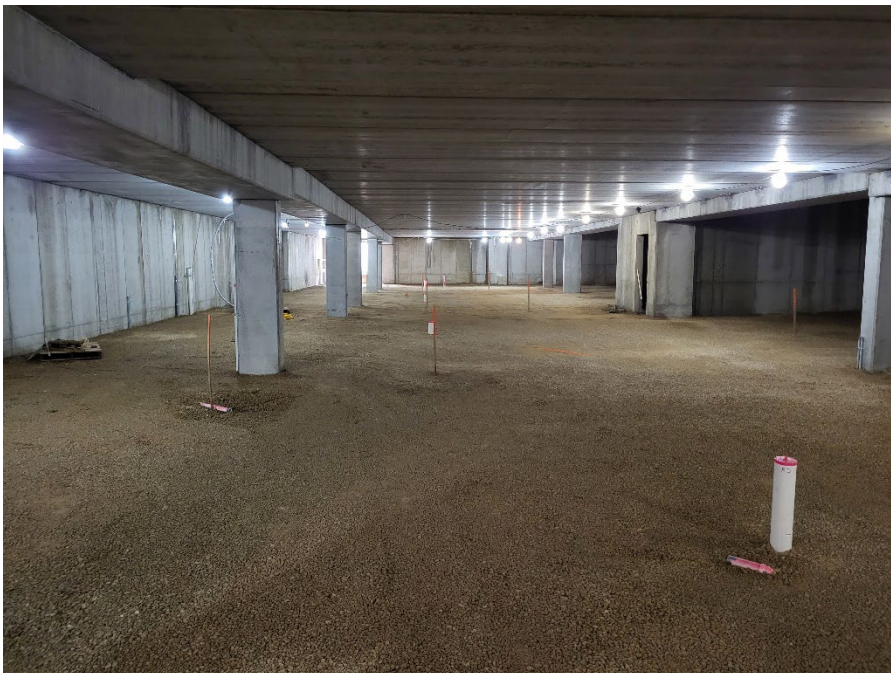
**Photo 4:** Gravel drainage layer prior to placement of vapor barrier, looking toward the southwest corner of the building (9/29/2023; 12:25).

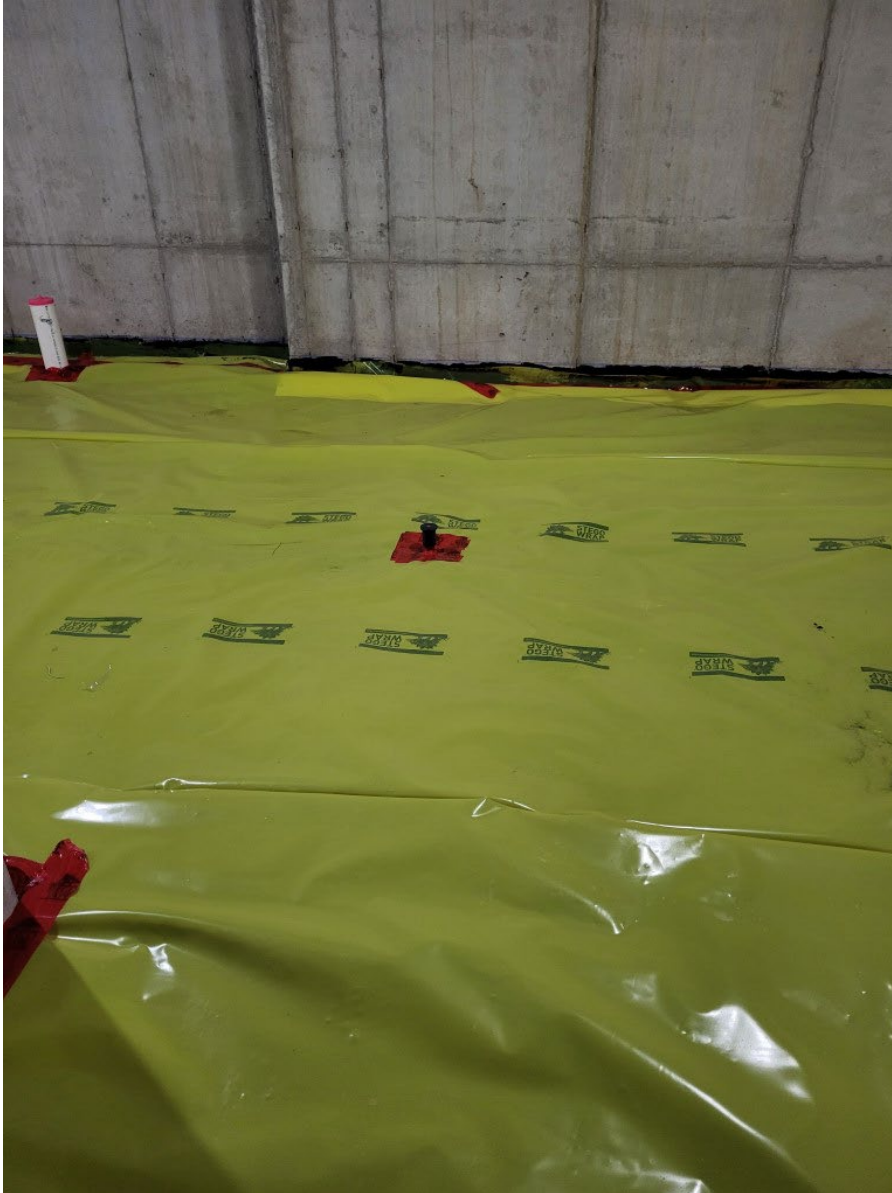
**Photo 6:** VP-3 installed and sealed into vapor barrier (10/5/2023; 15:36).

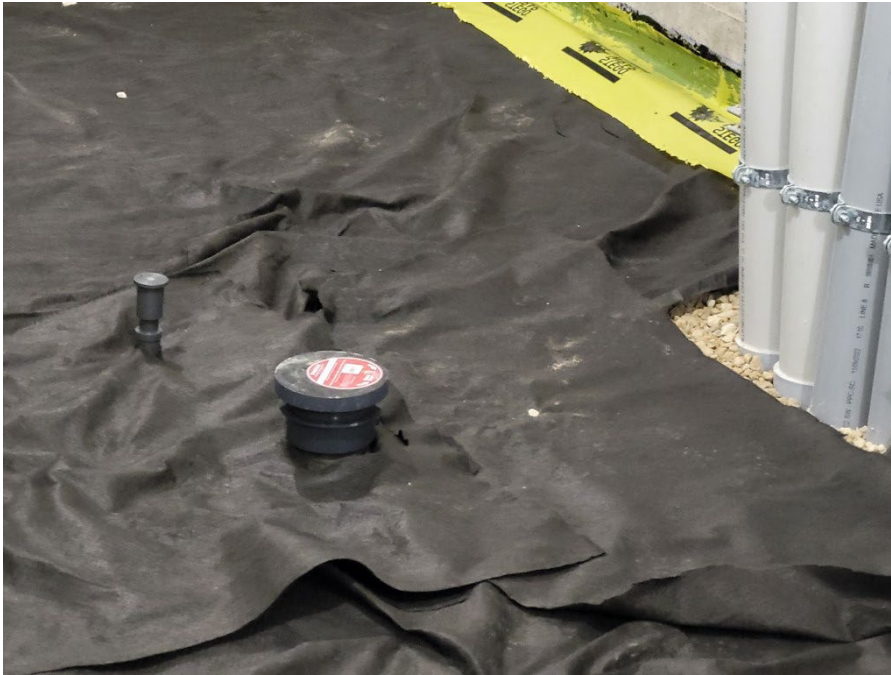
**Photo 7:** VP-1 installed in electrical room (to the left of the floor drain) prior to completion of the vapor barrier (10/5/2023; 17:49).
