Site Investigation Work Plan

**Former Heimes Garage
3418 – 66th Street
Kenosha, WI**

RE: Site Investigation Work Plan
Heimes Garage - Former
3418 – 66th Street
Kenosha, WI
BRRTS#: 03-30-409382
PECFA#: 53142-3443-18
FID#: 230058620

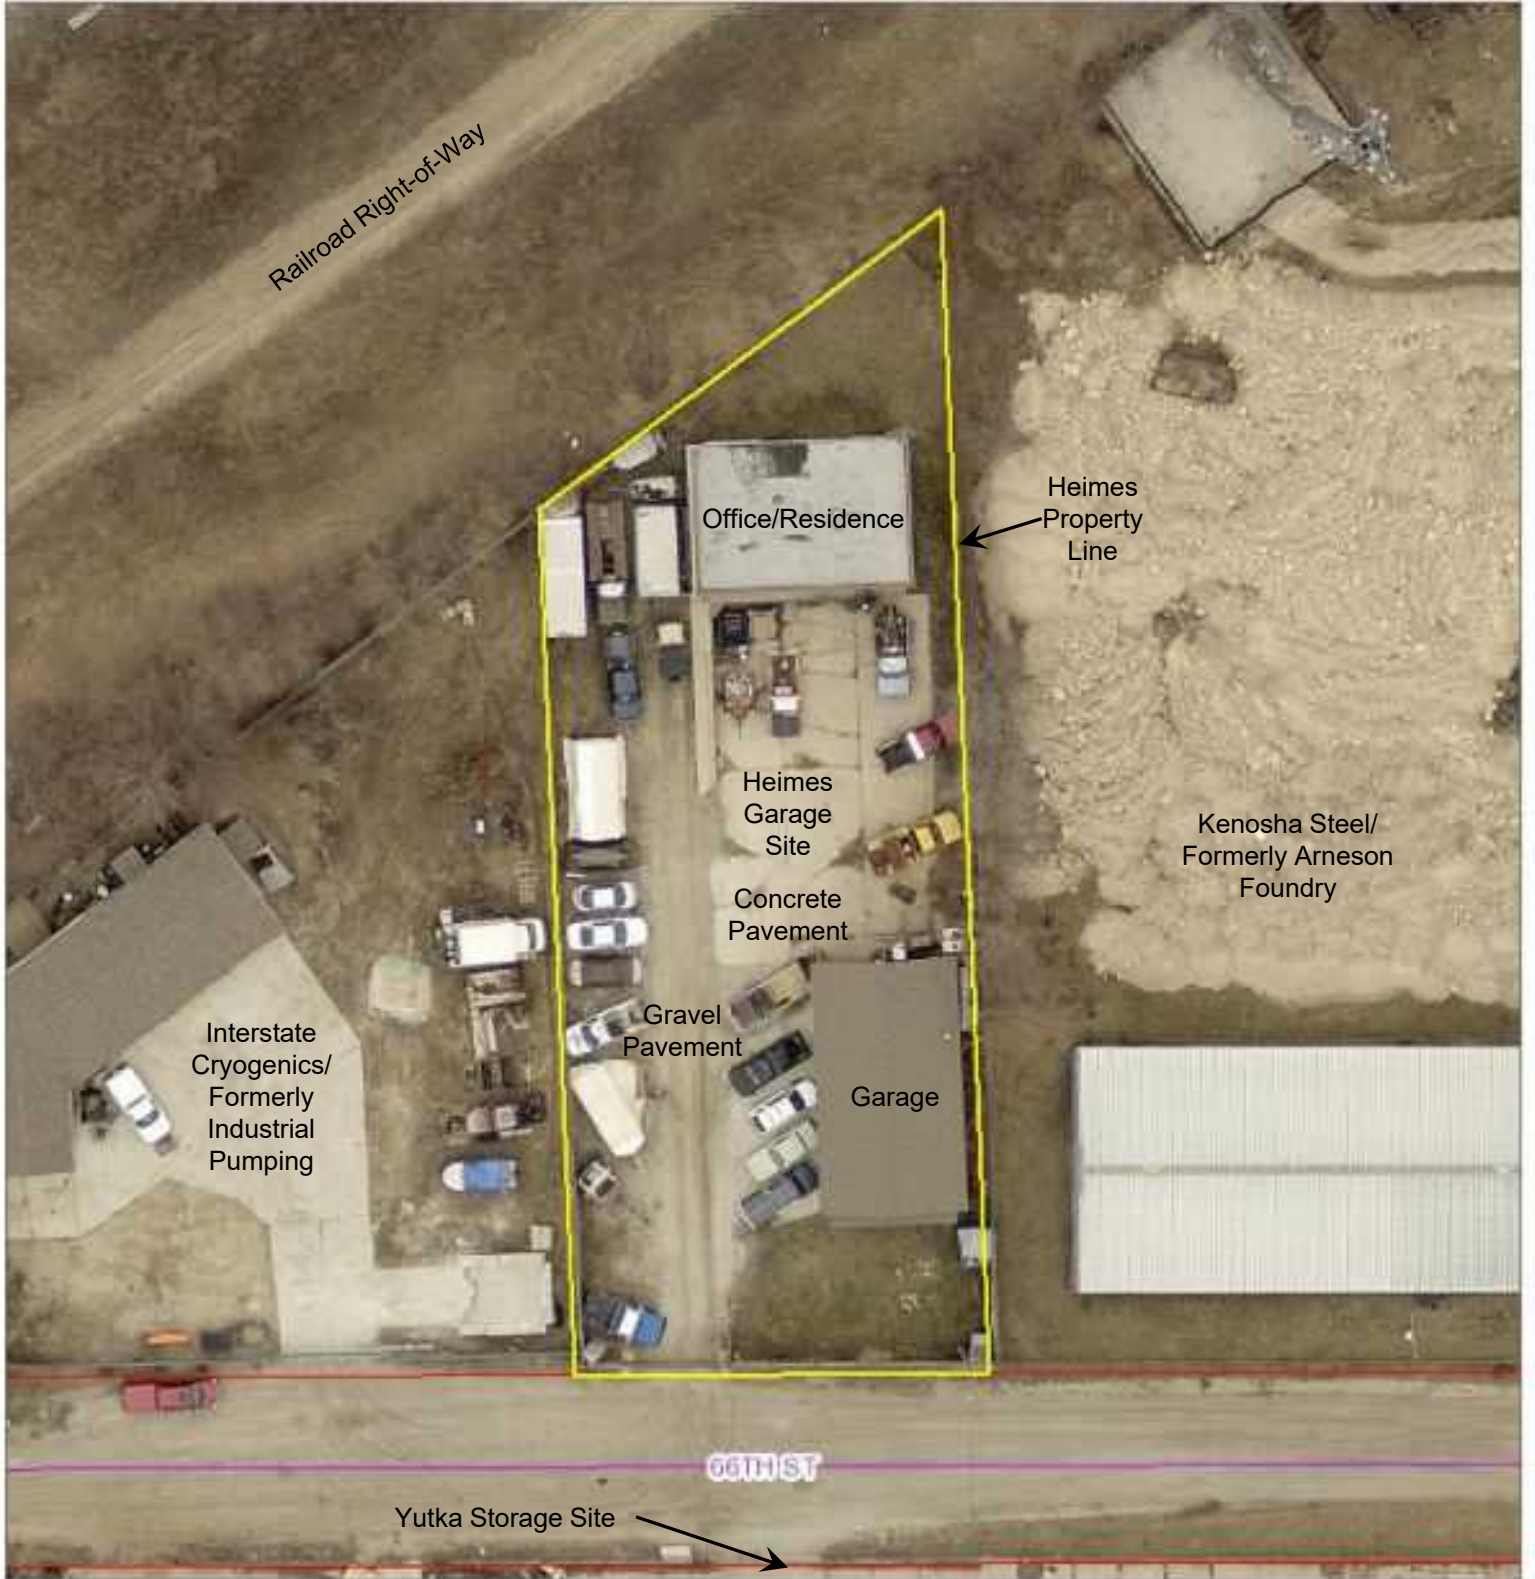
FIGURE 3 HEIMES GARAGE FORMER AST SYSTEM CONFIGURATION

The property was used historically for the bulk storage and distribution of petroleum and seven ASTs were located on the western portion of the property. Based on aerial photographs, the ASTs were present on site in 1937 and were still there in 1970. The ASTs were removed prior to the 1975 photograph. The potential for historical releases of petroleum from the AST systems as well as during the delivery and transference of petroleum offsite constituted a recognized environmental condition (REC). The Heimes former AST configuration is illustrated on Figure 3. Selected aerial photographs are provided in Appendix A.

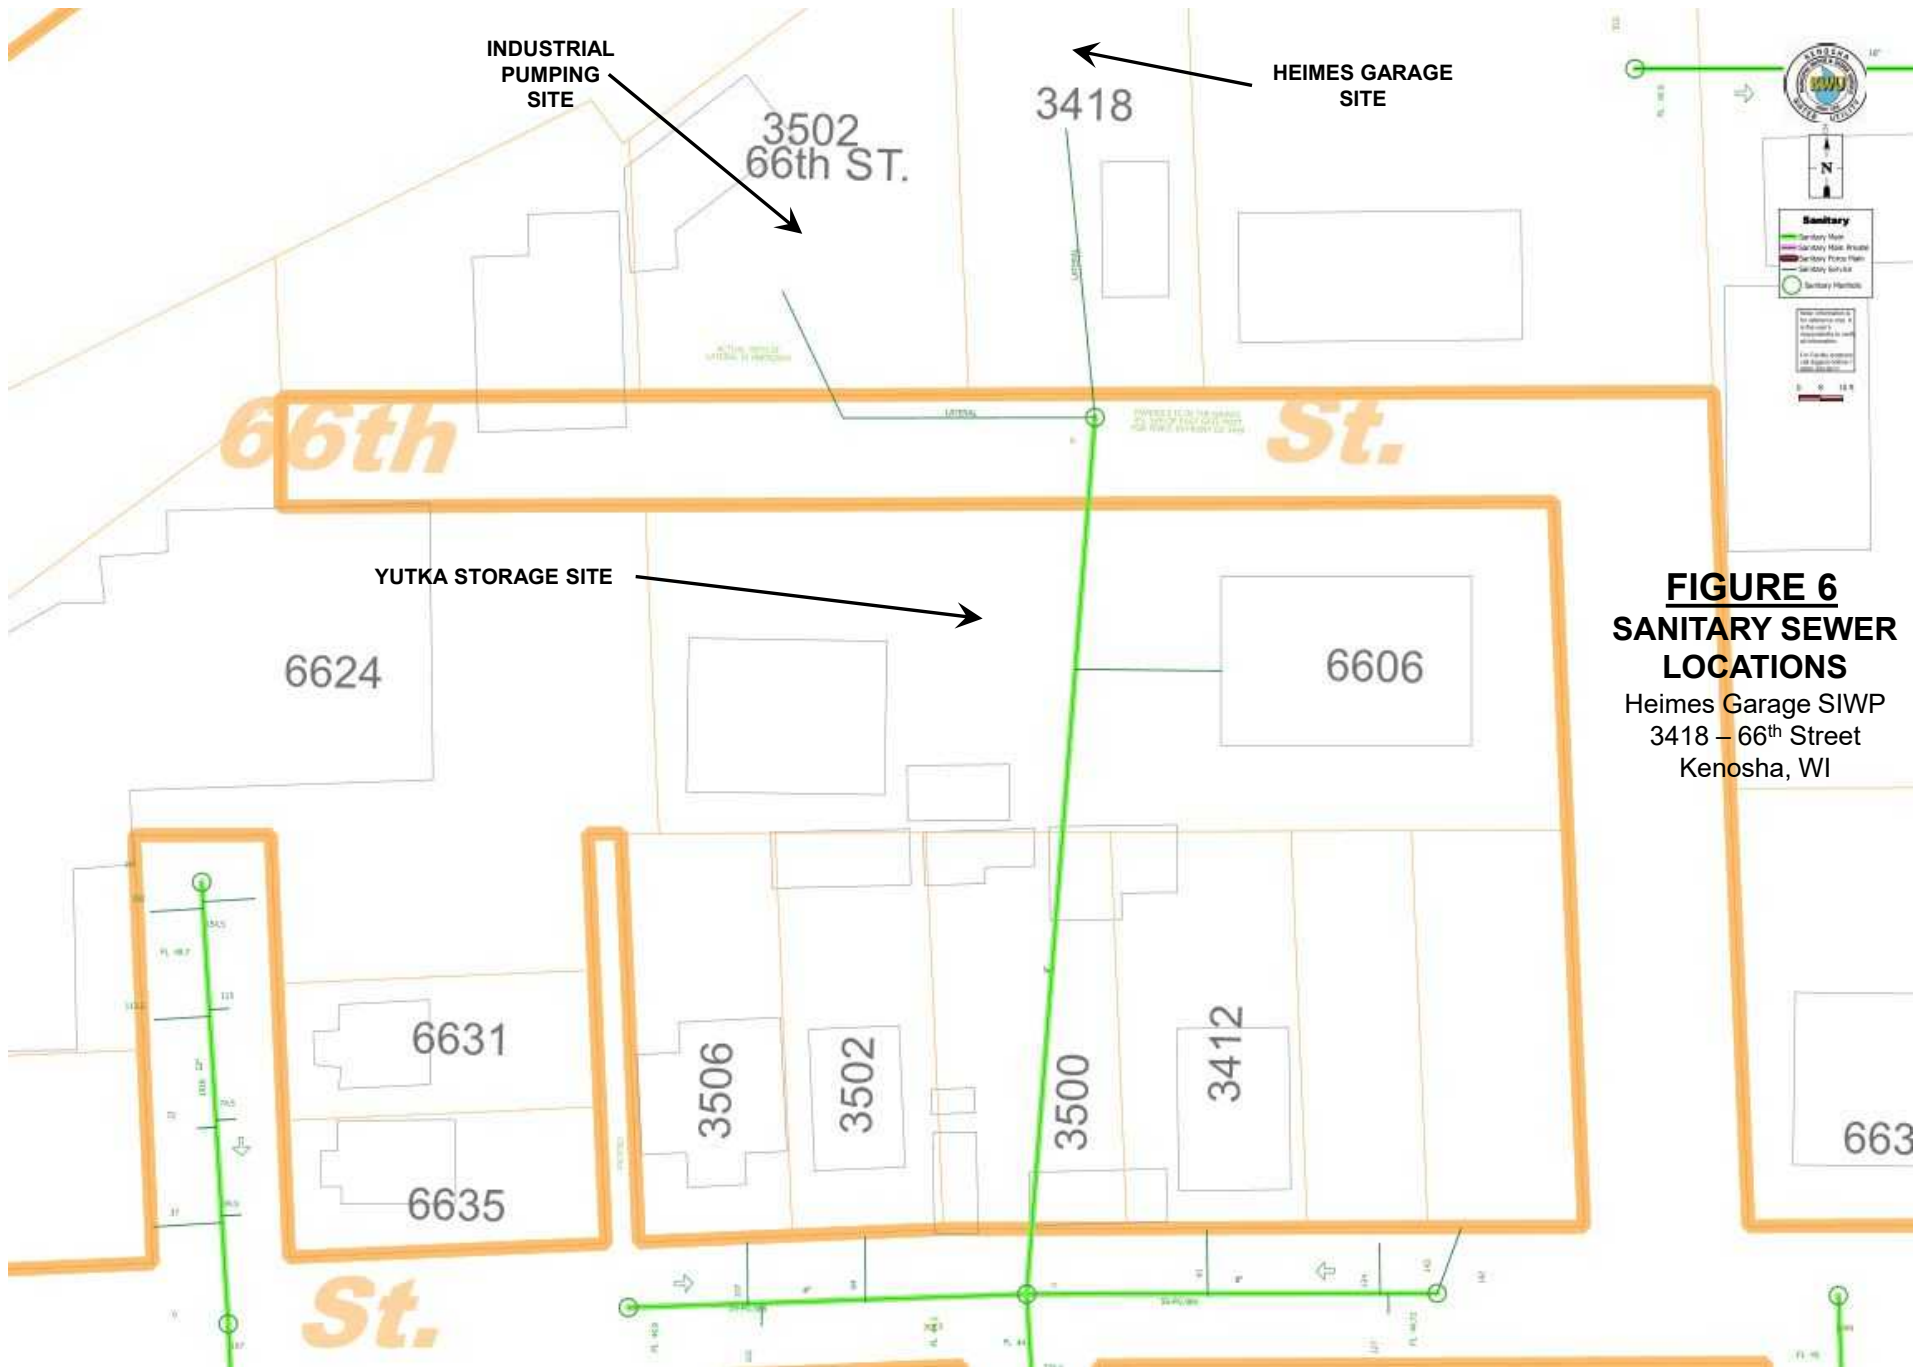
FIGURE 6
SANITARY SEWER
LOCATIONS
 Heimes Garage SIWP
 3418 – 66th Street
 Kenosha, WI

All underground utility locations are estimated and not verified
