FINAL SCREENING SITE INSPECTION REPORT  
FOR

**Try-Chem Corporation**

MILWAUKEE, WISCONSIN

U.S. EPA ID: WID048034300

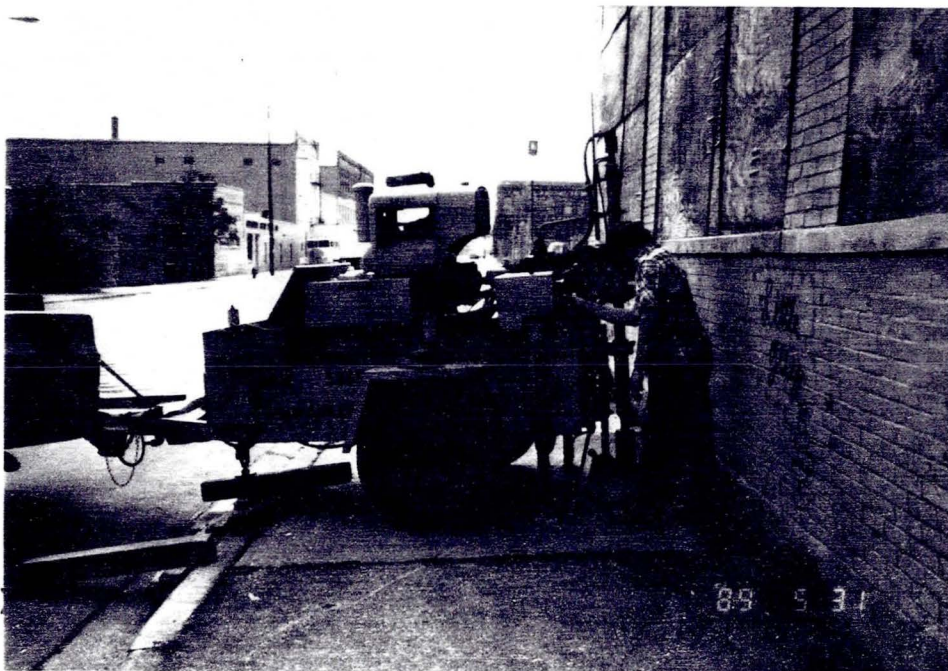
N.A.

DESCRIPTION: view of core drilling machine at sampling location SD1

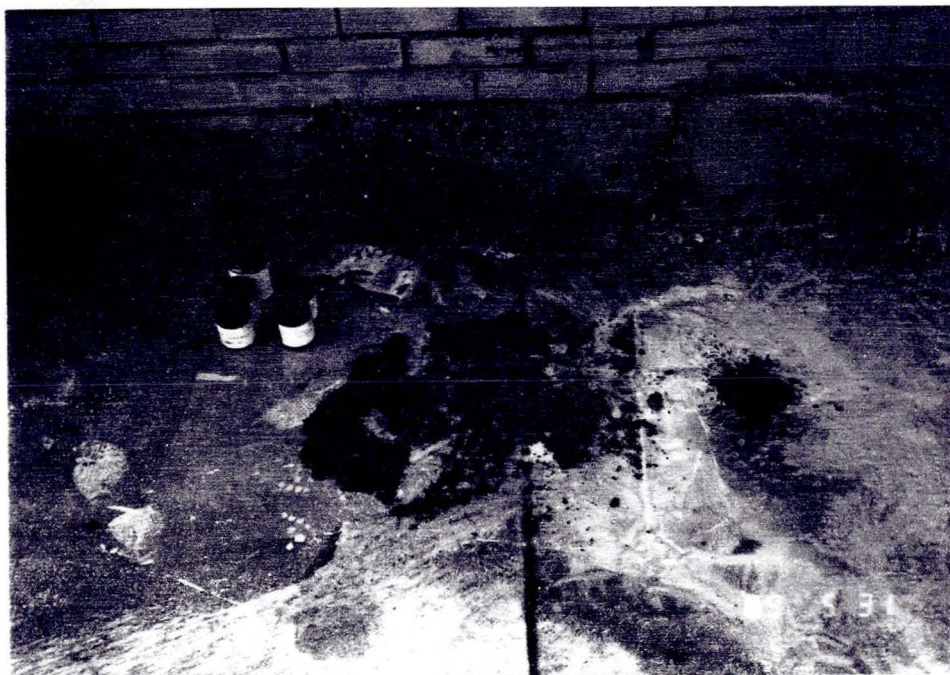
SAMPLE ID# (if applicable)  
SO2

DESCRIPTION: View of location of soil sample  
collected beneath concrete sidewalk.

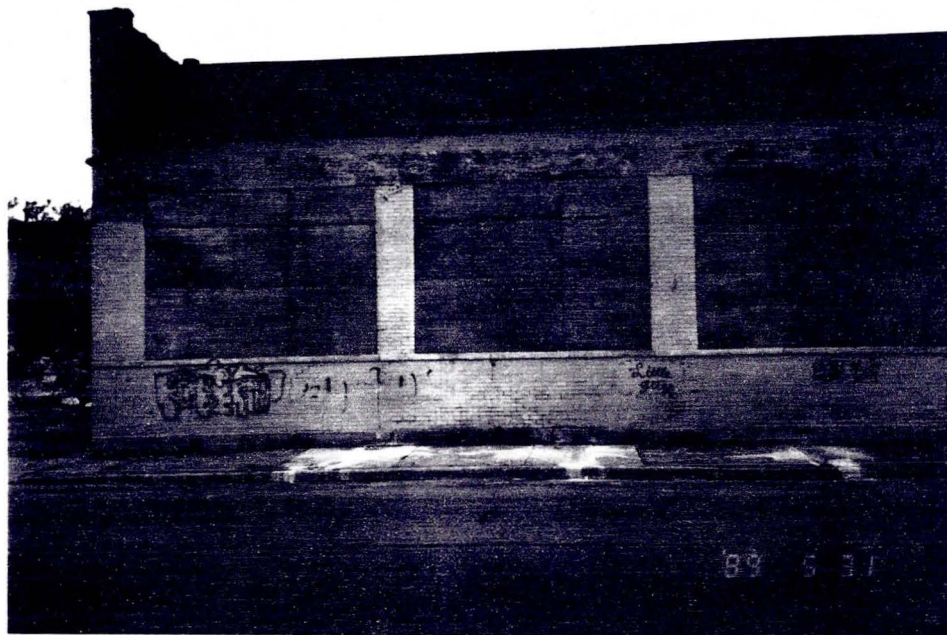
SAMPLE ID# (if applicable)  
N.A.

DESCRIPTION: View of North side of building showing  
location of soil samples SO1-SO3 (white stains at borings)

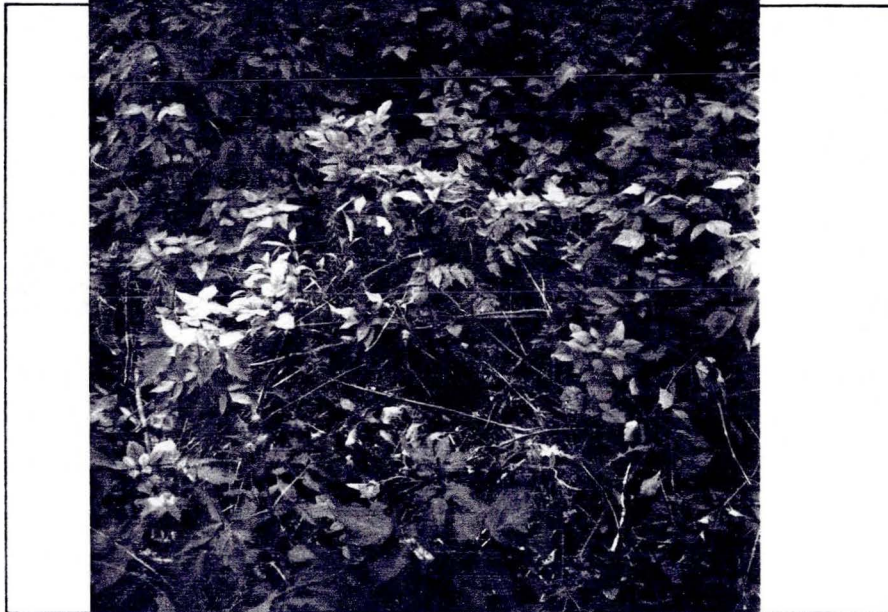
SAMPLE ID# (if applicable)  
504

DESCRIPTION: foreground shows location of potential background surface soil sample

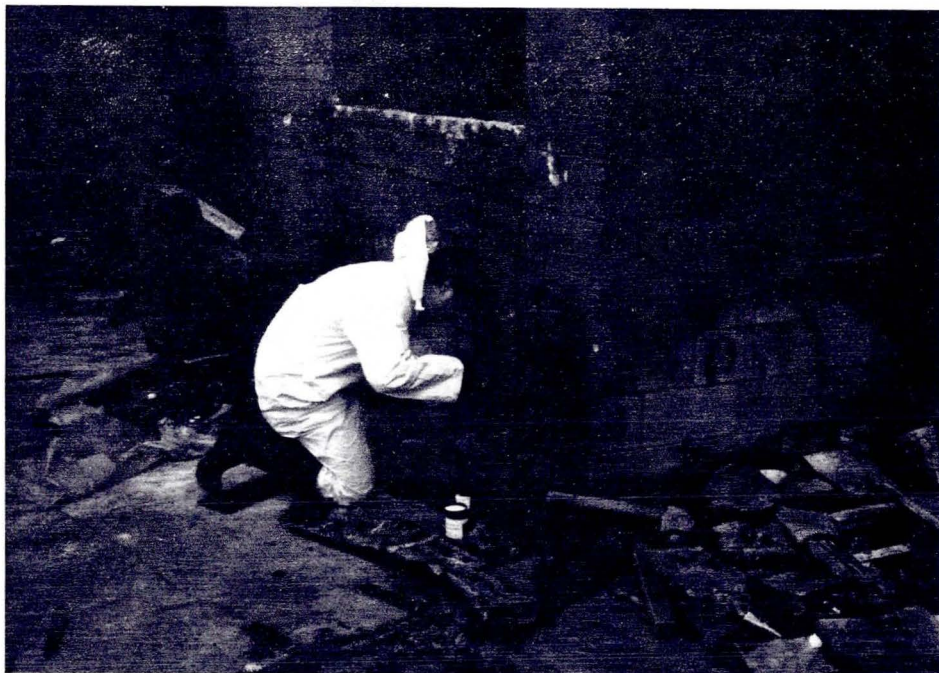
SAMPLE ID# (if applicable)  
505

DESCRIPTION: soil sampling location near North Central loading dock. visible stained soil at location.

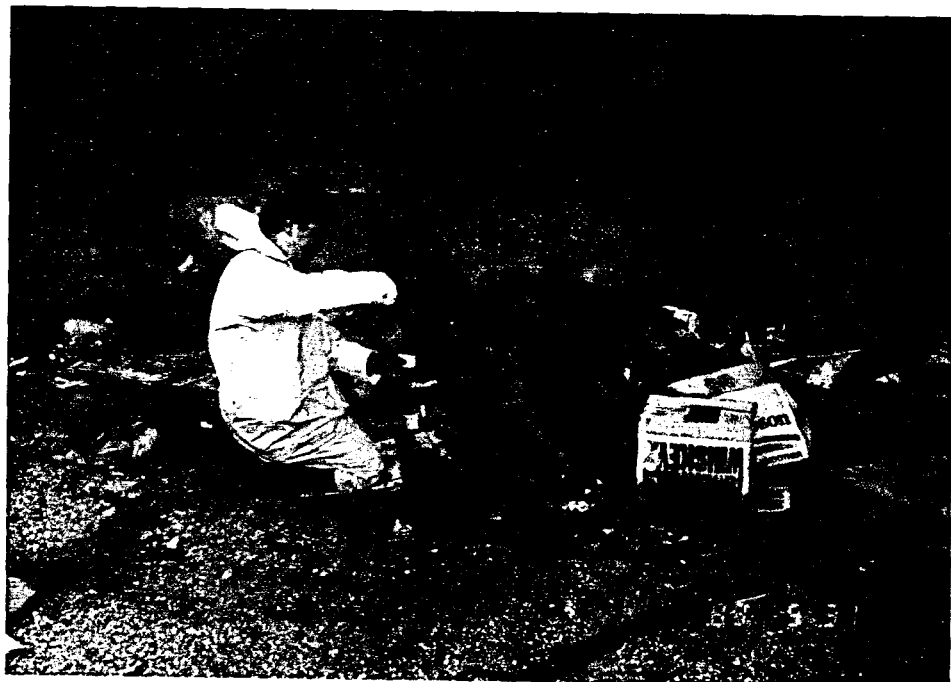
SAMPLE ID# (if applicable)  
506

DESCRIPTION: surface soil sampling location near  
southeast loading dock.

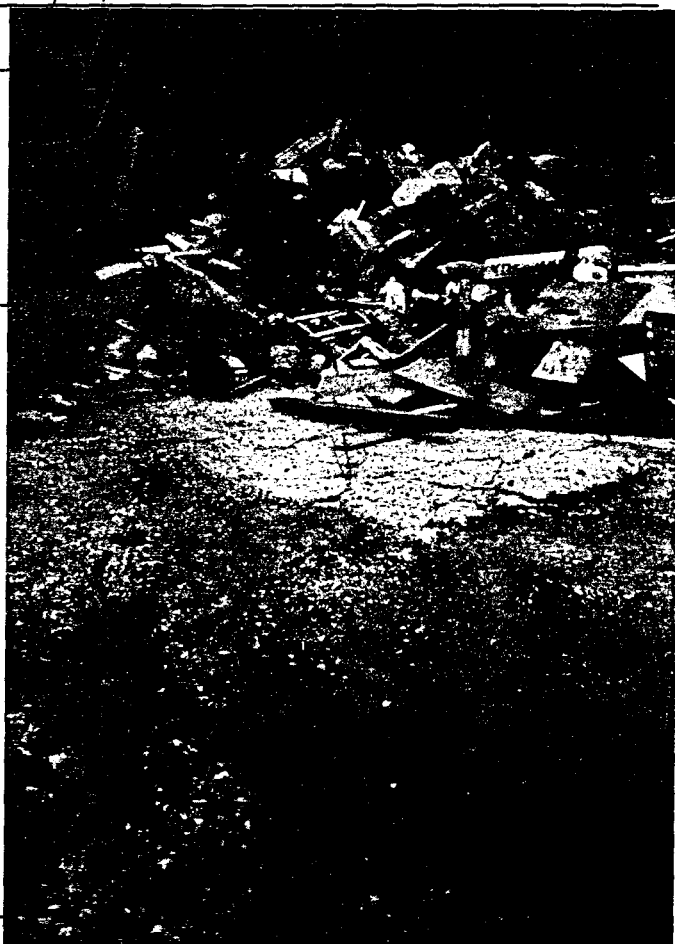
SAMPLE ID# (if applicable)  
507

DESCRIPTION: Foreground shows location of surface soil  
sample at northeast property corner

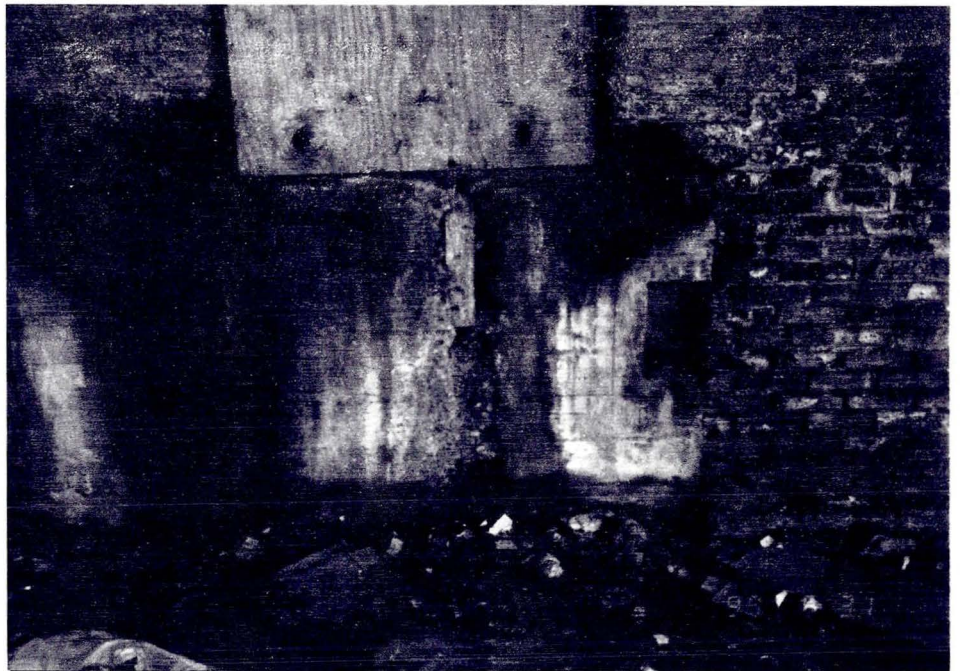
SAMPLE ID# (if applicable)  
N.A.

DESCRIPTION: View showing staining and dissolution of concrete at east loading dock area (close-up view)

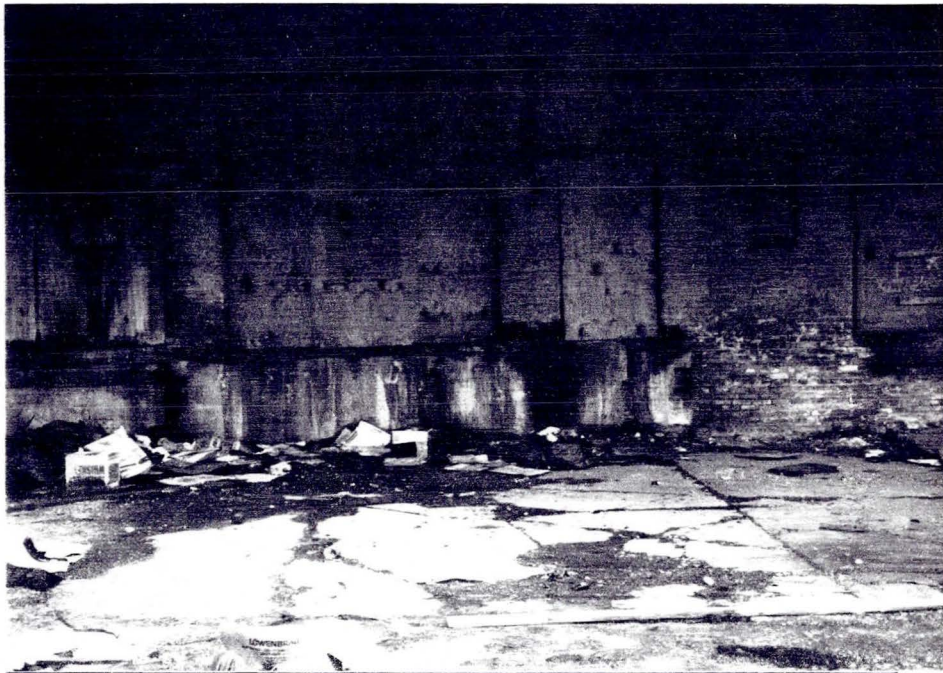
N.A.

DESCRIPTION: View of east loading dock area showing staining around doors and dissolution of building foundation

Field reports by the Milwaukee Health Department began in January 1983 and related to severe etching and damage to the public sidewalk in front of Try-Chem Corporation. Leakage was observed flowing out of the building foundation. Discharges through the building foundation are documented up to May 1984. Fluids were routinely observed flowing from the northeast corner of the building, across the sidewalk and into the storm sewer. In 1984, after previous meetings between Try-Chem Corporation and the City of Milwaukee Attorney, the City Attorney's office was pursuing legal proceedings against the Try-Chem Corporation for an injunction to close, or fine the facility.

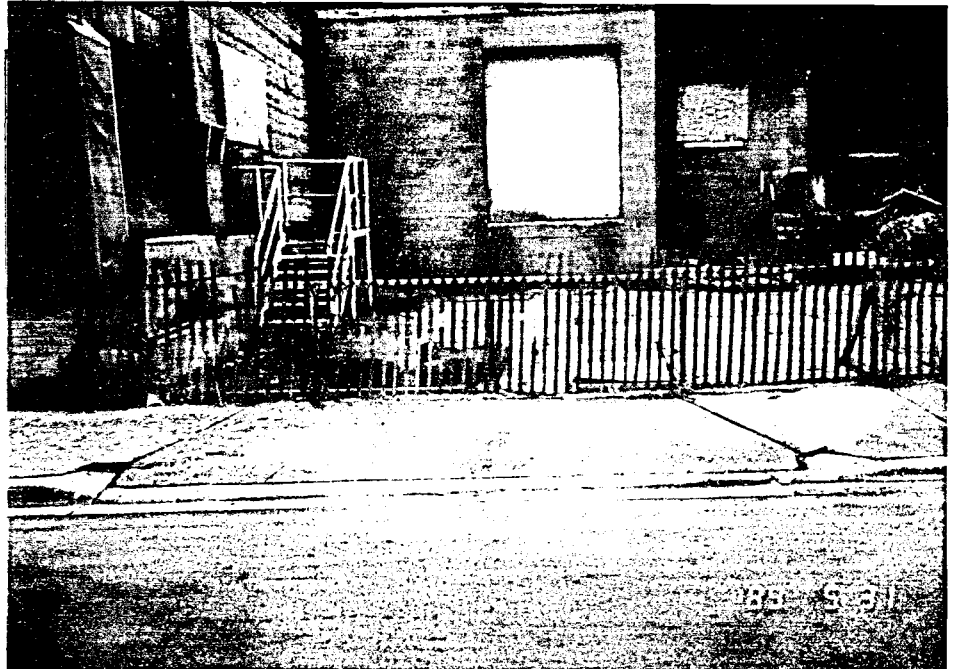
SAMPLE ID# (if applicable)  
N.A.

DESCRIPTION: View of South Central and South West loading dock (background). Storage area in foreground.
