Re: Slop Oil Release SERTS ID 20170502NO16-1

## NR708.05(6)(a) Immediate Action Report

# Immediate Response Action Report

Slop Oil Release SERTS ID 20170502NO16-1

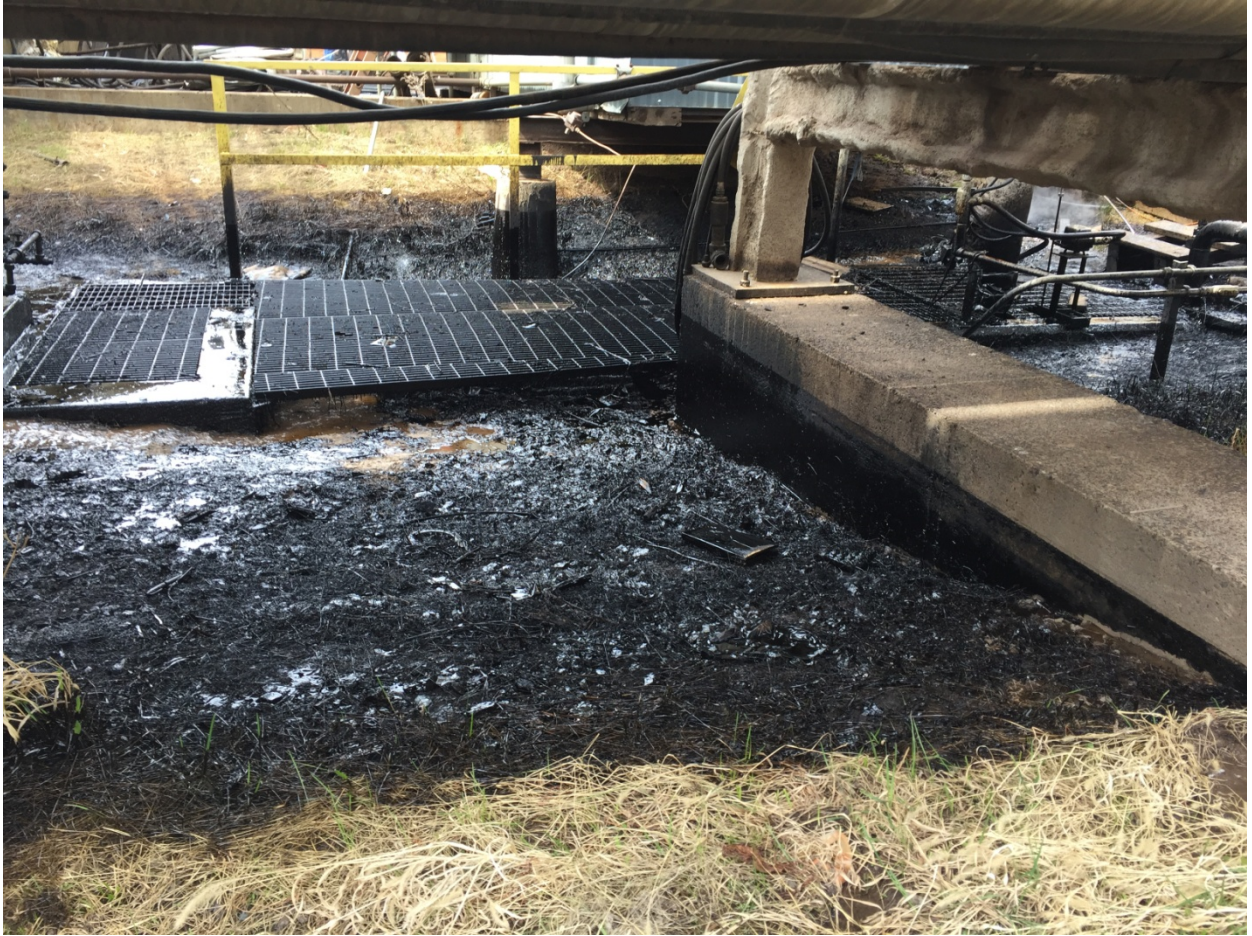
Photo 1: Looking north at the release site.

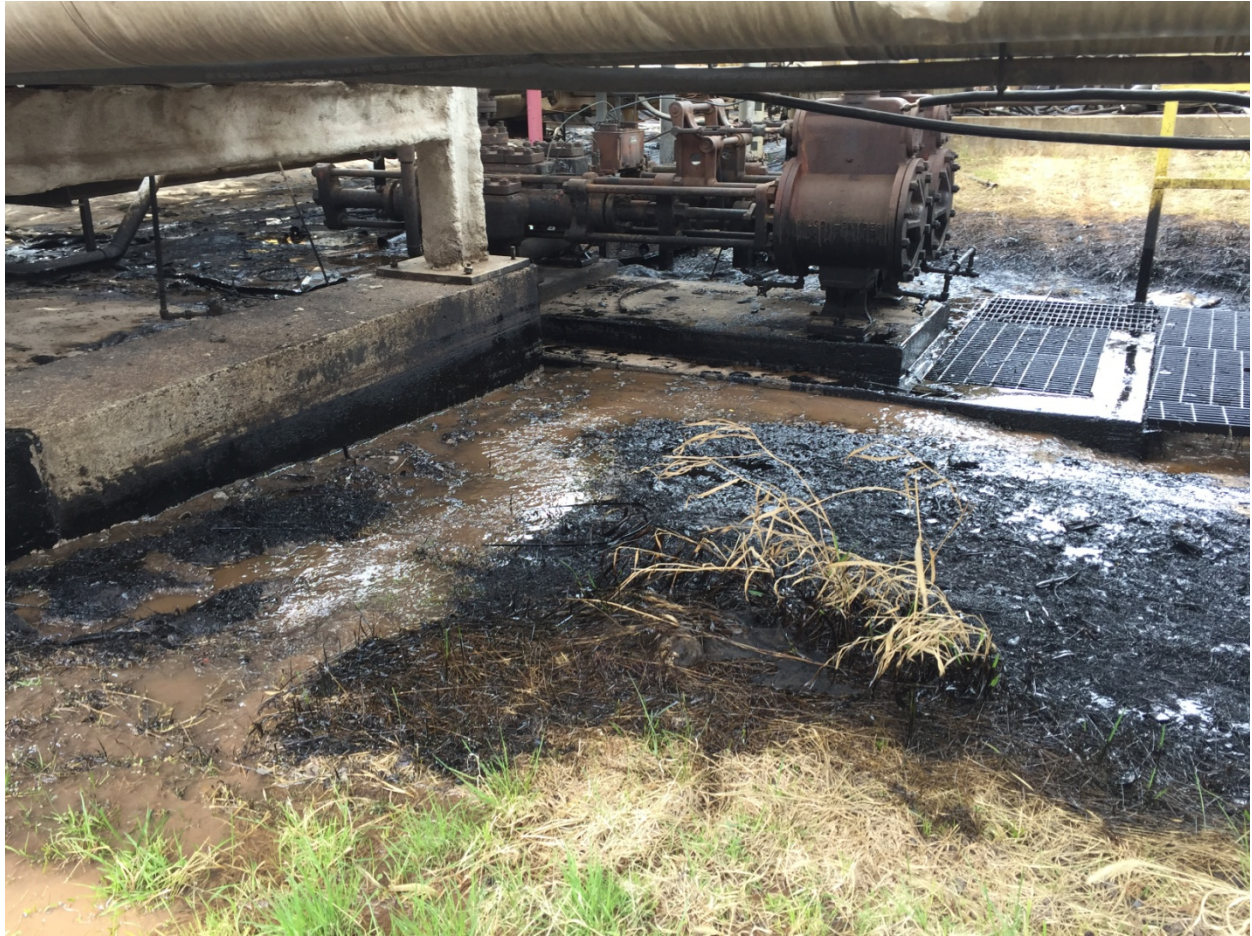
Photo 2: Looking north at the release site. The water seen entering the release site is runoff from the road located uphill and south of the release site. A sand dam and absorbent boom were placed at the edge of the road to prevent further water from entering the site. This can be seen in Photo 6.

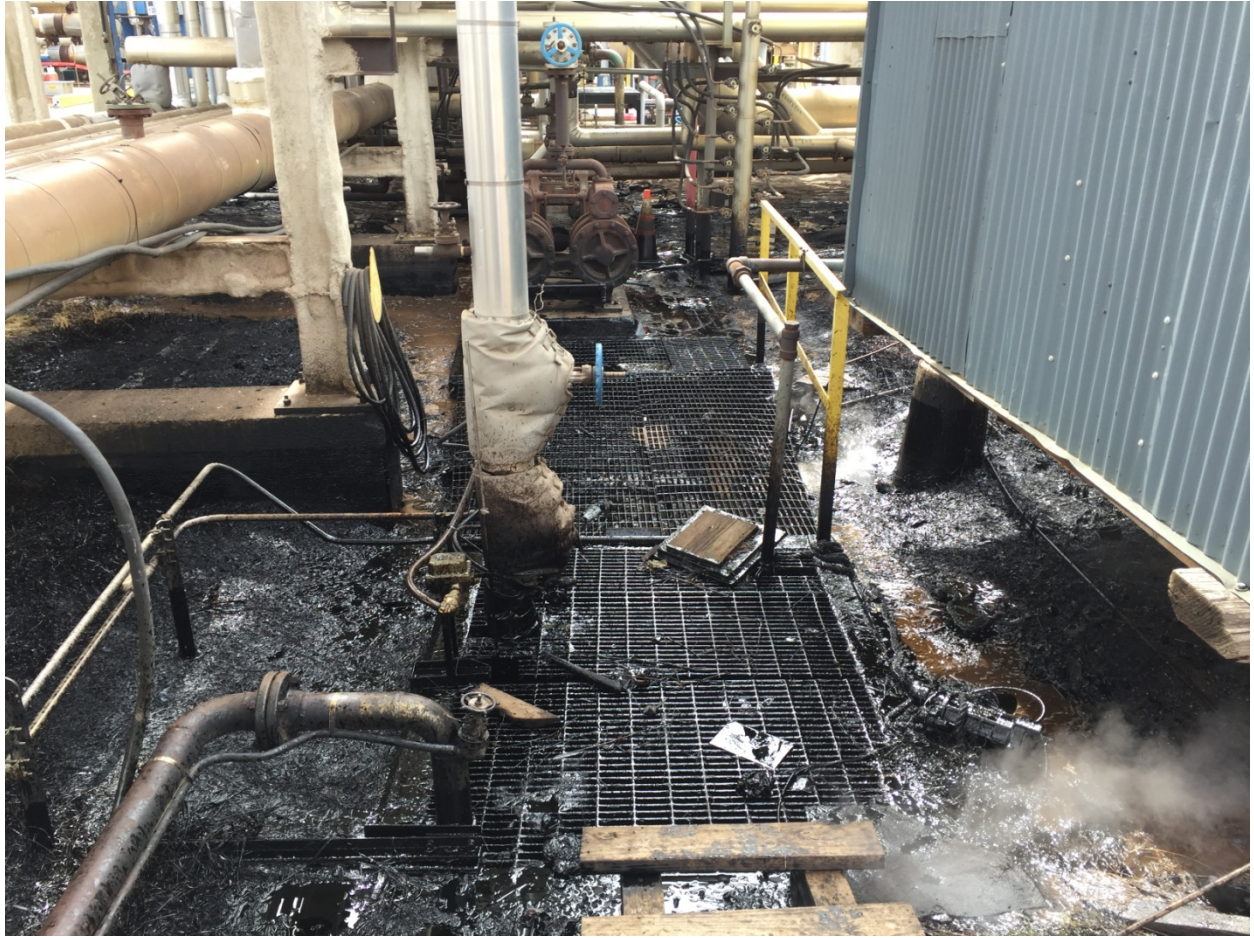
Photo 3: Looking west at the release site.

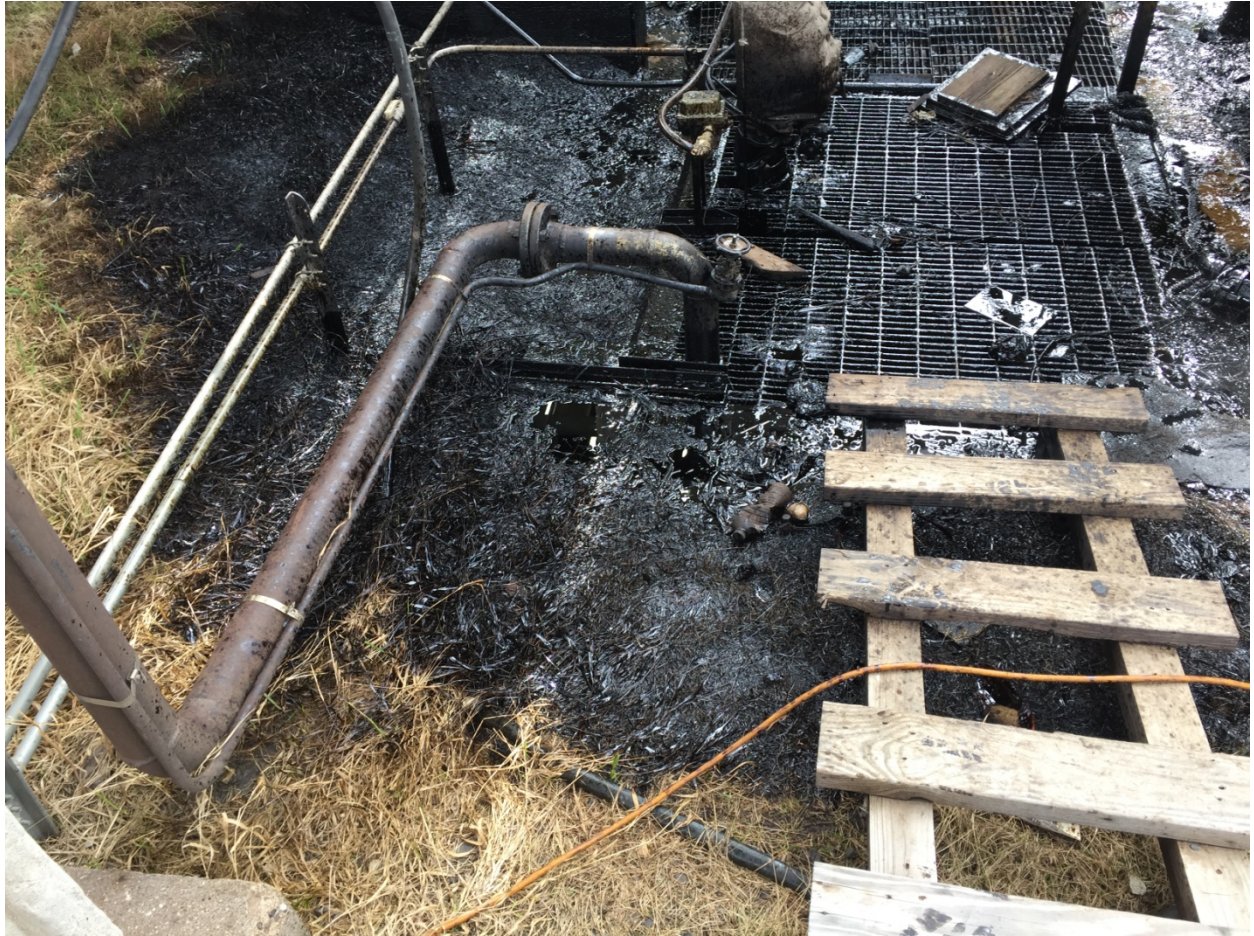
Photo 4: Looking west at the release site.

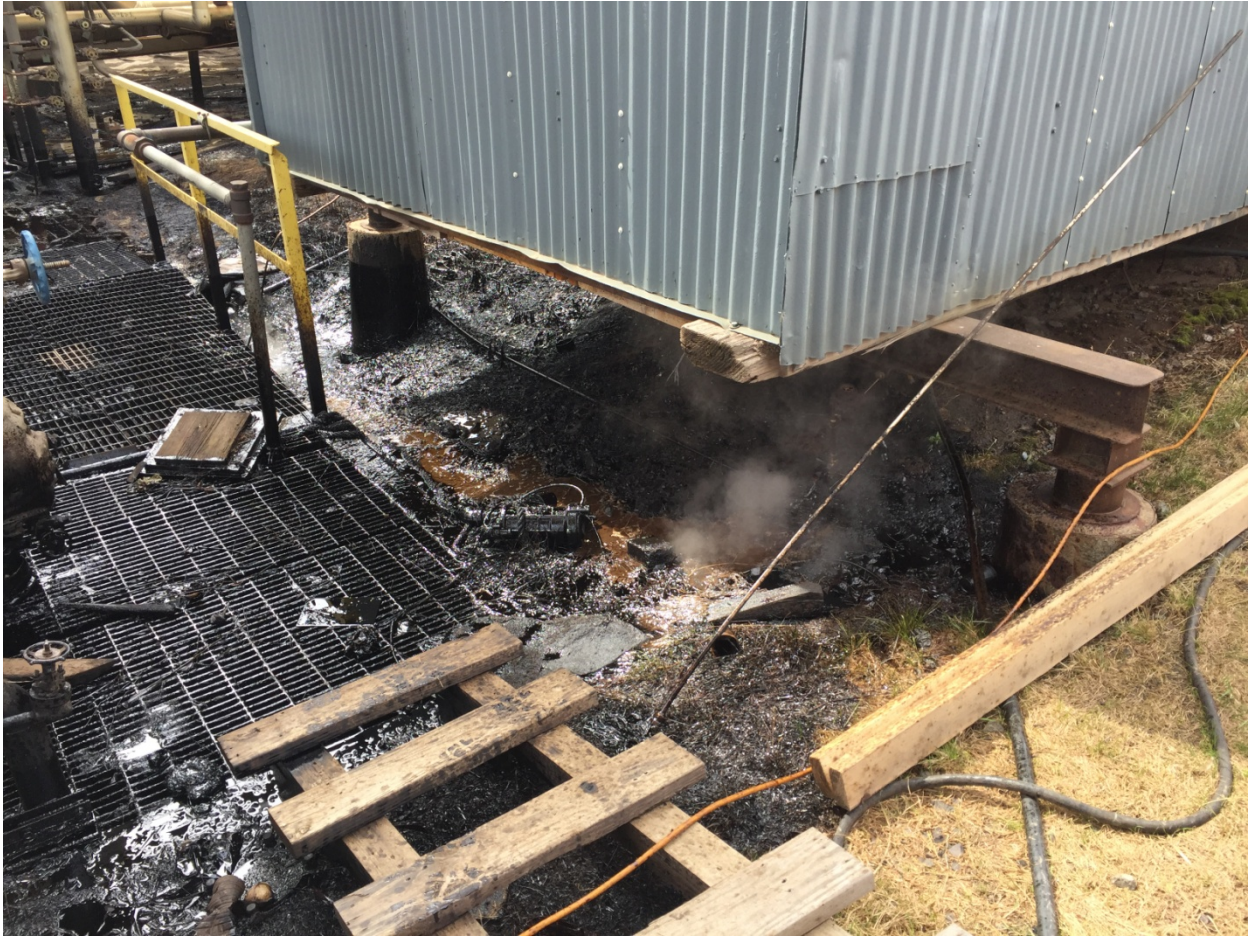
Photo 5: Looking northwest at the release site.

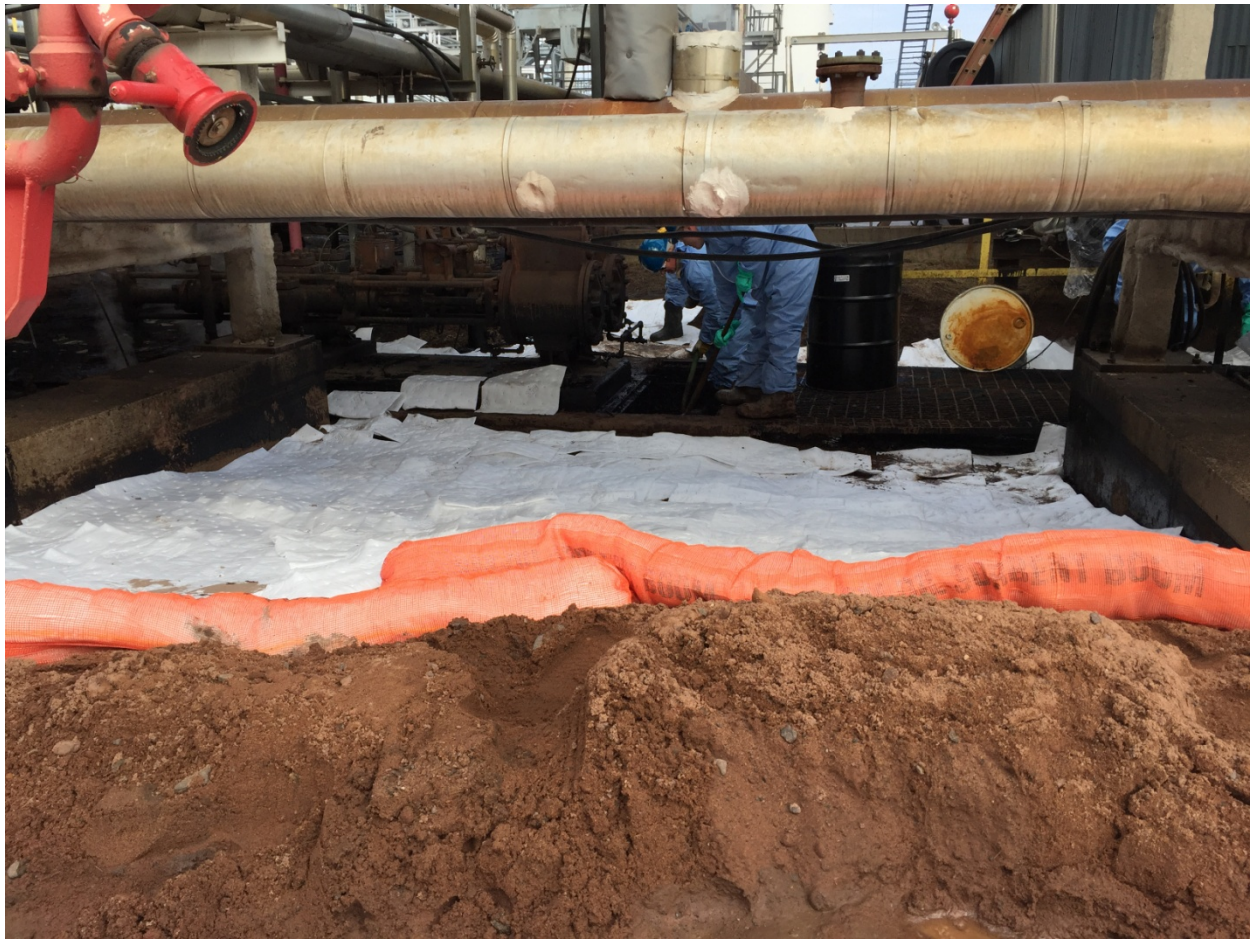
Photo 6: Looking north at the cleanup effort. As mentioned in Photo 2, a sand dam and absorbent booms were placed along the edges of the road to prevent further storm water from entering the site. Absorbent pads were placed on the excavated soil to soak up any potential contaminants that may have been missed after the initial excavation.

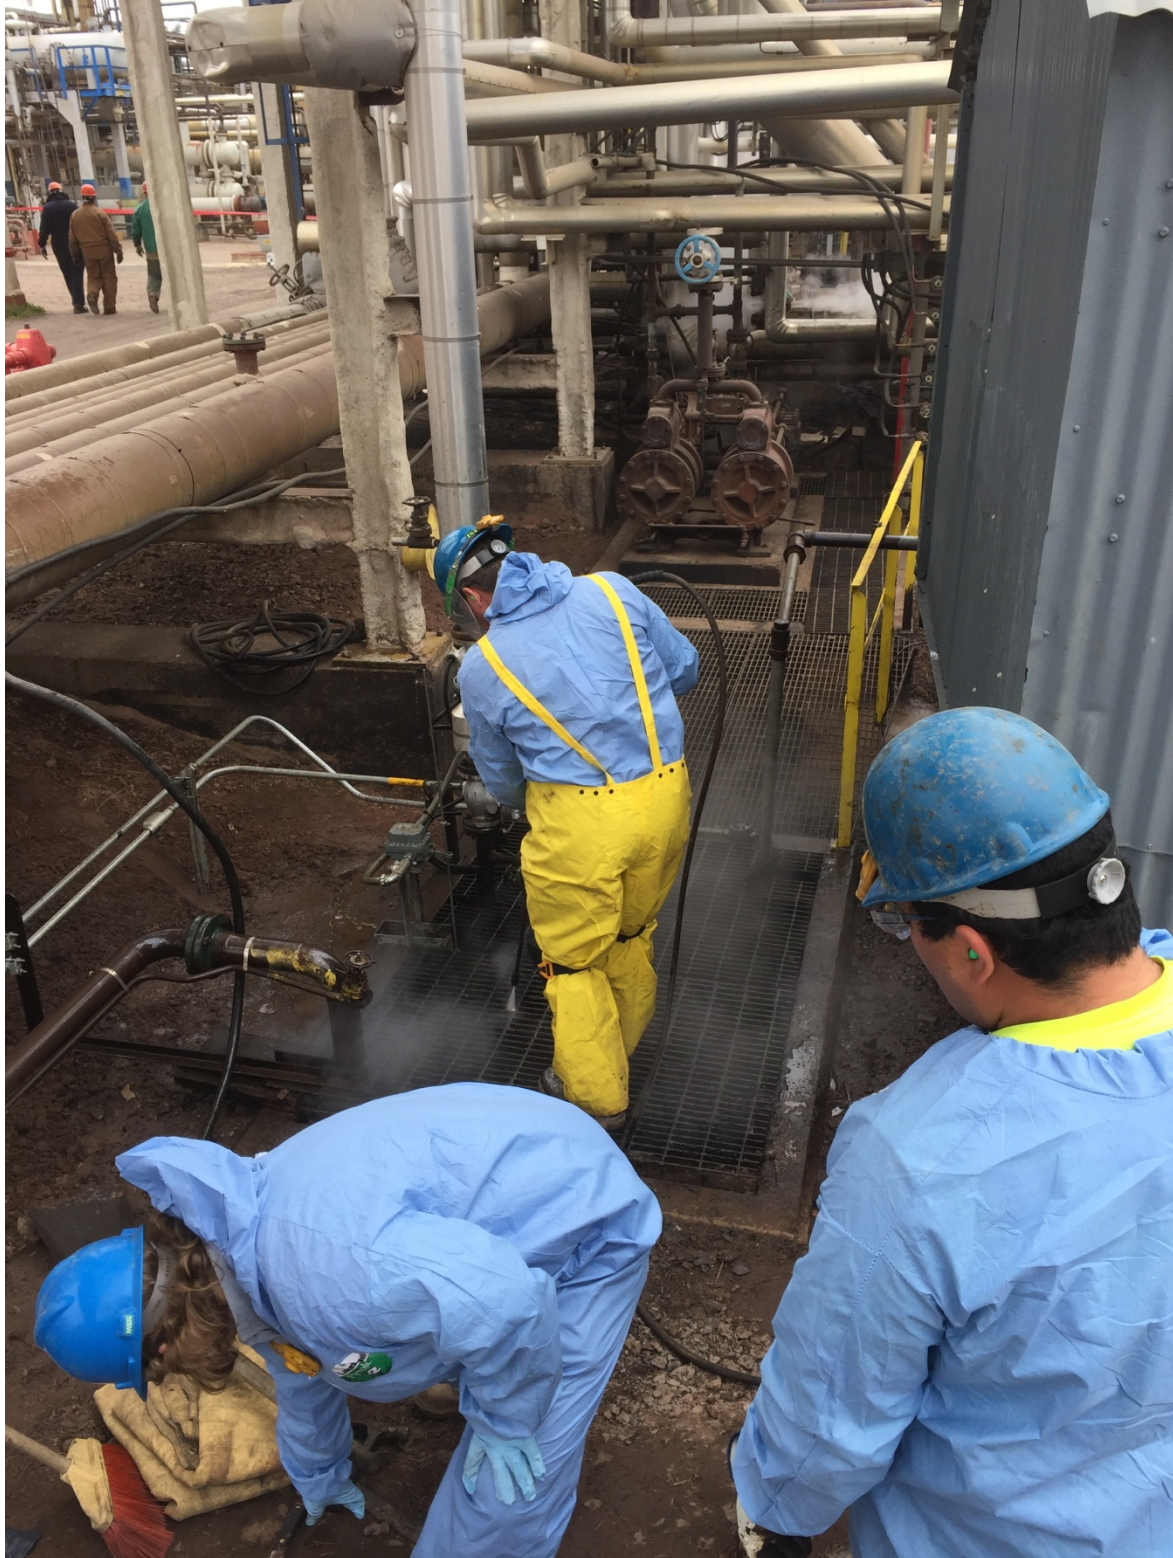
Photo 7: Looking west at the cleanup effort. In addition to soil removal, all contaminated surfaces were cleaned as well, which can be seen here. Steam pressure washers were used in combination with soap and hand tools to clean the affected surfaces.

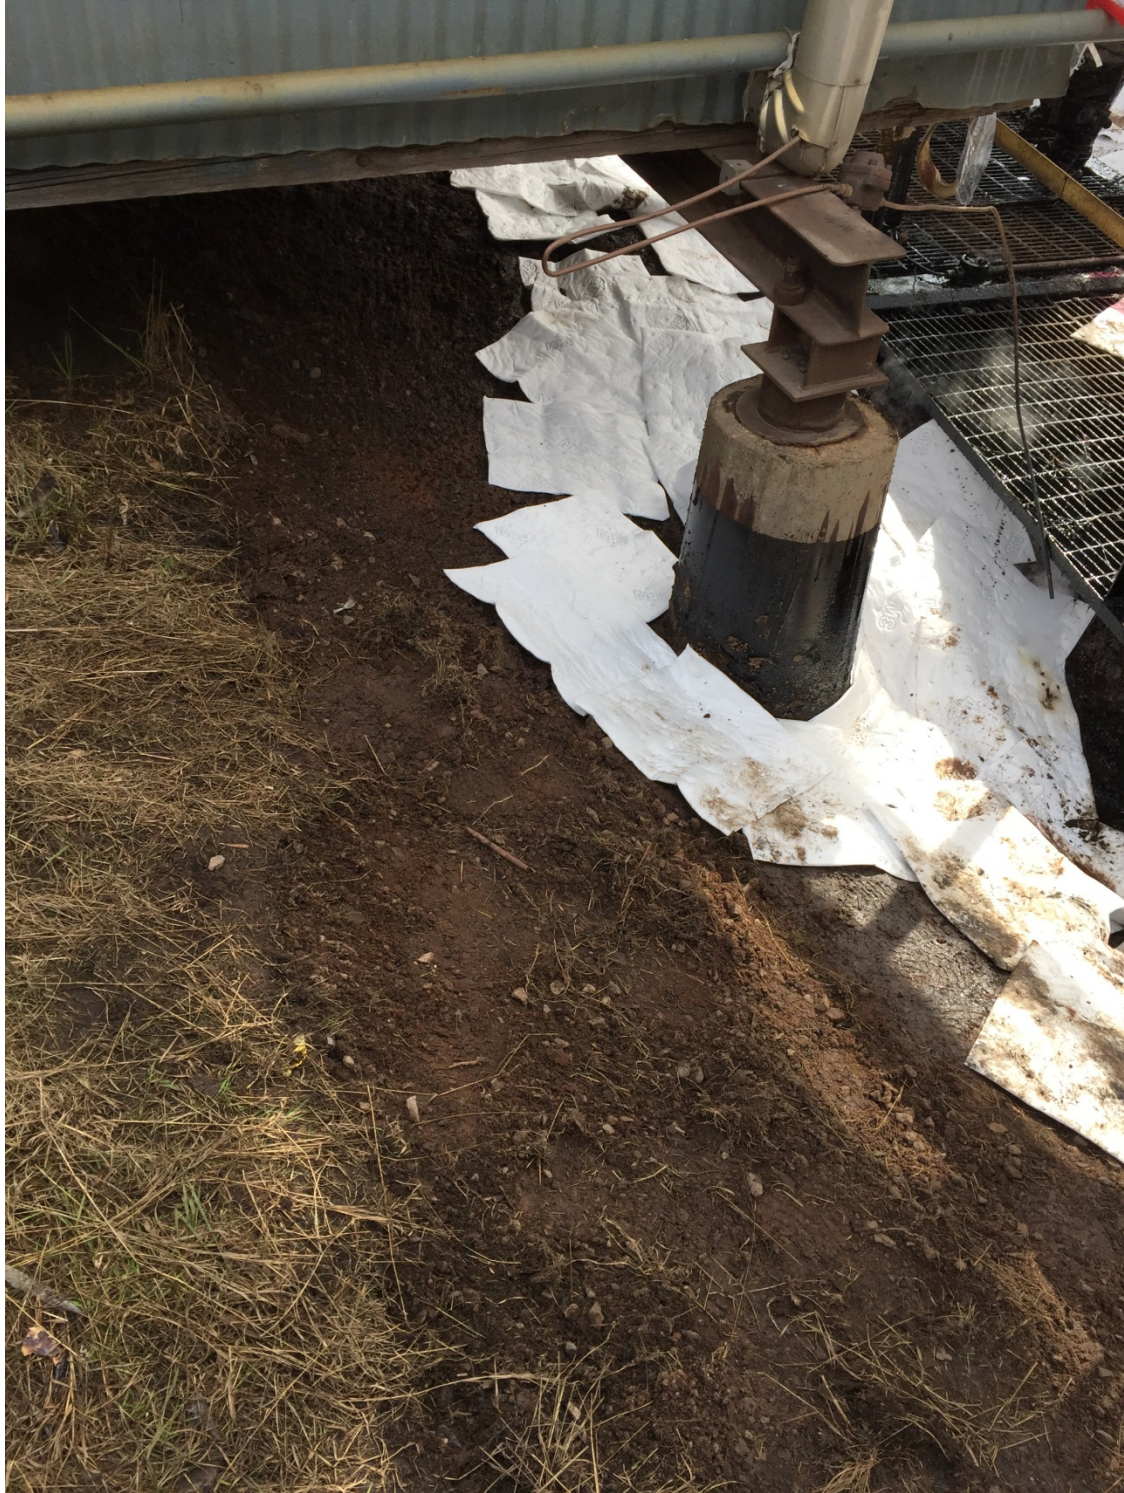
Photo 8: Looking southeast at the scraped and exposed visually clean soil. The grass line marks the extent of the release.

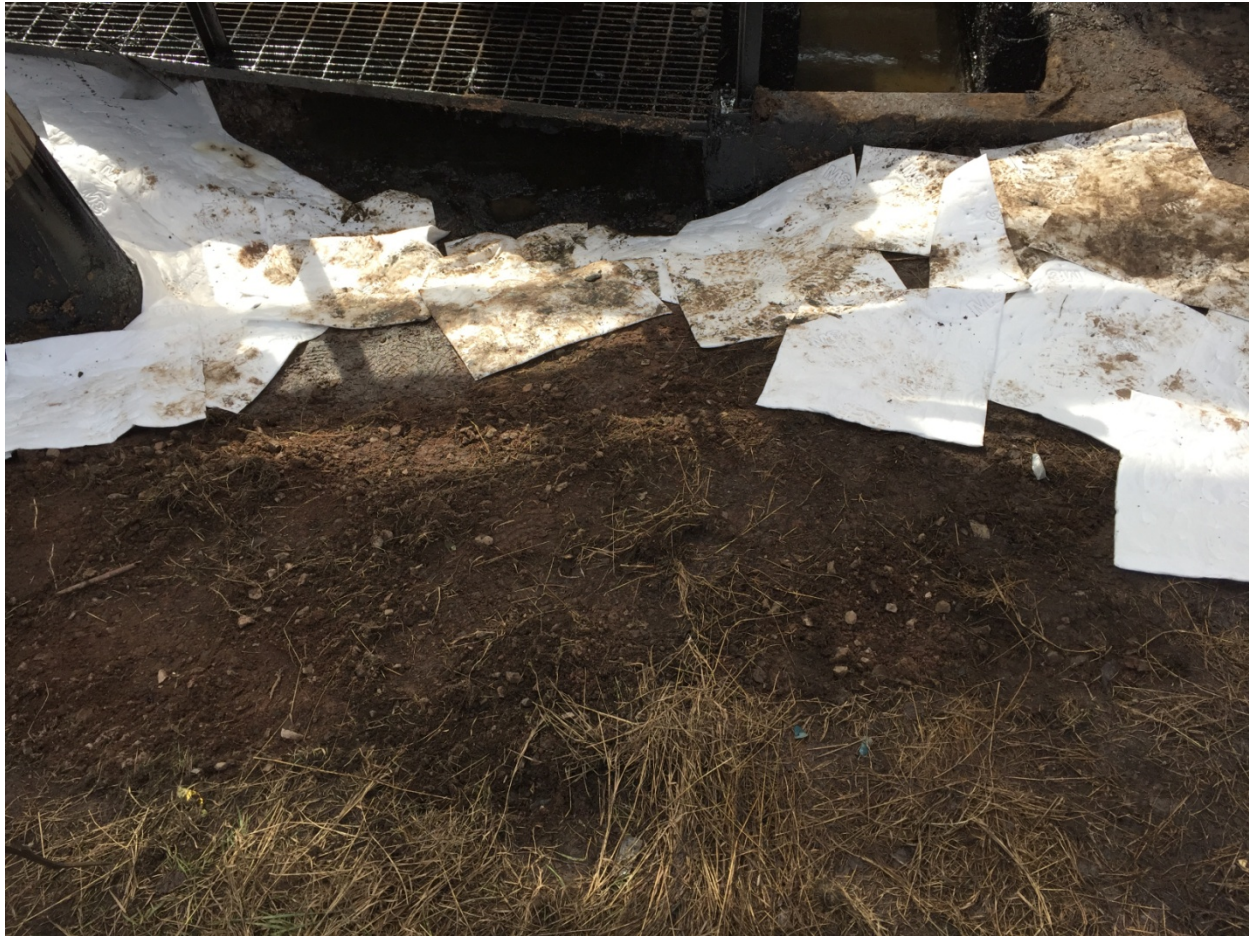
Photo 9: Looking south at the scraped and exposed visually clean soil. The grass line marks the northern extent of the release.

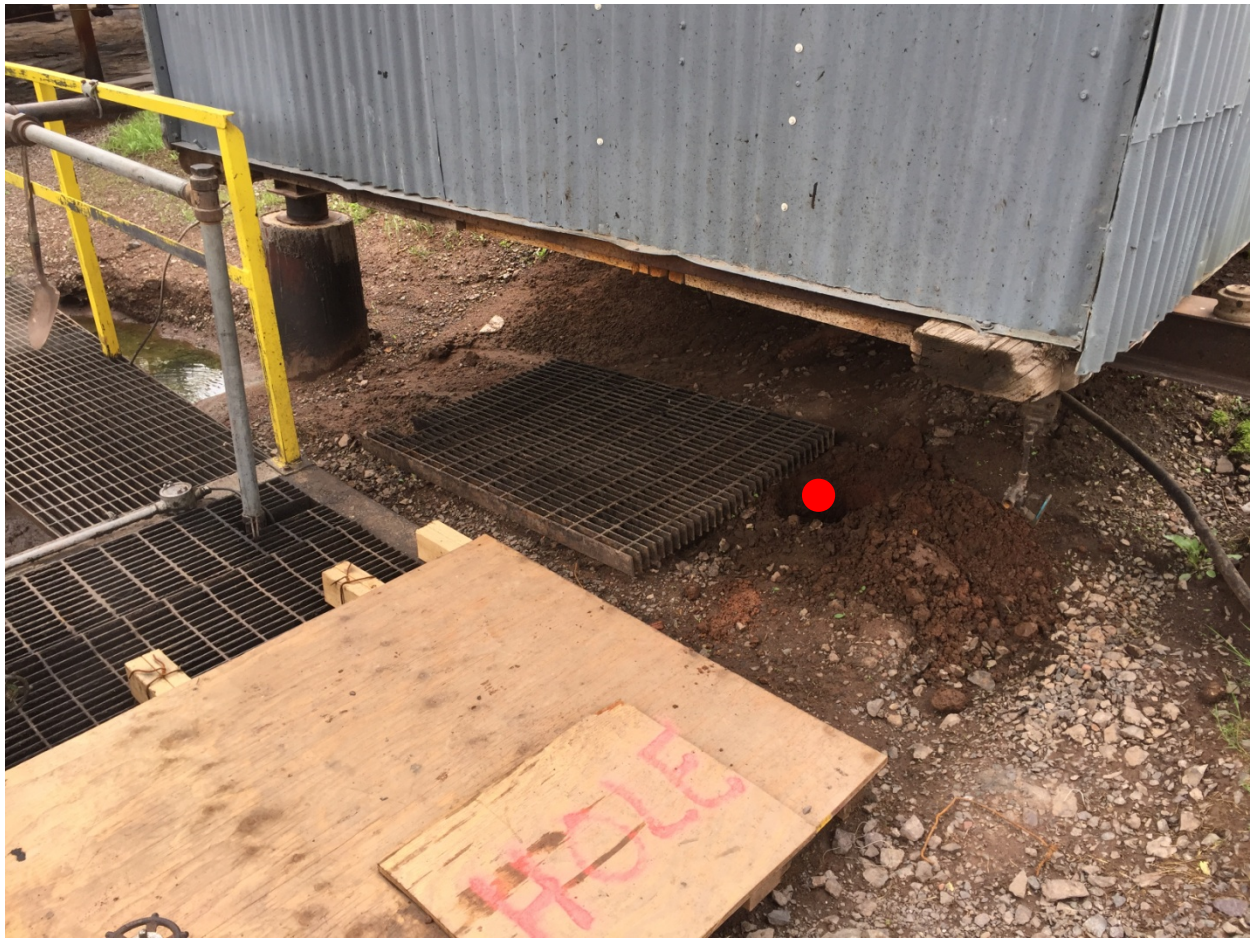
Photo 11: Looking northwest at the sample location of S2 (red dot).

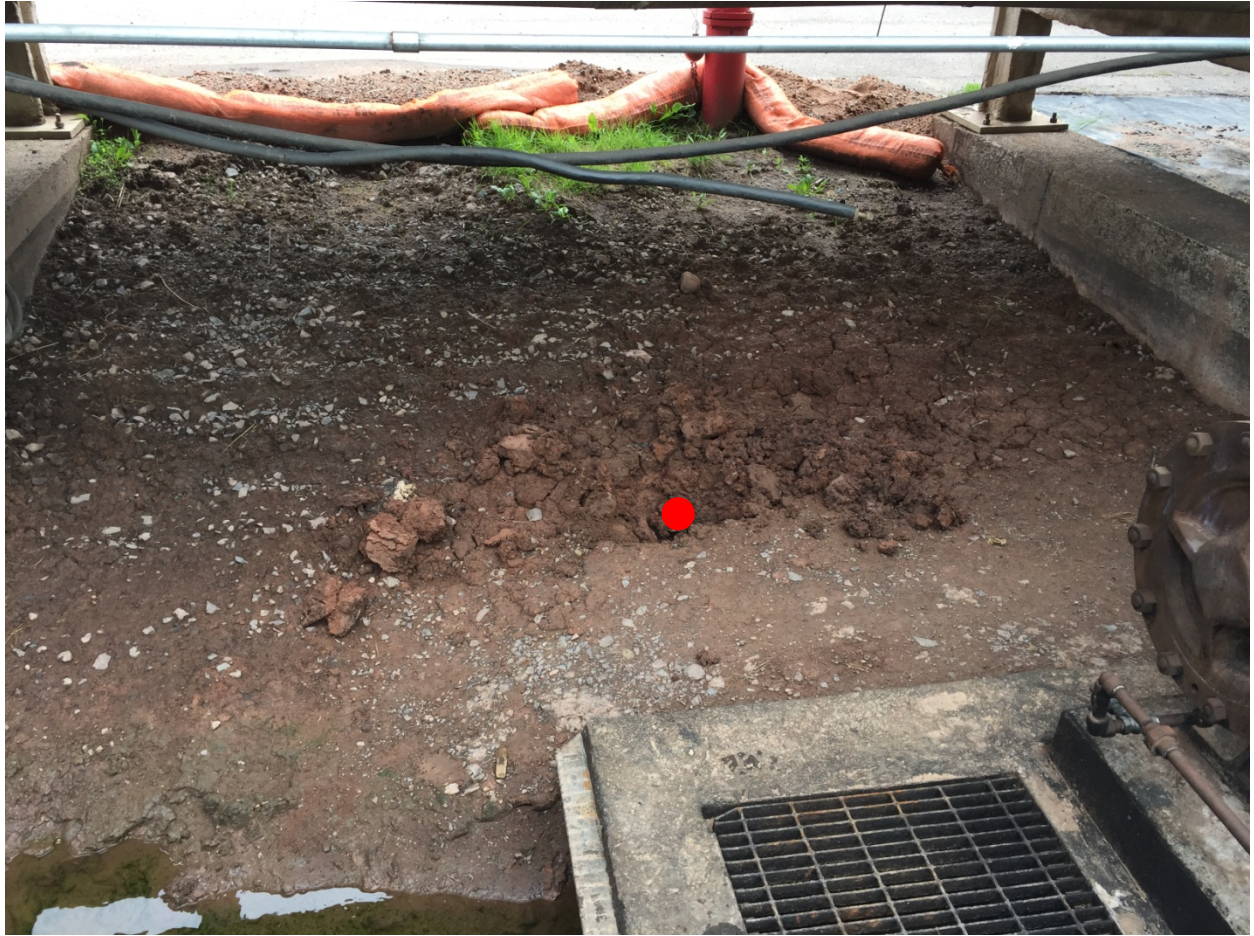
Photo 12: Looking south at the sample location of S3 (red dot).

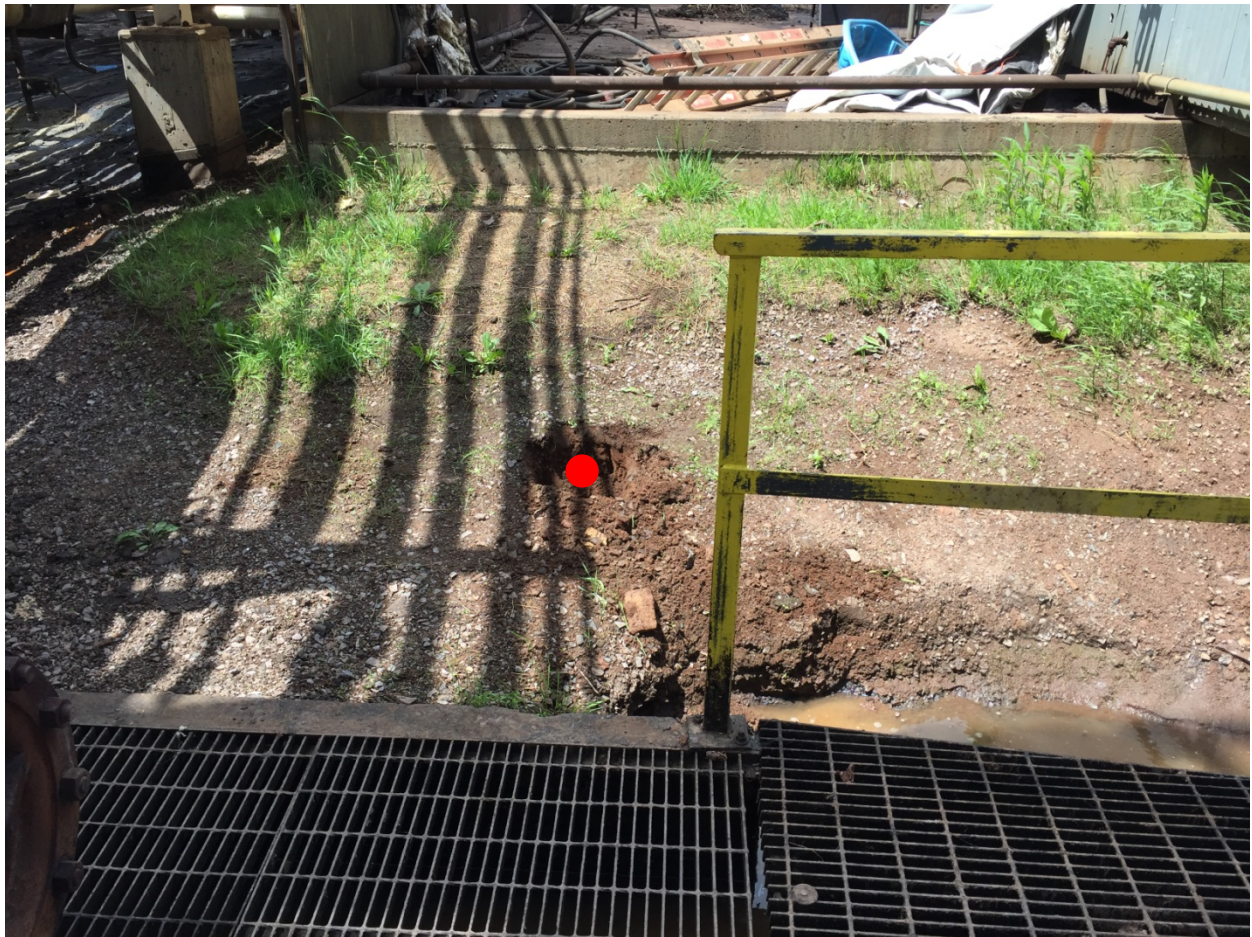
Photo 13: Looking north at the sample location of S4 (red dot).
