NO FURTHER ACTION REPORT

OSHKOSH CORPORTION SOUTH PLANT DIESEL SPILL

**2850 Hughes Street
City of Oshkosh
Winnebago County, Wisconsin**

WDNR Spill ID: 20200309NE71-1

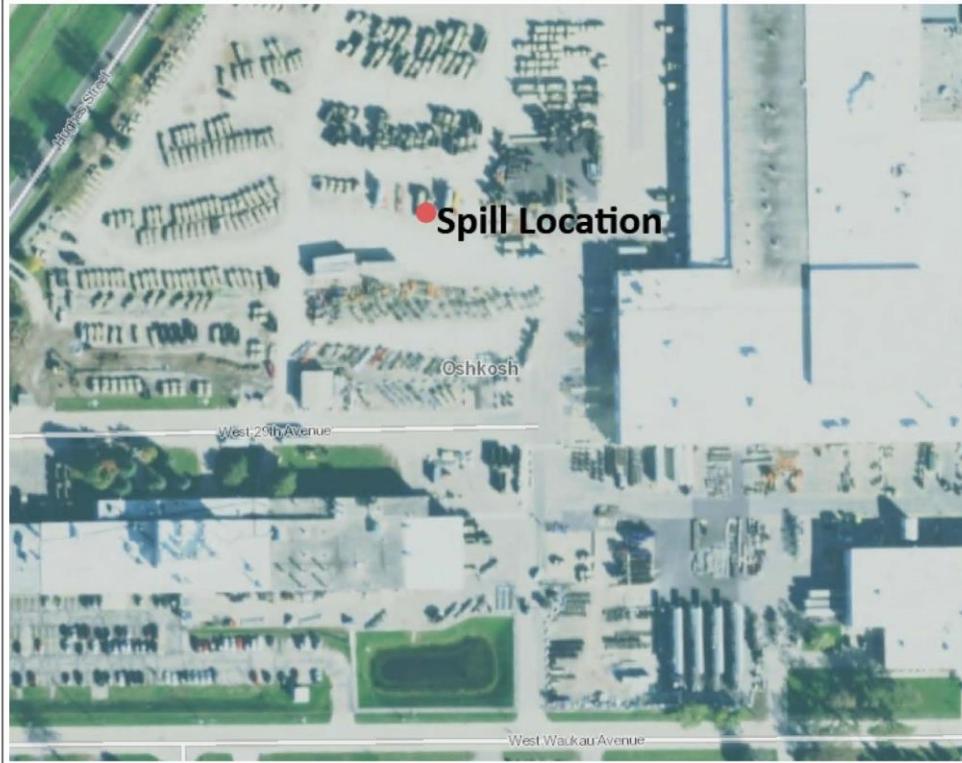
Figure 2 - Spill Location Map

Red Dot: Spill Location

The spill was located on the southwest portion of the Oshkosh property located at 2850 Hughes Street, in the City of Oshkosh, in Winnebago County, Wisconsin. More specifically, the spill occurred in the southwest $\frac{1}{4}$ of the southeast $\frac{1}{4}$ of Section 35, Township 18 North, Range 16 East at Wisconsin Transverse Mercator (WTM) Coordinates: 636350, 391024. See the attached Figure 1 - Site Location Map and Figure 2 – Spill Location Map.

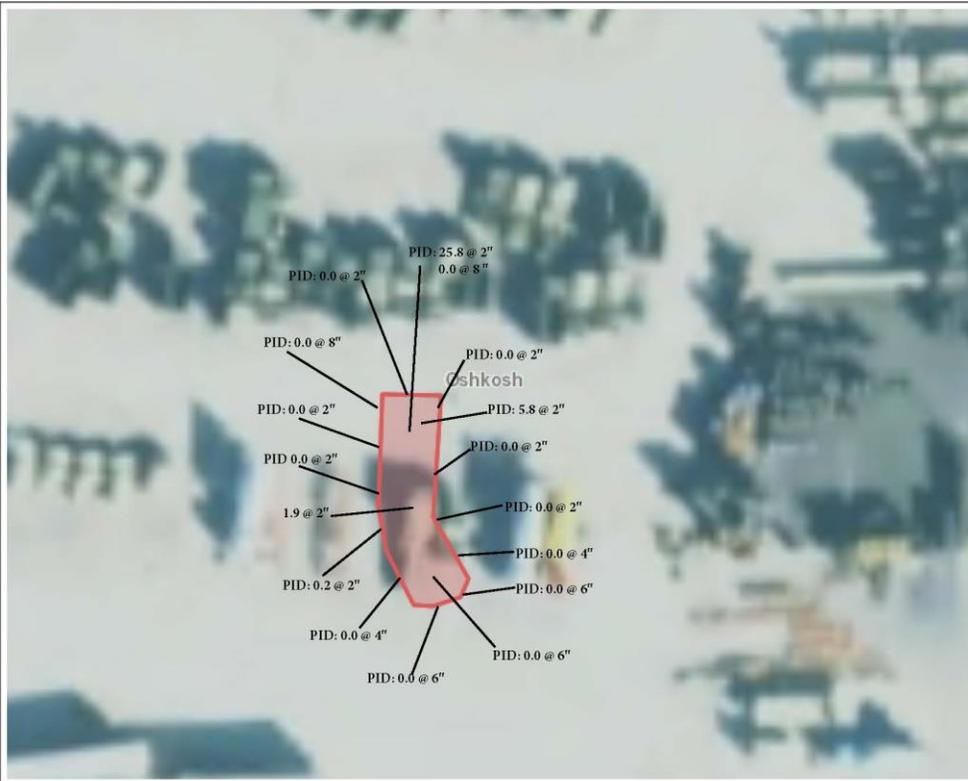
Figure 3 - Excavation Limits Map

Excavation limits extended approximately 30 feet by 70 feet with depths ranging from approximately 2 to 4 inches in the southern portion of the spill area to approximately 10 inches below ground surface in the north central portion of the spill area where the diesel fuel had pooled at the time of the spill.

Red Polygon: Approximate Excavation Limits

In total, approximately 30 tons of diesel impacted granular absorbent, gravel and soil was excavated and disposed of at Waste Management's Valley Trail Landfill. Figure 3 – Excavation Limits identifies the excavation extent, location, depth and field screening results for the soil analyzed during the excavation. Further discussion of waste disposal is provided in Section 2.4 of this report.

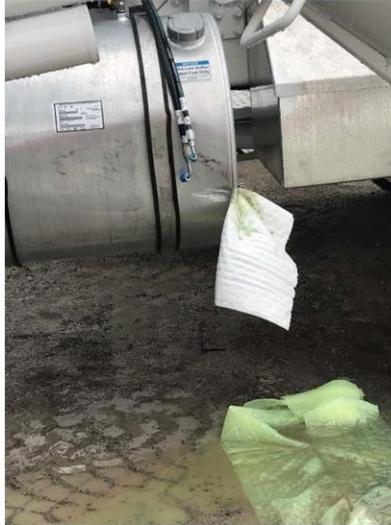
View of leaking saddle tank.

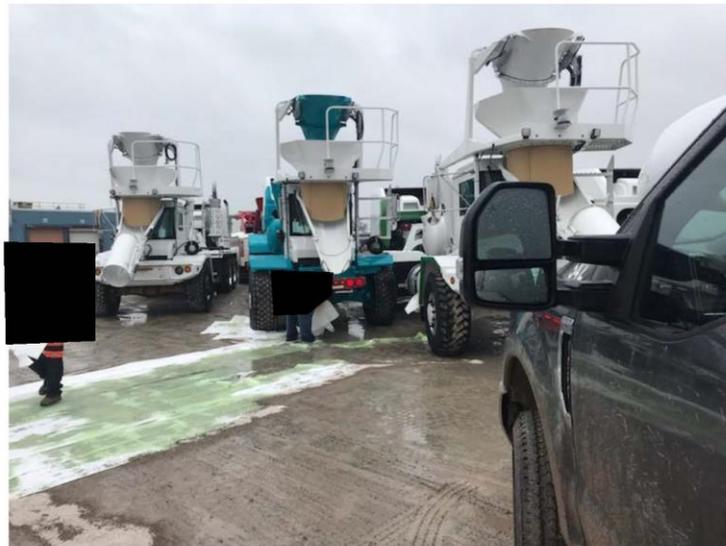
Absorbents being placed over spill.

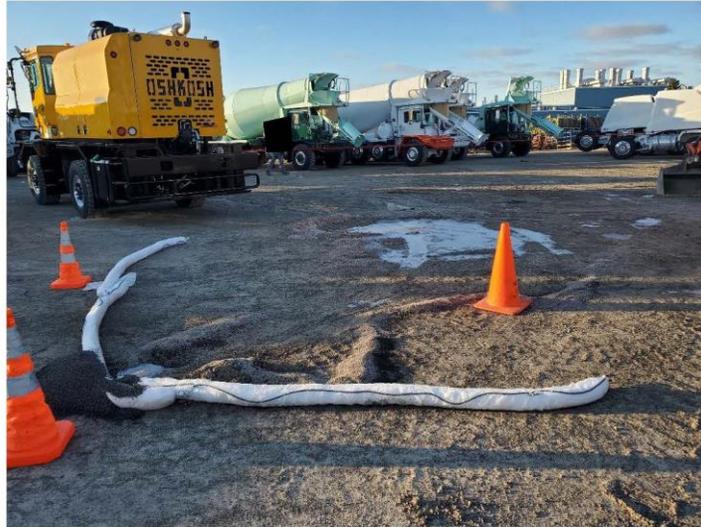
View of spill location prior to excavation, looking south southwest

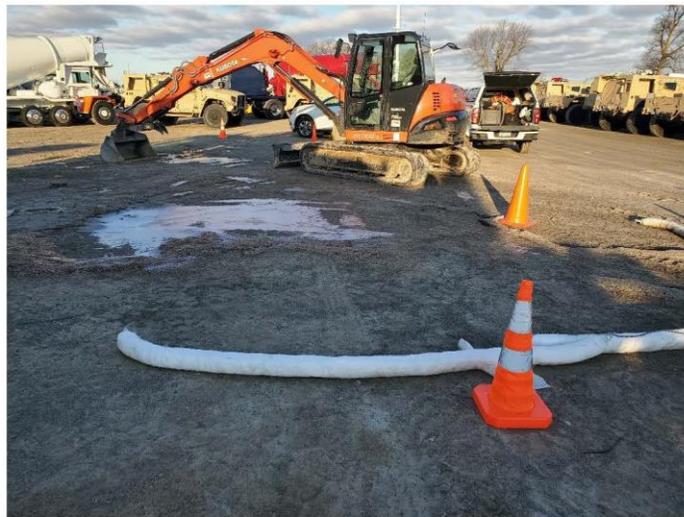
View of spill area prior to excavation, looking west

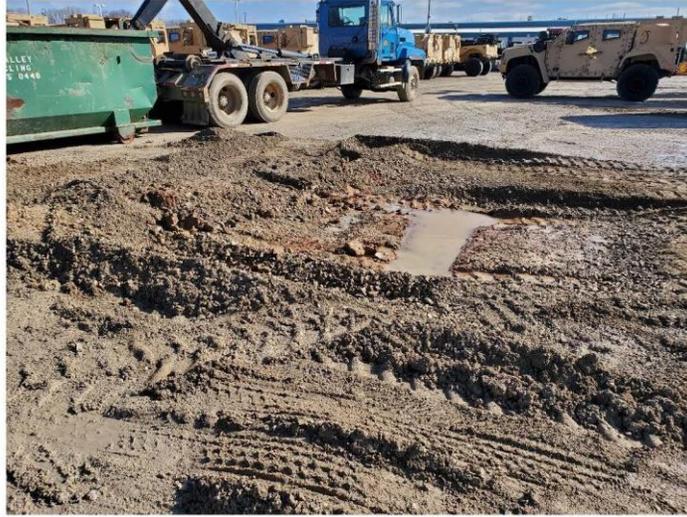
North end of excavation (water is the result of the weeks rain events), view looking east

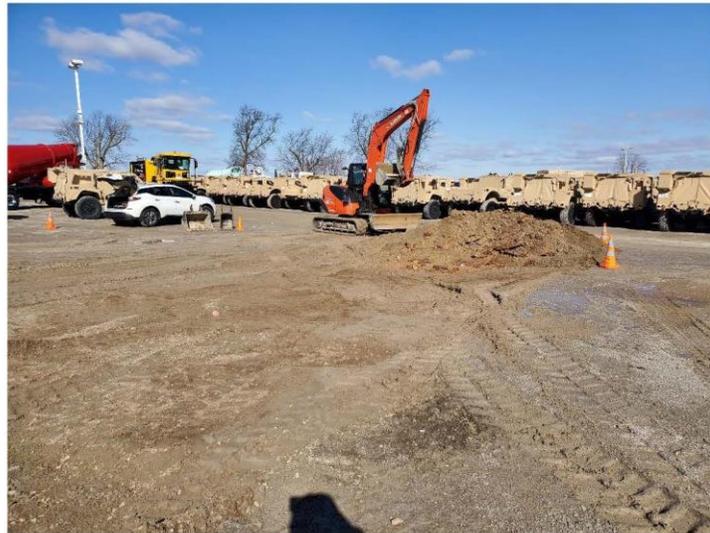
Scrape/excavation, view looking northwest

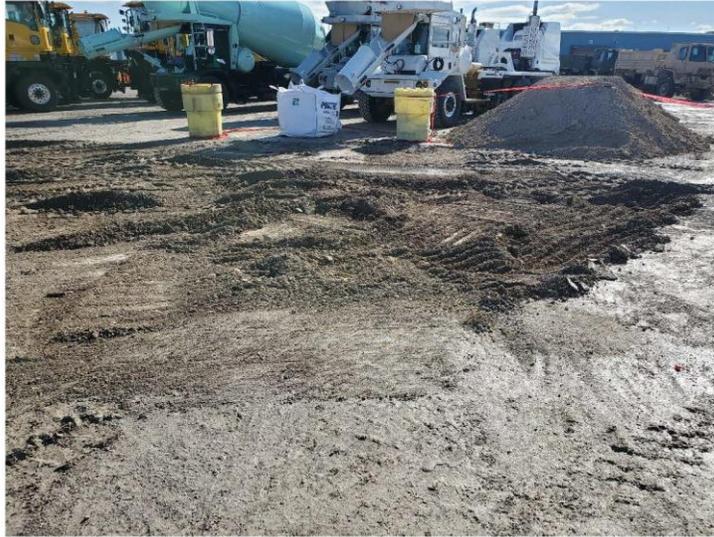
South end of scrape/excavation, view looking east

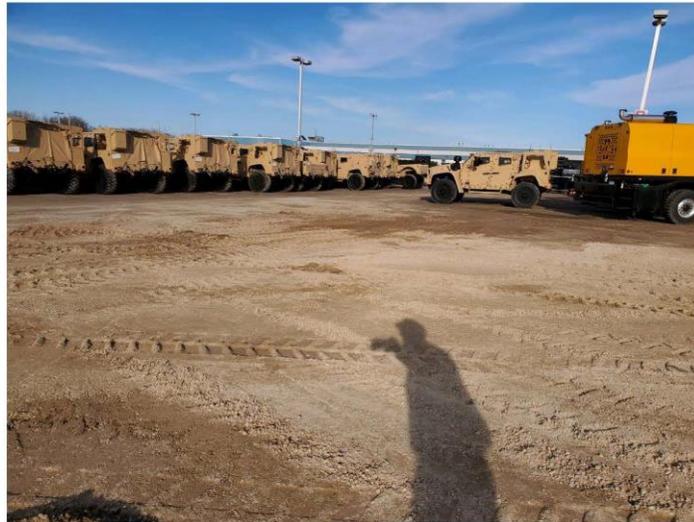
Spill area following backfill/compaction, view looking northeast

- Water Management – Not applicable. No water was encountered as part of the spill response action.
- Restoration – On March 13, 2020, following impacted gravel and soil excavation, gravel was utilized to backfill the parking lot area of the excavation.

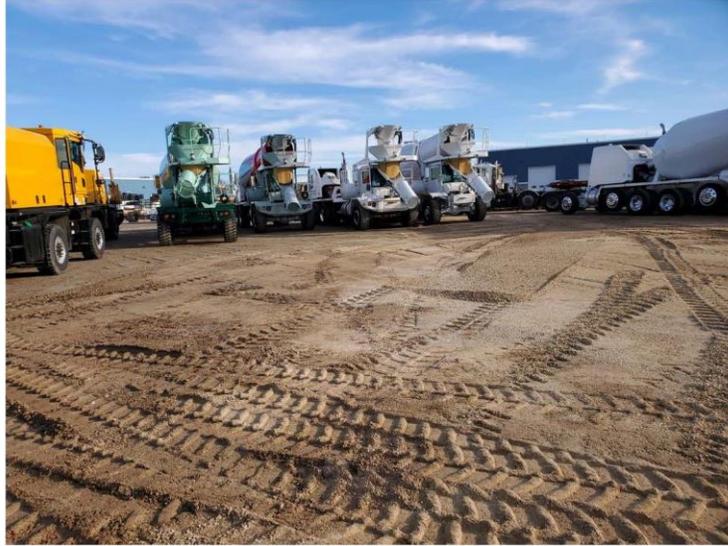
Spill area following backfill/compaction, view looking southeast
