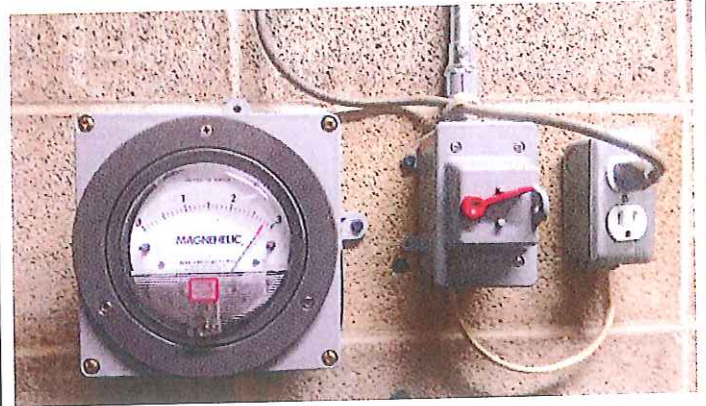
2. View of the Magnehelic pressure gage mounted behind the dry cleaning machine. The pressure gage is reading 2.5 inches of water.

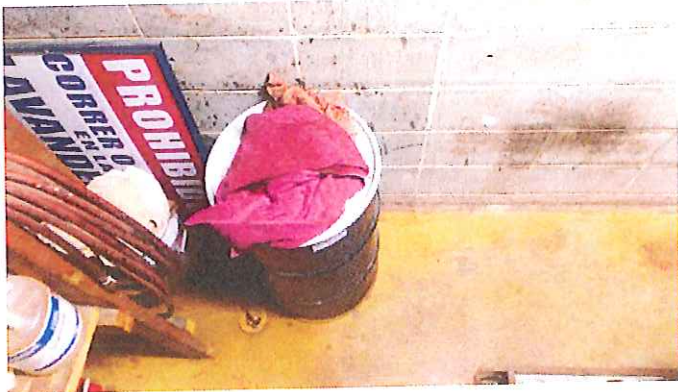
3. View of the interior concrete floor of the Village Clean facility behind the dry cleaning machine....

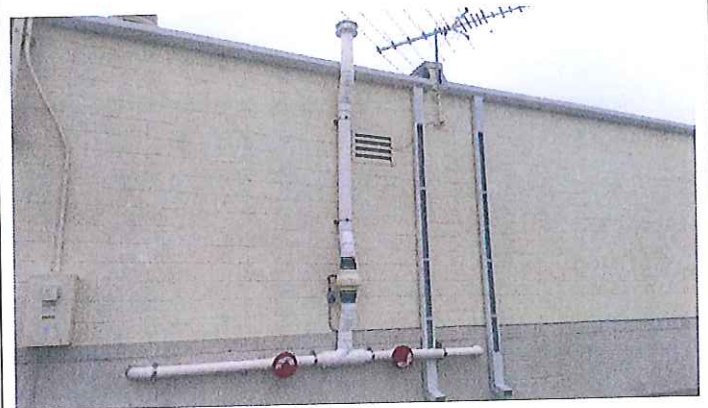
4. View of the PVC piping mounted on the exterior wall of the Village Clean facility. ...
