**Re: WI - 45-Day Documentation and No Further Action Letter - Ch. NR. 708
Wisconsin Public Service Corporation
Non-PCB Mineral Oil
3706 County Rd. WW Brokaw, WI (Marathon County)
Reported 7/11/2023, SERTS ID: 20230711WC37-1**

In accordance with Wisconsin Administrative Code NR 708.05(6) and NR 708.09, Wisconsin Public Service Corporation respectfully submits the following documentation describing the immediate actions taken, the outcome of those actions, and a final report and letter of compliance documenting that no further action is necessary to respond to a hazardous substance discharge or environmental pollution at the below referenced site.

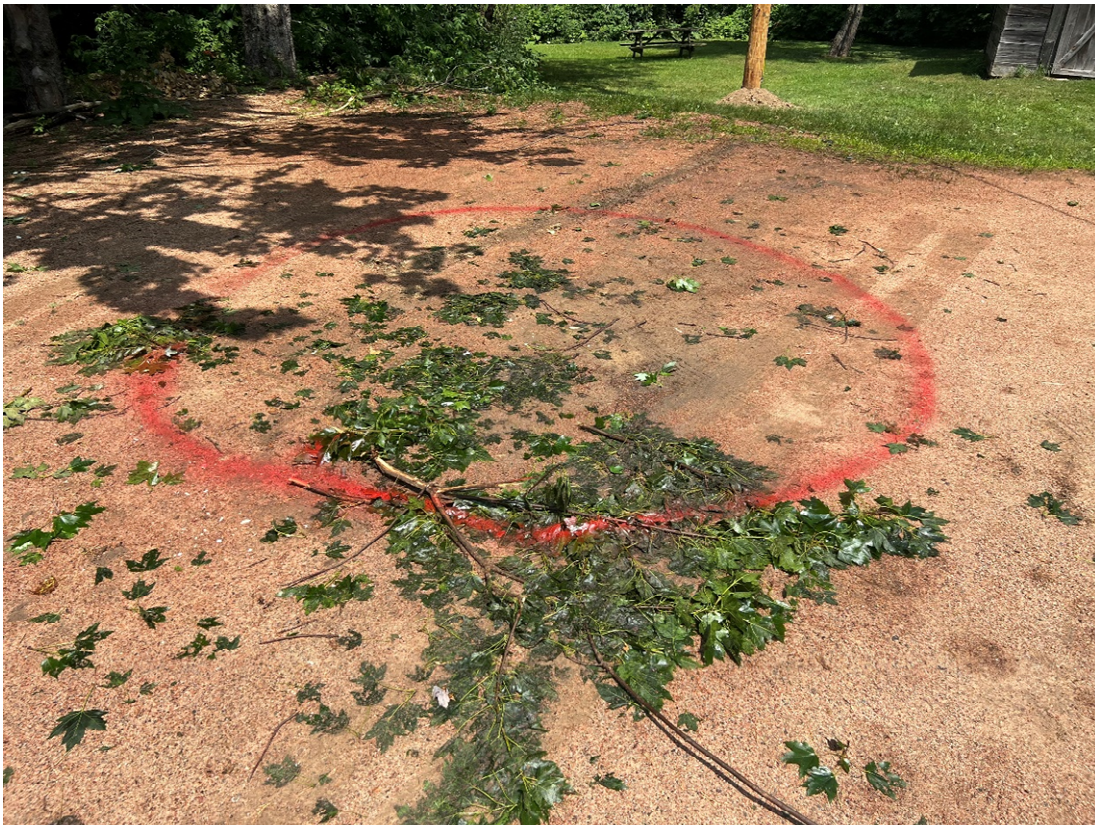
Figure 2: Impacted Area 1

- Time of Spill: The spill occurred on 22:00 hours on July 10, 2023
- Incident Description: On the evening of Monday, July 10, 2023, WEC Environmental dispatch was notified that a 15 kVA pole mounted transformer had released an unknown amount of non-PCB mineral insulated Oil (MIO). The release was the result of high winds causing a tree to fall and knock down a utility pole supporting the transformer. The transformer fell to the ground and released the MIO onto an 8'x8' area where transformer fell on gravel driveway and 40'x15' area impacted gravel, vegetation, and soil where the MIO was spread by rain. WEC contracted SET Environmental Inc., (SET) to remediate the impacted area. SET crews used hand excavation to remove all visually and olfactorily impacted gravel, grass, and soil. The impacted material was containerized into 4 x 55 gallon open top steel drums for disposal. The excavated gravel area was then graded flat, and the excavated soil area was restored with topsoil, grass seed and grass mat. When the damaged transformer arrived at the Wisconsin Public Service Transformer Repair and Maintenance shop it was inspected and found to have released 11 gallons of MIO.

Migration Potential of Release: Due to the remedial actions taken, there were no impacts to human health. Impacts were limited to the grass and soil. No surface water bodies, wetlands, or storm water conveyances were impacted by the release.

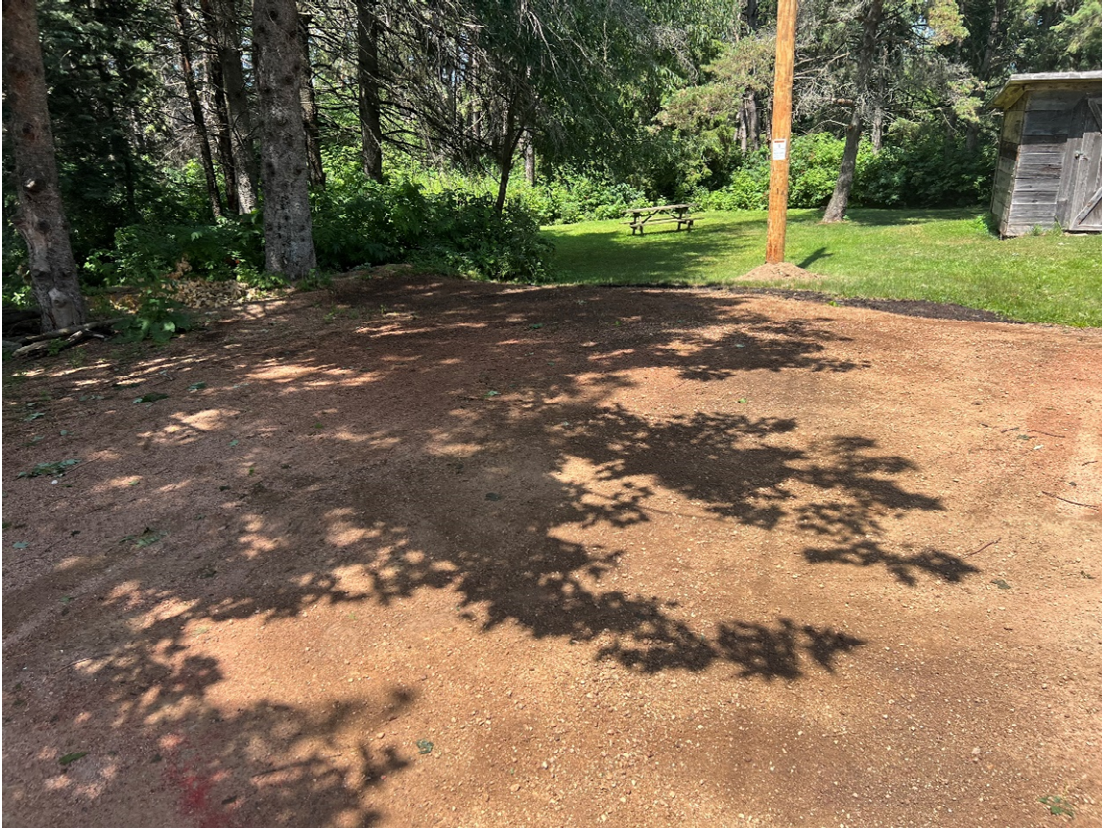
Figure 3: Impacted Area Remediated and Restored

Visual and Olfactory Evidence: There is no remaining visible or olfactory evidence of the release.

Conclusion: (Closure Documentation): All practicable response and remediation measures were effectively implemented. The area has been restored to its original condition and there is no further action necessary for this incident. Maps of the release location and photographs are attached (Figures 1-3).
