Technical Memorandum

To: Alex Smith, Enbridge Energy
From: Ryan Erickson
Subject: Nemadji Corridor Response: Tank 13/16 Pipeline Excavation
WDNR #: 02-16-513788
Date: March 7, 2019
Project: 49161092

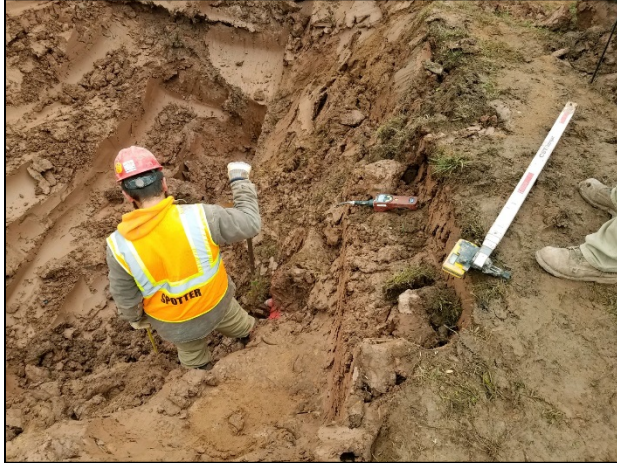
Photo 1

Photo 1: Tank 13/16 pipeline construction excavation on the southeast end of the project trench. Photo taken by the site inspector on October 17, 2018.

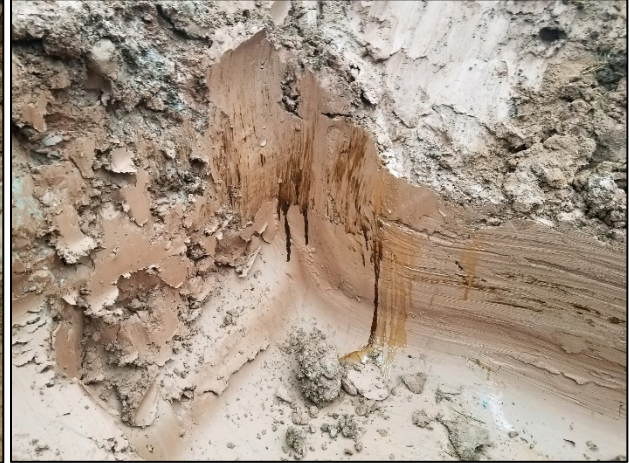
Photo 2

Photo 2: Free-product observed on a sidewall near the southeast end of the project trench excavation. Photo taken by the site inspector on October 17, 2018.

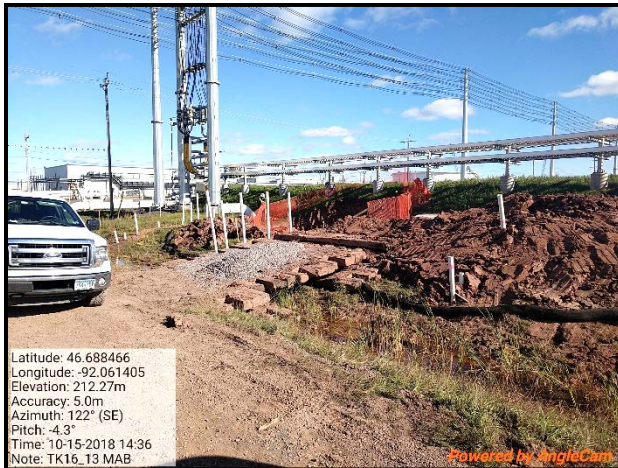
Photo 3

Photo 3: Southeast end of the Tank 13/16 pipeline excavation. Photo taken facing southeast on October 15, 2018.

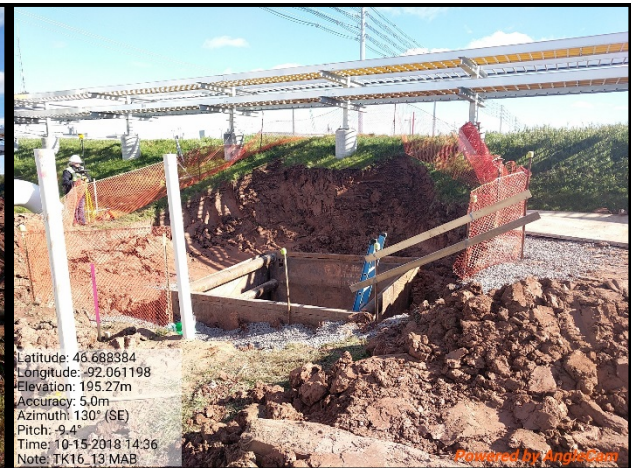
Photo 4

Photo 4: Southeast end of the Tank 13/16 pipeline excavation showing trench box and exposed excavation sidewalls. Photo taken facing southeast on October 15, 2018.

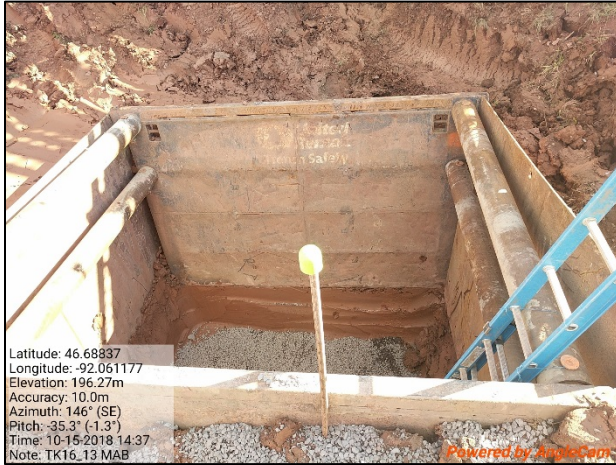
Photo 5

Photo 5: Bottom of the final Tank 13/16 pipeline excavation. Field screening samples B-1 through B-4 were collected from the exposed soil beneath the bottom edge of the trench box. Photo taken facing southeast on October 15, 2018.

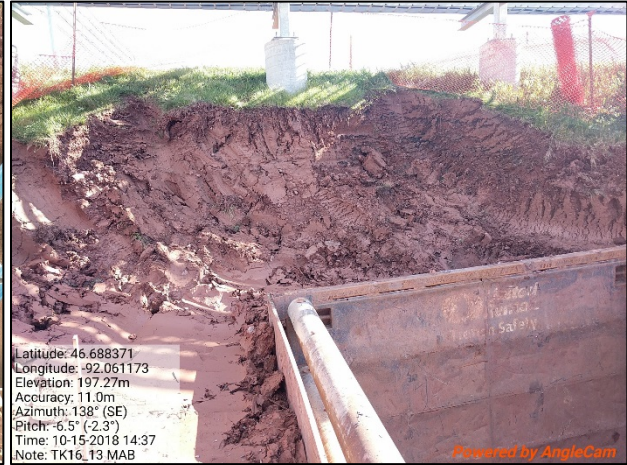
Photo 6

Photo 6: Exposed soil in the northwest Tank 16 containment berm. Field screening samples S-1 through S-4 were collected from the exposed soil away from the trench box. Photo taken facing southeast on October 15, 2018.

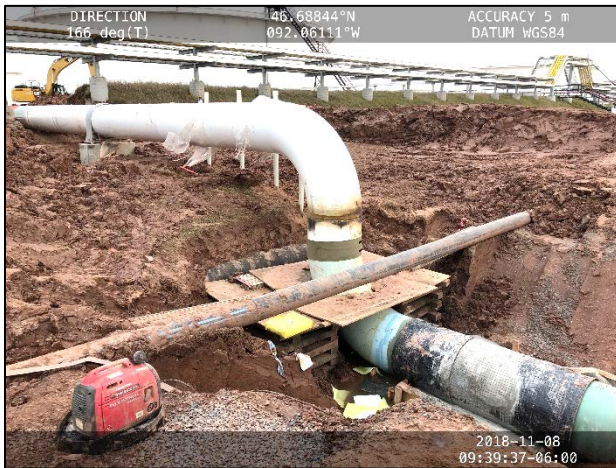
Photo 7

Photo 7: Southeast end of the final Tank 13/16 pipeline excavation. Photo taken facing south on November 8, 2018.
