UPDATE REPORT

LOU JOHN APPRAISAL
AMERY, WISCONSIN

WDNR BRRTS #03-49-514936
PECFA #54001-1026-00
REI PROJECT #6190

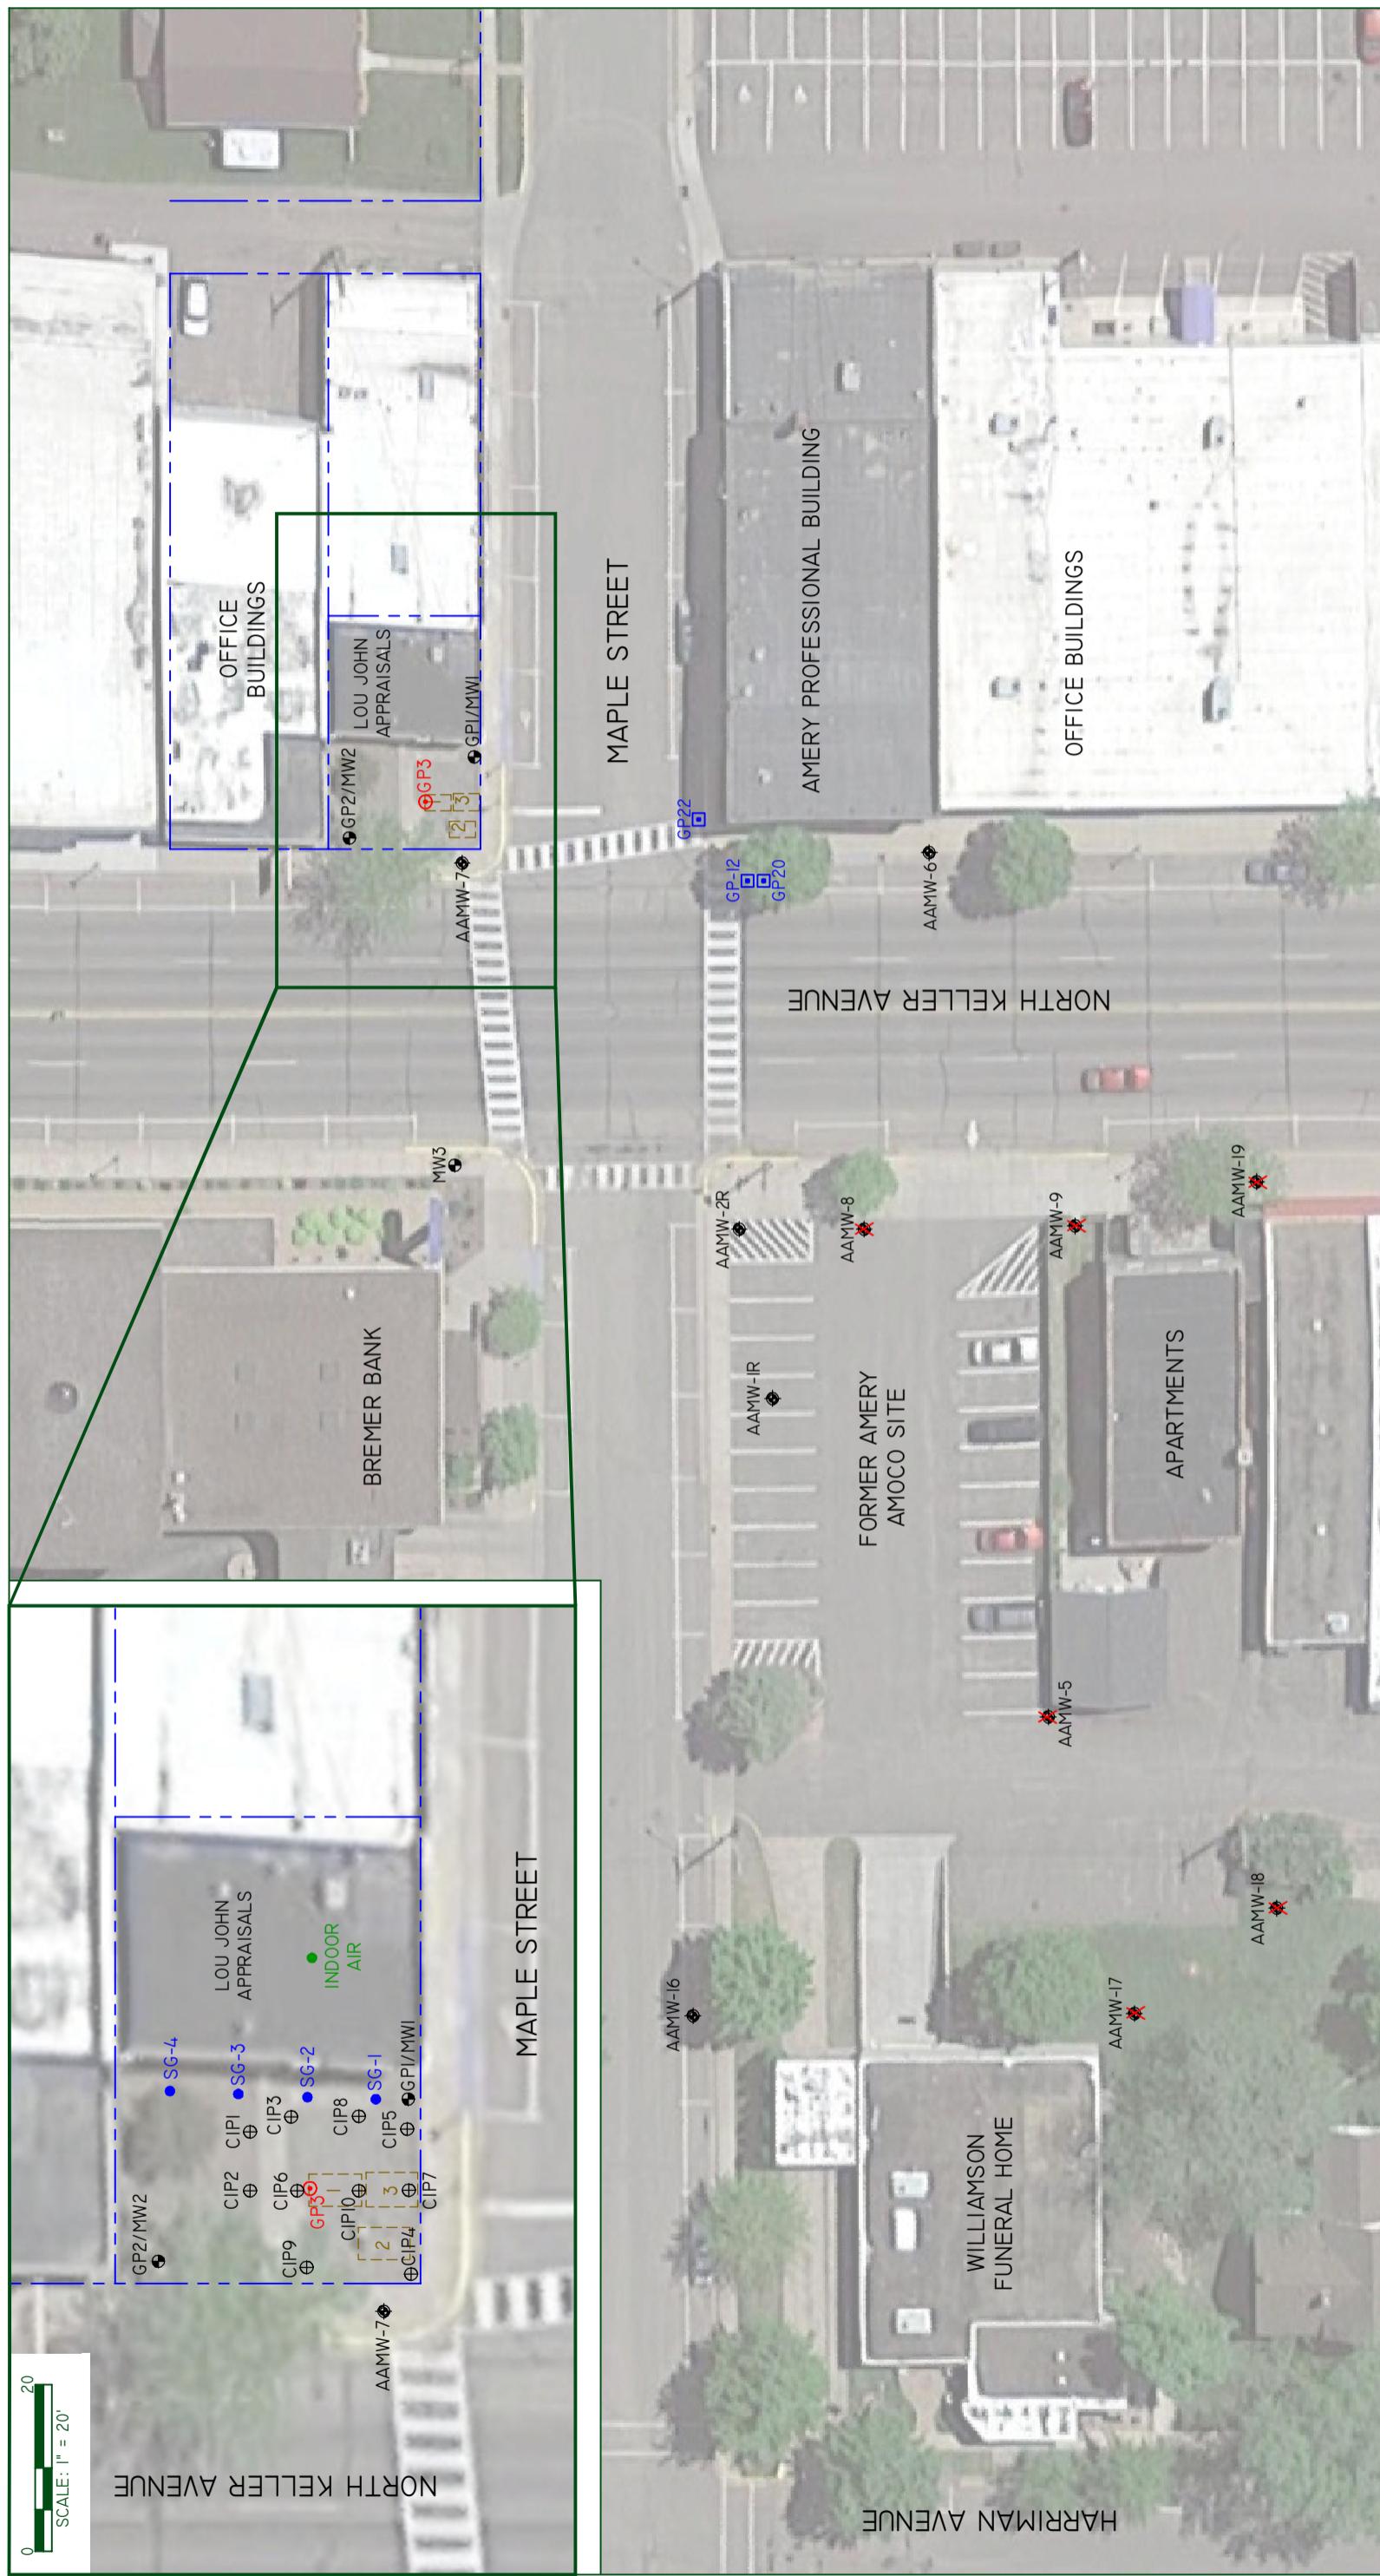
FIGURE 2 : SITE MAP

Figure 2 presents the locations of the completed carbon injection borings. A breakdown of the boring specific injection intervals is provided in Appendix A. Borehole abandonment forms are included in Appendix B. Photographs of the carbon injection process are included in Appendix C. Overall the completion of the proposed carbon injection scope of services went as planned and minimal daylighting occurred.

The property was previously used as a gas station and soil and groundwater related petroleum contamination has been identified beneath the surface. The site is currently operated as Hudson Staffing. The site layout as well as all soil and groundwater sampling points are presented on Figure 2.

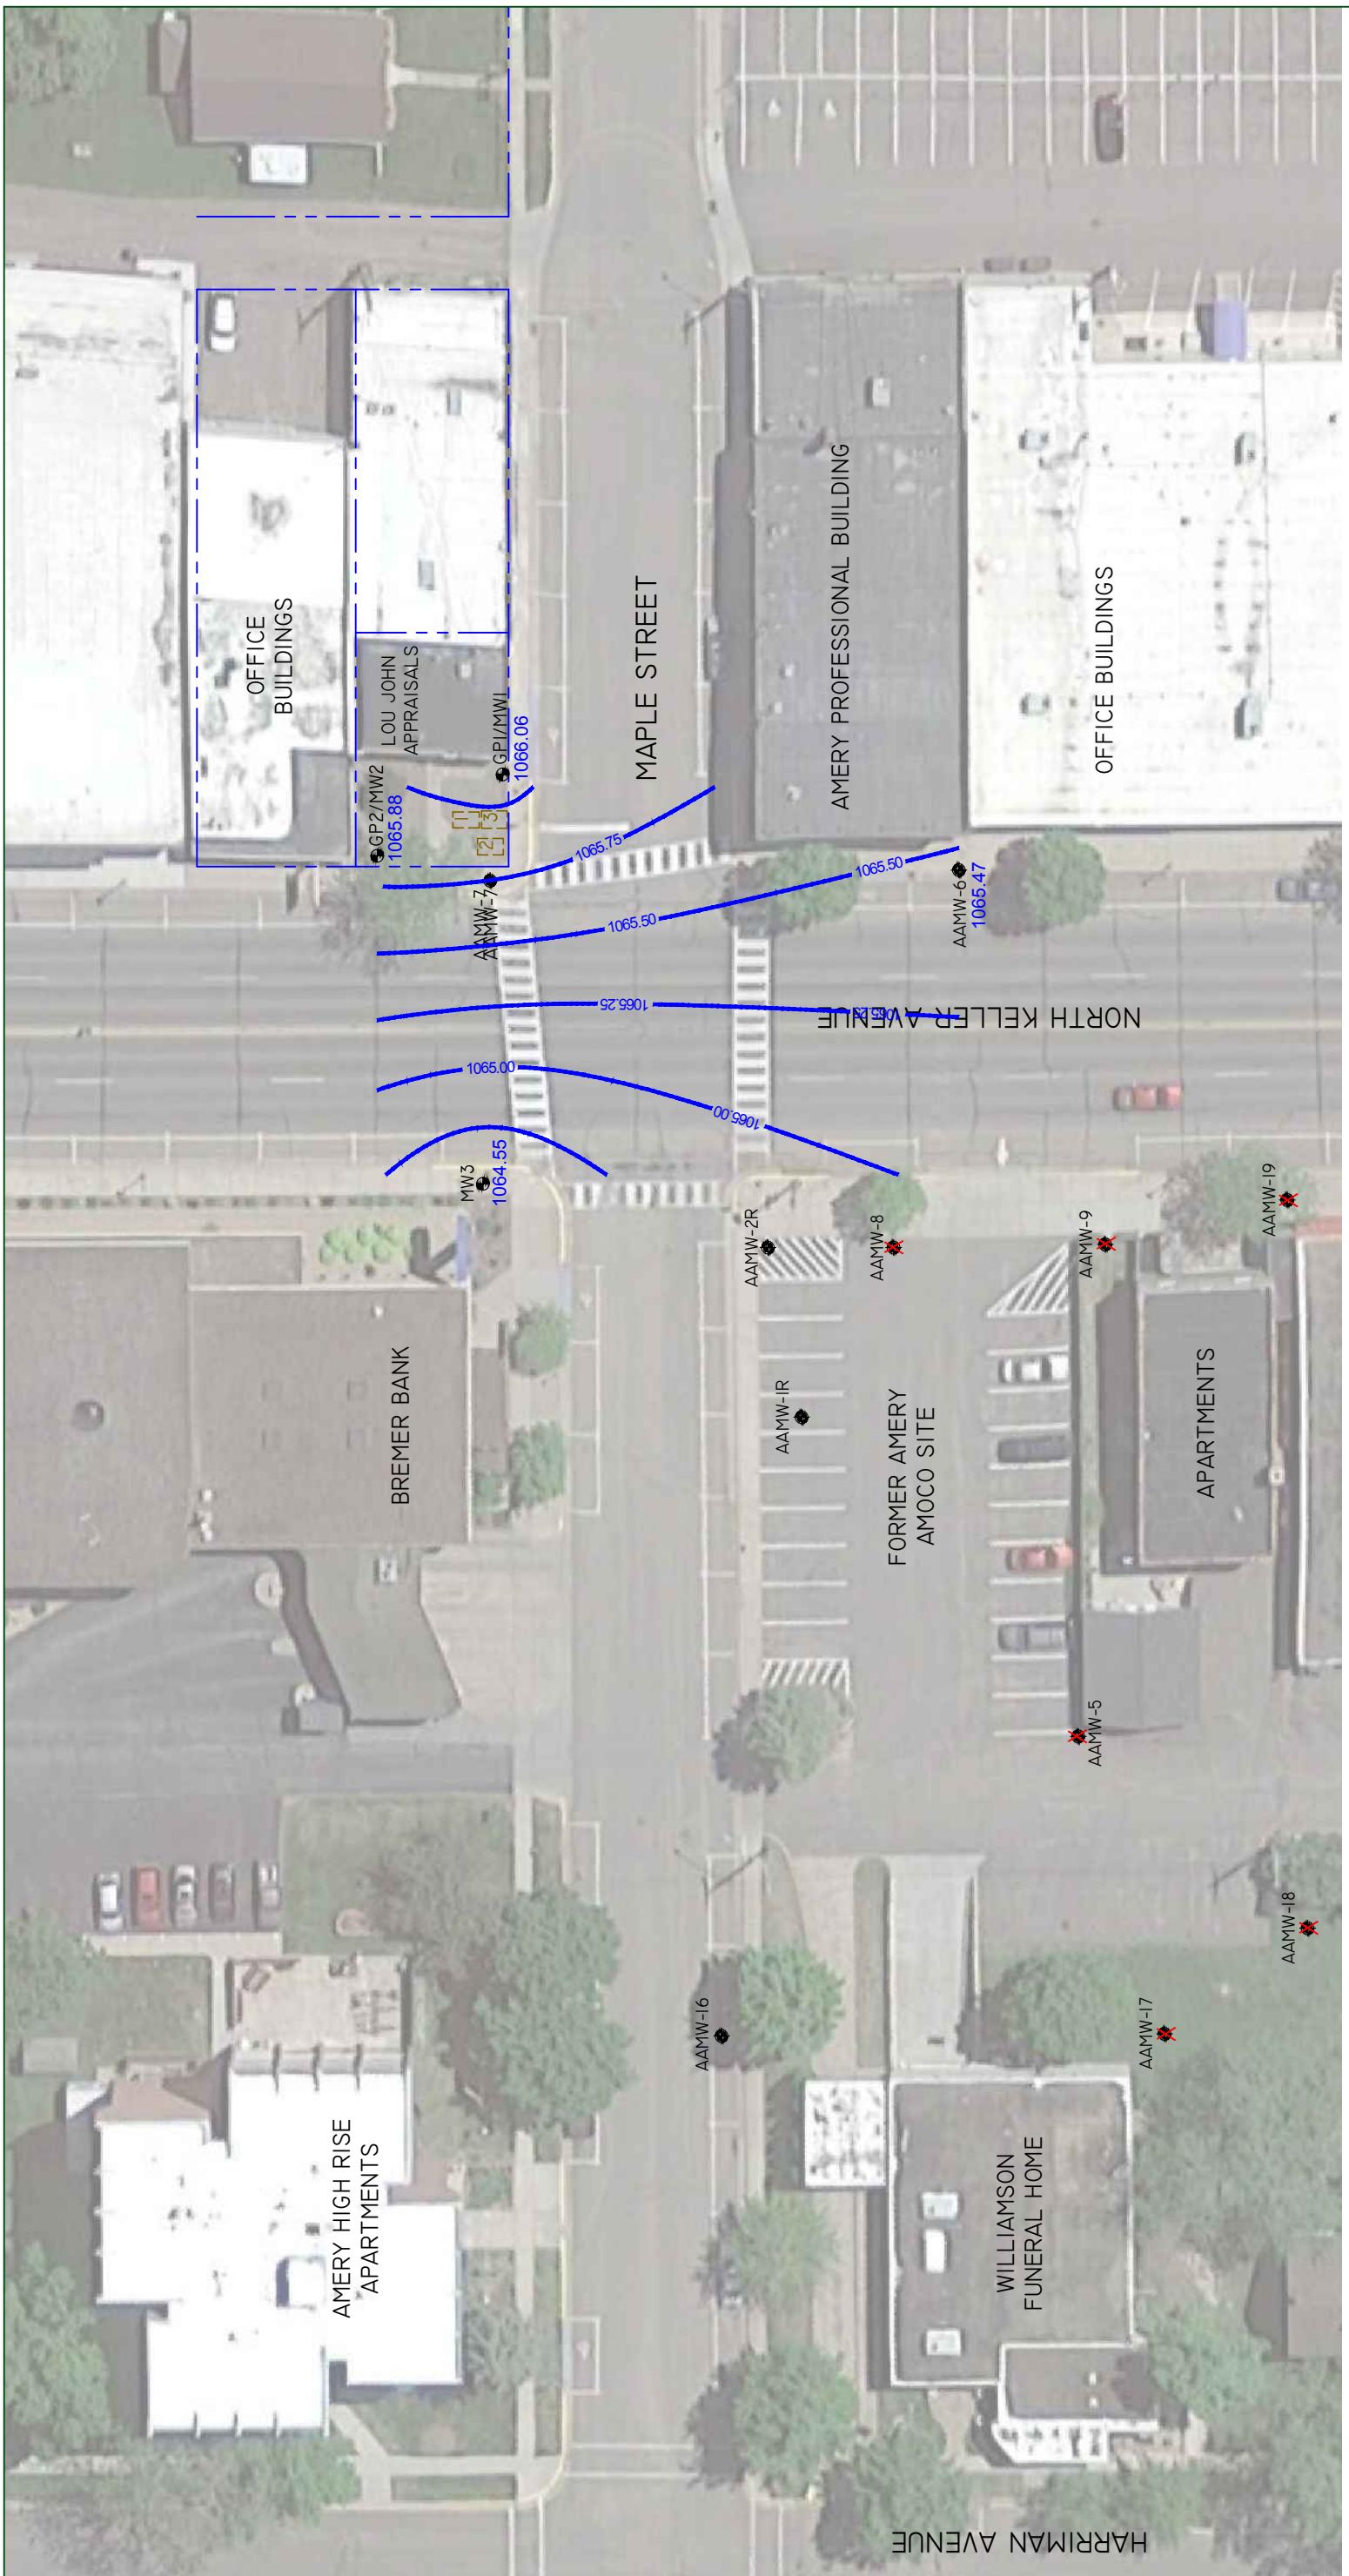
FIGURE 3 : GROUNDWATER FLOW DIRECTION (12/11/2018)

Figure 3 is a water table contour map for the December 11, 2018 groundwater sampling event. Groundwater is shown flowing from the east to the west and is consistent with historical groundwater flow directions.

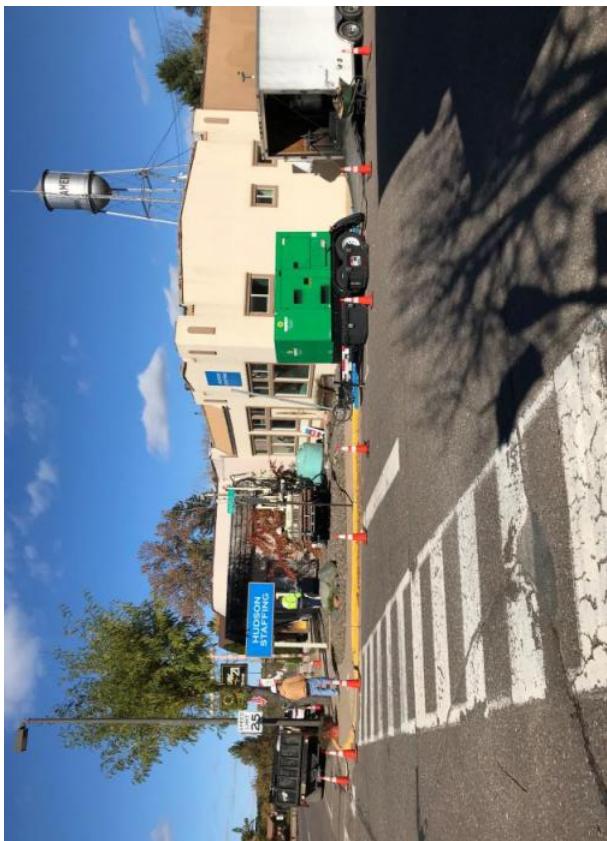
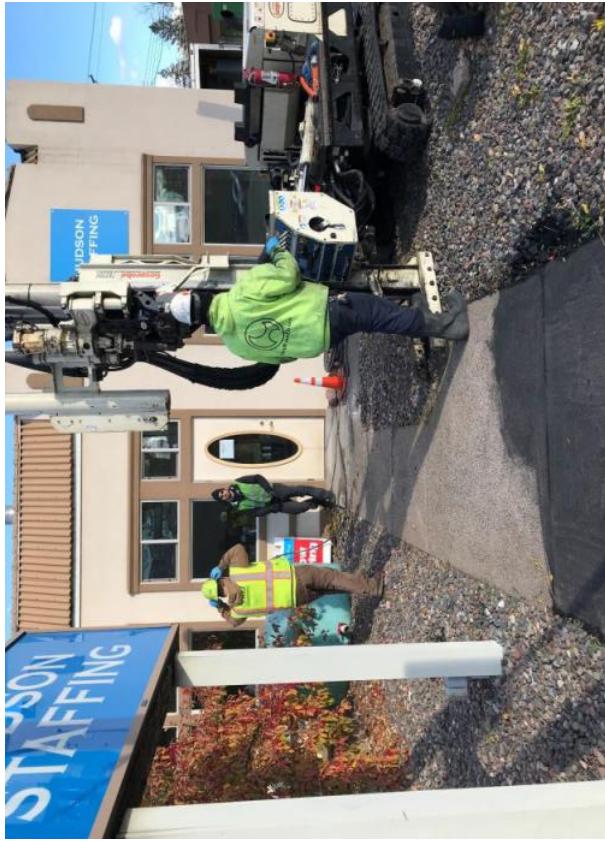
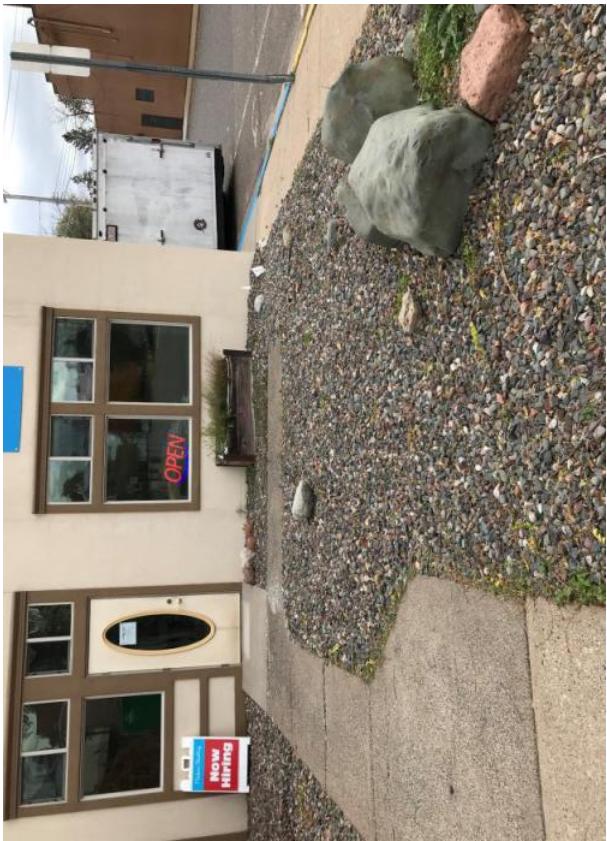
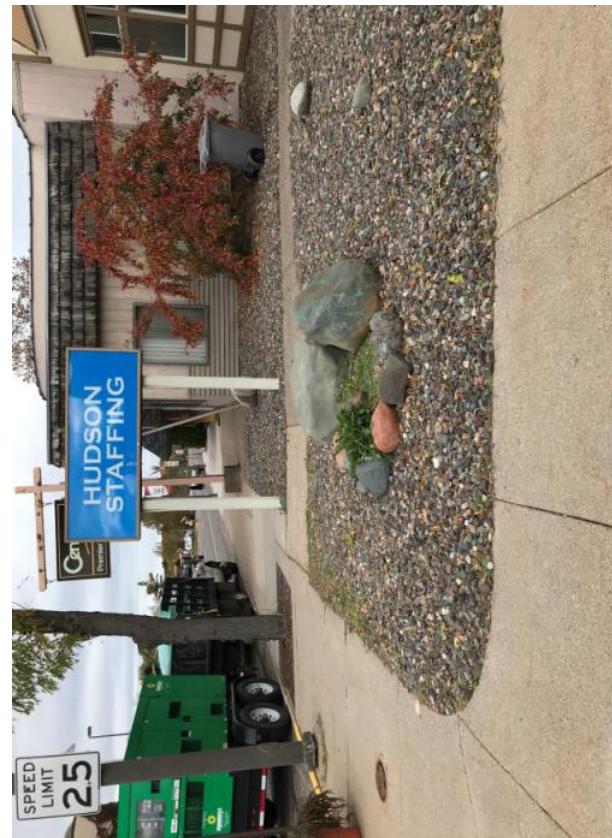
Pre entry site conditions and advancing carbon injection borings

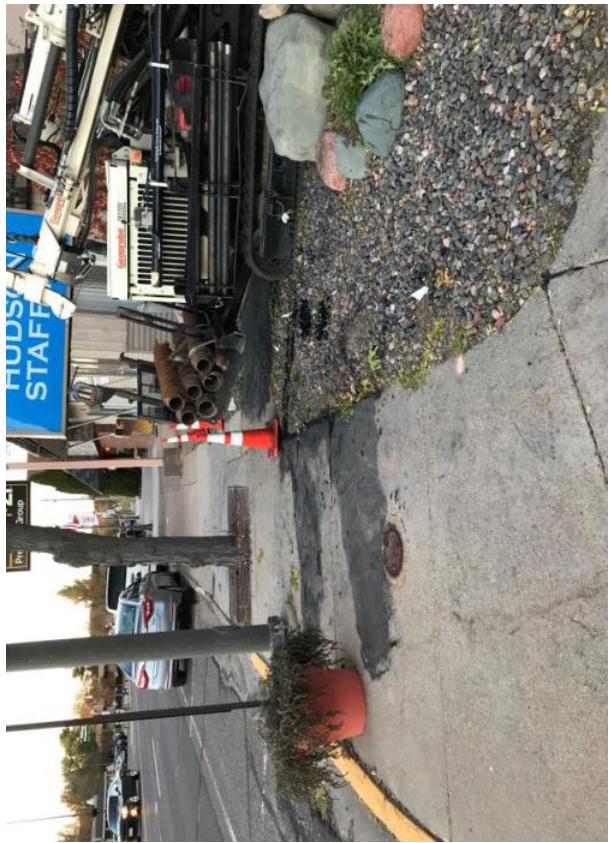
One of the negative side effects of the carbon injection process is the displacement of the existing formation water by the carbon slurry. Approximately 2,600 gallons of water and 5,300 pounds of carbon were injected into the subsurface. While injecting below the water table, the carbon slurry will displace the groundwater it is being

injected into. The displaced water was likely responsible for the detections observed in the groundwater collected from MW2 on December 11, 2018.

Area of daylighted formation water and carbon slurry near AAMW7

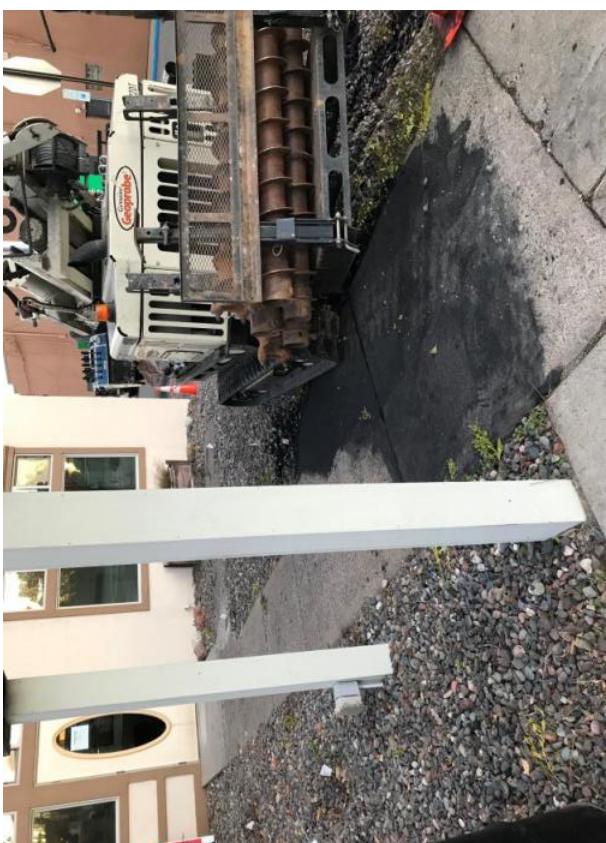
Area of daylighted formation water and carbon slurry

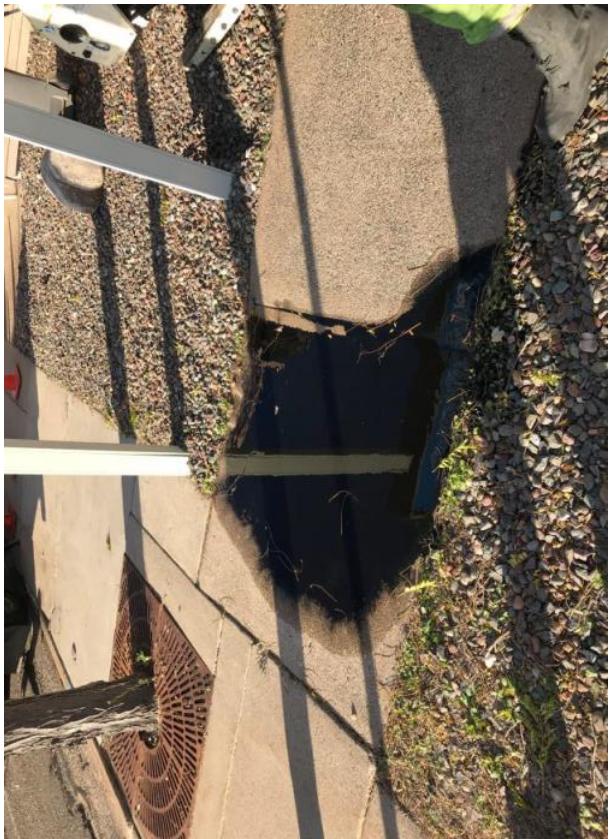
Daylighted formation water and carbon slurry

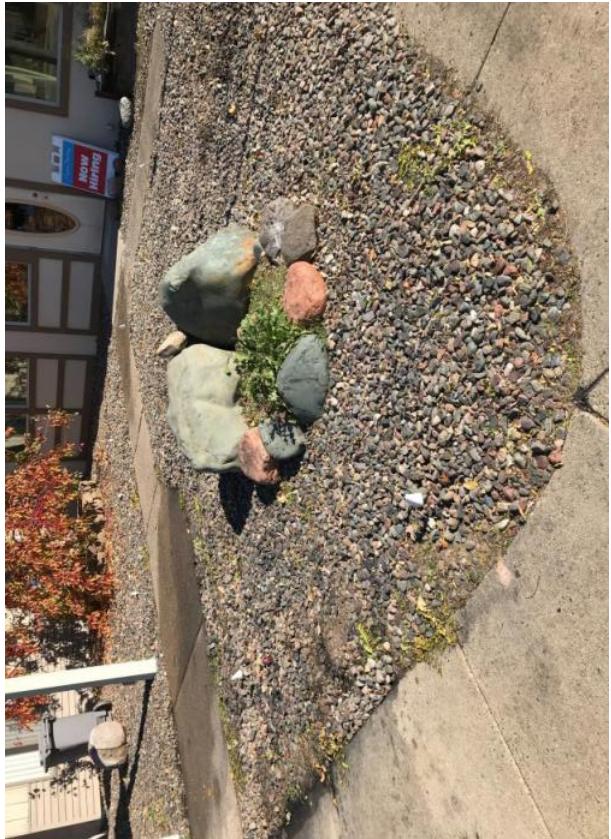
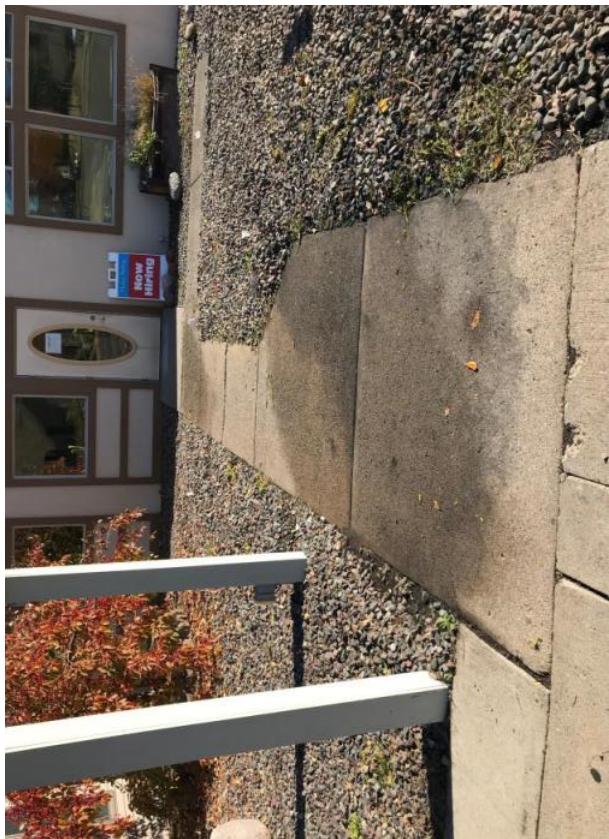
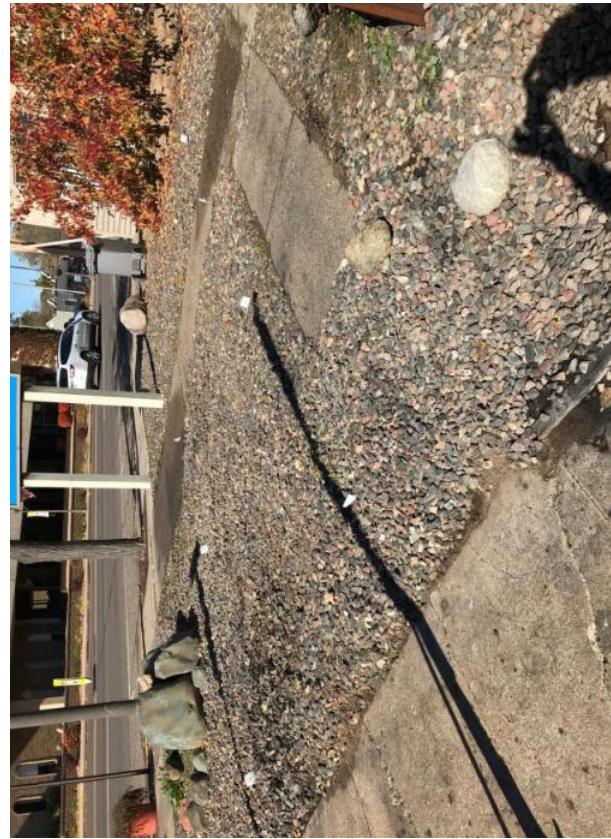
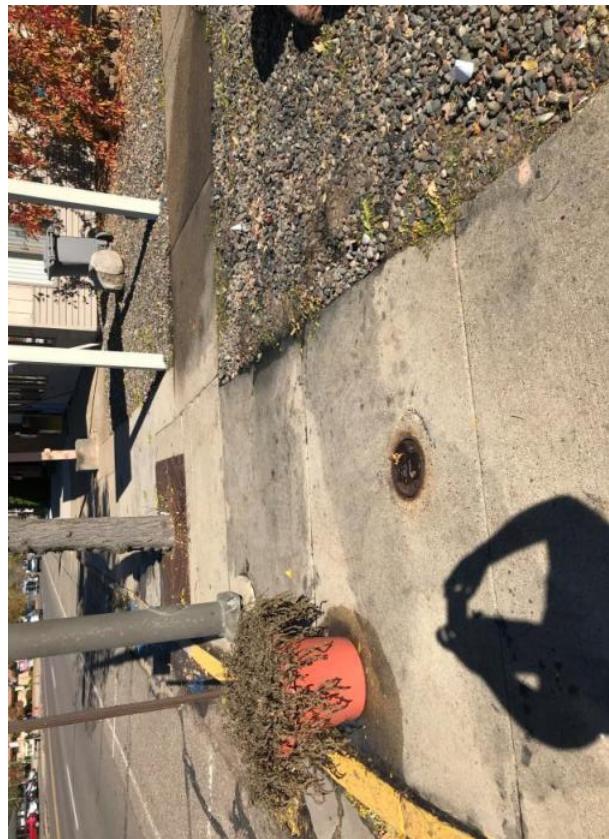
Site conditions following restoration efforts
