**VAPOR MITIGATION WORK PLAN AND RESPONSE TO WDNR COMMENTS  
FORMER MIRRO PLANT NO. 20 SITE  
44 WALNUT STREET, CHILTON, WISCONSIN  
BRRTS NOS. 02-08-520157 (ERP) AND 06-08-426946 (VPLE)**

# VAPOR MITIGATION WORK PLAN

**MIRRO PLANT NO. 20 (FORMER)  
44 WALNUT STREET  
CHILTON, WISCONSIN**

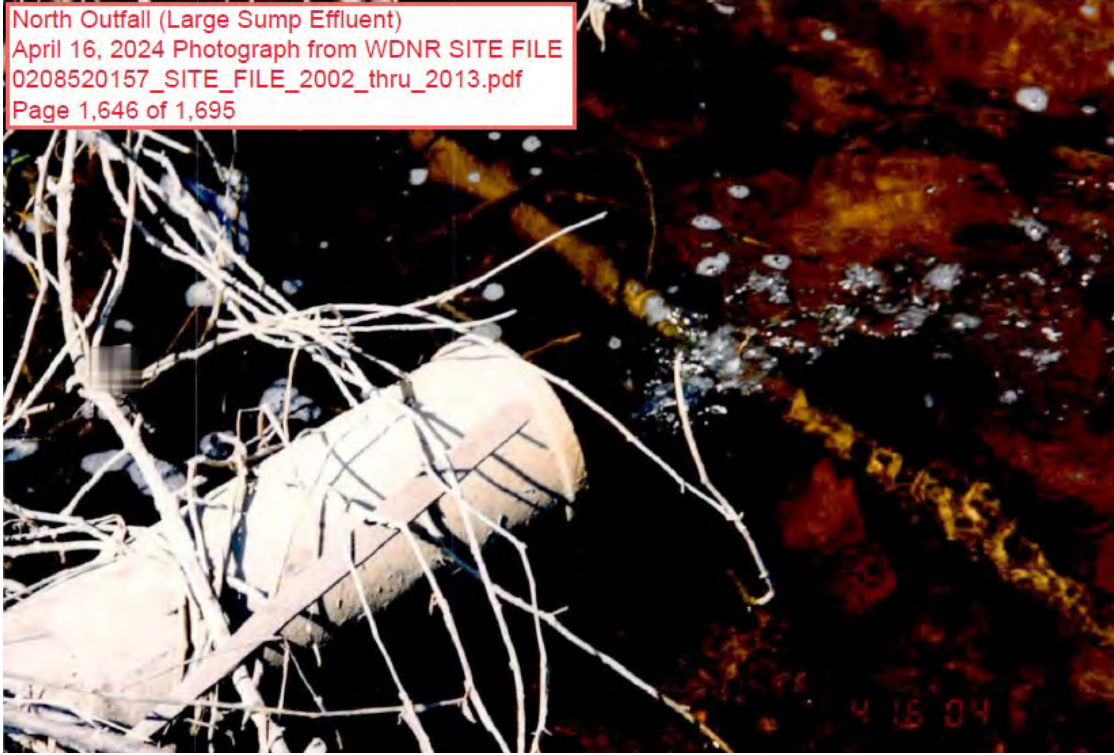
Photo 1: North Outfall photo taken on April 16, 2004, from WDNR BRRTS on the Web site file for the former Mirro Plant No. 20 project

- Photographs of the former Mirro Plant No. 20 North outfall available on the WDNR BOTW database collected in 2004 by TEMCO and subsequent photographs collected by Ramboll during the 2020 and 2021 site investigation activities continue to demonstrate no evidence of solids being discharged to the Manitowoc River from the Large Sump (Attachment B).

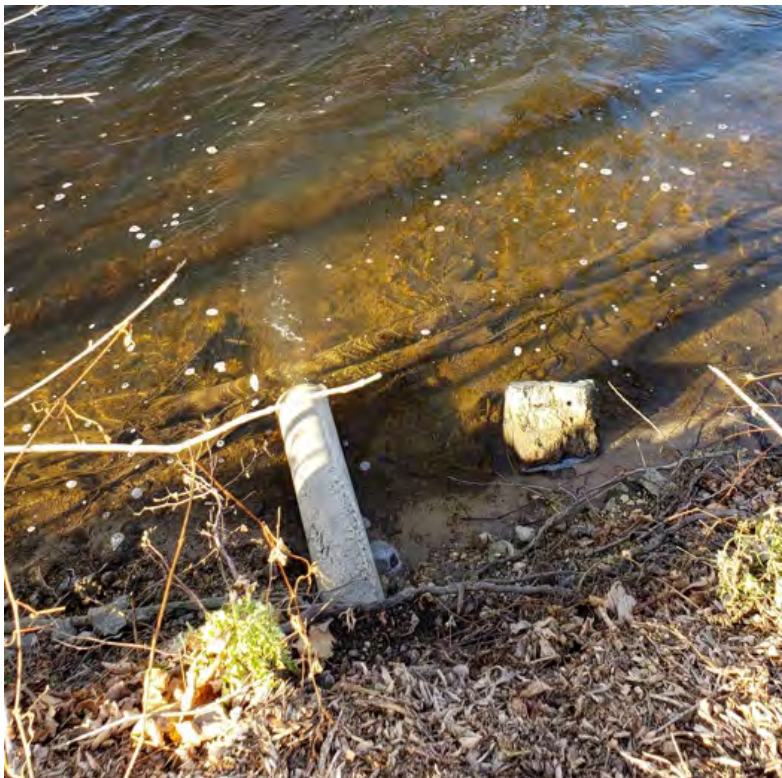
Photo 2: North Outfall photo taken by Ramboll on December 10, 2020

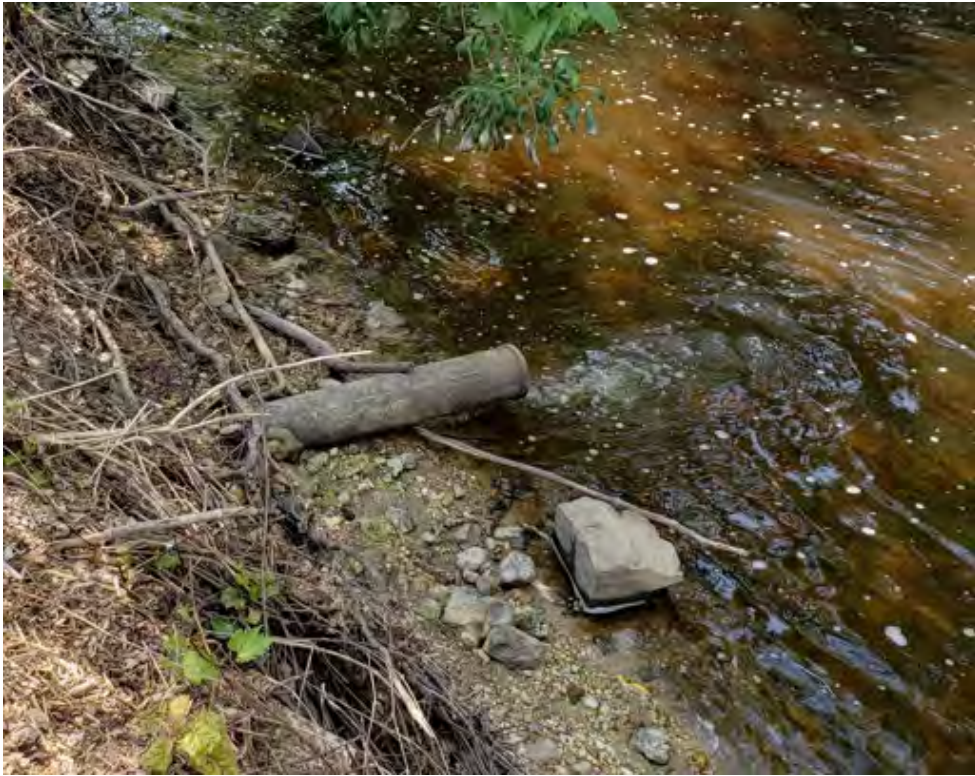
Photo 3: North Outfall photo taken by Ramboll on August 5, 2021

- Lead concentrations in basement solid samples collected by Stantec in 2020 (SS-4 at 6,800 milligrams per kilogram [mg/kg]) and Ramboll in 2021 (Pre-East Sump at 2,600 mg/kg) were elevated; however, water samples collected from each sump during the respective investigation were either non-detect or qualified with a “J” and estimated at a concentration of 0.30 micrograms per liter (µg/L), several orders of magnitude below the surface water criteria of 140 µg/L. As such, potential lead impacted basement solids which may enter the trench network, and ultimately the sumps, are not causing elevated or detectable dissolved lead concentrations in sump water. Additionally, water observed by Ramboll on December 10, 2020, and August 5, 2021, was clear and did not appear to contain solids.

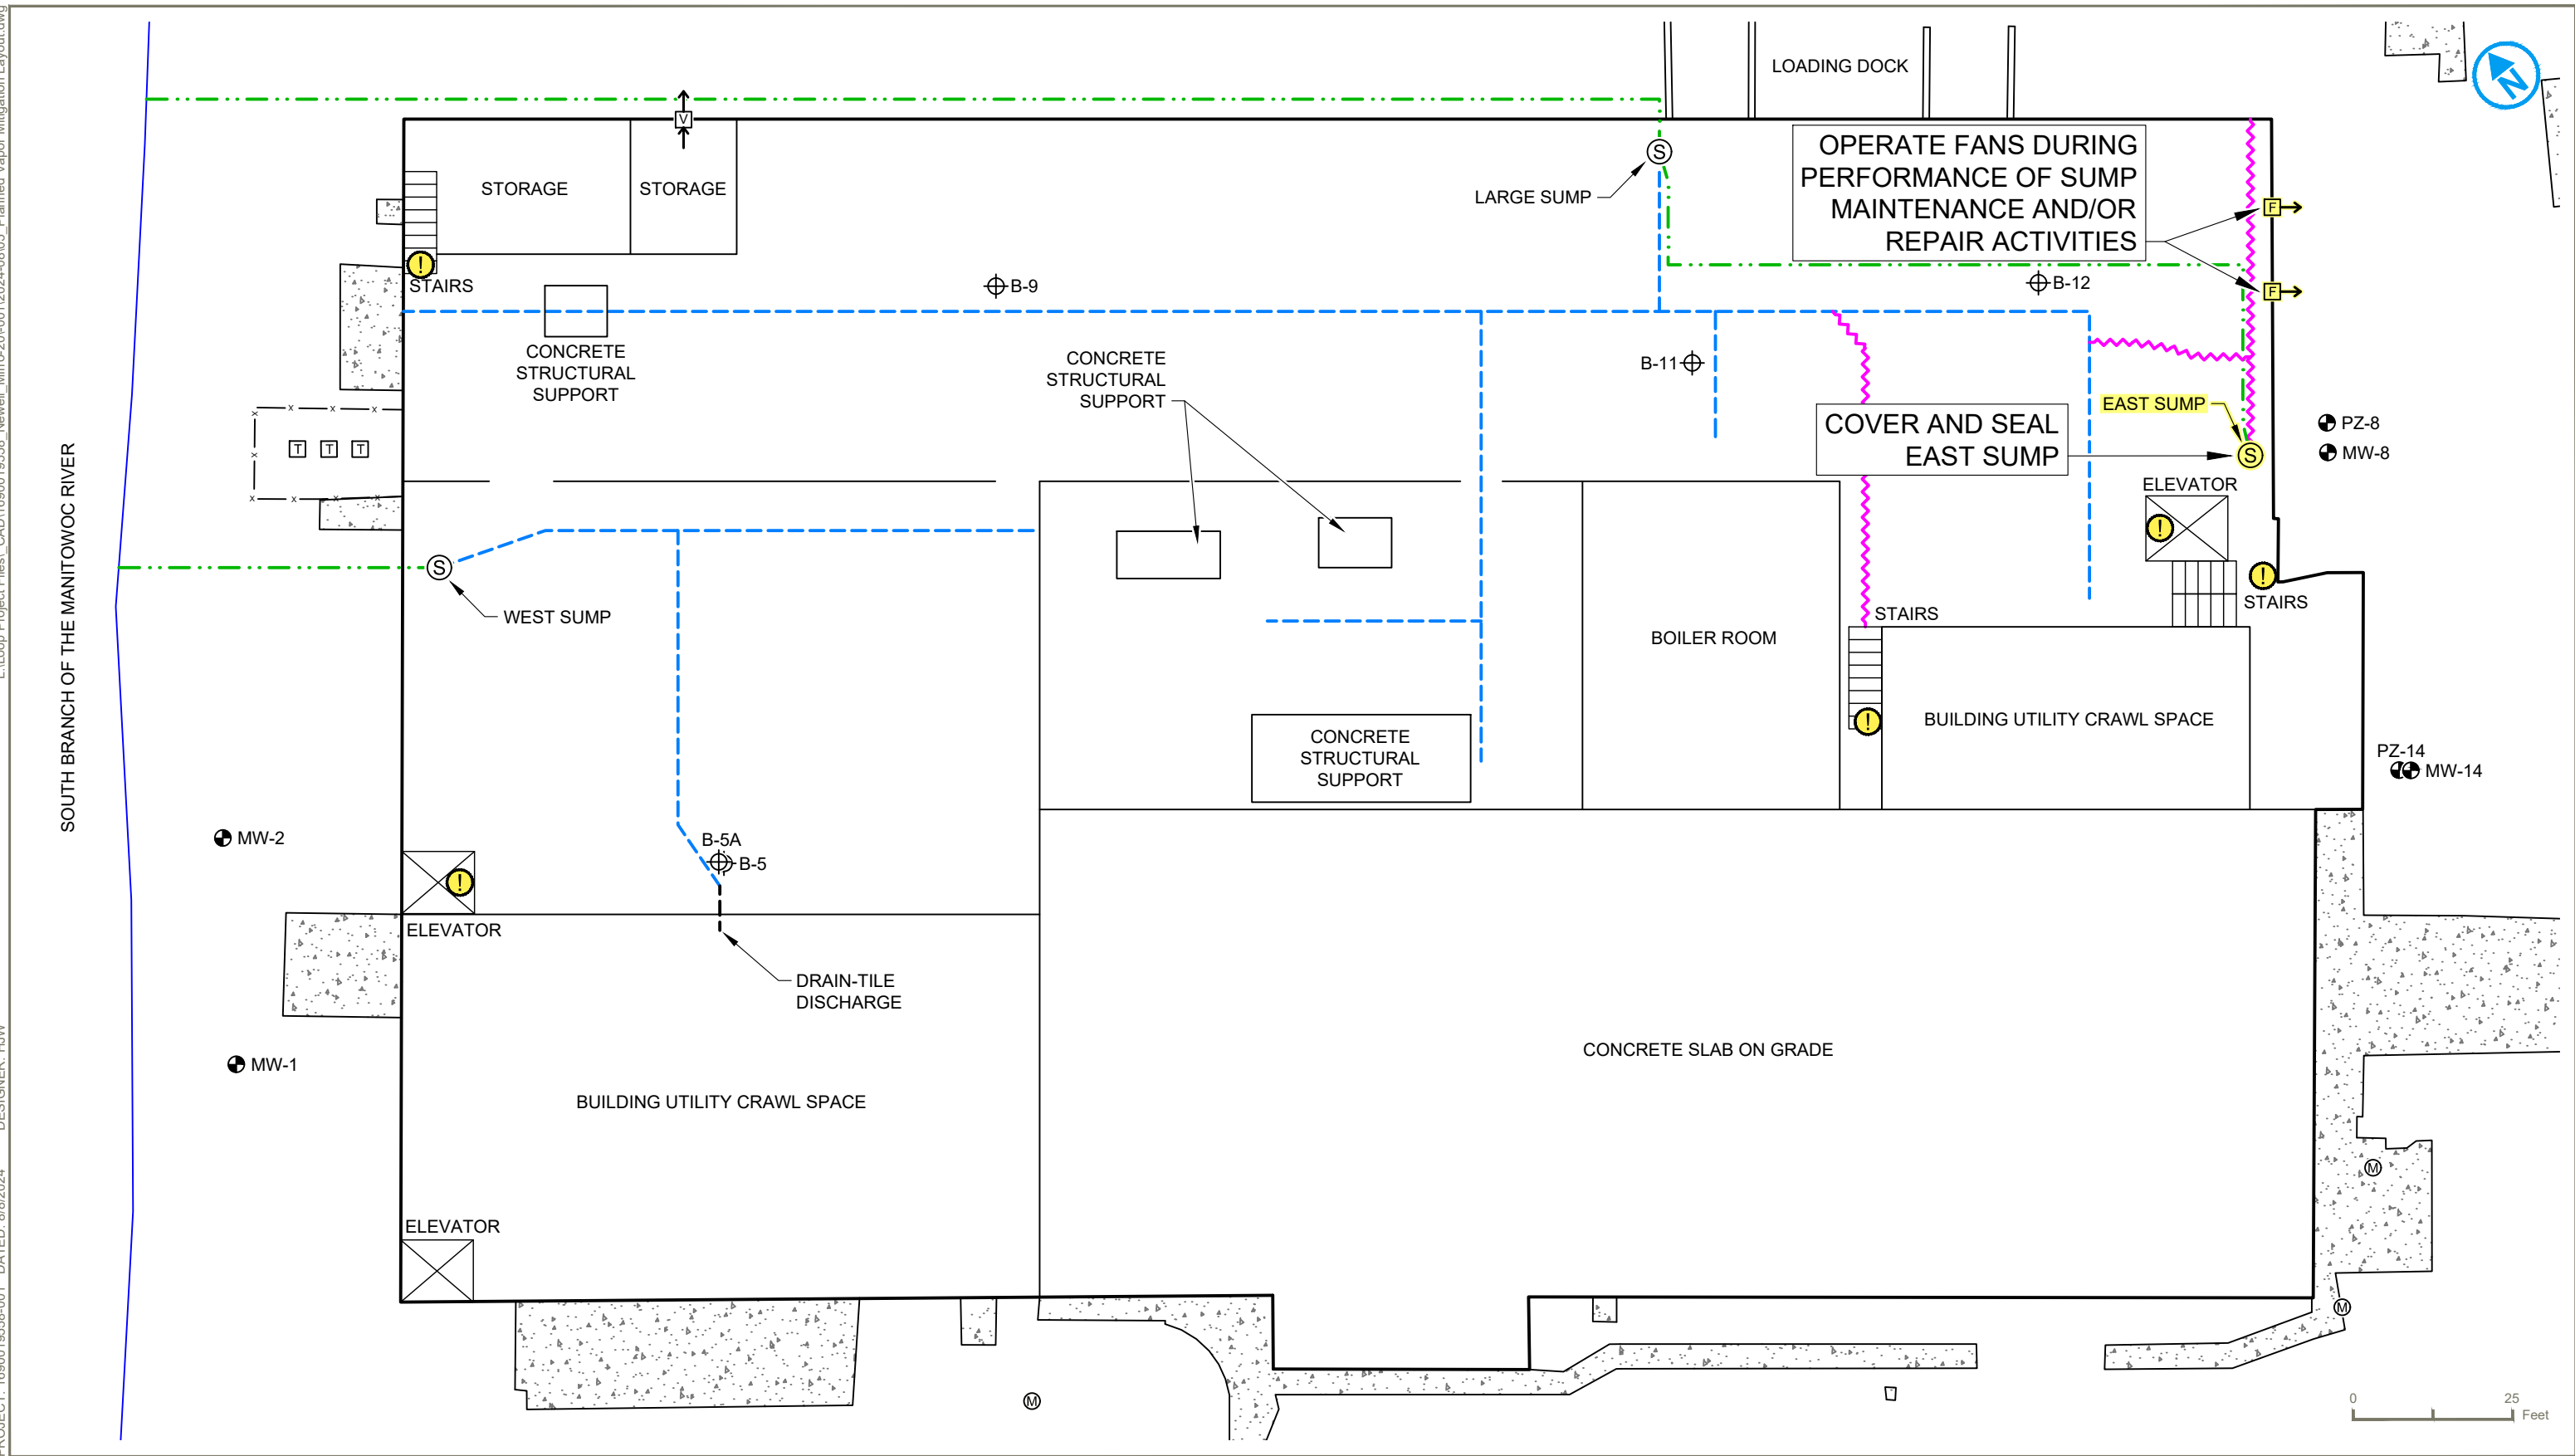
CHAIN LINK FENCE		ORIGINAL TRENCH NETWORK		WARNING SIGN
	CONCRETE AREA		POST-2002 FLOOR SAWCUTS		GROUNDWATER MONITORING POINT
	SUMP PIT		FAN		GROUNDWATER MONITORING WELL
	MANHOLE		WALL VENT		SUMP DISCHARGE LINE
	TRANSFORMER

- cover and seal the east sump, to the extent practicable;
- install signage to limit access to the basement area; and
- develop an operation and maintenance (O&M) plan for the current property owner to follow to ensure that these measures remain in place and protective in the future.

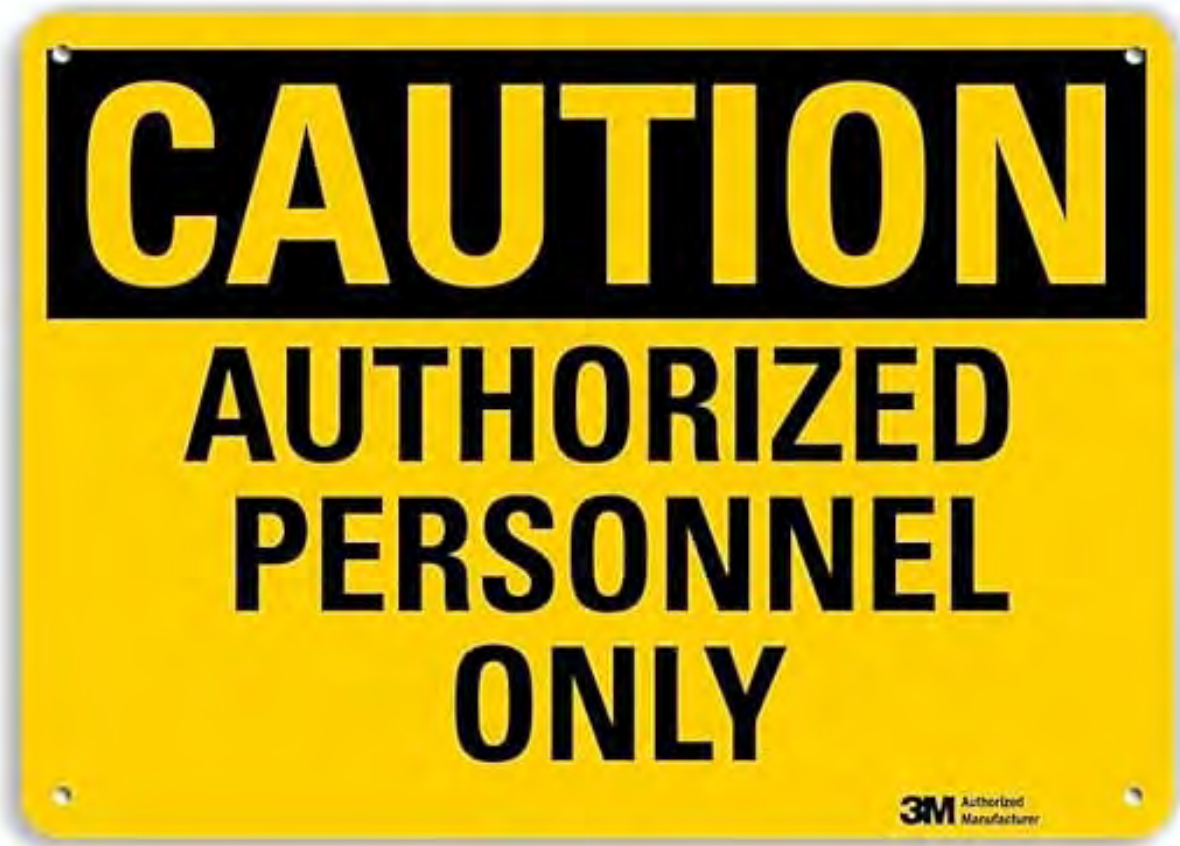
Example of sign to be placed at all entrances to the basement.

- **Limit Use of Basement:** While the current use of the basement is generally limited to building maintenance activities, additional measures could be taken to alert building occupants to the potential hazards and/or further limit access to the basement. This could be accomplished through the placement of signage at entrance points to the basement and limiting access to the basement to only authorized individuals.
