SUBJECT: Final Case Closure with Continuing Obligations
Pioneer Bank, 701 S. Central Ave., Marshfield, WI
DNR BRRTS Activity #: 03-72-521604

PIONEER BANK – FORMER TEXACO STATION
 701 SOUTH CENTRAL AVENUE
 MARSHFIELD, WISCONSIN

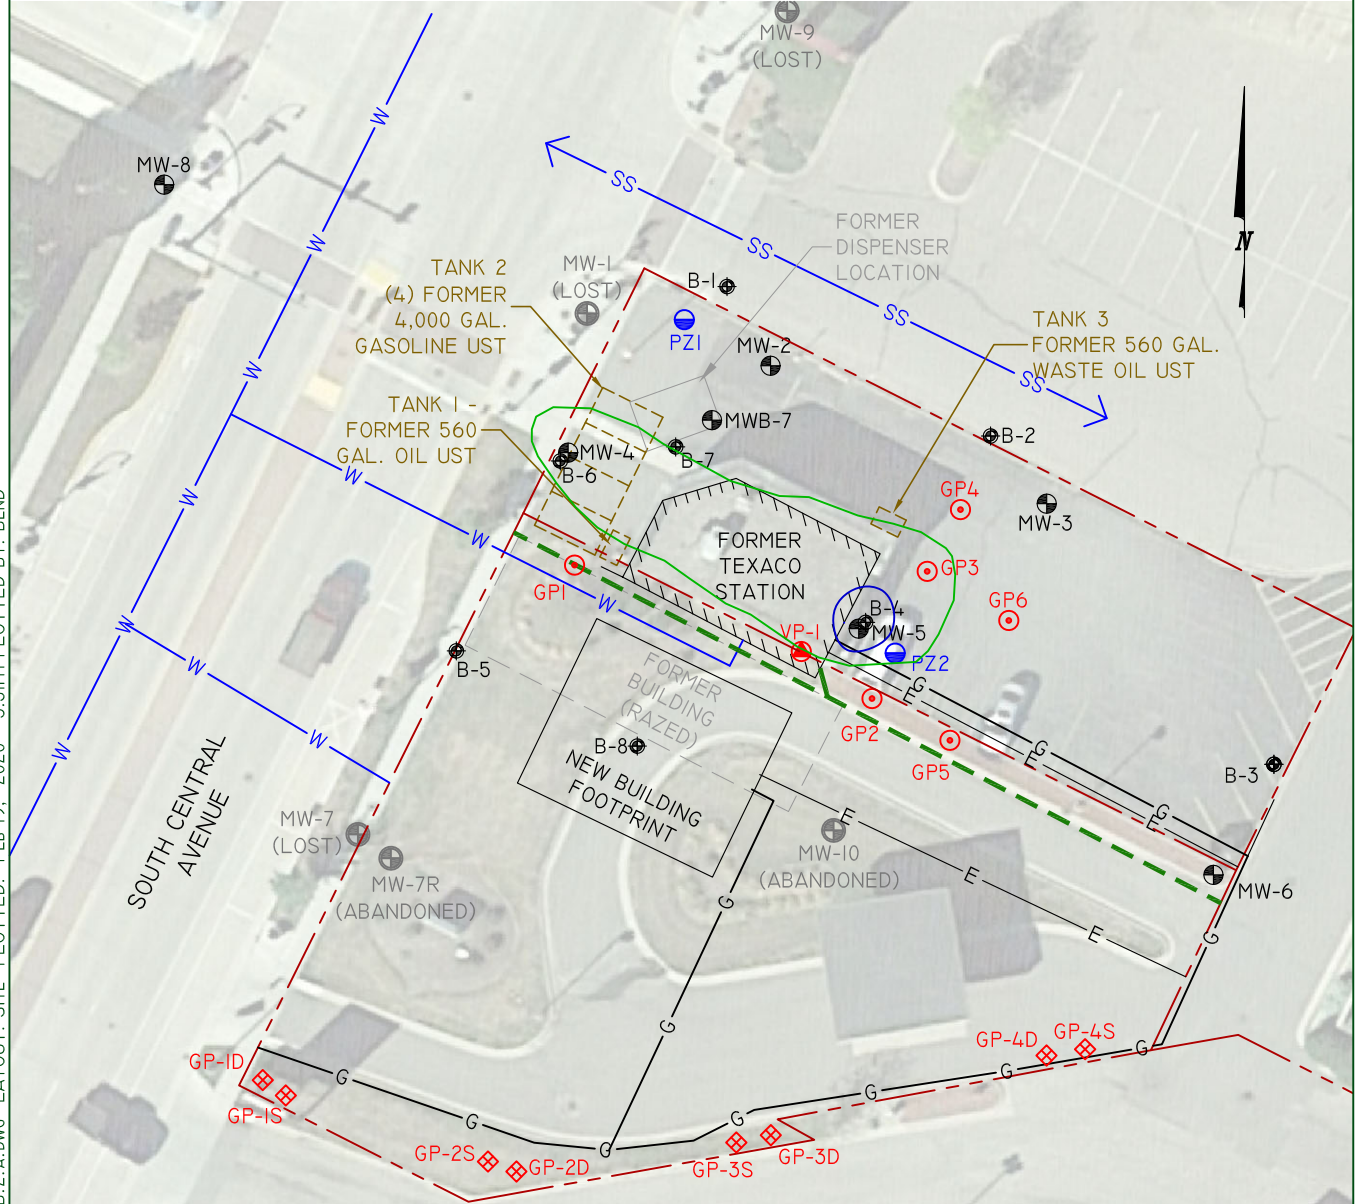
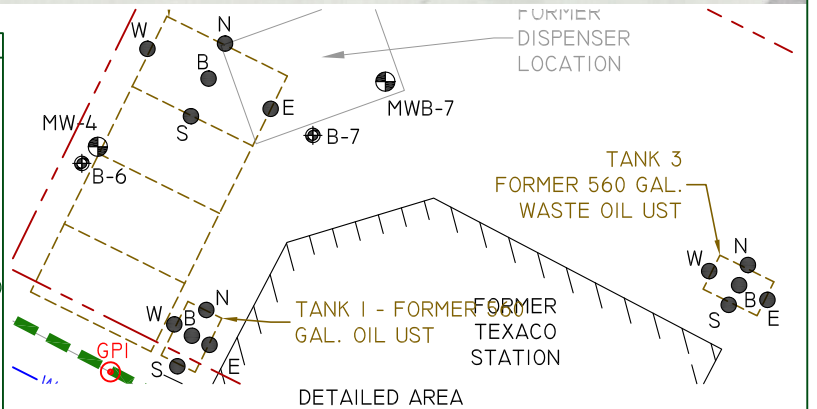
FIGURE B.2.b: RESIDUAL SOIL CONTAMINATION	
PROJECT NO. 5403 AXUC	DRAWN BY: STH
DATE: 09/26/2019

Soil contamination remains as indicated on the attached map, "Figure B.2.b: Residual Soil Contamination, 09/26/2019". If soil in the specific locations described above is excavated in the future, the property owner or right-of-way holder at the time of excavation must sample and analyze the excavated soil to determine if contamination remains. If sampling confirms that contamination is present, the property owner or right-of-way holder at the time of excavation will need to determine whether the material is considered solid or hazardous waste and ensure that any storage, treatment or disposal is in compliance with applicable standards and rules. Contaminated soil may be managed in accordance with ch. NR 718, Wis. Adm. Code, with prior DNR approval. This continuing obligation also applies to the ROW holders for South Central Avenue.

Soil contamination exceeding the NR 720 Groundwater Protection Pathway RCL for petroleum compounds is found near the center of the property extending west into the right-of-way including under property building. The NR 720

- ii. Describe the concentration(s) and types of soil contaminants found in the upper four feet of the soil column. Soil contamination exceeding the NR 720 Groundwater Protection Pathway standard is exceeded at MW-5, B-4, B-6, GP-2, and on the western side wall of tank 3 for petroleum compounds. MW-5 also has an exceedance of the NR 720 Direct Contact standard for naphthalene, ethylbenzene, and benzo(a) pyrene.

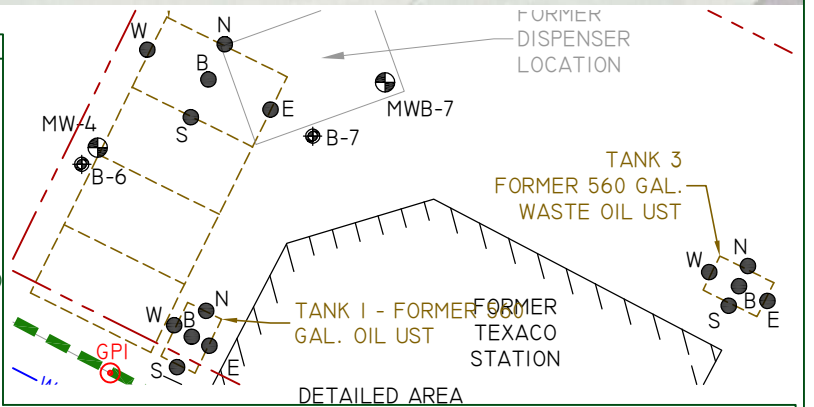
- ESTIMATED EXTENT OF DISSOLVED PHASE GROUNDWATER CONTAMINATION EXCEEDING THE NR 140 ENFORCEMENT STANDARD (ES) FOR PETROLEUM COMPOUNDS.
- ESTIMATED EXTENT OF DISSOLVED PHASE GROUNDWATER CONTAMINATION EXCEEDING THE NR 140 PREVENTATIVE ACTION LIMIT (PAL) FOR PETROLEUM COMPOUNDS.

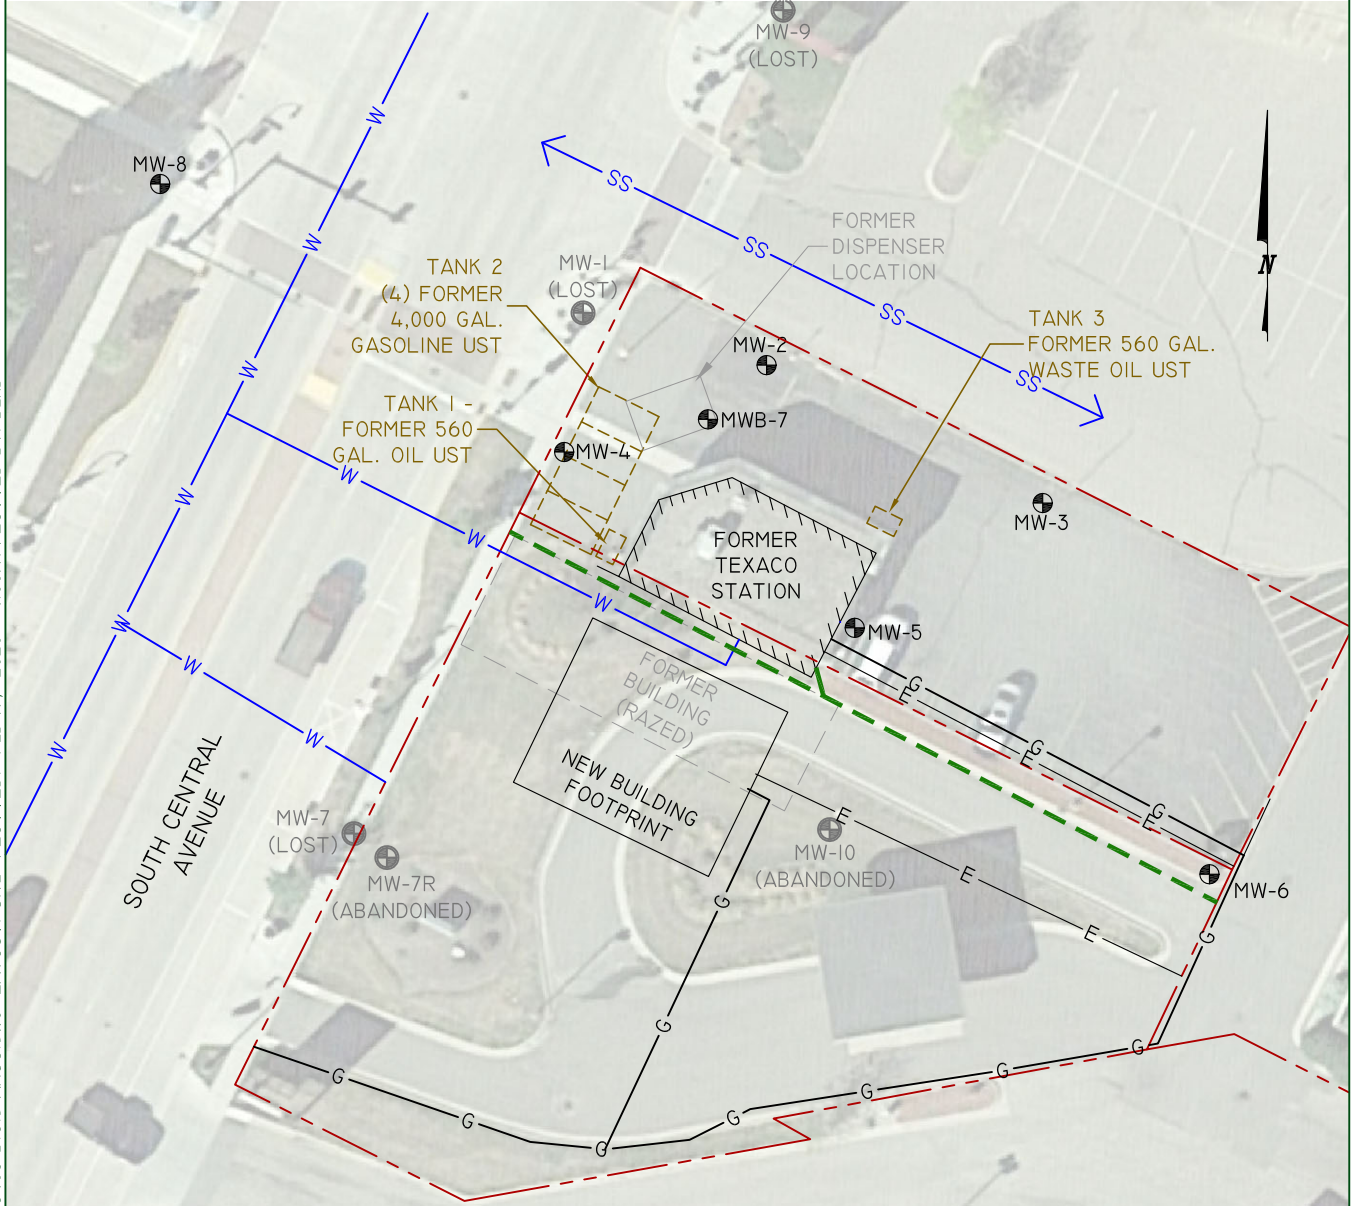
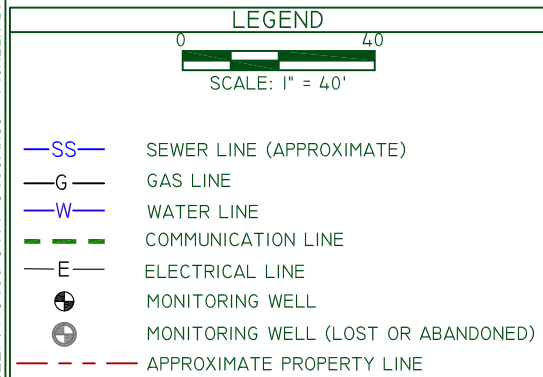
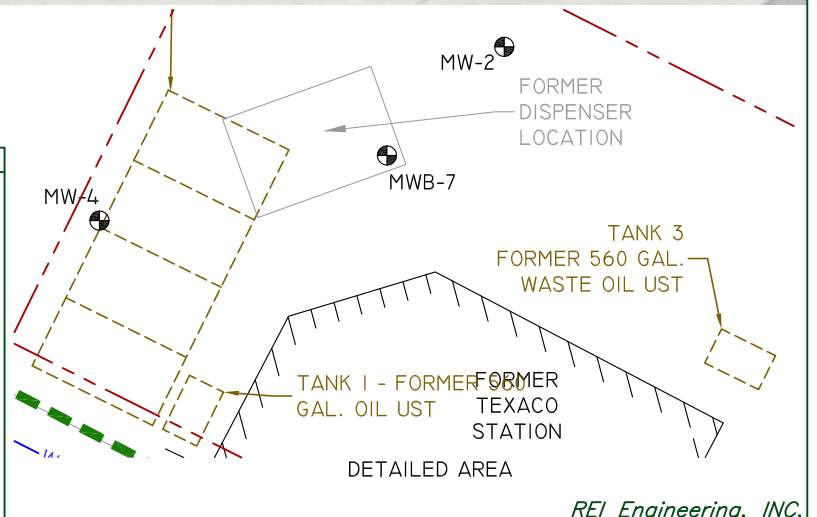
Monitoring well(s) MW-1, MW-7, and MW-9 located along South Central Avenue shown on the attached map, "Figure B.3.d: Monitoring Wells, 09/27/2019", could not be properly filled and sealed because they were missing due to being paved over, covered or removed during site development activities. Your consultant made a reasonable effort to locate the well and to determine whether they were properly filled and sealed but was unsuccessful. You may be held liable for any problems associated with the monitoring wells if they create a conduit for contaminants to enter groundwater. If any of the groundwater monitoring wells are found, the then current owner of the property on which the well is located is required to notify the DNR, to properly fill and seal the wells and to submit the required documentation to the DNR. This continuing obligation also applies to the ROW holders for South Central Avenue.
