**PHASE I ENVIRONMENTAL SITE
ASSESSMENT**

**FORMER MOBILE BLASTING
SITE
1604 SOUTH 43RD STREET
WEST MILWAUKEE, WISCONSIN**

Prepared for
Real Estate Recycling
Dain Bosworth Plaza
60 South Sixth Street, Suite 2110
Minneapolis, MN 55402

November 20, 1998

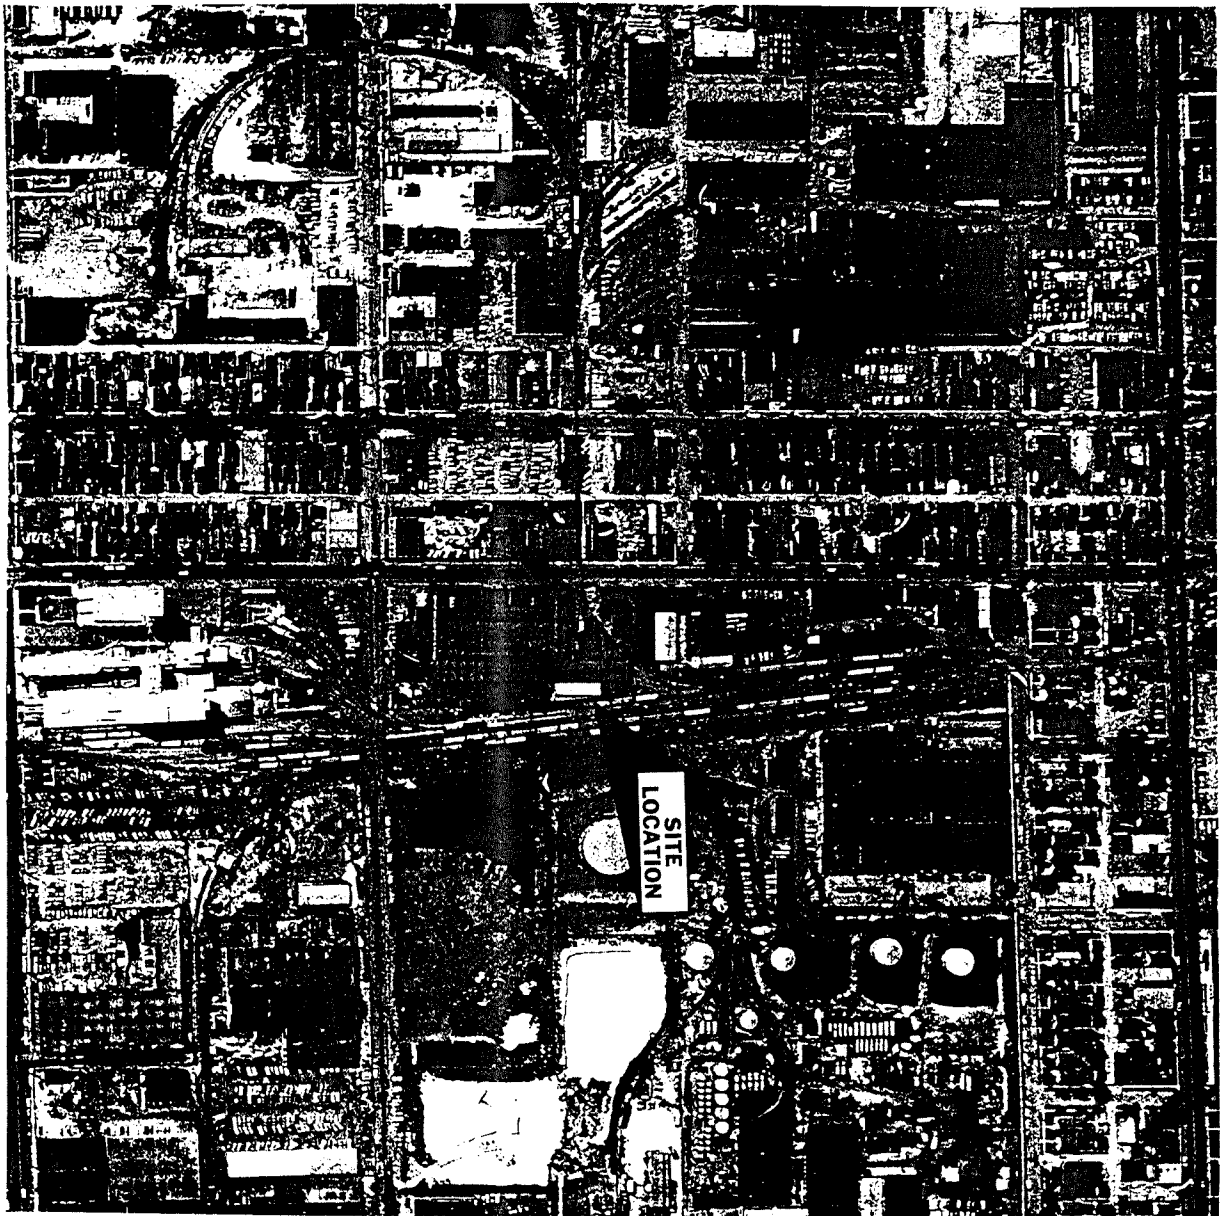
1967

- **1967:** The Property and areas surrounding the Property appear in similar conditions in this photograph to the conditions observed in the 1963 aerial photograph. However, the pond present east of the Property appears to be in the process of being filled in. The extent of the pond has been reduced from the east since the 1963 aerial photograph was taken.

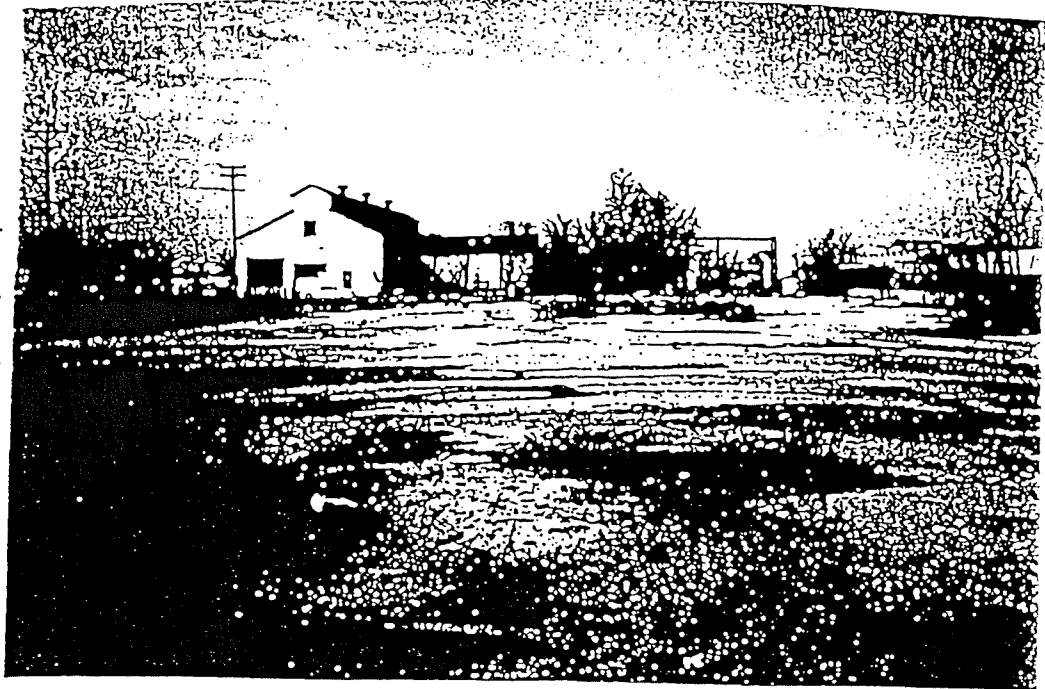
Former location of Seyer Steel facility in foreground,
Mobile Blasting building in background

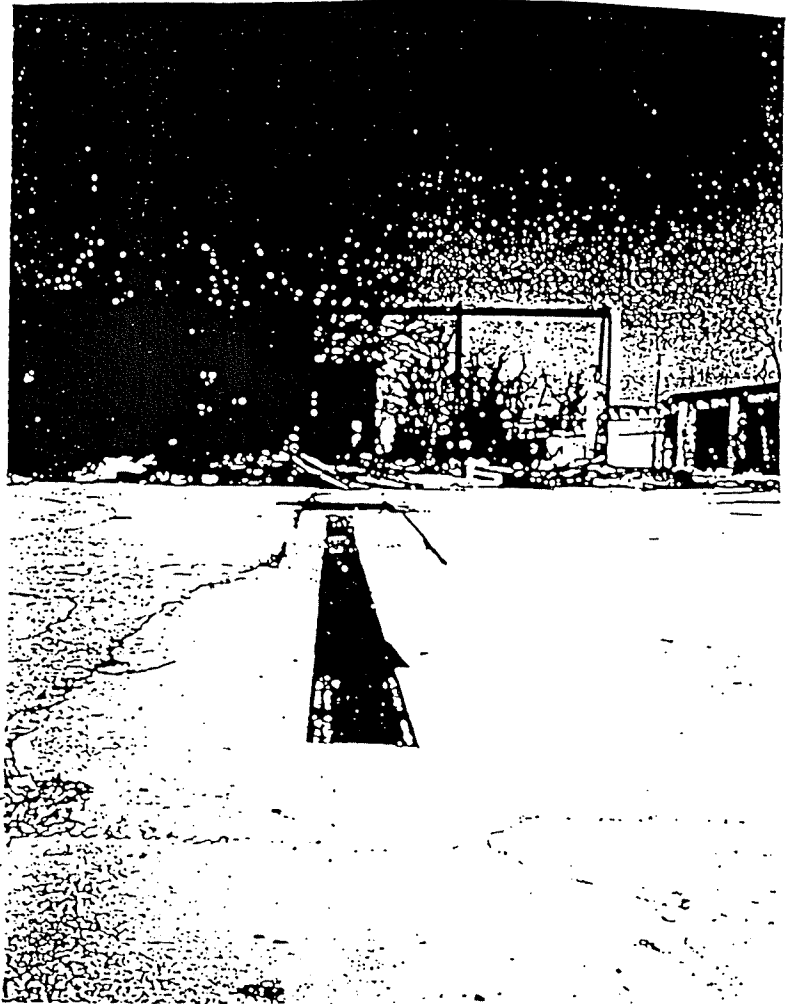
5

Viewing from across from former
Singer Steel facility. Mobile Blasting
building in background.

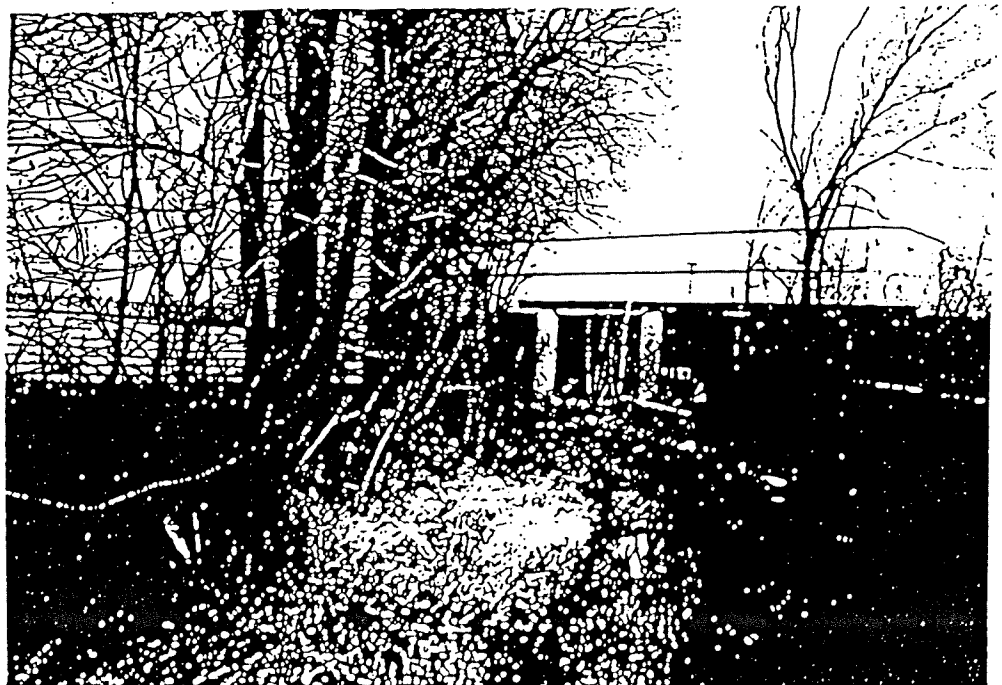
6

Exposed spur alongside Mobile Blasting building.
