SUBJECT: Final Case Closure with Continuing Obligations
Ginseng Wisconsin, 400 Main St., Marathon, WI
DNR BRRTS Activity #: 03-37-526881
FID #: 737201190

GINSENG WISCONSIN 400 MAIN STREET MARATHON, WISCONSIN		FIGURE B.1.a: LOCATION MAP	
PROJECT NO.	5454	DRAWN BY:	DATE:
		NAP	10/21/10

<p>REI CIVIL & ENVIRONMENTAL ENGINEERING, SURVEYING</p>	GINSENG WISCONSIN 400 MAIN STREET MARATHON, WISCONSIN	
	FIGURE B.3.a.1: GEOLOGIC CROSS SECTION

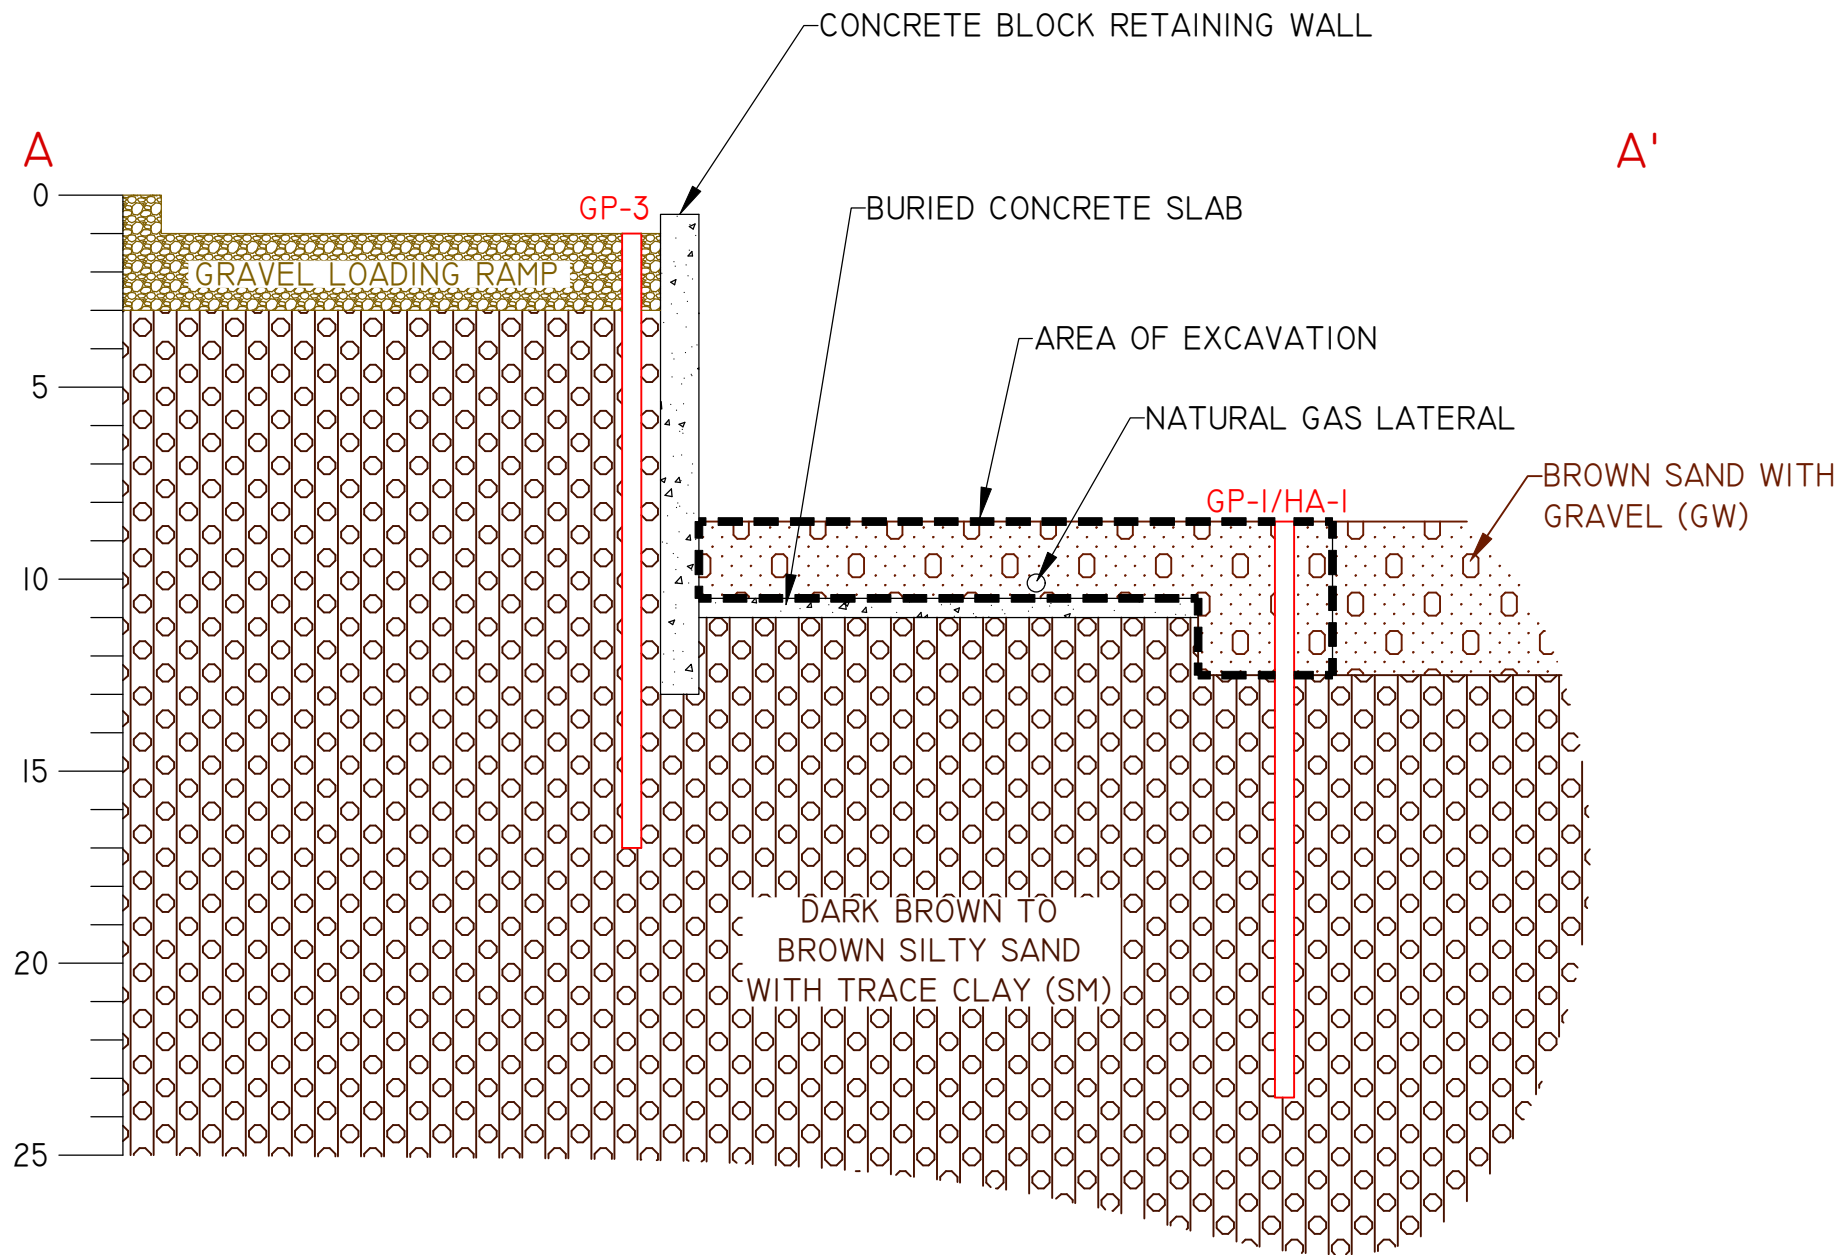
- A. **Soil/Geology**
 - i. **Describe soil type(s) and relevant physical properties, thickness of soil column across the site, vertical and lateral variations in soil types.**
Soil types across the site are fairly consistent. Gravel and sand dominate the upper two (2) feet of the soil column. Brown silty sand with trace clay is then present to a depth of 15 feet bls.
 - ii. **Describe the composition, location and lateral extent, and depth of fill or waste deposits on the site.**
Waste deposits were not encountered during this investigation.
 - iii. **Describe the depth to bedrock, bedrock type, competency and whether or not it was encountered during the investigation.**
Bedrock was not encountered in the geotechnical borings advanced by American Engineering Testing, Inc. to their maximum depth of 26.5 feet bgs.
