RE: Pleasant Prairie Power Plant Sulfate in Groundwater
BRRTS# 02-30-527479
Request for Technical Assistance and No Further Action Determination

Enclosed please find the technical memorandum, *Pleasant Prairie Power Plant (P4) Sulfate in Groundwater BRRTS#: 02-30-527479*, dated August 1, 2019, which was prepared with the intent of obtaining a No Further Action determination from the Department. We have also included a request for technical assistance (Form 4400-237) with the accompanying fee of \$350 in the form of a check.

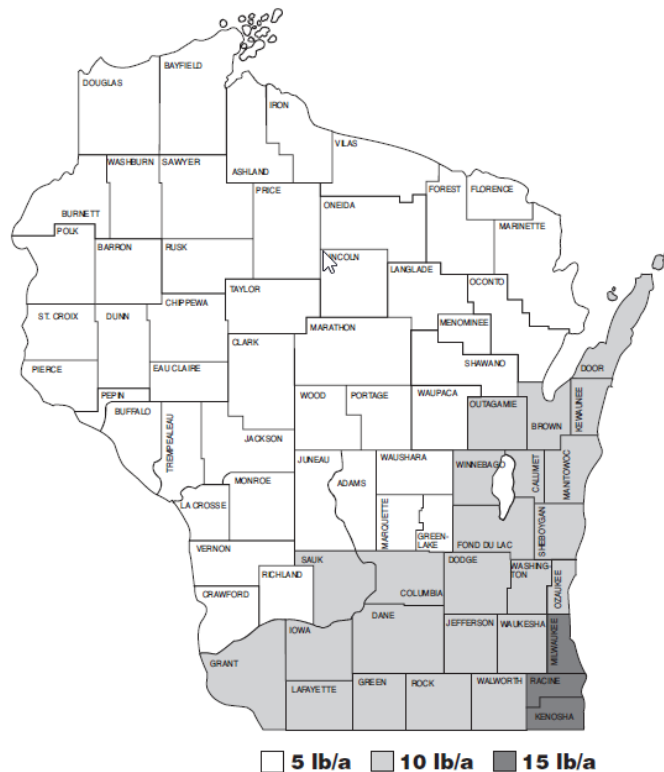
Figure 12-6. Sulfate sulfur in precipitation.

Source: National Atmospheric Deposition Program, 1999.

The amount of sulfate deposition and the acidity of precipitation has decreased as levels of SO₂ released to the atmosphere have been reduced in the last 30 years. In this area of the state the sulfate concentrations in precipitation have decreased from >2 mg/L in 1985 to <1 mg/L in 2017 (Attachment A1). Similarly, the pH in precipitation has increased from about 4.4 S.U. in 1985 to 5.8 S.U. in 2017 (Attachment A2). The presence of over a century of sulfate in precipitation likely contributed to sulfate concentrations detected in groundwater, and the acidity of the precipitation influences the geochemical conditions of the aquifer. Changes in geochemical conditions can increase the potential sulfate release from soils and aquifer solids (discussed above).

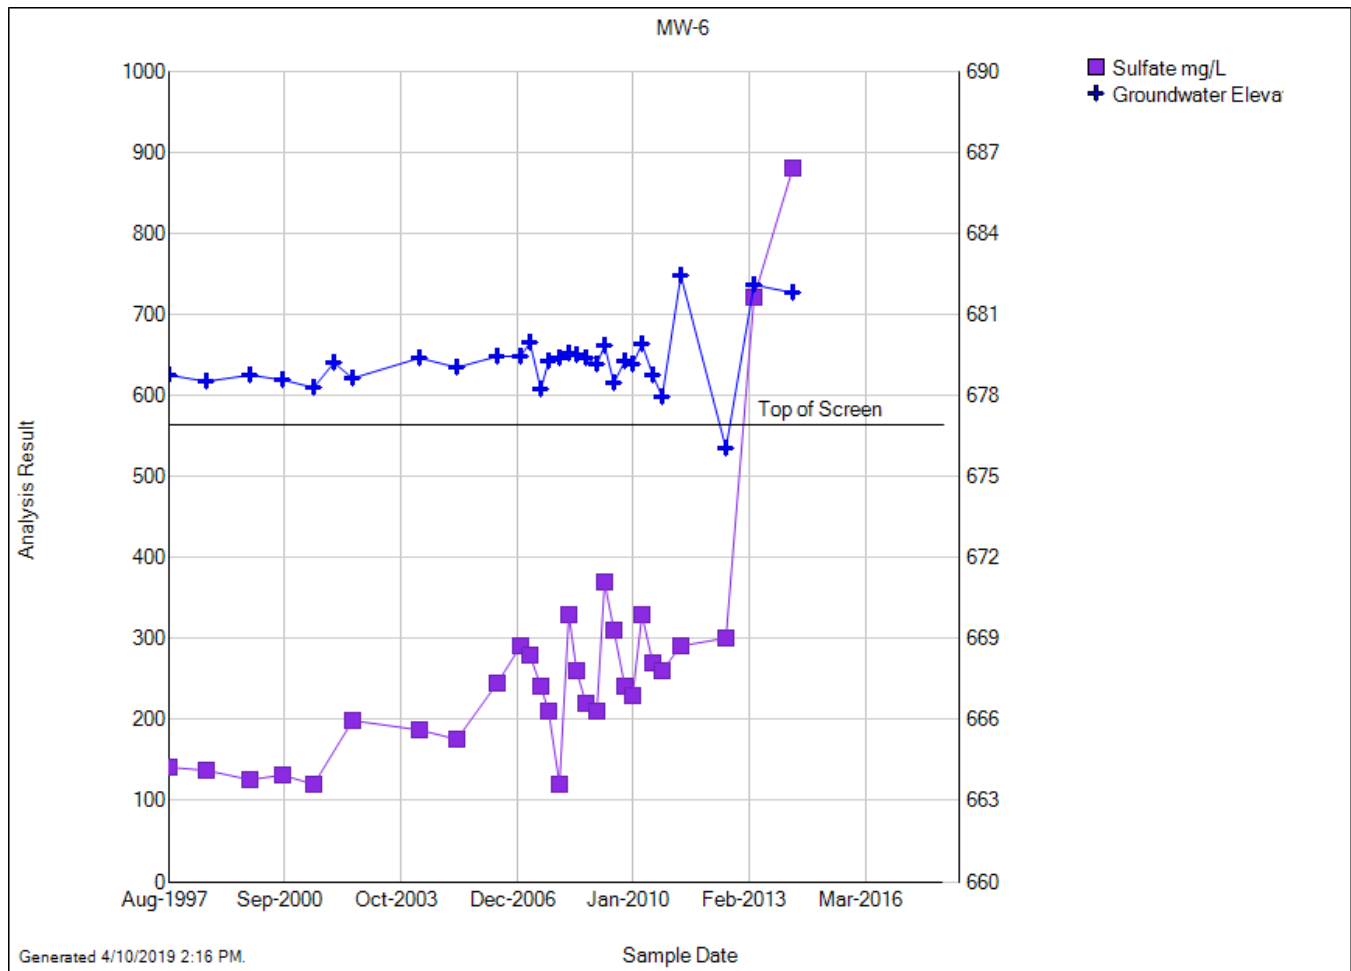
upgradient well MW-6 were attributed to oxidation of sulfide minerals at shallow depths in the soil column. High sulfate concentrations were a result of changes in groundwater elevation, which increased the potential for oxidation of pyrite minerals. In particular, the increase in sulfate during 2013, followed a significant decline and subsequent rebound in groundwater elevation (see below). When the water elevation is compared to the top of the screen elevation in MW-6, it is apparent that air (oxygen) was in contact with the aquifer materials which can explain the sharp increase in sulfate observed in MW-6 during 2013.

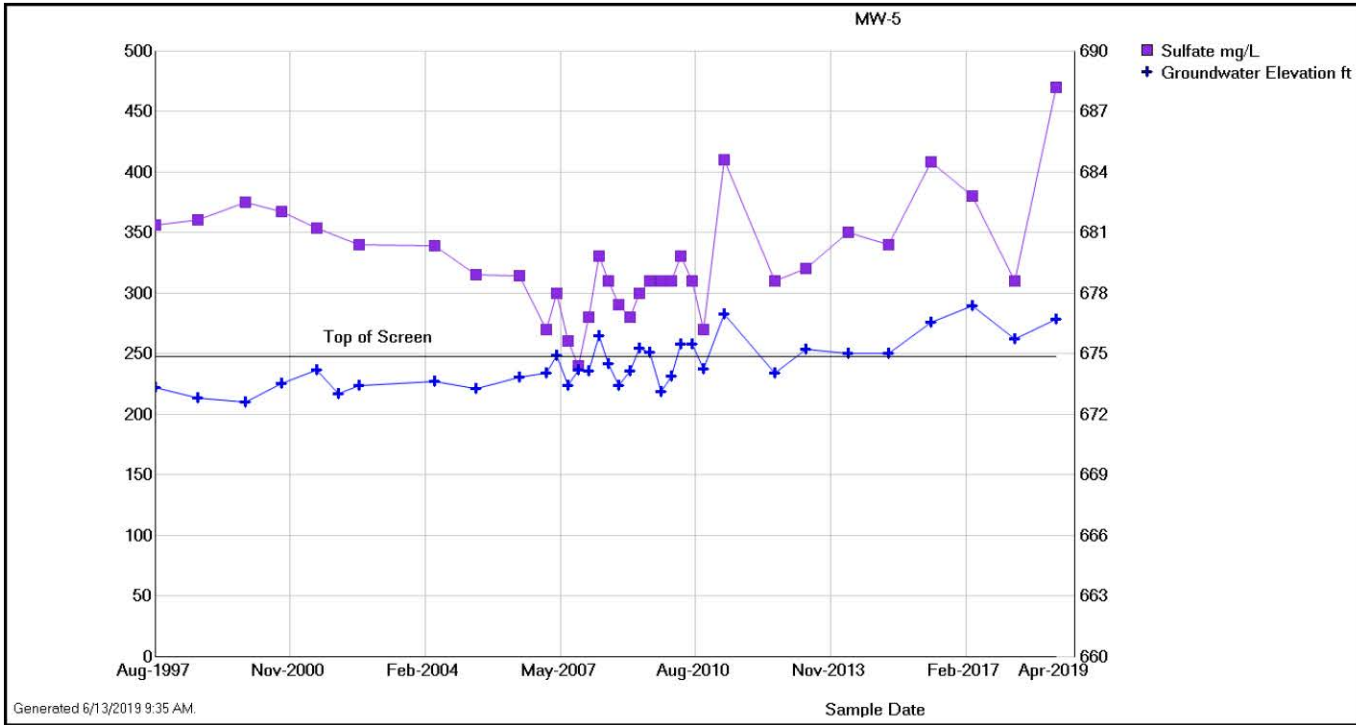
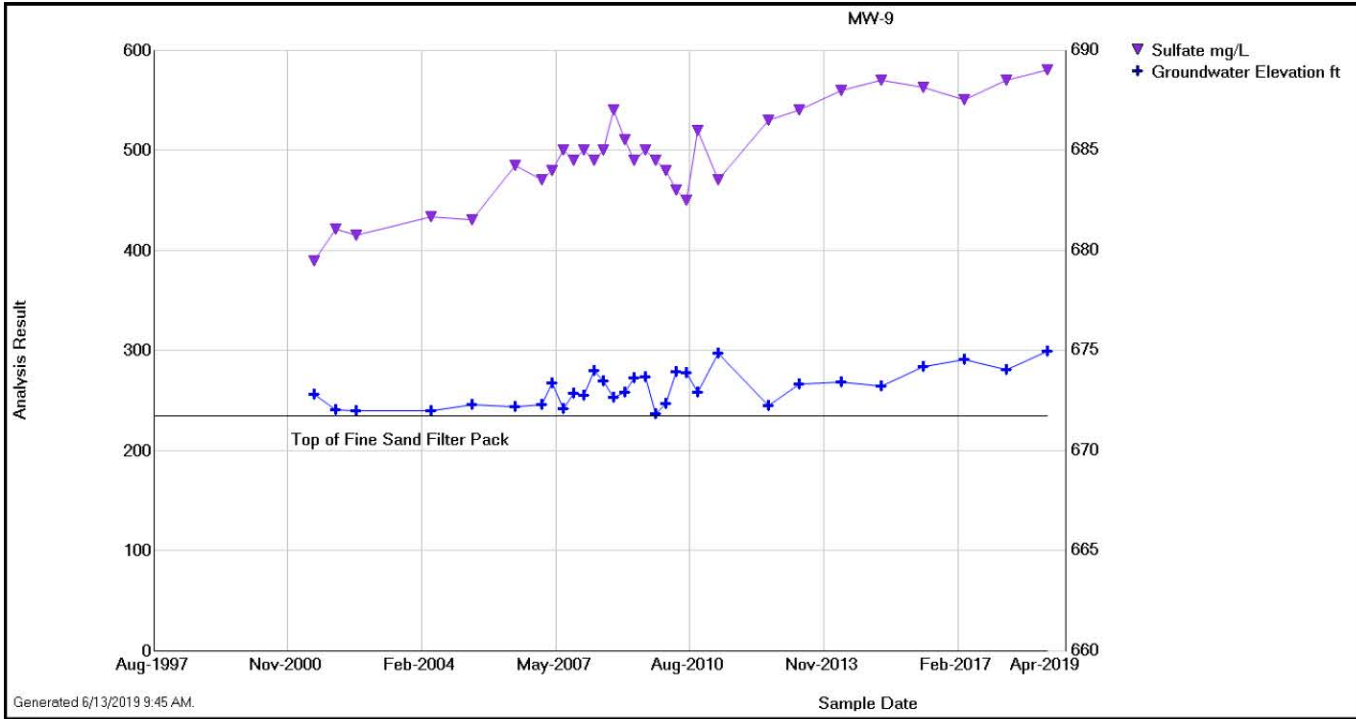
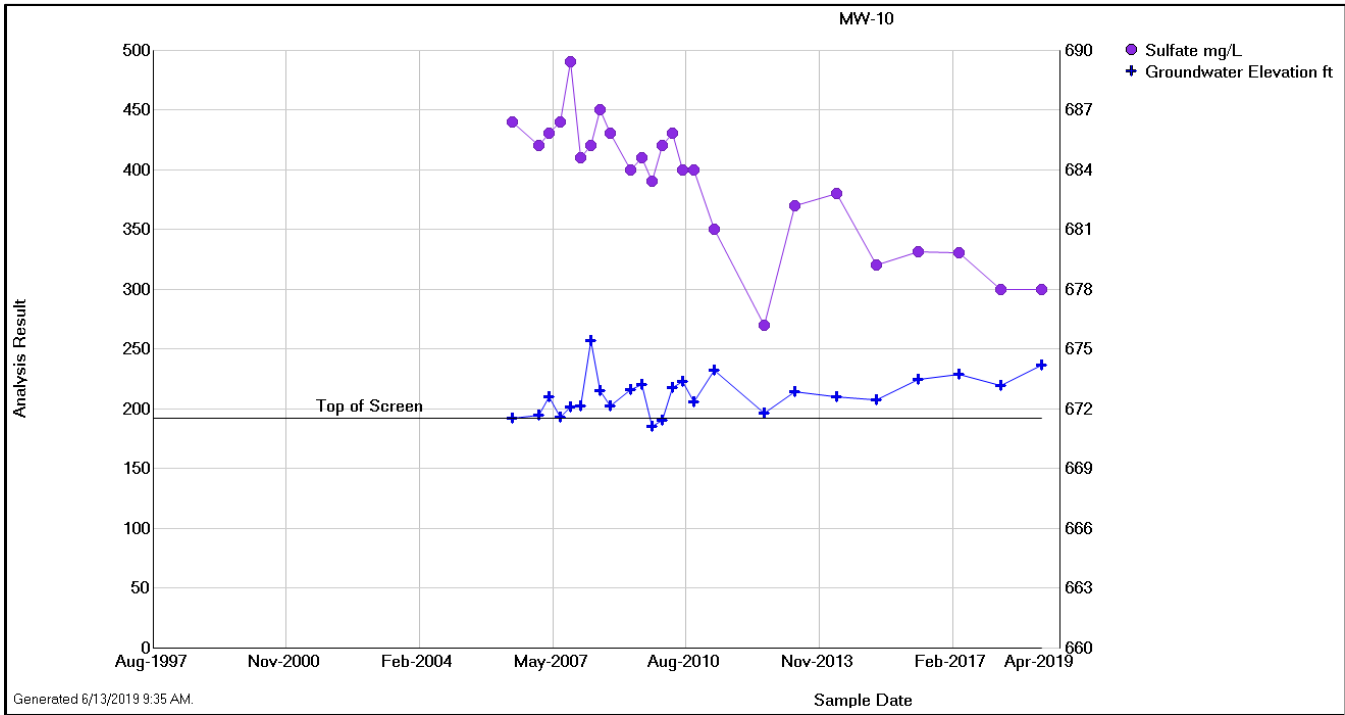
Groundwater elevations and sulfate concentrations are plotted for monitoring wells MW-5, MW-9, and MW-10. As shown in the plots, sulfate concentrations appear elevated when water elevations are at or near the screened interval. Significant increases also occur following periods when the water elevation declines to be within the screened interval (i.e. MW-5 and MW-9 in fall 2010, or MW-10 in fall 2012) which allows oxygen to contact the aquifer materials. P-4 is a piezometer, therefore changes in water elevation are not expected to result in variability in groundwater concentrations, however concentrations exhibit similar trends which indicates groundwater concentrations may be responding to variable water levels in upgradient recharge areas.

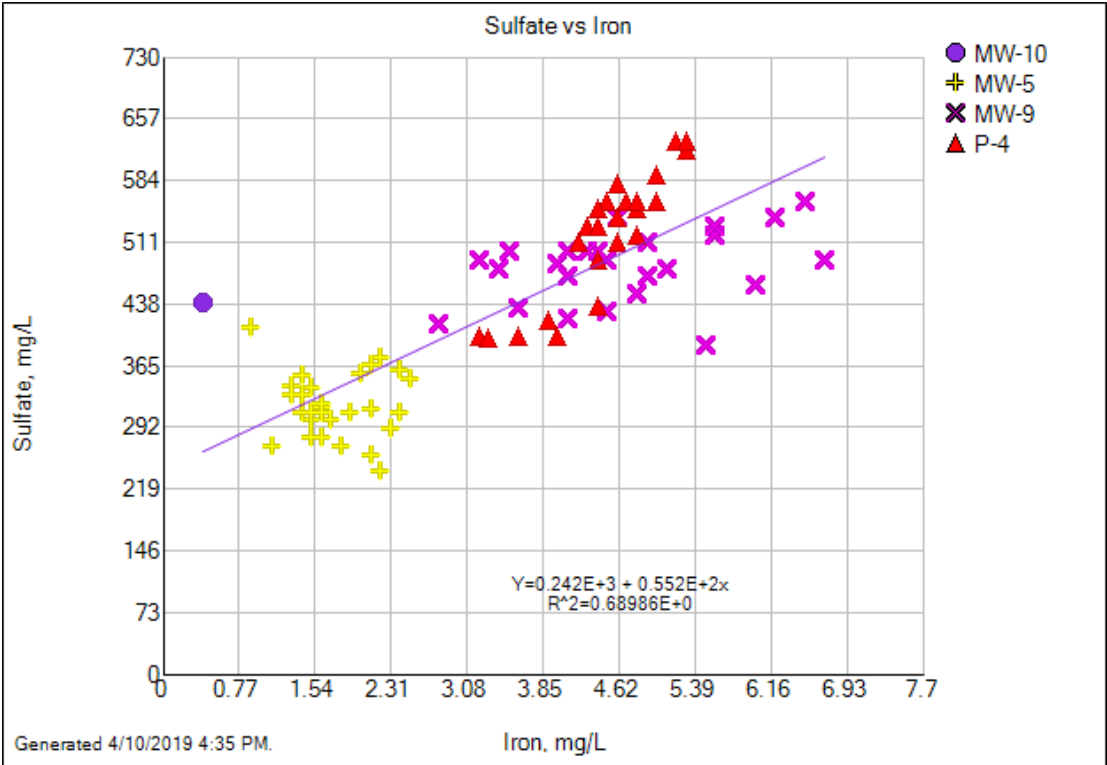
A scatter plot of iron and sulfate concentrations in these wells (below) provides support that pyrite oxidation is occurring because the resulting iron and sulfate concentrations show a relatively high correlation.

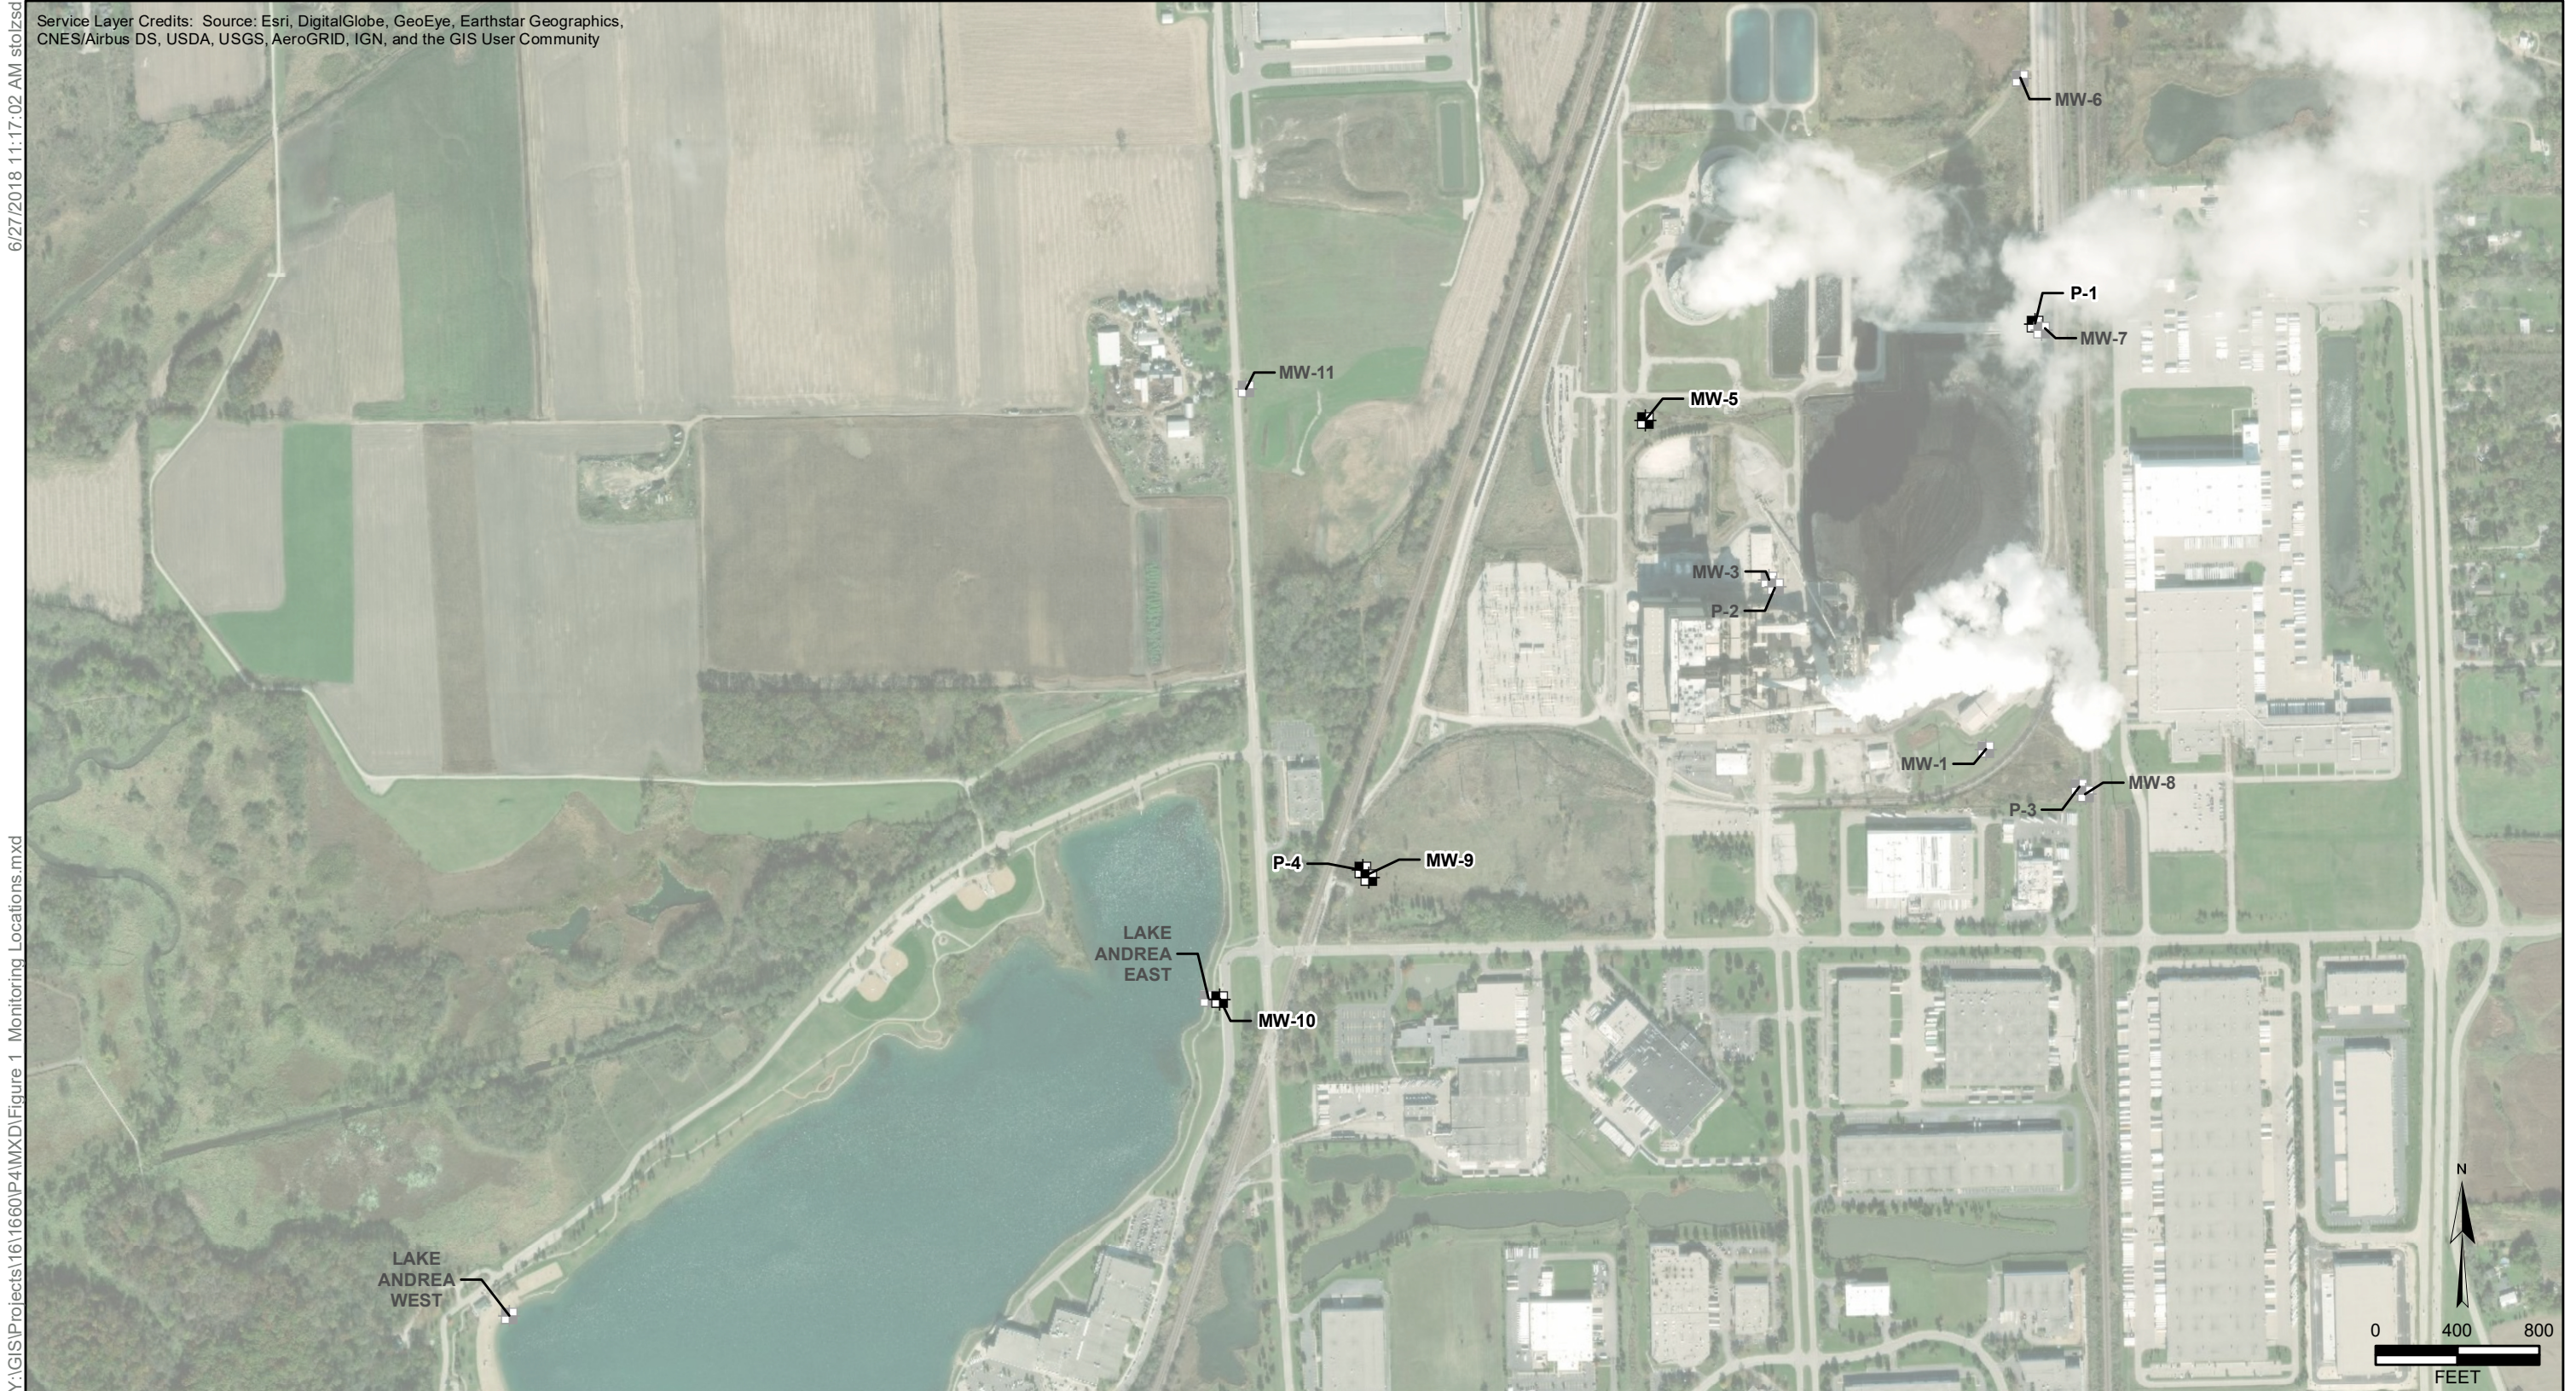
MONITORING LOCATIONS

- CURRENT MONITORING LOCATION
- PAST MONITORING LOCATION

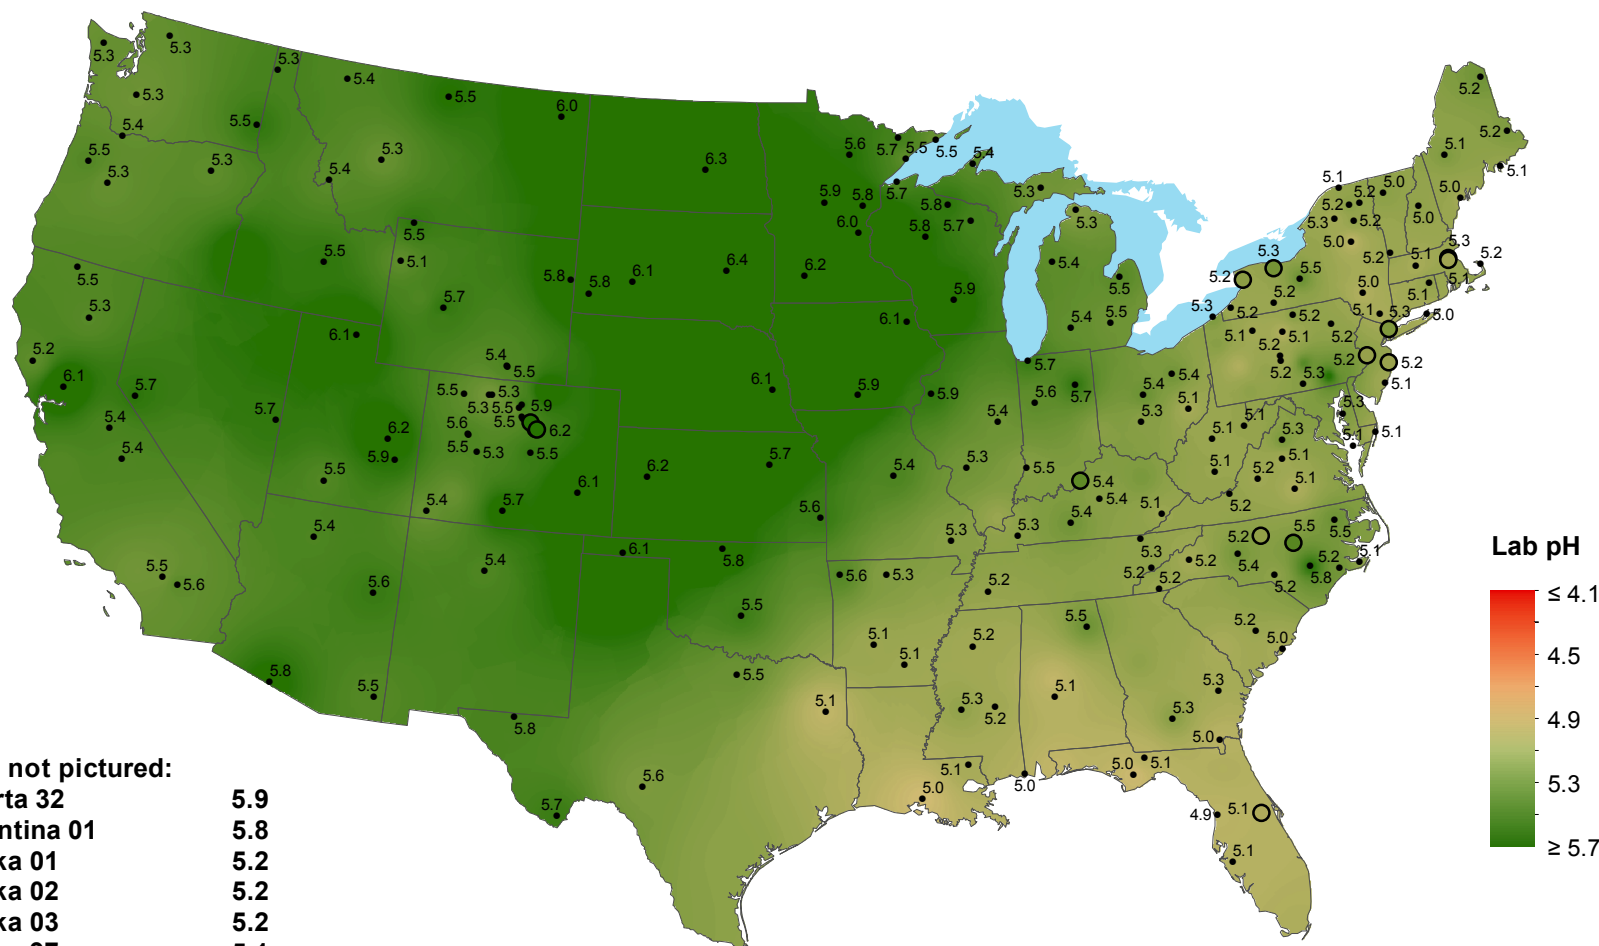
Hydrogen ion concentration as pH from measurements made at the Central Analytical Laboratory, 2017
