**Pleasant Prairie Power Plant Sulfate in Groundwater**  
***Pleasant Prairie Power Plant, Pleasant Prairie, WI***  
***BRRTS#: 02-30-527479***

On behalf of We Energies, O'Brien & Gere Engineers, Inc., a Ramboll Company (Ramboll), has prepared this letter report discussing the presence of sulfate in groundwater at the Pleasant Prairie Power Plant (P4), BRRTS#: 012-30-527479. This letter report was prepared with the intent of obtaining a No Action Required or No Further Action determination from the Wisconsin Department of Natural Resources (WDNR). On August 1, 2019, We Energies submitted a technical memorandum, *Pleasant Prairie Power Plant (P4) Sulfate in Groundwater BRRTS#:02-30-527479*, and technical assistance form (Form 4400-237) and associated fee. In email correspondence on October 1, 2019, WDNR provided comments on the technical memorandum; the comments were further discussed on a conference call on October 18, 2019. This letter report was prepared to address comments received from WDNR.

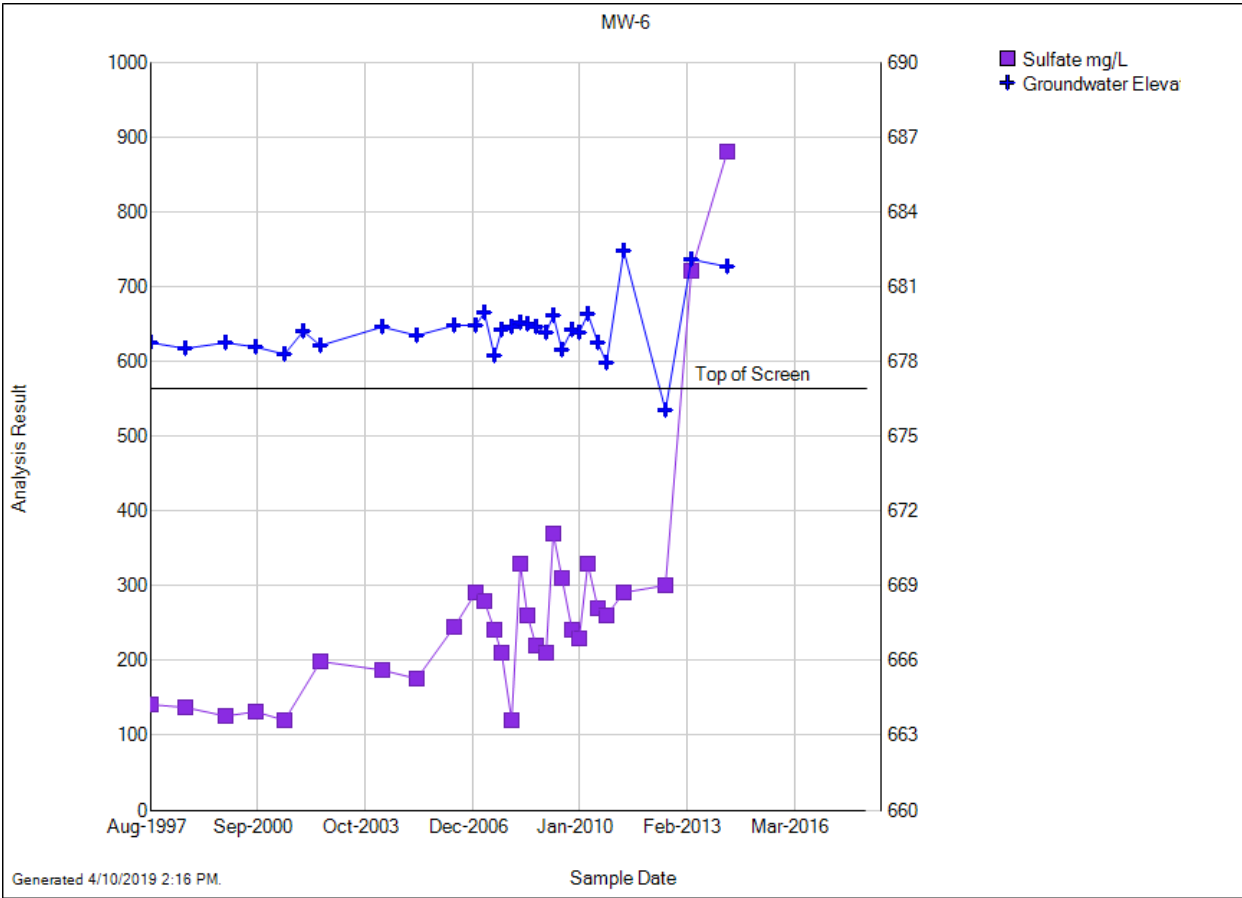
The natural sources of sulfate at the P4 site, as described in the Sulfate Concentrations in the Silurian Dolomite and Overlying Sand and Gravel section above, can be mobilized or migrate due to changes in the geochemical conditions at the site. In the November 13, 2014 technical memorandum *Groundwater Monitoring Program Review, We Energies Pleasant Prairie Power Plant* (NRT, 2014), increasing concentrations of sulfate and arsenic in groundwater at upgradient well MW-6 were attributed to oxidation of sulfide minerals at shallow depths in the soil column. High sulfate concentrations were a result of changes in groundwater elevation, which increased the potential for oxidation of pyrite minerals. In particular, the increase in sulfate during 2013, followed a significant decline and subsequent rebound in groundwater elevation (see below). When the water elevation is compared to the top of the screen elevation in MW-6, it is apparent that air (oxygen) was in contact with the aquifer materials which can explain the sharp increase in sulfate observed in MW-6 during 2013.

#### Groundwater concentrations and elevations in MW-6.

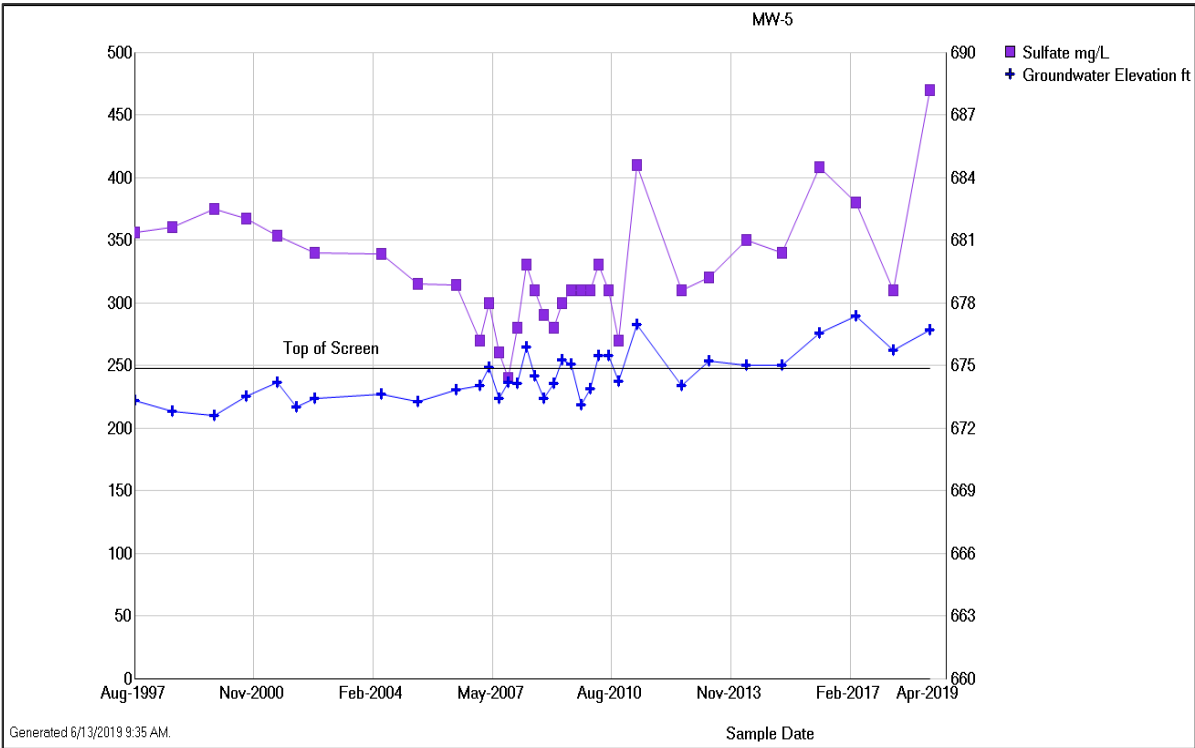
Groundwater elevations and sulfate concentrations are plotted for monitoring wells MW-5, MW-9, and MW-10. As shown in the plots, sulfate concentrations appear elevated when water elevations are at or near the screened interval. Significant increases also occur following periods when the water elevation declines to be within the screened interval (i.e. MW-5 and MW-9 in fall 2010, or MW-10 in fall 2012) which allows oxygen to contact the aquifer materials. P-4 is a piezometer, therefore changes in water elevation are not expected to result in variability in groundwater concentrations, however concentrations exhibit similar trends which indicates groundwater concentrations may be responding to variable water levels in upgradient recharge areas.

### Groundwater concentrations and elevations in MW-5.

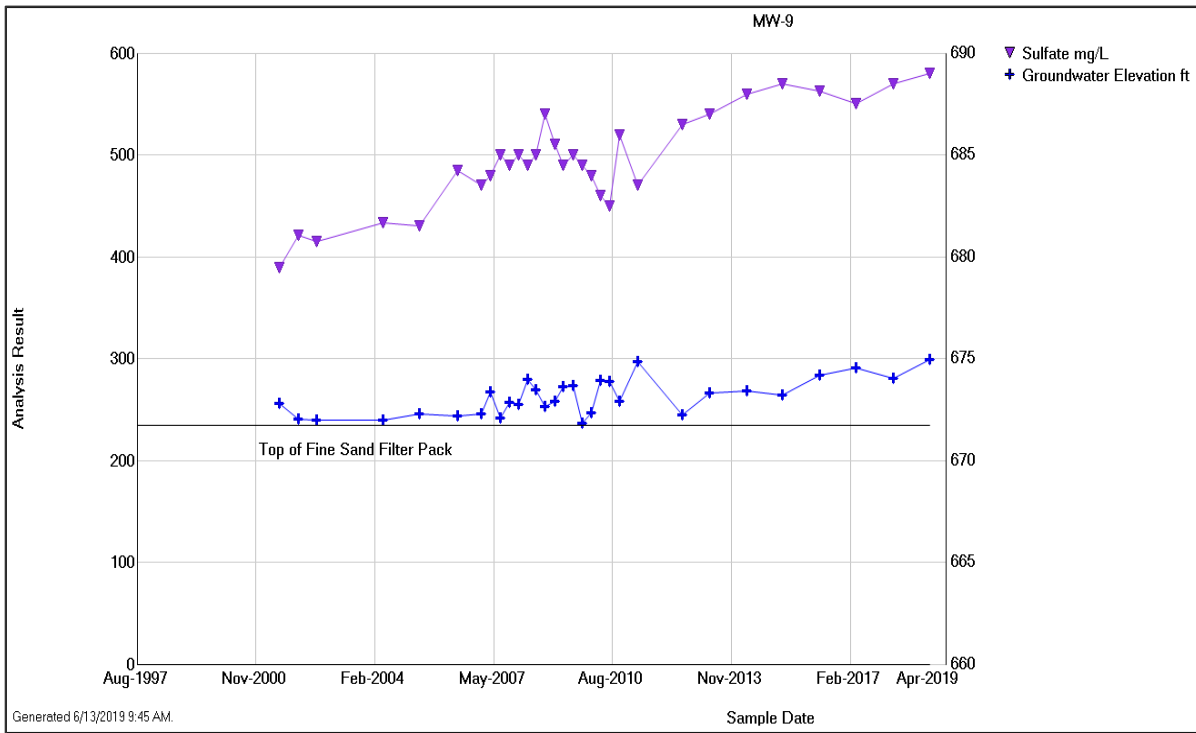
### Groundwater concentrations and elevations in MW-9.

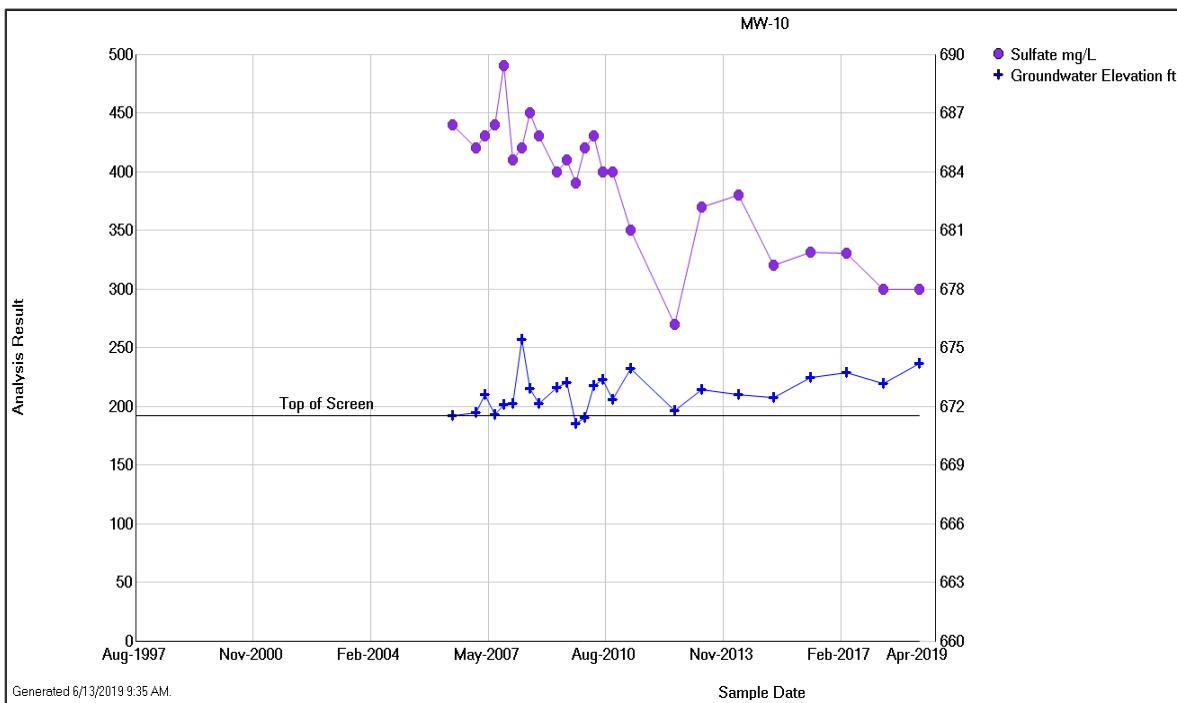
### Groundwater concentrations and elevations in MW-10.

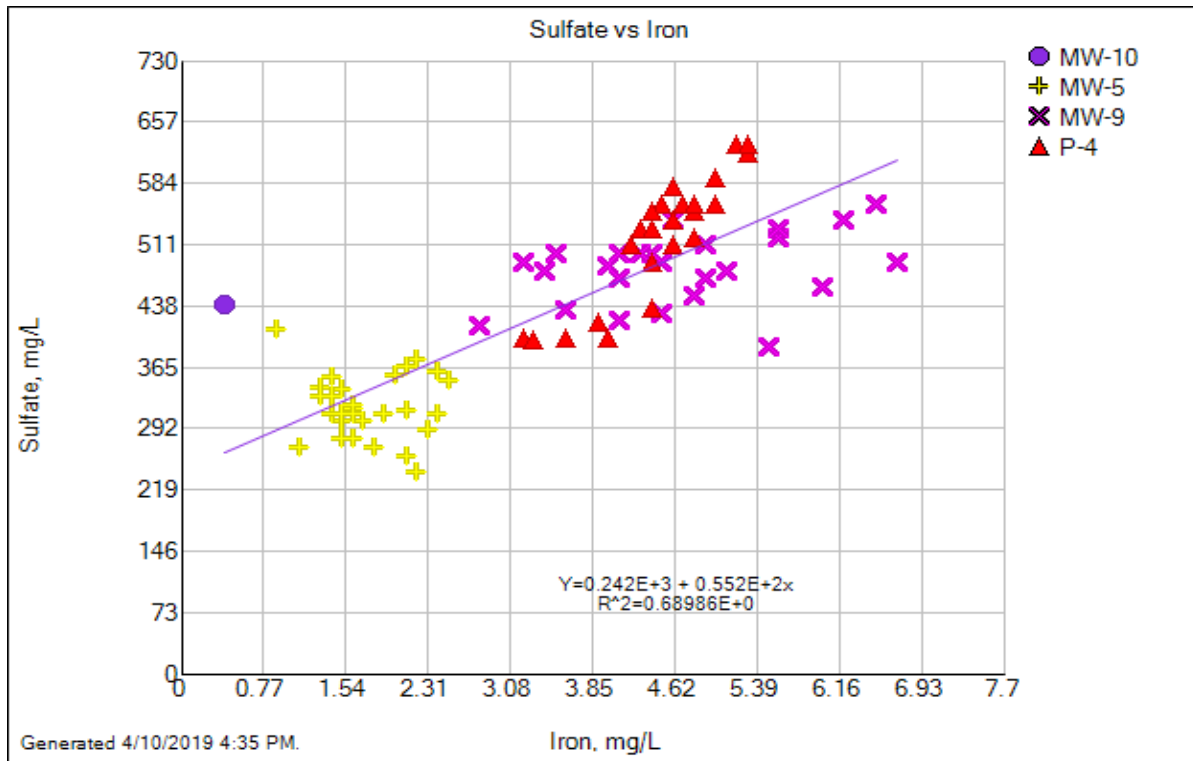
A scatter plot of iron and sulfate concentrations in these wells (below) provides support that pyrite oxidation is occurring because the resulting iron and sulfate concentrations show a relatively high correlation.

**Sulfate and iron concentrations in downgradient wells.**

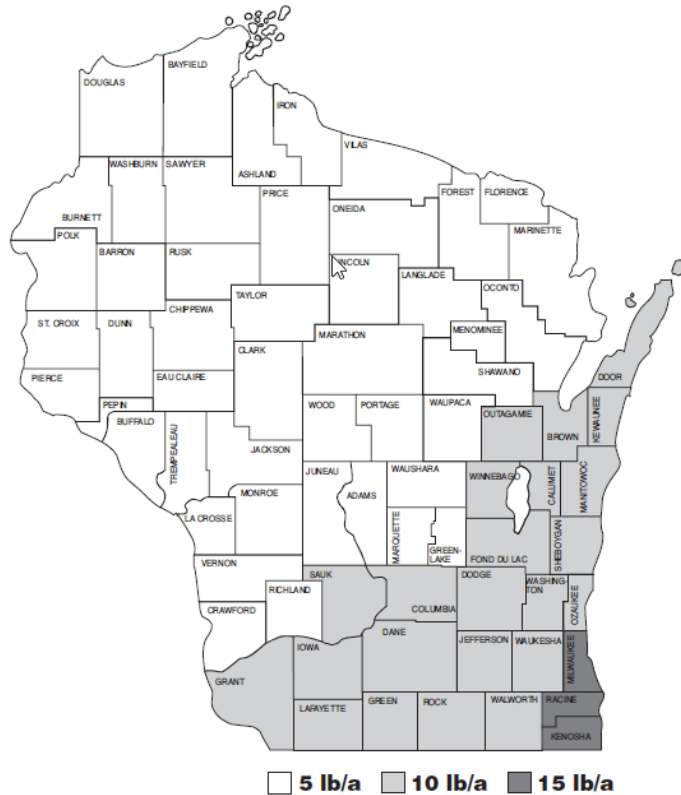
**Figure 12-6. Sulfate sulfur in precipitation.**

Sulfate in precipitation is elevated in the southeast portion of the state, including Milwaukee, Racine, and Kenosha Counties (see Figure 12-6 below.) Sulfate deposition occurs when sulfur dioxide reacts with water in the air to form sulfate and sulfuric acid. The sulfate and sulfuric acid are deposited or transferred to surface or groundwater when it rains. Through evaporation and evapotranspiration water is removed and sulfate may become concentrated in soils, surface water, and groundwater. Due to the distribution of industry and heavy transportation traffic in southern Wisconsin and northern Illinois, the southeast portion of Wisconsin is susceptible to higher concentrations and more sulfate deposition with acidic precipitation as shown in the figure below.

The amount of sulfate deposition and the acidity of precipitation has decreased as levels of SO<sub>2</sub> released to the atmosphere have been reduced in the last 30 years. In this area of the state the sulfate concentrations in precipitation have decreased from >2 mg/L in 1985 to <1 mg/L in 2017 (Attachment C1). Similarly, the pH in precipitation has increased from about 4.4 S.U. in 1985 to 5.8 S.U. in 2017 (Attachment C2). The presence of over a century of sulfate in precipitation likely contributed to sulfate concentrations detected in groundwater, and the acidity of the precipitation influences the geochemical conditions of the aquifer. These changes in geochemical conditions can increase the potential sulfate release from soils and aquifer solids.

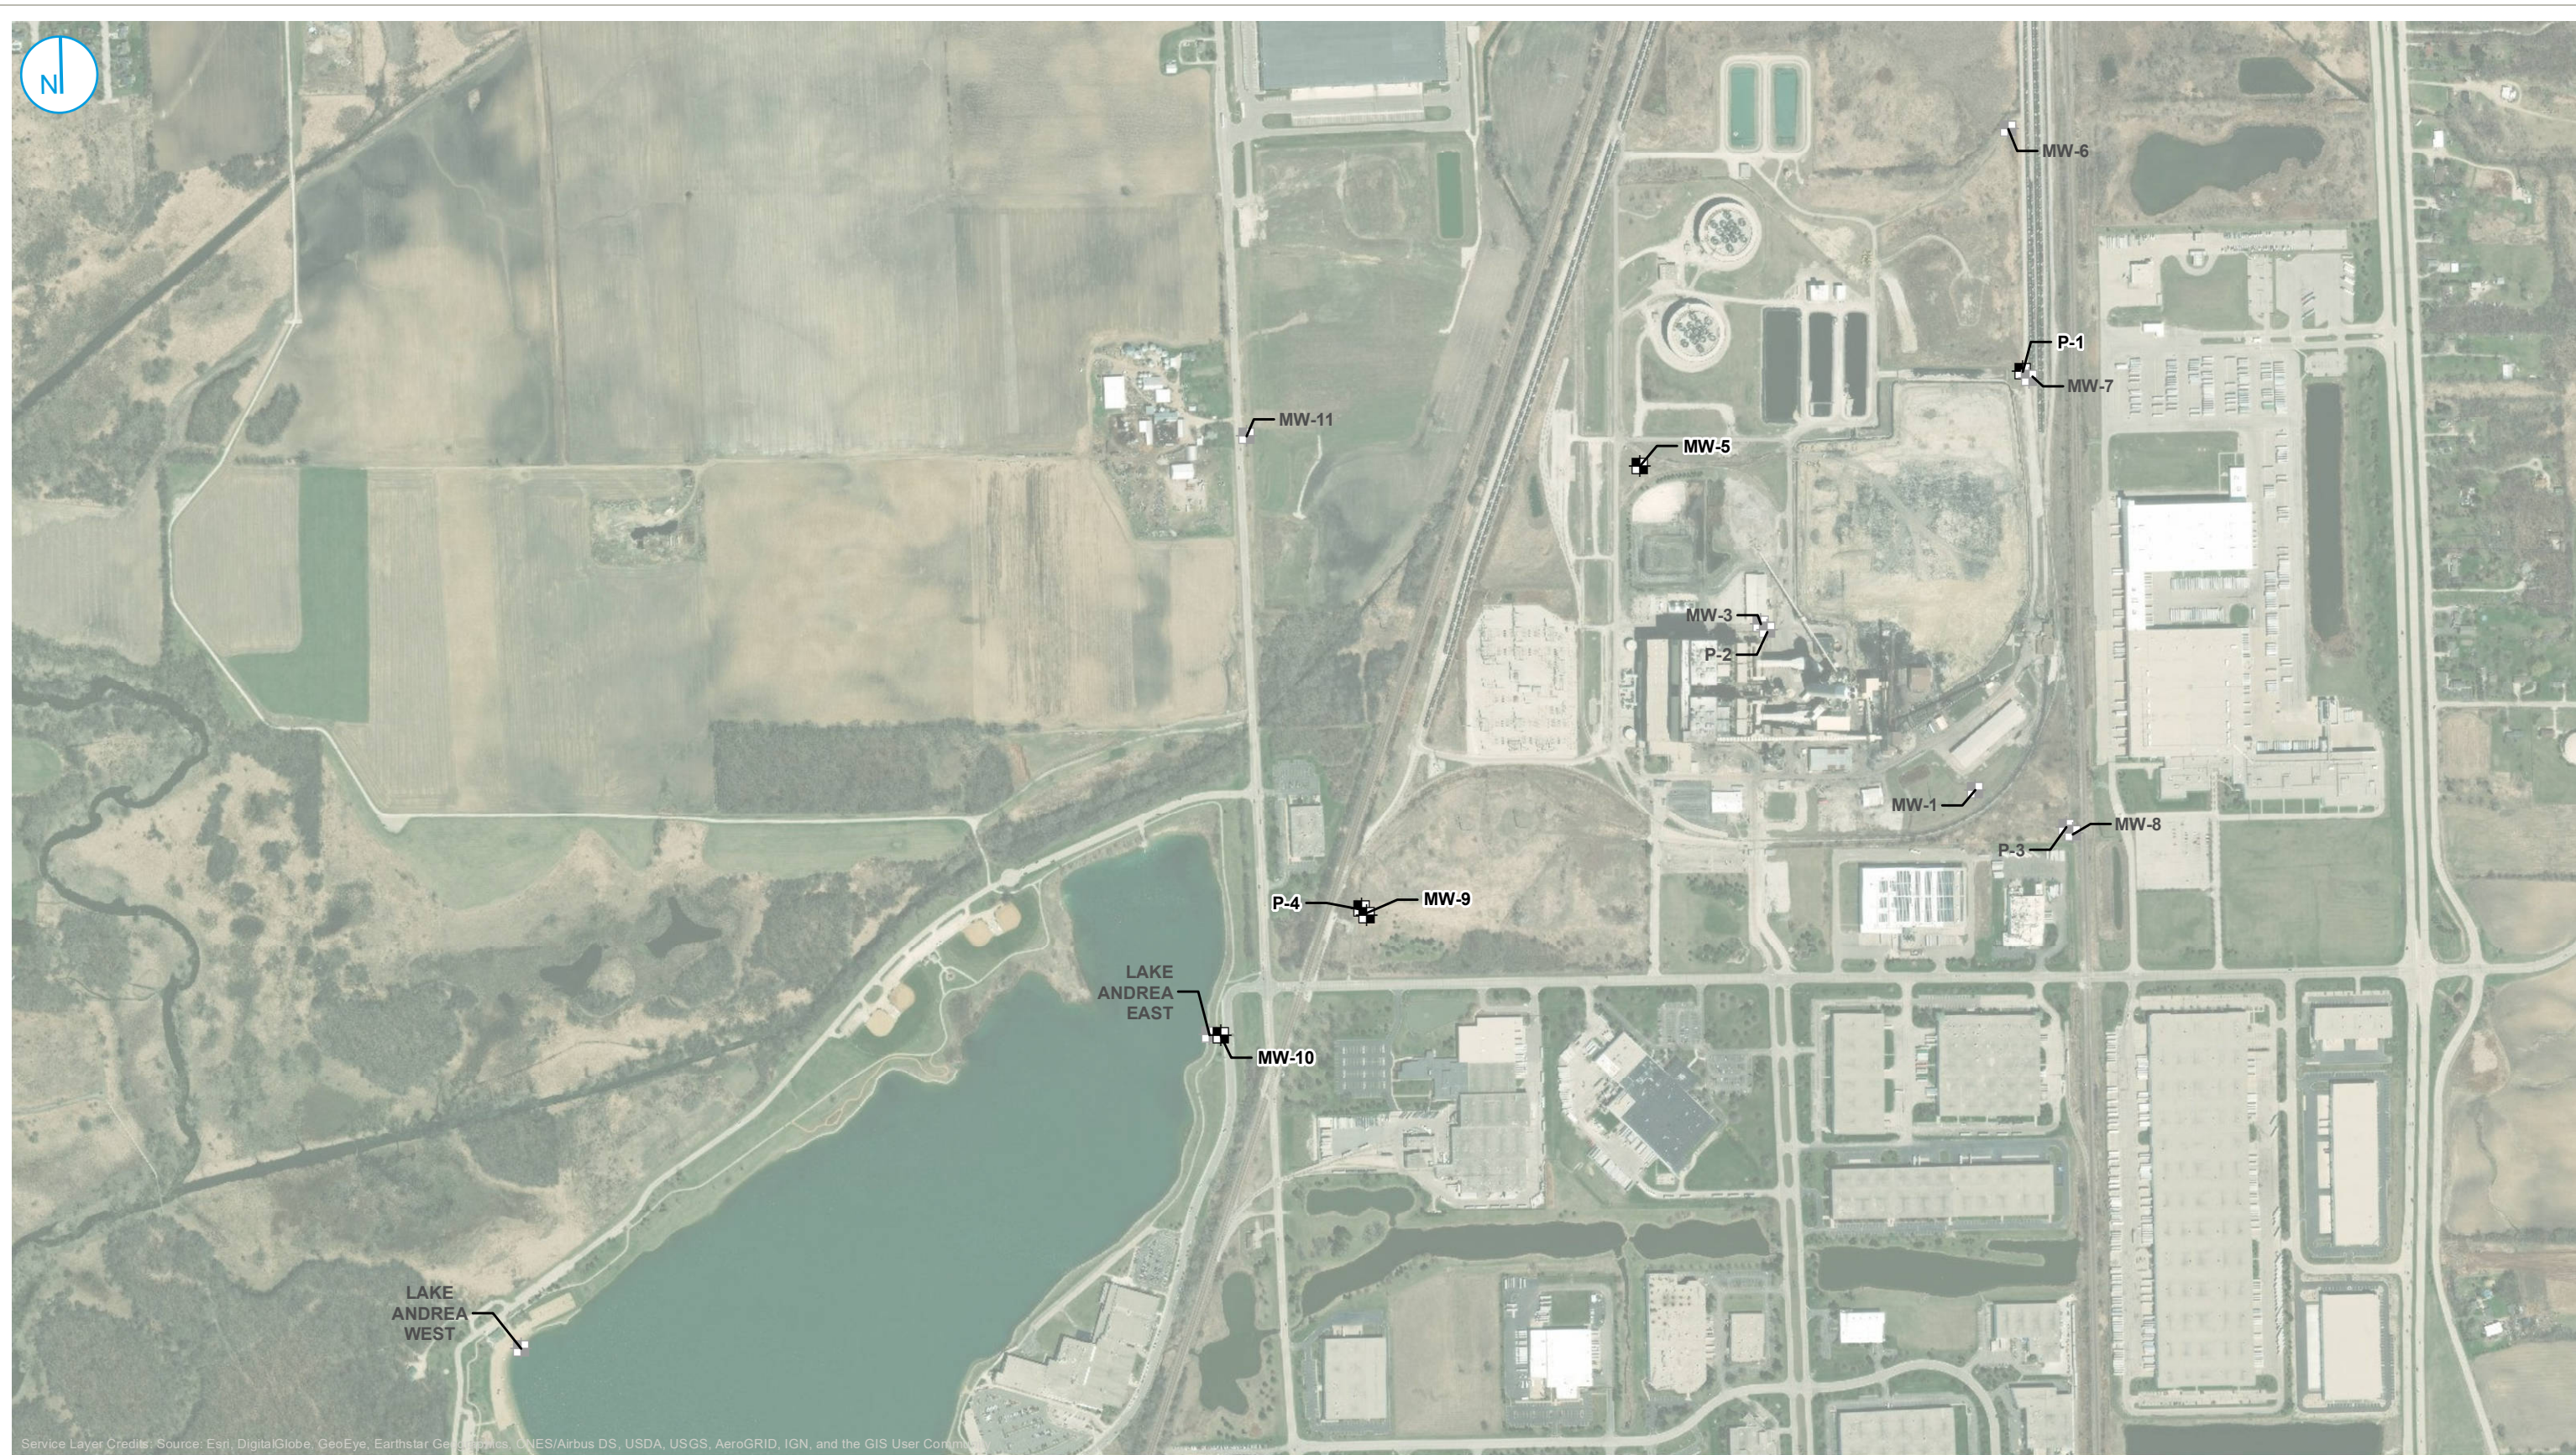
FIGURE 1

### MONITORING LOCATIONS

The sulfate concentrations detected in groundwater from monitoring wells onsite (Figure 1) and trends were discussed in detail in the June 29, 2018 memorandum, additional evaluation including the 2019 results are included in the Figure below, Table 1, and are summarized as follows:

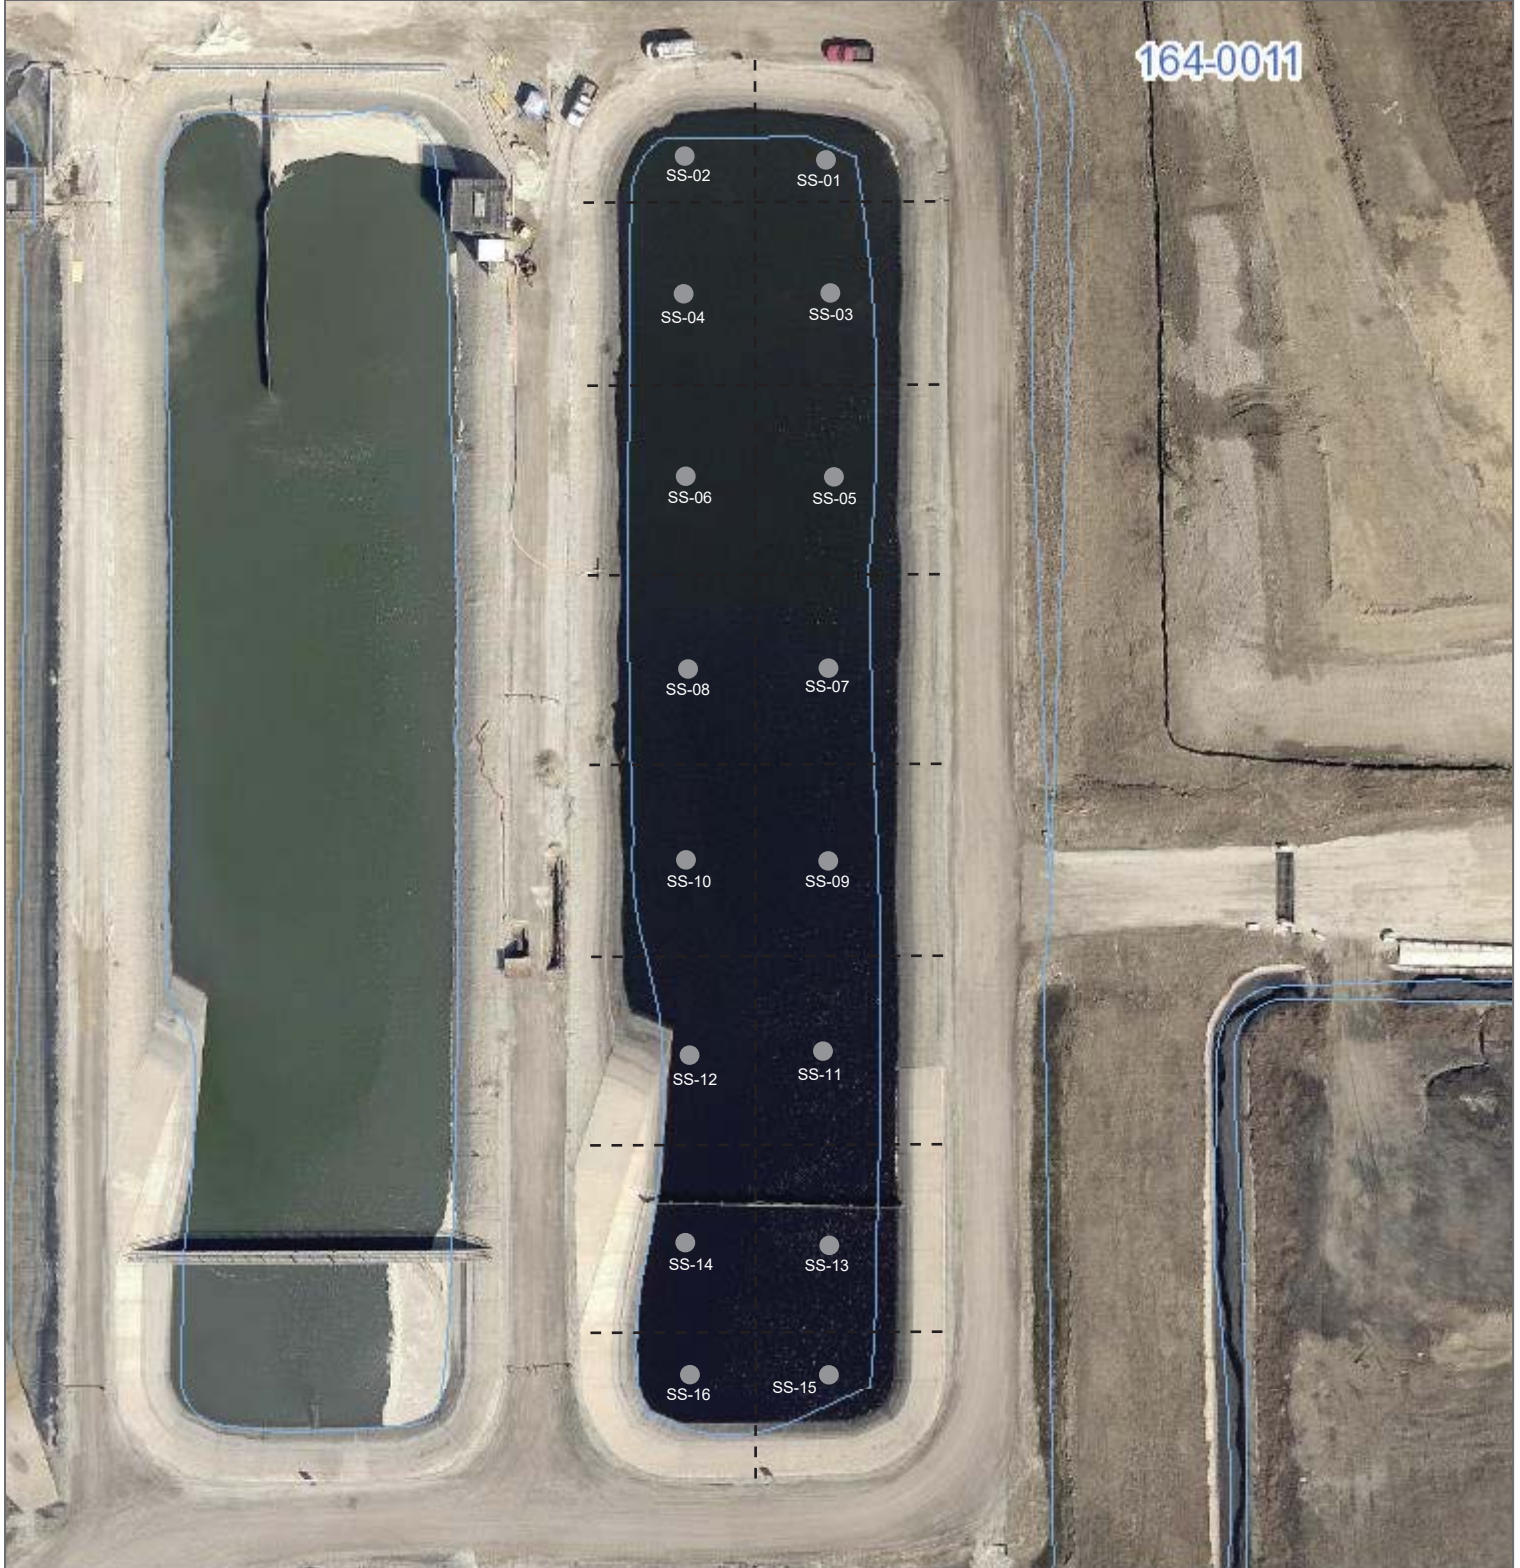
# FIGURE 2 - SOIL SAMPLE LOCATION MAP

● APPROXIMATE POST-LINER REMOVAL SOIL SAMPLE LOCATION

Following removal of the Coal Pile Runoff Basin, soil samples were collected from the soils underlying the basin. The samples were analyzed for metals and indicators of potential impacts, and the results are provided in Table 2a and 2b and locations are shown in Figure 2. The results indicate that arsenic in nine

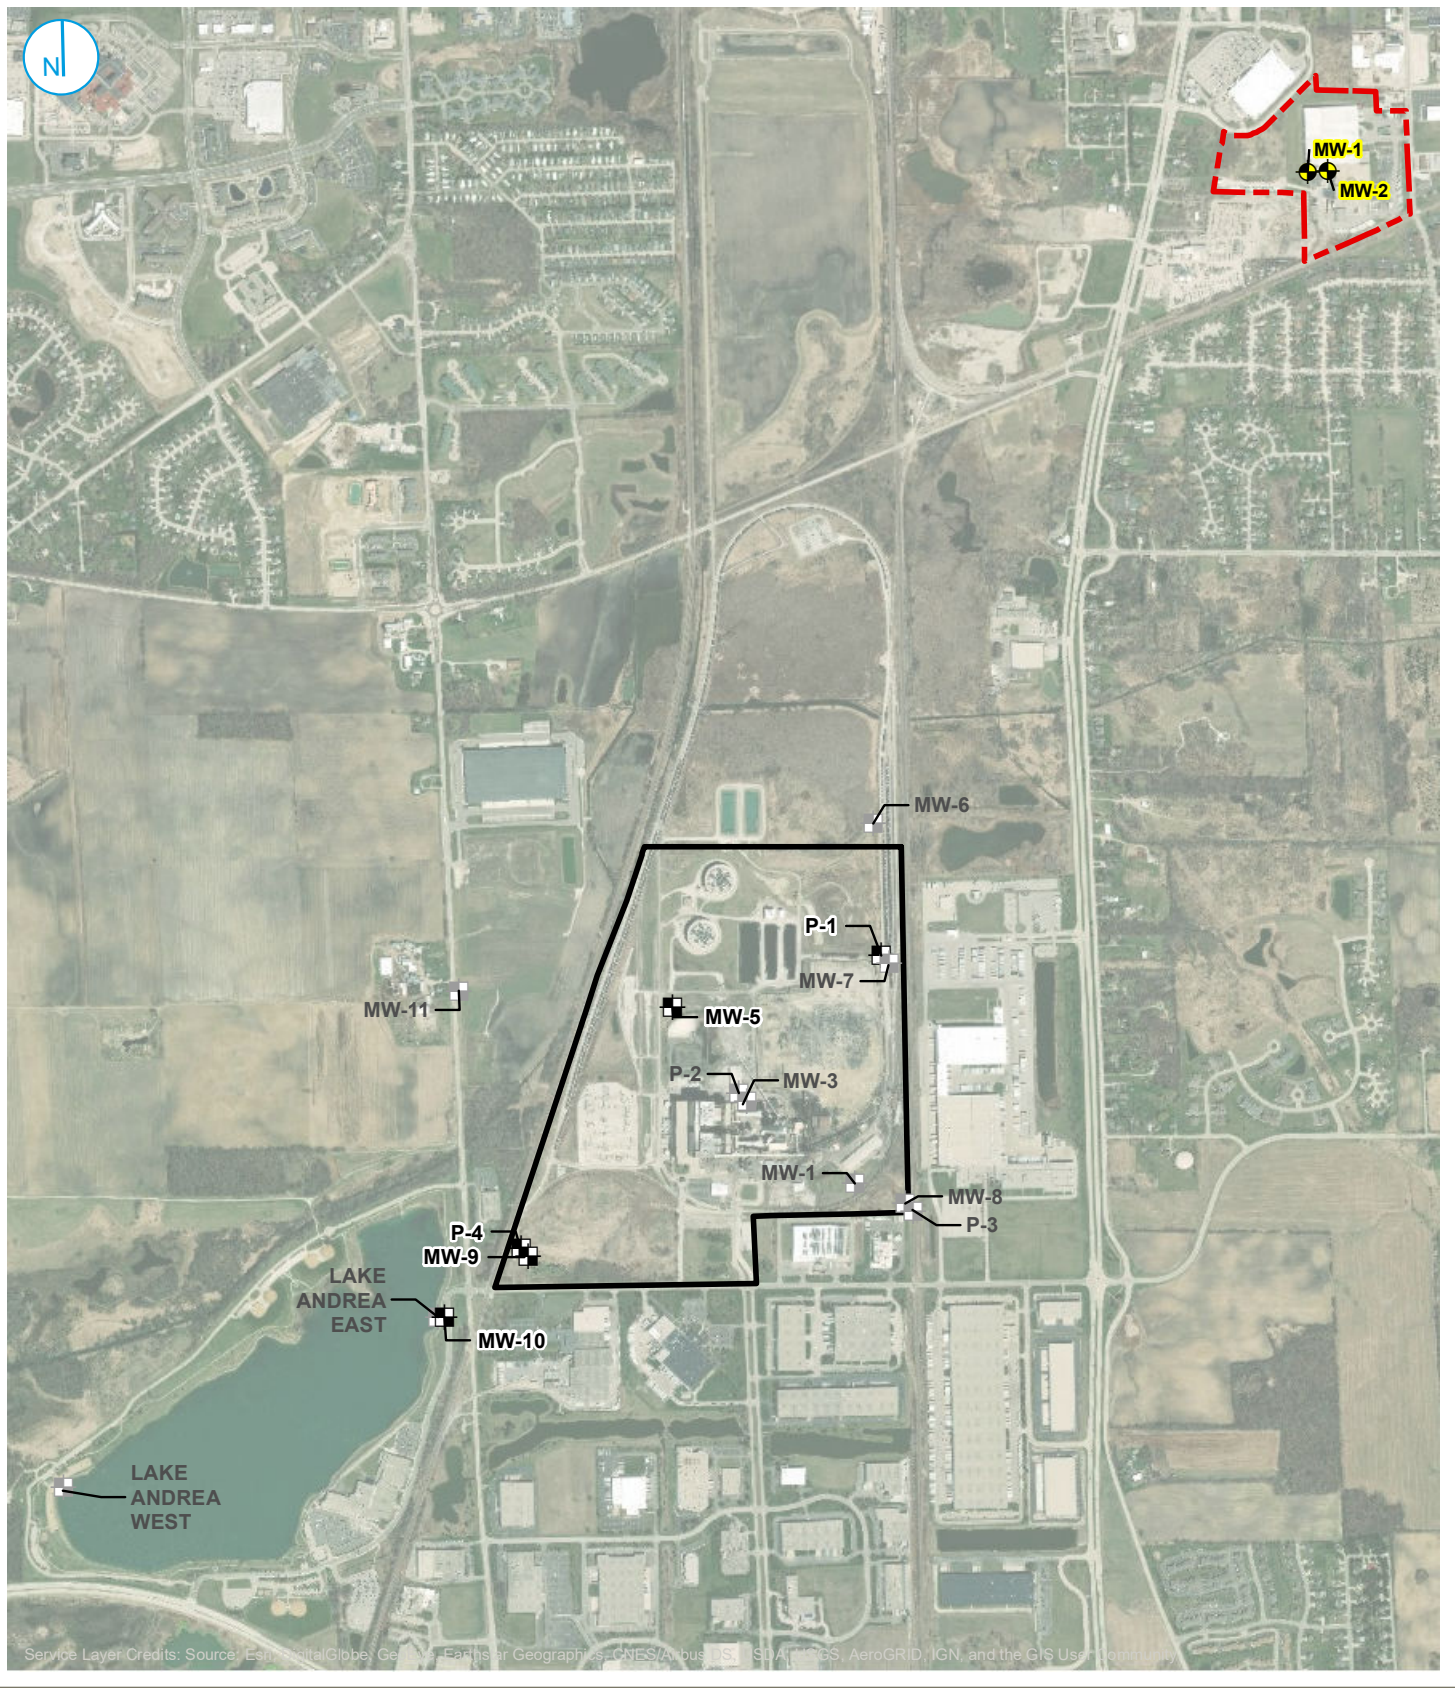
### FIGURE 03

### OCEAN SPRAY SITE

One site, BRRTS Case #02-30-107682, was identified with accessible information that included concentrations of sulfate in shallow groundwater wells. The site is located about 1.5 miles northeast of the P4 property (Figure 3). The concentrations of sulfate in shallow groundwater monitoring wells and remediation sumps ranged from non-detect in sump locations to 870 mg/L in an upgradient background well (MW-1, Table B-1 Attachment B). This upgradient background well is screened within clay till and the measured water elevations were variable but were within the screened elevation of the well, (potentially resulting in oxidation of sulfide minerals in clay). The measured concentrations are similar to those associated with the P4 groundwater and, as discussed previously, within the range of regional concentrations reported in the summary report (Kammerer, 1984). The BRRTS activity for this identified site was closed on September 25, 2002, with a groundwater use restriction because of residual petroleum impacts with no further requirements related to sulfate concentrations.

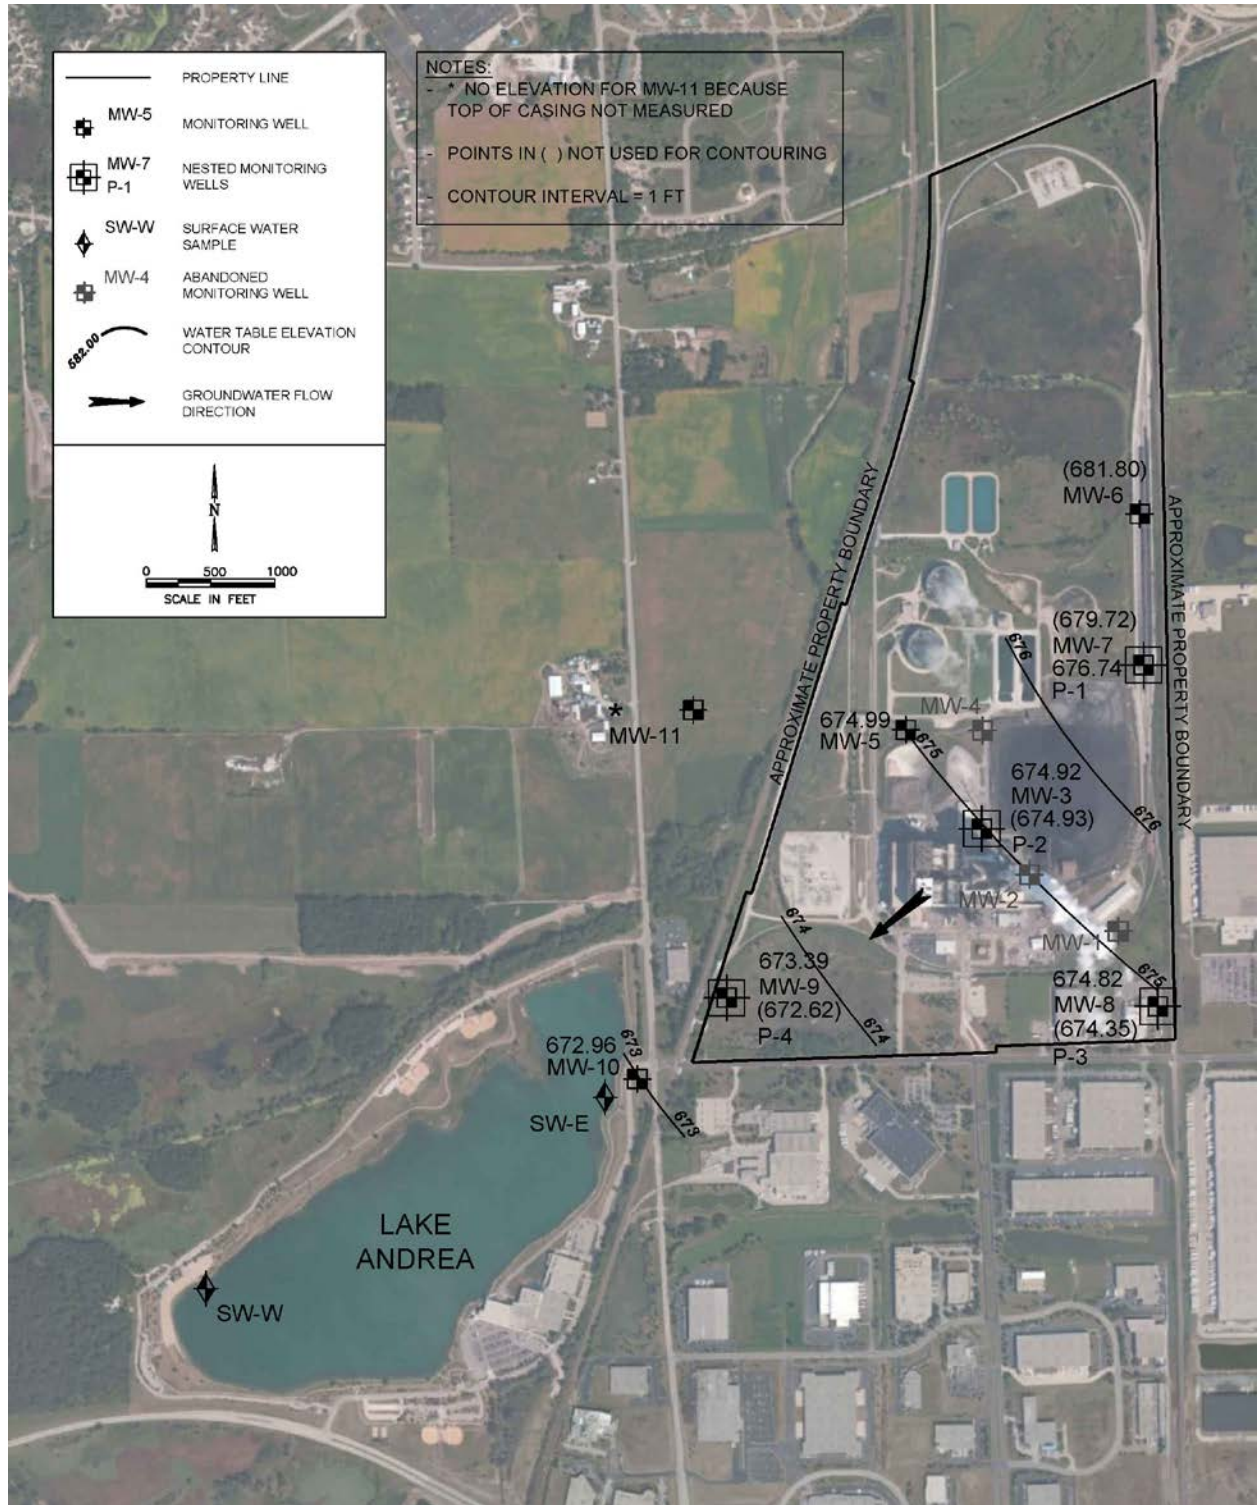
**Figure 1. Site map showing current monitoring locations and groundwater elevations in April 2014. MW6, MW7, P3, and P4 were not used for contouring because they are screened in clay; MW3 was used instead of P2 for contouring because MW3 is closer to the water table; and MW11 was not used for contouring because the top of casing elevation was not surveyed.**

The groundwater flow direction is to the southwest as shown in Attachment A. Based on flow directions, the sulfate concentrations and trends detected in groundwater are likely the result of several factors which include natural sources and the former plant activities (development), however, the plant infrastructure (as historically attributed) is unlikely to have been the source of sulfate concentrations. The relative contribution from each of these potential sources was not evaluated, but the previously suspected sources from the former plant infrastructure and operations that are associated with this BRRTS case have been removed and as a result will not impact groundwater.
