Pleasant Prairie Power Plant Sulfate in Groundwater
Pleasant Prairie Power Plant, Pleasant Prairie, WI
BRRTS#: 02-30-527479

February 14, 2020

On behalf of We Energies, O'Brien & Gere Engineers, Inc., a Ramboll Company (Ramboll), has prepared this letter report discussing the presence of sulfate in groundwater at the Pleasant Prairie Power Plant (P4), BRRTS#: 012-30-527479. This letter report was prepared with the intent of obtaining a No Action Required or No Further Action determination from the Wisconsin Department of Natural Resources (WDNR). On August 1, 2019, We Energies submitted a technical memorandum, *Pleasant Prairie Power Plant (P4) Sulfate in Groundwater BRRTS#:02-30-527479*, and technical assistance form (Form 4400-237) and associated fee. In email correspondence on October 1, 2019, WDNR provided comments on the technical memorandum; the comments were further discussed on a conference call on October 18, 2019. This letter report was prepared to address comments received from WDNR.

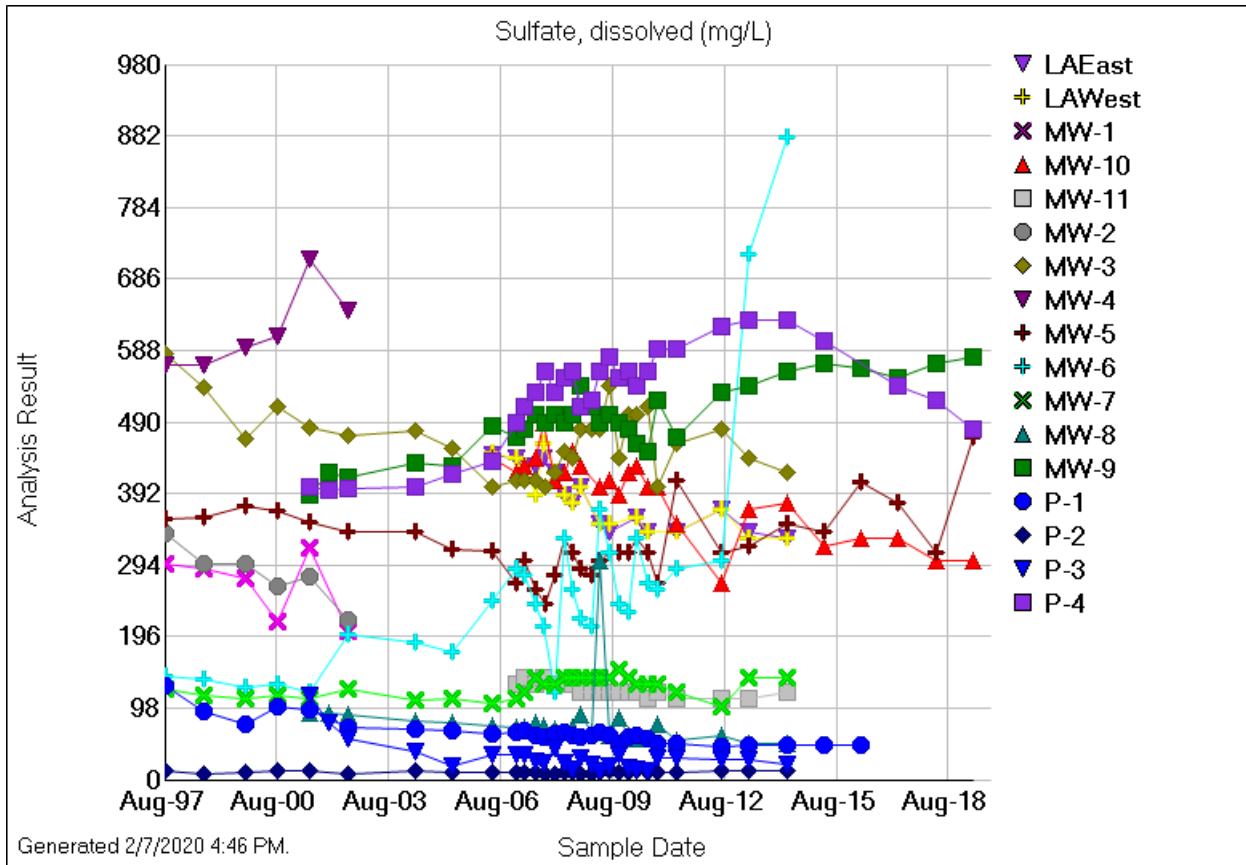
- An upward trend reported in MW-9 concentrations may have peaked and are stabilizing based on the last five rounds of data.
- Upward trends which were reported in piezometer P-4 are no longer observed and no statistically significant trends are observed. Recent data from the last five rounds suggest a downward trend.

- A downward trend reported in MW-10 is no longer present and concentrations indicate a stable trend. However, the median concentration detected over the eight most recent sampling events (330.5 mg/L) is less than the median concentration (420 mg/L) detected previously (1997-2011) indicating overall improvement in groundwater quality.

- Concentrations of sulfate in MW-5 have been variable following completion of basin lining activities and following their recent removal; recent data from the last three events indicates sulfate continues to be variable with concentrations ranging 160 mg/L (from 470 to 310 mg/L).

Sulfate concentrations in groundwater monitoring wells.

The sulfate concentrations detected in groundwater from monitoring wells onsite (Figure 1) and trends were discussed in detail in the June 29, 2018 memorandum, additional evaluation including the 2019 results are included in the Figure below, Table 1, and are summarized as follows:

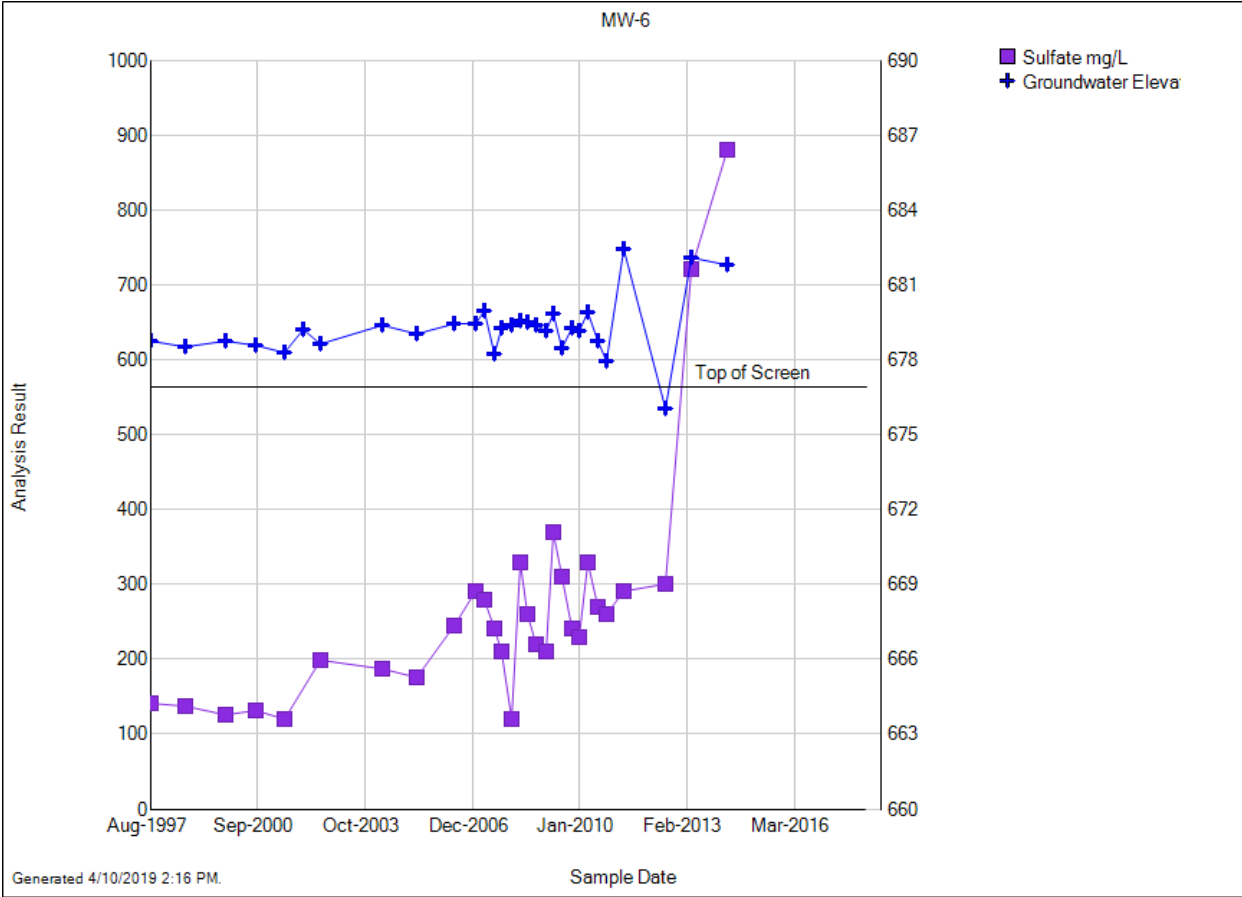
increase in sulfate during 2013, followed a significant decline and subsequent rebound in groundwater elevation (see below). When the water elevation is compared to the top of the screen elevation in MW-6, it is apparent that air (oxygen) was in contact with the aquifer materials which can explain the sharp increase in sulfate observed in MW-6 during 2013.

Groundwater concentrations and elevations in MW-6.

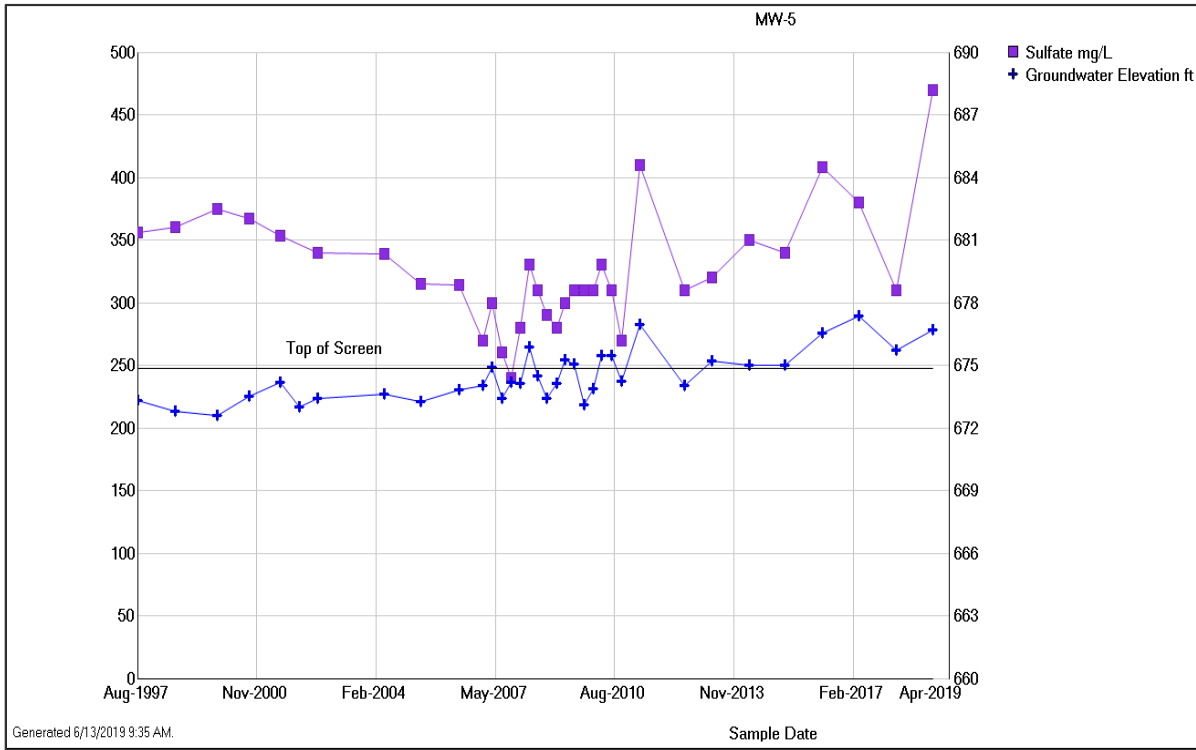
Groundwater elevations and sulfate concentrations are plotted for monitoring wells MW-5, MW-9, and MW-10. As shown in the plots, sulfate concentrations appear elevated when water elevations are at or near the screened interval. Significant increases also occur following periods when the water elevation declines to be within the screened interval (i.e. MW-5 and MW-9 in fall 2010, or MW-10 in fall 2012) which allows oxygen to contact the aquifer materials. P-4 is a piezometer, therefore changes in water elevation are not expected to result in variability in groundwater concentrations, however concentrations exhibit similar trends which indicates groundwater concentrations may be responding to variable water levels in upgradient recharge areas.

Groundwater concentrations and elevations in MW-5.

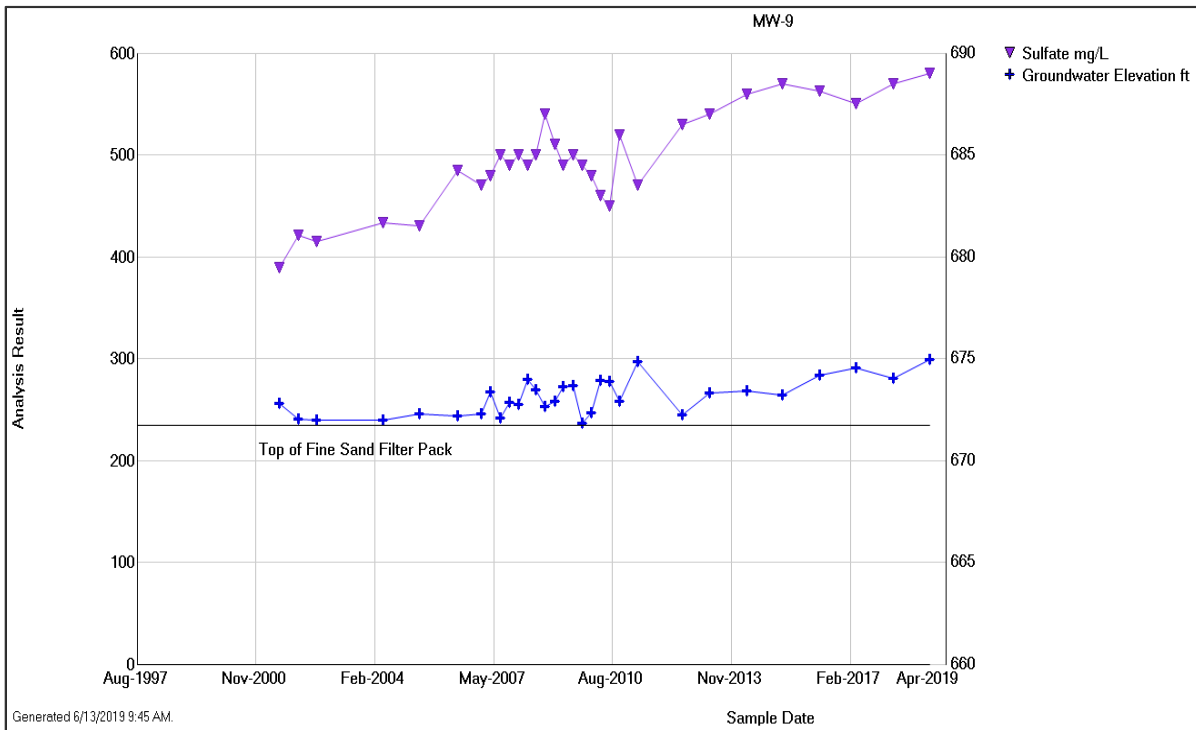
Groundwater concentrations and elevations in MW-9.

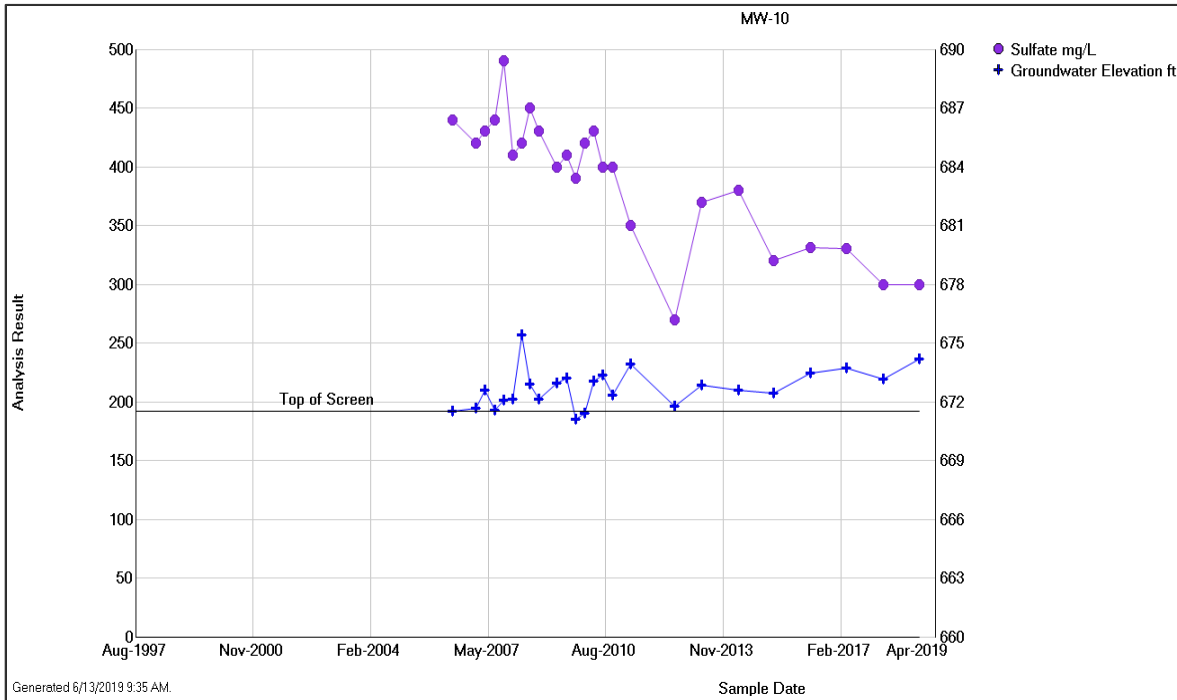
Groundwater concentrations and elevations in MW-10.

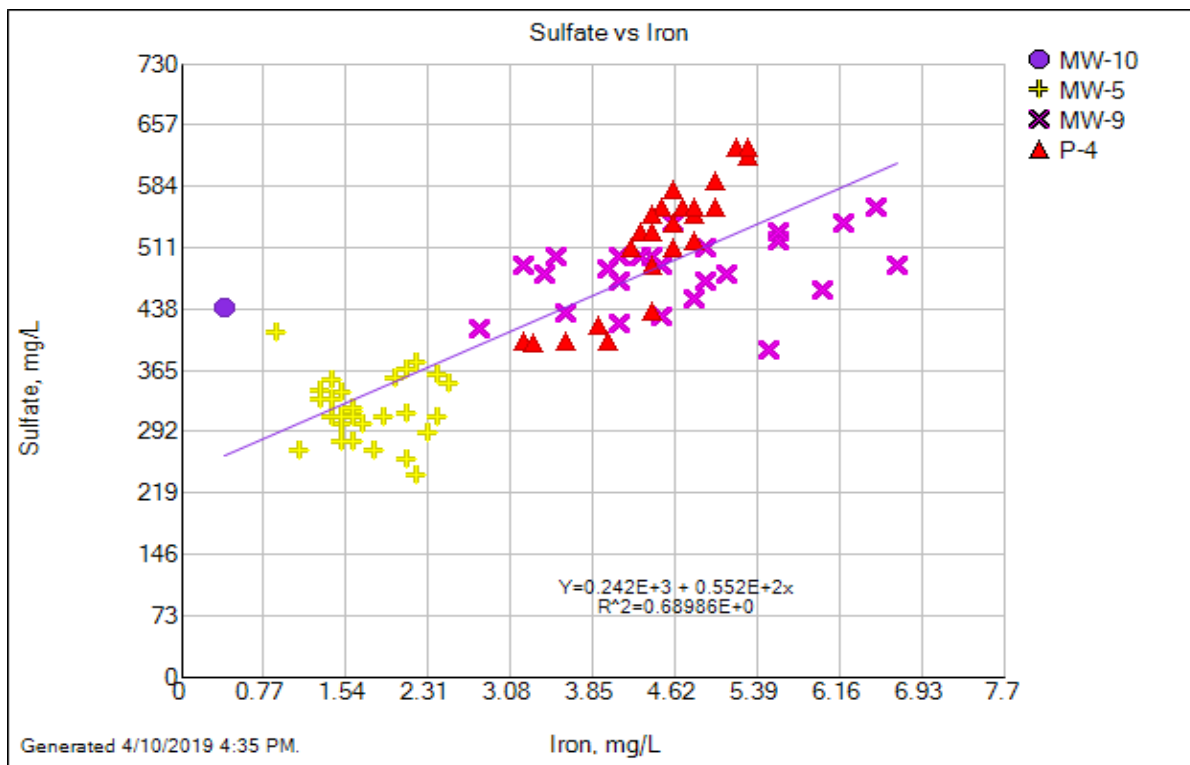
A scatter plot of iron and sulfate concentrations in these wells (below) provides support that pyrite oxidation is occurring because the resulting iron and sulfate concentrations show a relatively high correlation.

Sulfate and iron concentrations in downgradient wells.

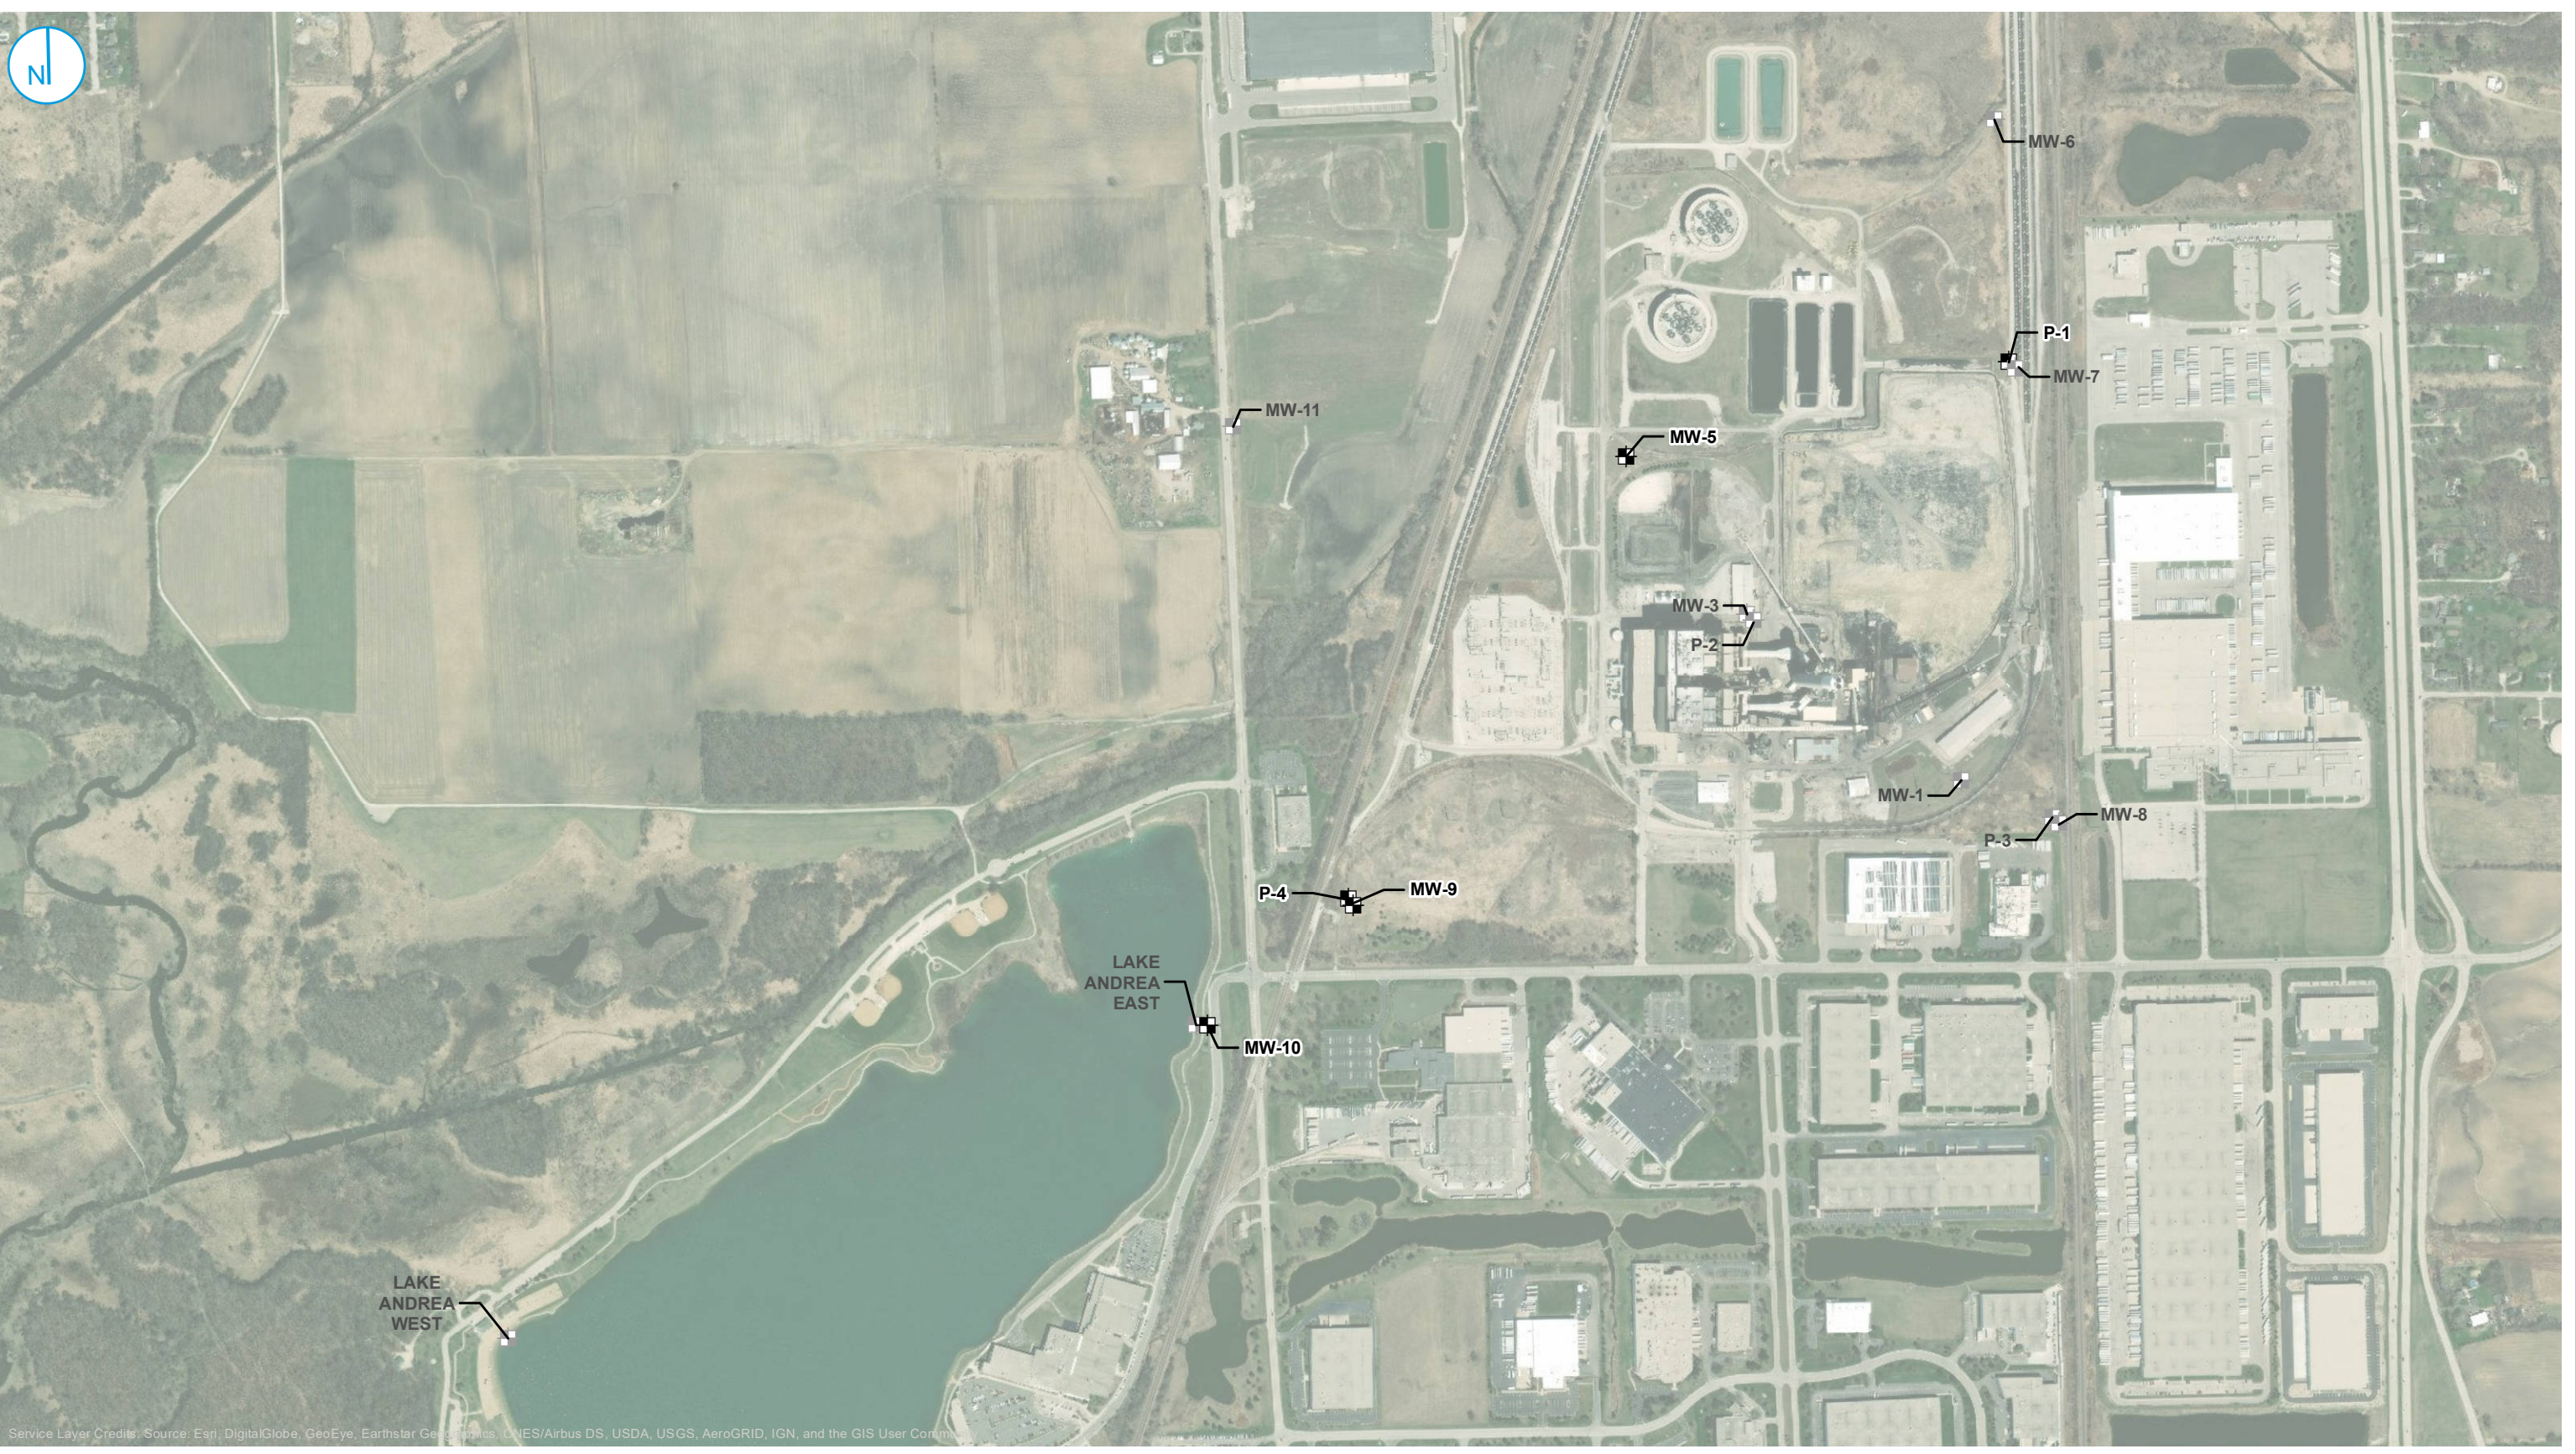
FIGURE 1

MONITORING LOCATIONS

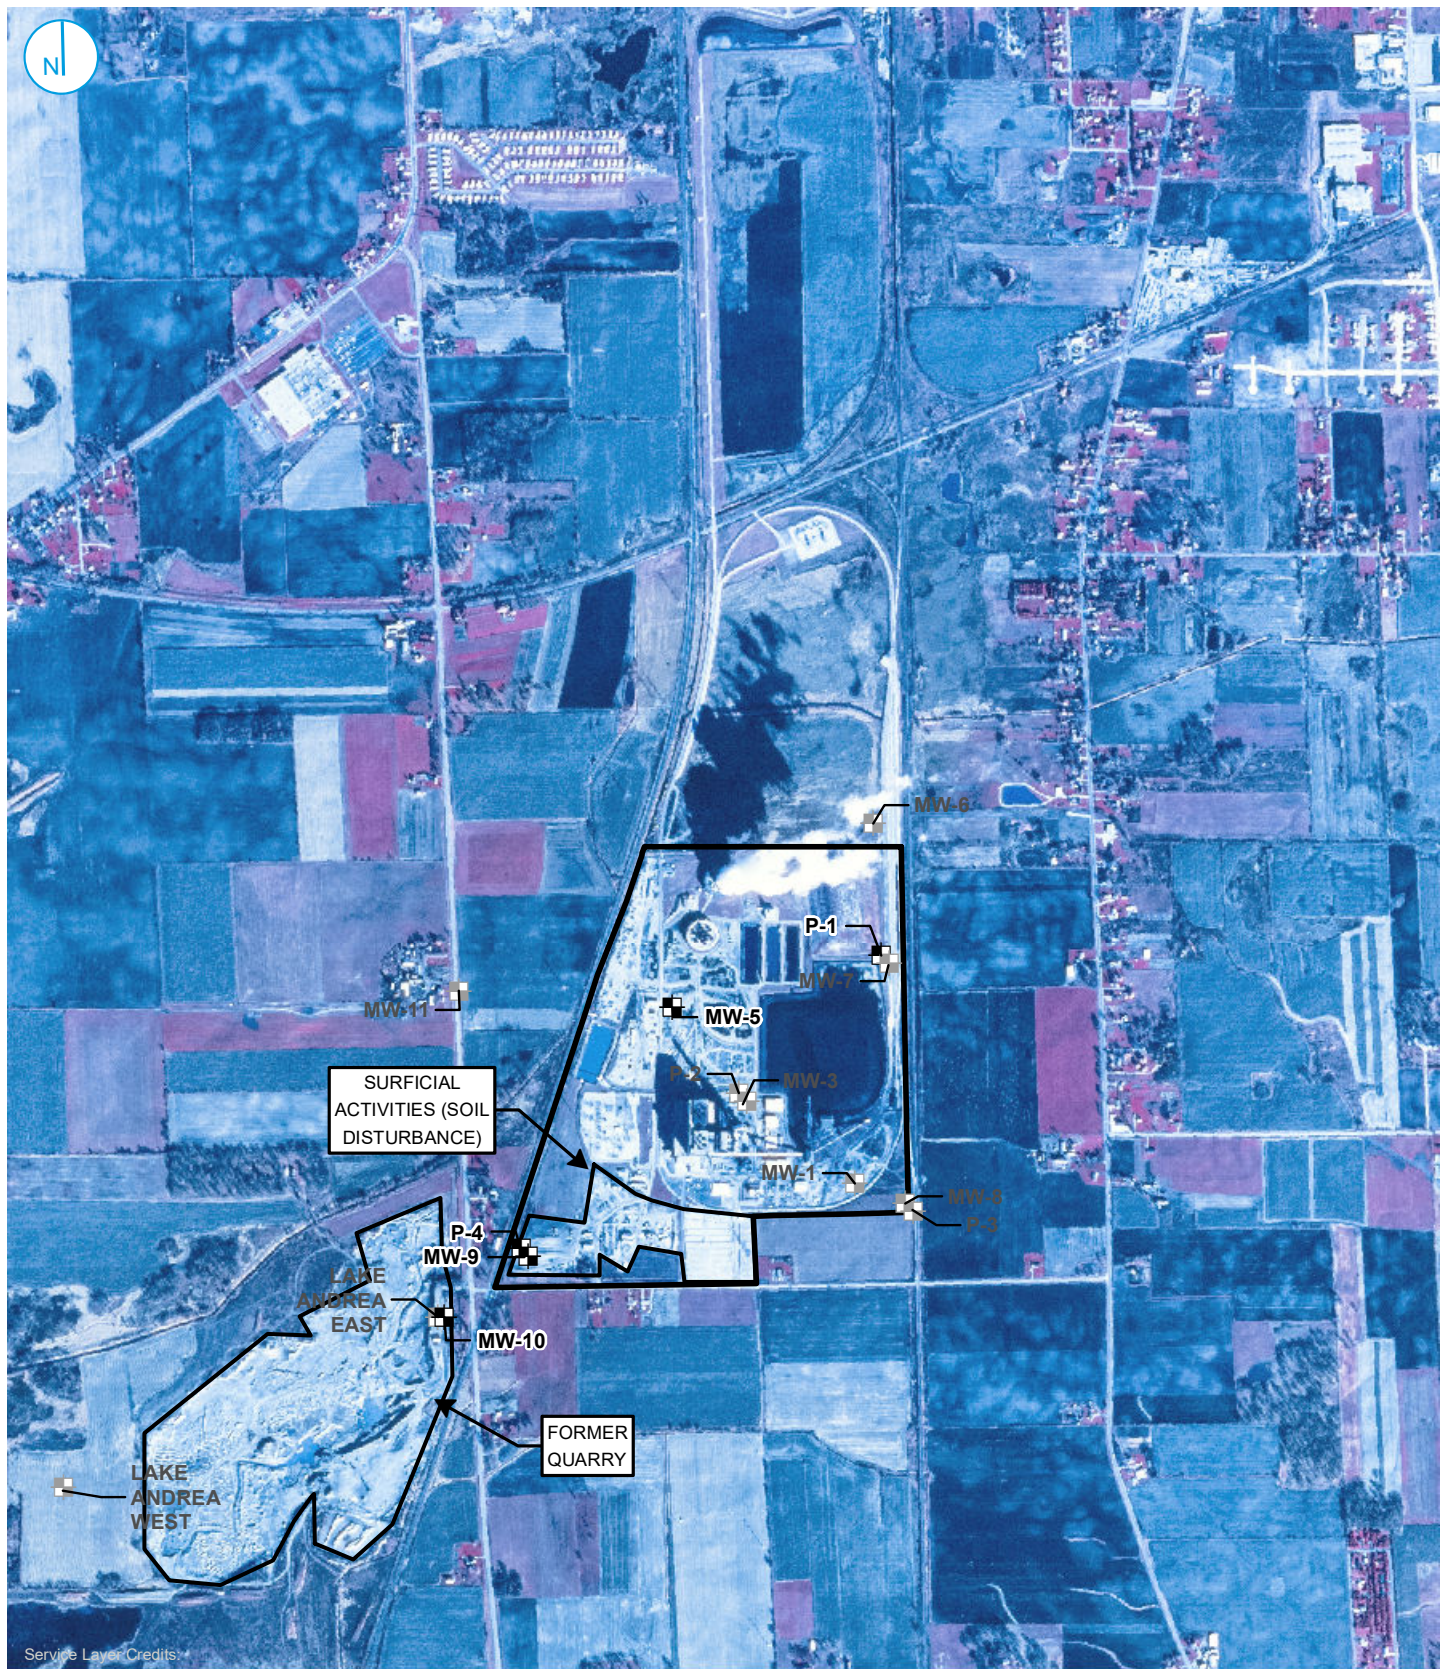
FIGURE 03

1981 IMAGERY

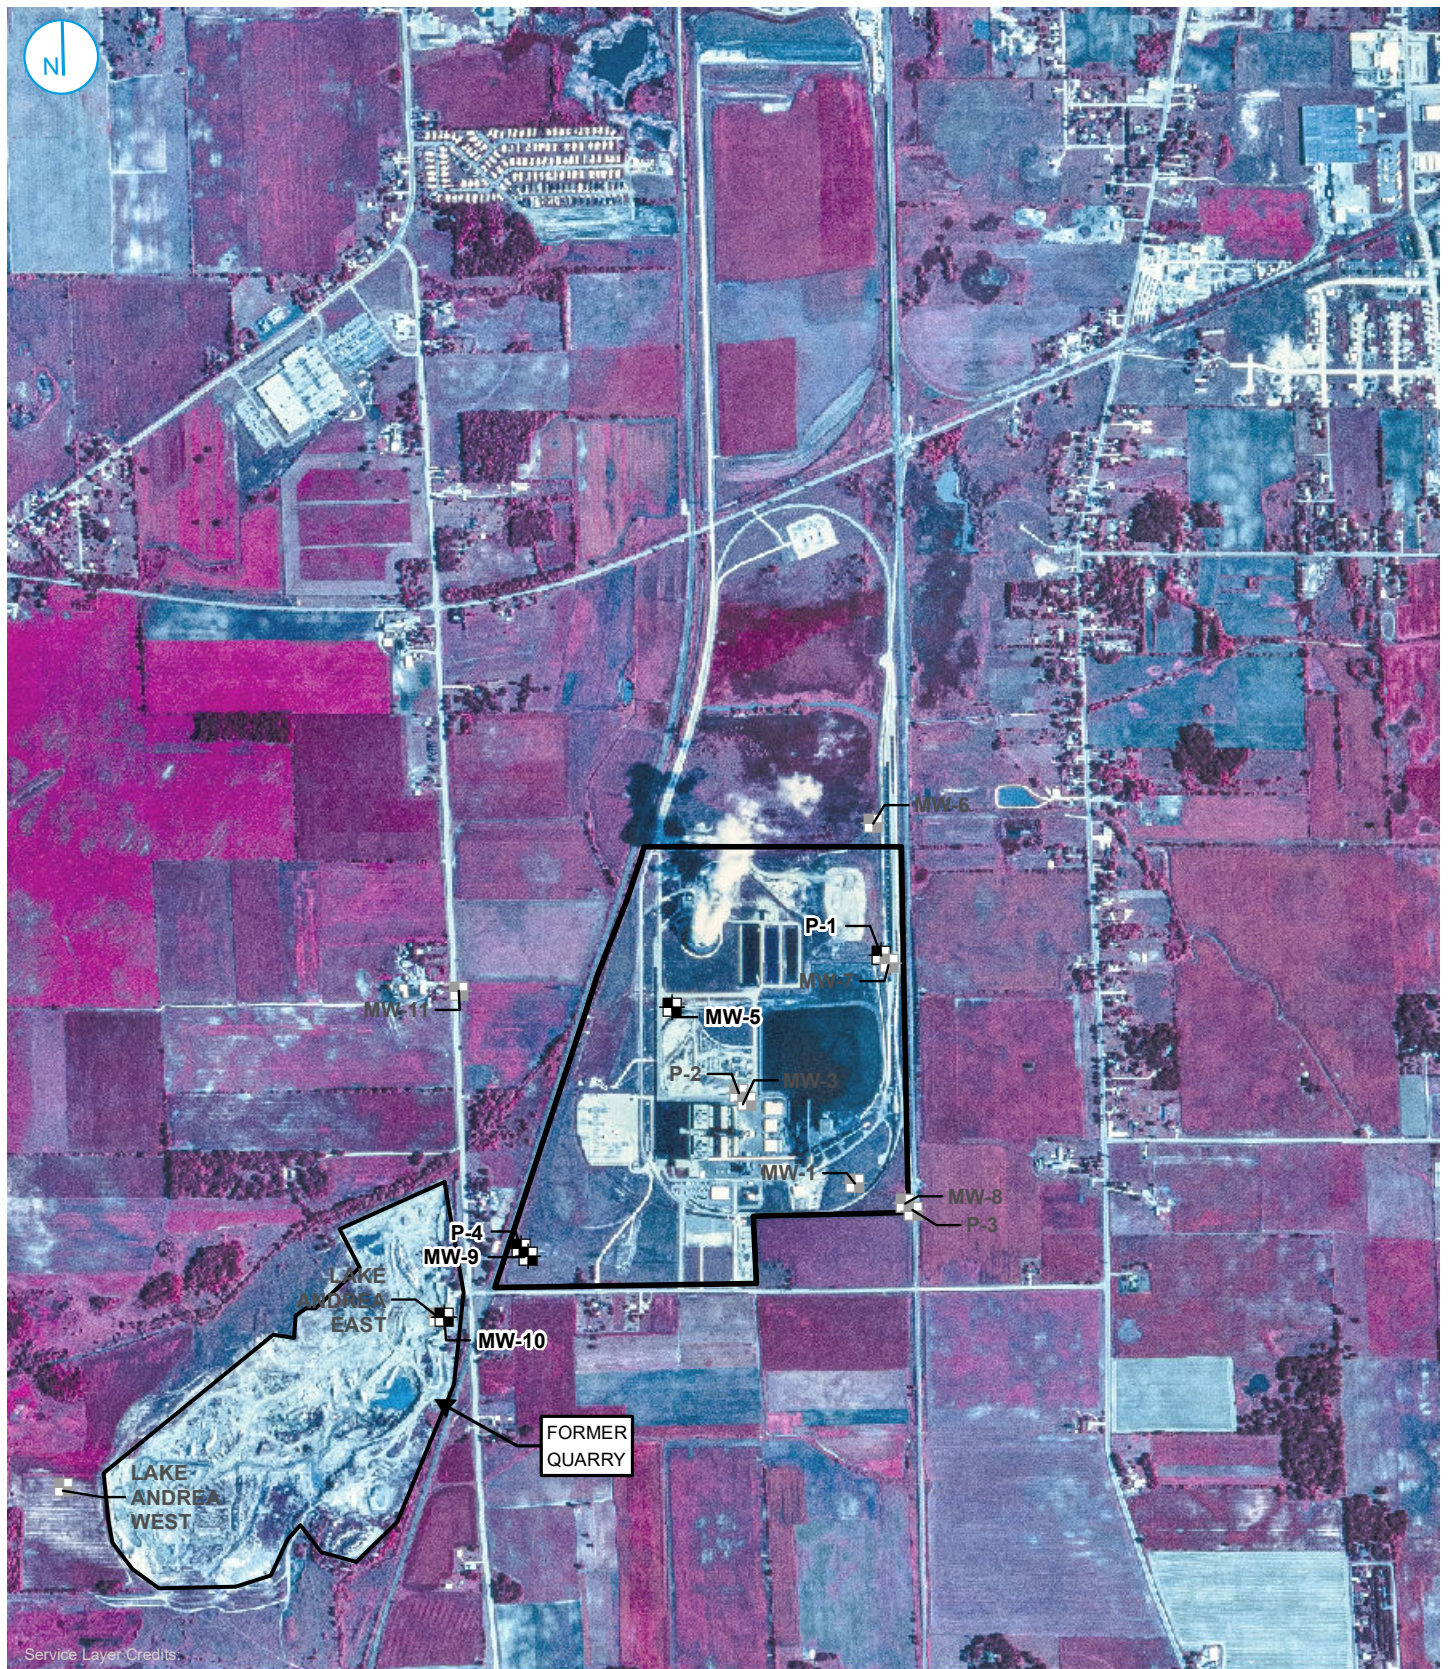
FIGURE 04

1987 IMAGERY

- Pyrite and other sulfide minerals within formerly anaerobic clay till or road base materials (see historic aerials Figures 3 and 4)
- Lake Andrea was a former quarry as shown in historic aerials from 1974 to the 1990's (Figures 3-5), it is unclear what was mined from the quarry, but minerals were exposed to oxidation during the quarrying activities and could result in long term elevated sulfate within the lake

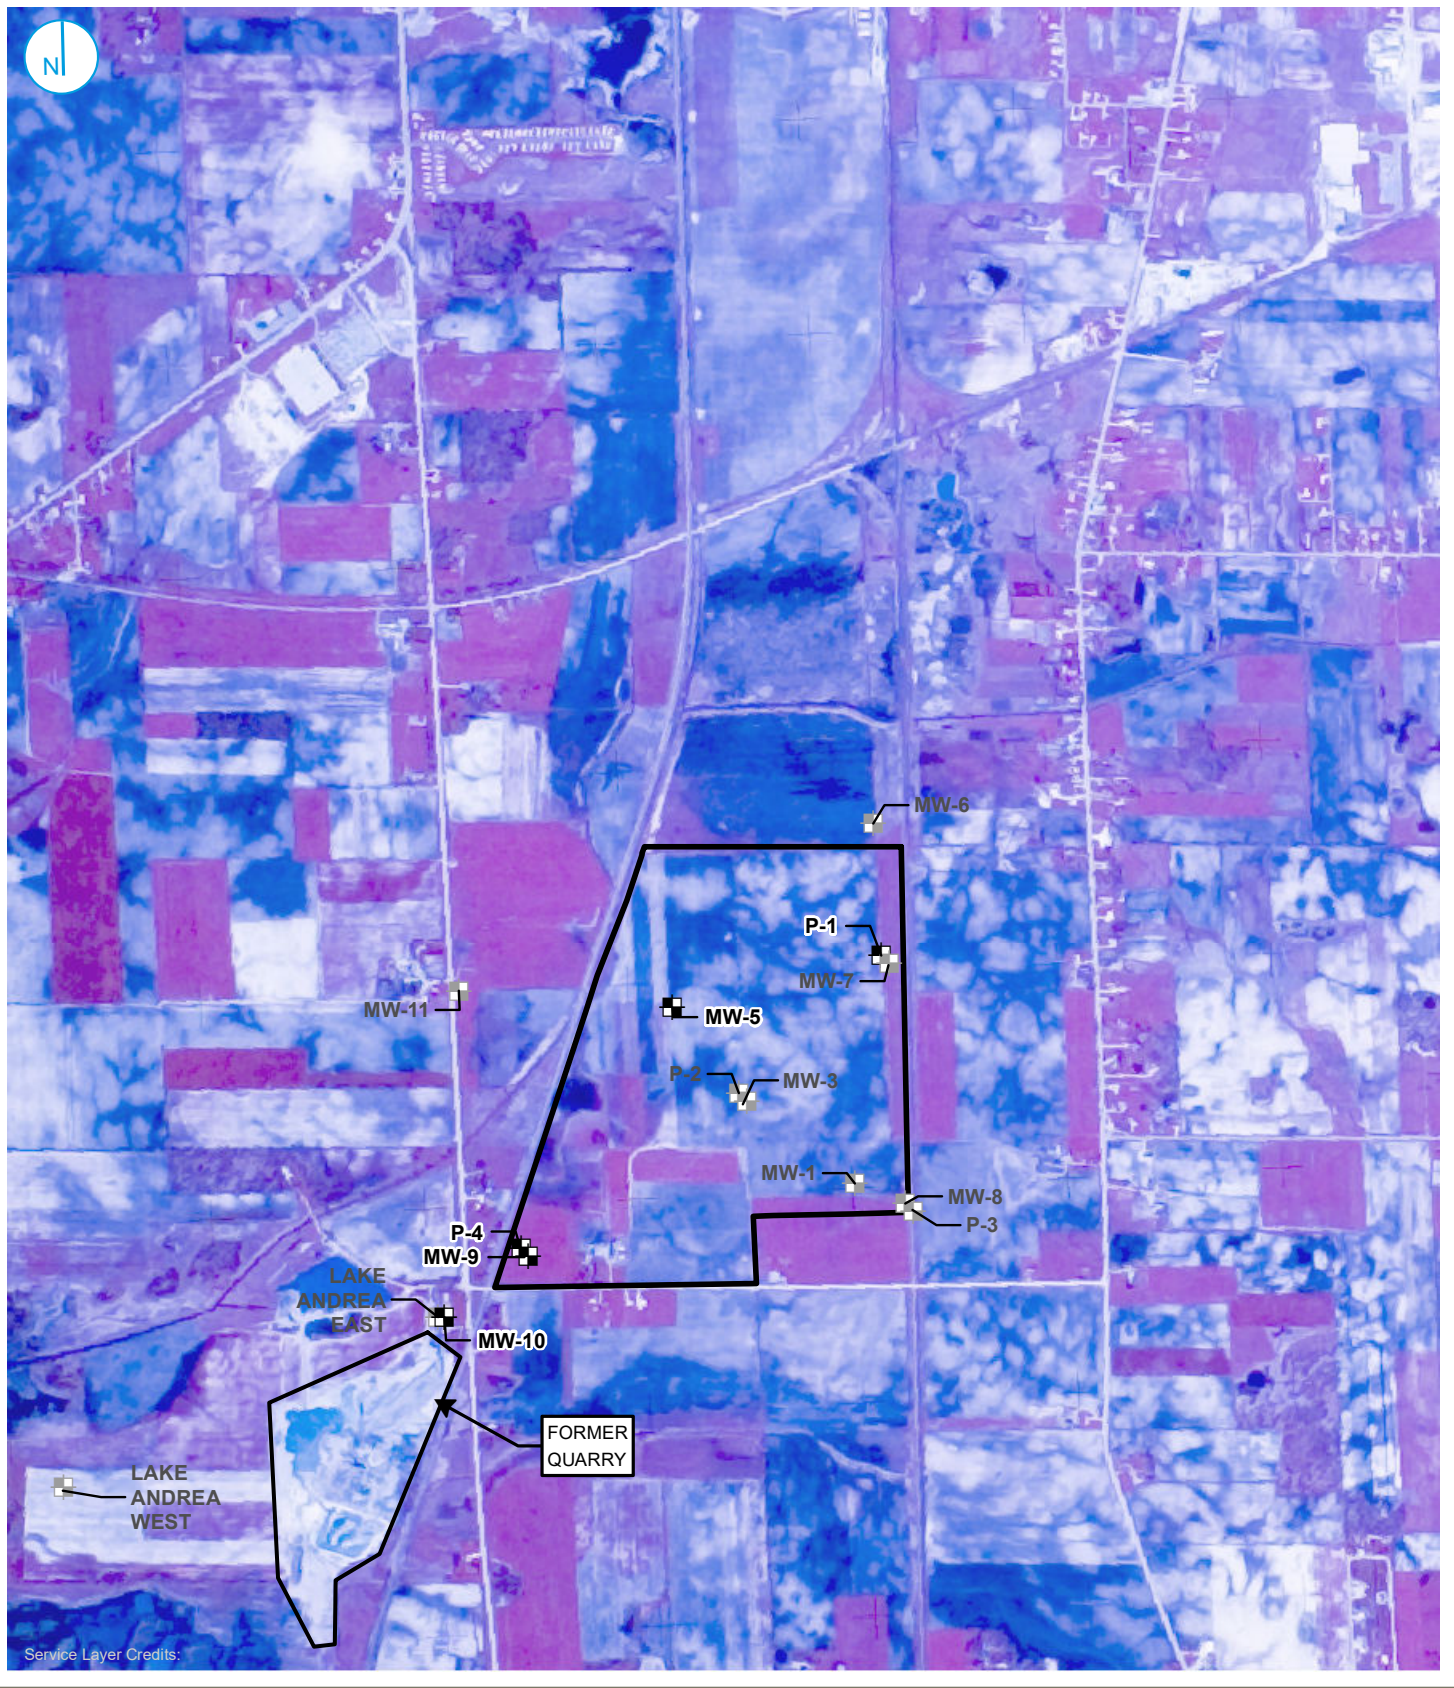
FIGURE 05

1974 IMAGERY
